# **RCRA FACILITY ASSESSMENT REPORT**

**A.A. SYDCOL WASTE TRANSFER FACILITY**

**A.A. SYDCOL, LLC**

Arizona Department of Environmental Quality  
Waste Programs Division  
Solid /Hazardous Waste Section  
Hazardous Waste Permits and Support

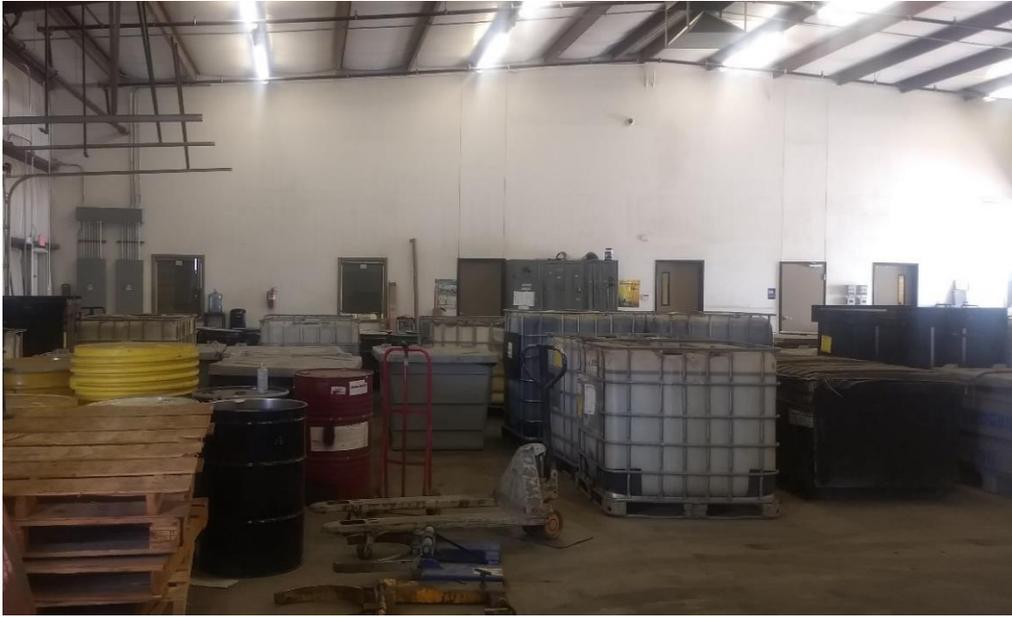
On the eastern end of the central building are the administrative offices and laboratory. They are separated from the warehouse by a fire-rated wall that runs end to end and from floor to roofline (see Figure 10). These offices are cooled by air conditioner. The central building is served by an onsite septic system for collecting sanitary wastes.

*Figure 10 - Warehouse Interior - Fire-rated Wall in Back*

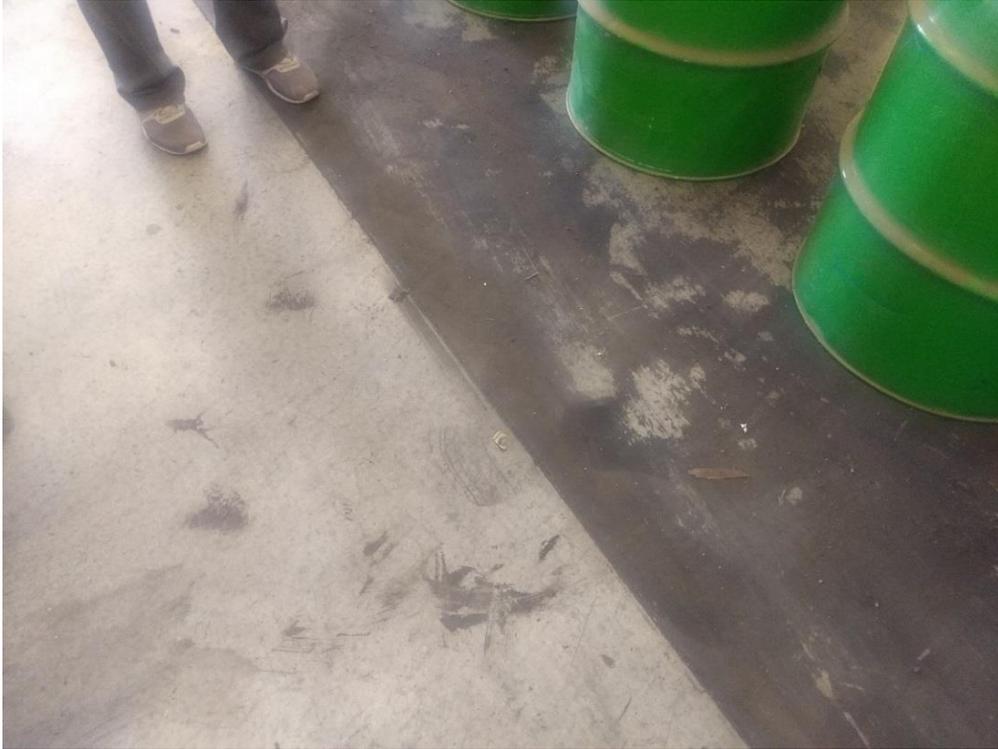
The floor of the warehouse is coated with a black epoxy (see Figure 16). The epoxy coating serves to reduce wear to the concrete and to form a barrier from spills to the underlying porous concrete. During the VSI it was noted that the epoxy was worn in some heavily trafficked areas.

Figures 6 through 15 show the exterior and interior of the building. The interior of the building has a concrete base with epoxy coating, but due to mechanical wear, the epoxy coating was noted to have suffered significant wear (Figure 16). Section 2.2 describes the operations occurring within SWMU1.

*Figure 16 - Epoxy Coating In Warehouse*

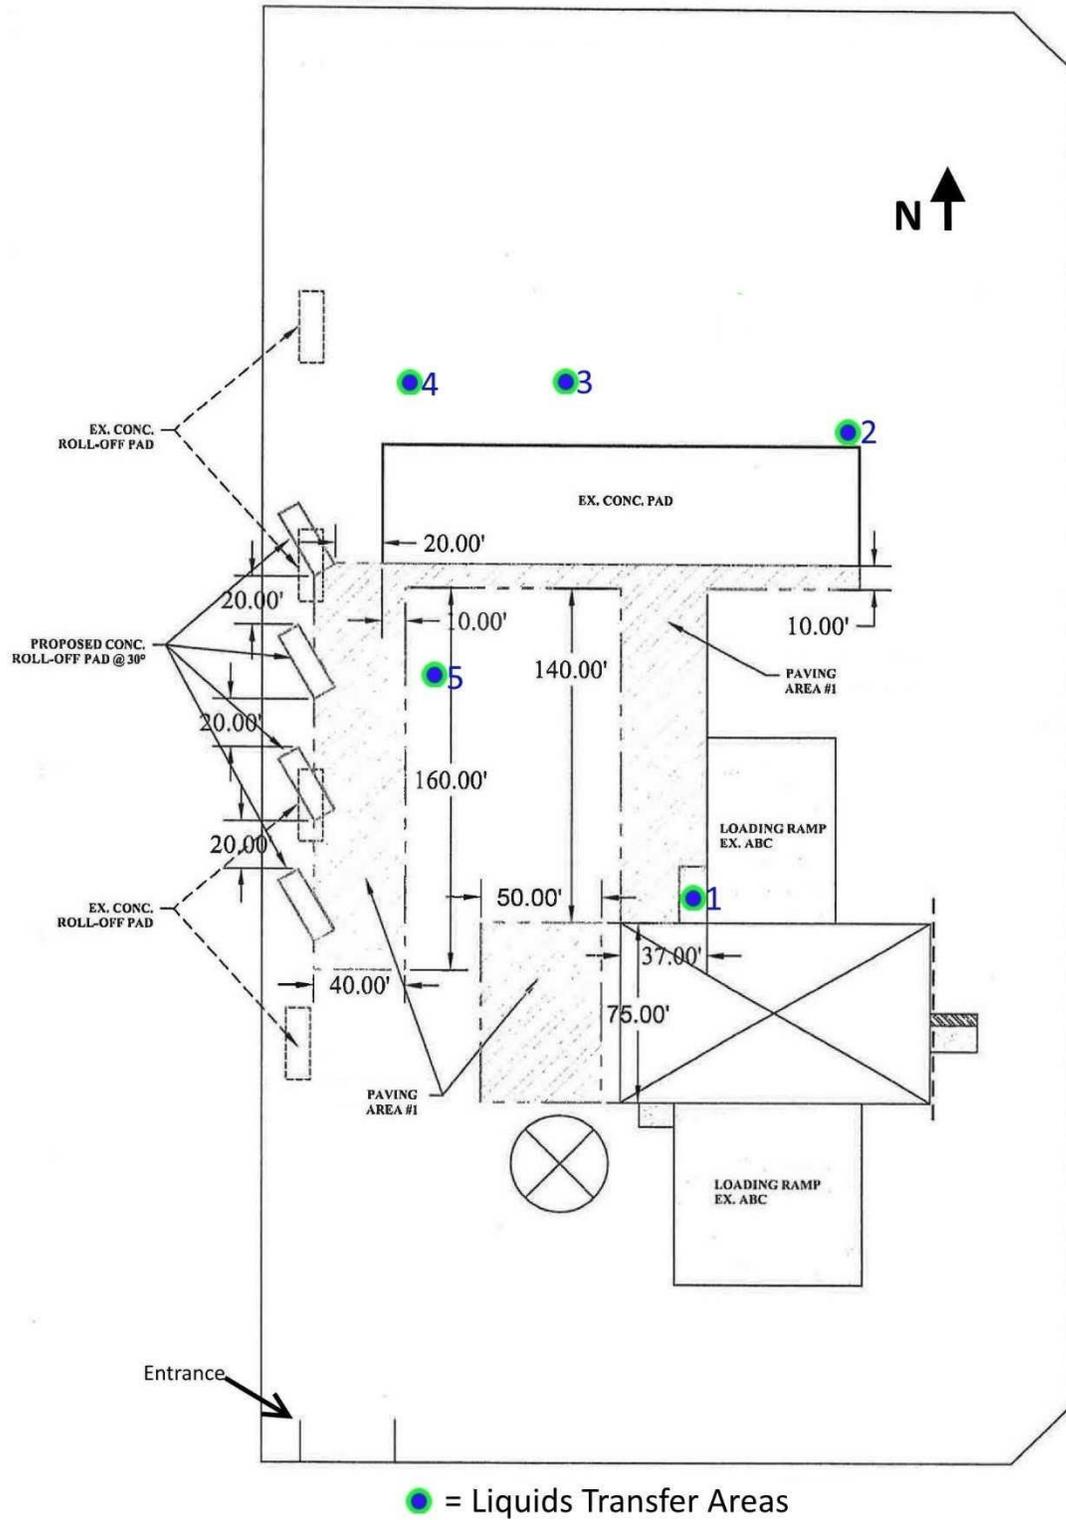
During the VSI ADEQ noted that consolidation of liquid solid wastes was being performed at SWMU2 (see Figure 21), but no spills were observed. There is no history of release of solid wastes at SWMU2. No spills have been reported by AAS.

Figure 21 - Liquids Transfer Areas (August 2018)

SWMU or AOC Number	SWMU or AOC Name	Media	Potential for Release	Recommendation
SWMU 1	Central Building	Soil	Low	None
SWMU 2	Main Outdoor Storage Pad / HWMU3	Soil, Soil Gas	High	Sample soils at locations where liquid consolidation has occurred. Soil solids should be analyzed for metal constituents, Soil gas for VOCs and Semi-VOCs
SWMU 3	Concrete Pads for Bulk Storage	Soil	Medium	Conduct a follow-up visual survey of the former locations of pads, and current locations. Sample soils at any locations with visible staining.
SWMU 4	Outdoor Storage Pad / HWMU1	Soil	Low	None
SWMU 5	Outdoor Storage Pad / HWMU2	Soil	Low	None
SWMU 6	Septic System	Soil, Soil Vapor	Medium	Include in closure plan sampling of areas surrounding septic tank and below underground conduit to the septic tank. Analyze for VOCs, Semi-VOCs, and metals.

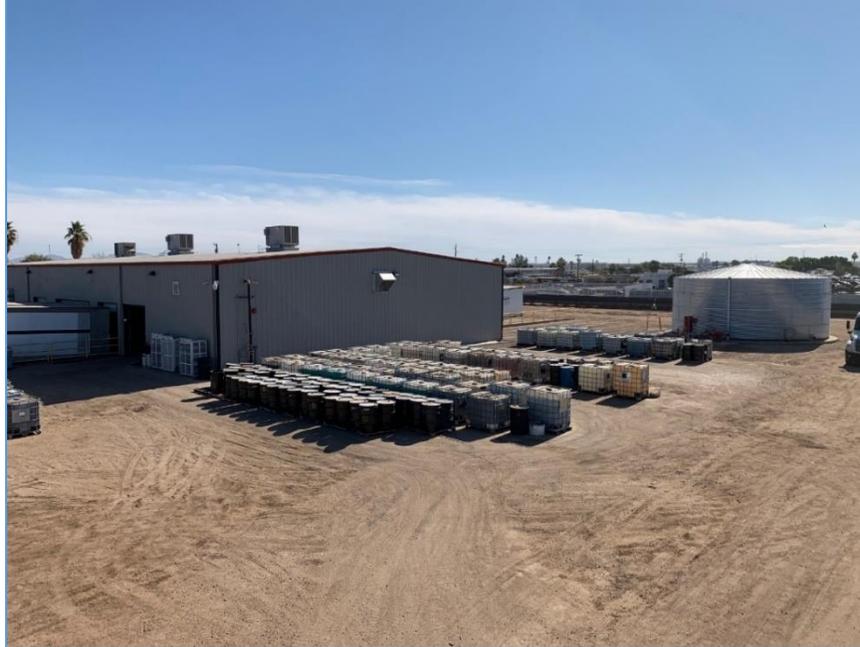
The 2021 Hazardous Waste Permit Application identifies a new outdoor storage pad for hazardous wastes to be located to the west of the Main Building. This pad will have a concrete base and be about 50 feet by 100 feet. It will be sloped towards the southern concrete containment curb; spills and accumulated precipitation will be directed to the rear of the pad at the approximately six inch high berm. Figure 29 shows the location and arrangement of this SWMU.

*Figure 29 - Location of SWMU4 (future HWMU2)*

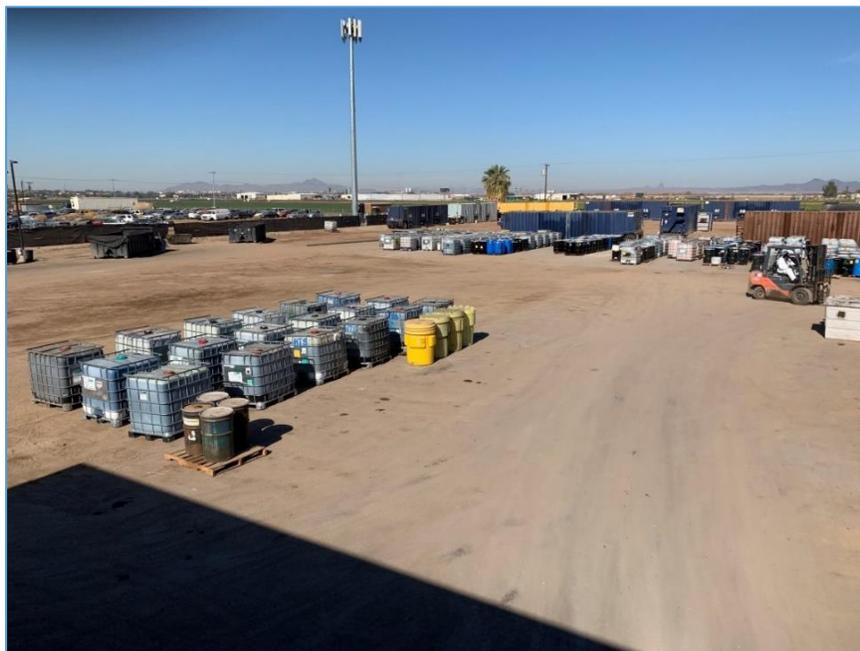
The 2021 Hazardous Waste Permit Application identifies a new outdoor storage pad for hazardous wastes to be located to the north of SWMU4. This pad will have a concrete base and be about 100 feet by 85 feet. The pad will be sloped towards the west. Spills and accumulated precipitation will be directed to the rear of the pad from the northwest to the southwest corners. It is designed to handle all the characteristic and listed hazardous wastes shown in Figure 33 (Table 1 from 2021 Part A application). So long as they are compatible with hazardous wastes, non-hazardous solid wastes may also continue to be managed at this location. Figure 30 shows the location and arrangement of this SWMU. This SWMU is also shown in Figure 34, from the 2021 hazardous waste permit application.

*Figure 30 - Location of SWMU5 (future HWMU3)*
