**SIXTH FIVE-YEAR REVIEW REPORT FOR
MOUNTAIN VIEW MOBILE HOME ESTATES
SUPERFUND SITE
GILA COUNTY, ARIZONA**

United States Corps of Engineers, Seattle District

U.S. Environmental Protection Agency

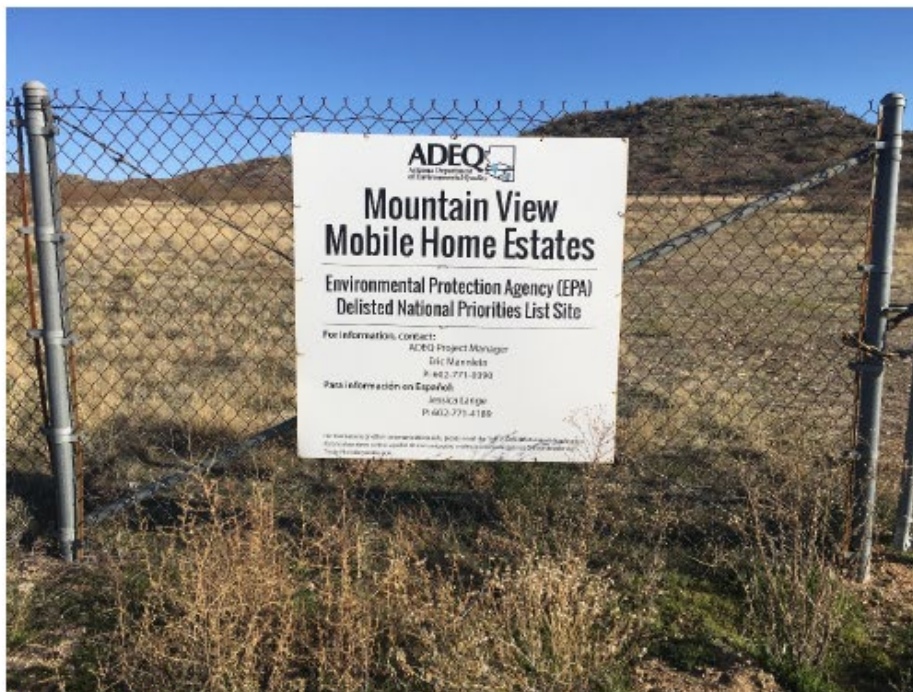
Figure 1 - Southern gate to site, showing new information sign

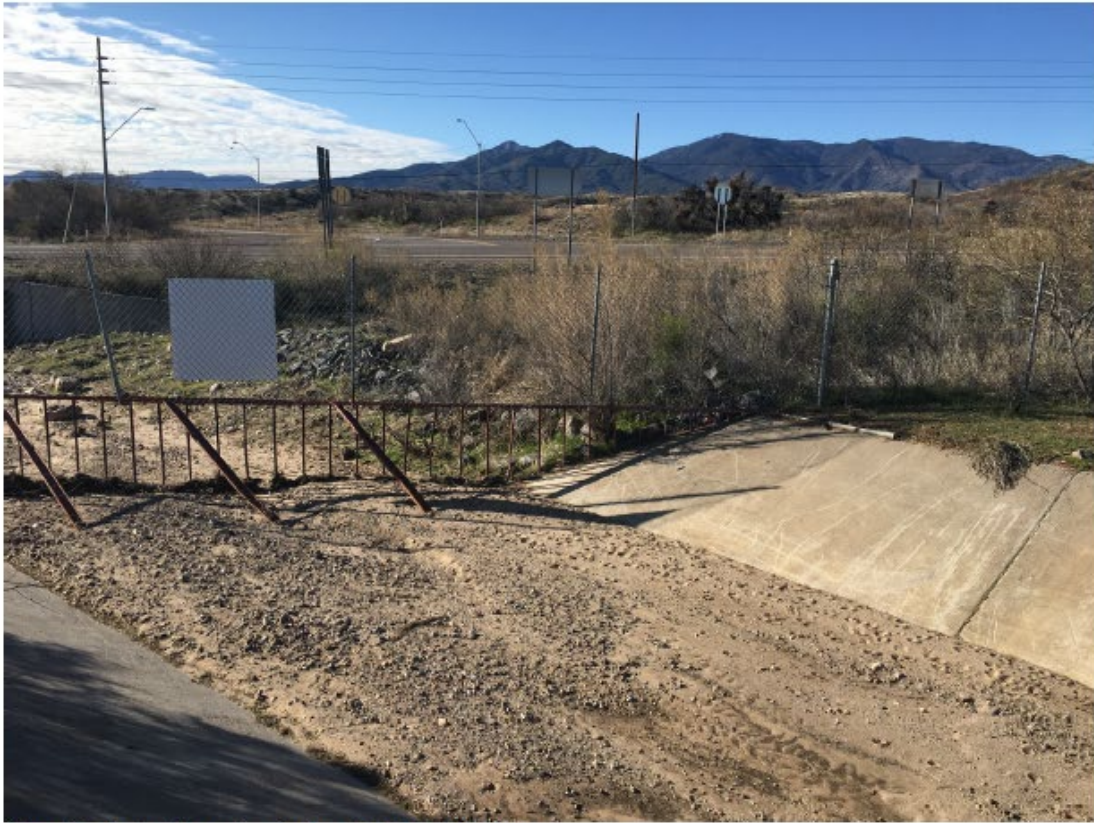
The concrete lined drainage channel that cuts across the site was found to be free of debris, except at the downstream grate, where minor buildup of sediment and debris was present. The downstream grate across the channel at the fence line was modified in 2019 to allow for more debris to pass through. The upstream grate was holding back sediment and debris buildup from off site. The grates both appeared to be functional and in good shape. There was no new evidence of graffiti on the channel walls.

Figure 6 – Grate at fence line, leading to double box culvert

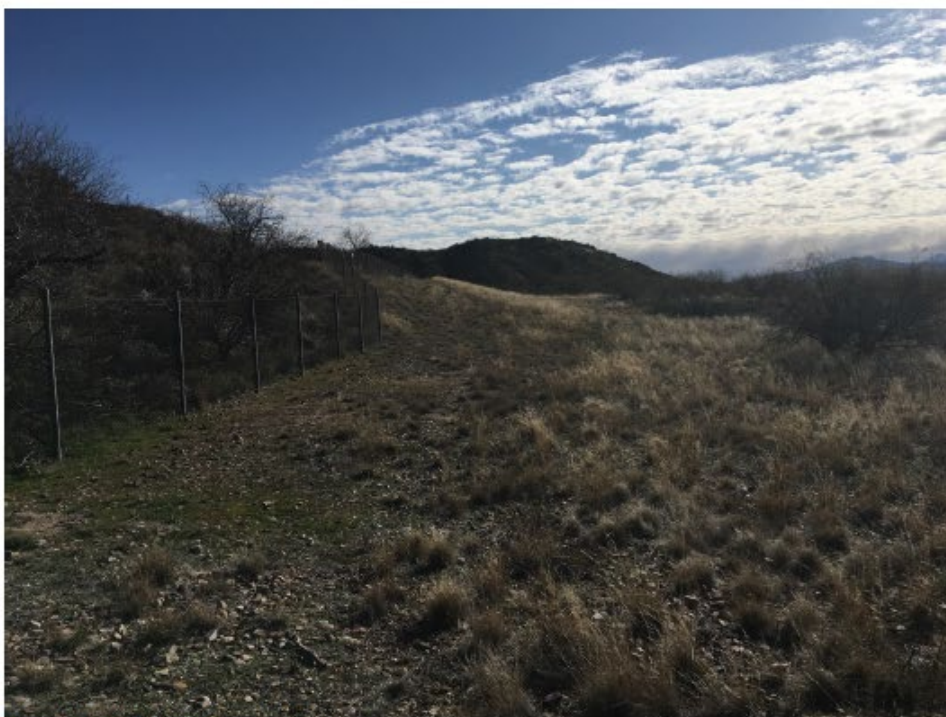
The north boundary of the site was observed, the fence line here runs parallel to the railroad tracks. The fence appeared to be in good working order, no damage or indication of vandalism or trespassing. The gate on the north side of the site was closed and secured. The team passed through this gate to inspect the upstream culvert intakes. These culverts are not within the site boundaries, and are not ADEQ responsibility, but they appear to be functional and help divert storm flows underneath the site.

Figure 8 – North fence line, facing east

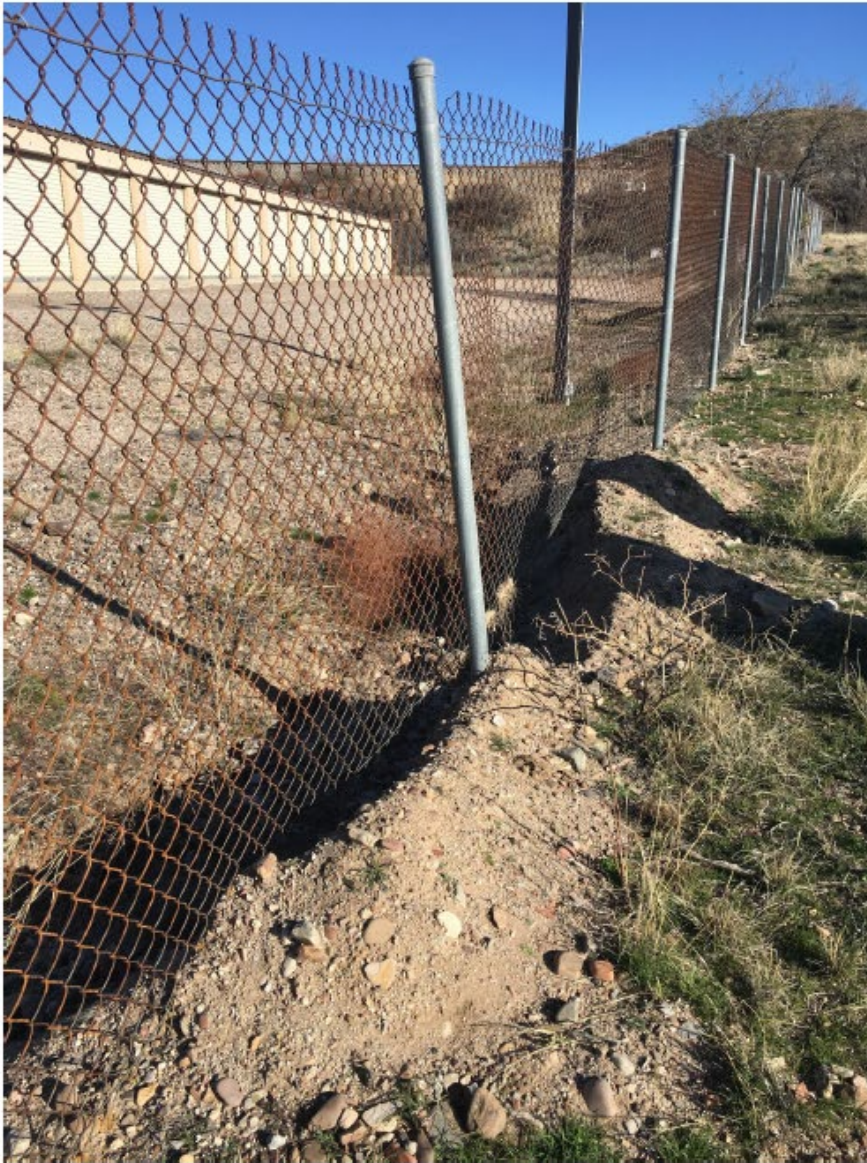
Minor erosion under the fence line was observed on the west side of the site, adjacent to the storage unit property. According to Mr. Mannlein the owner of the storage units has been pushing material up towards the fence. This may be an issue in the future due to runoff from the storage unit site. This potential concern was not currently affecting the protectiveness of the fencing, nor the effectiveness of the cap.

Figure 9 – Fence line near the storage units, showing mounded up material

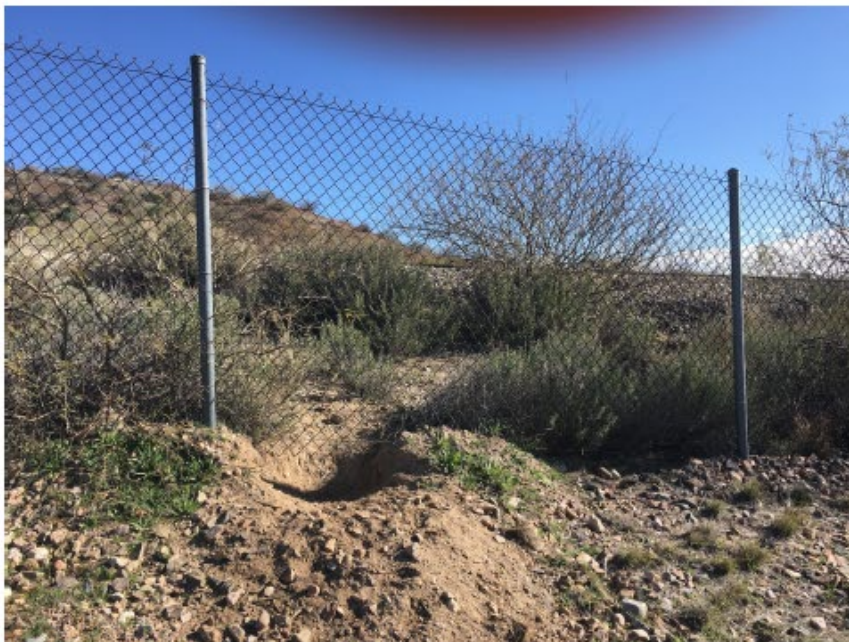
Figure 10 – Animal burrow under north fence line

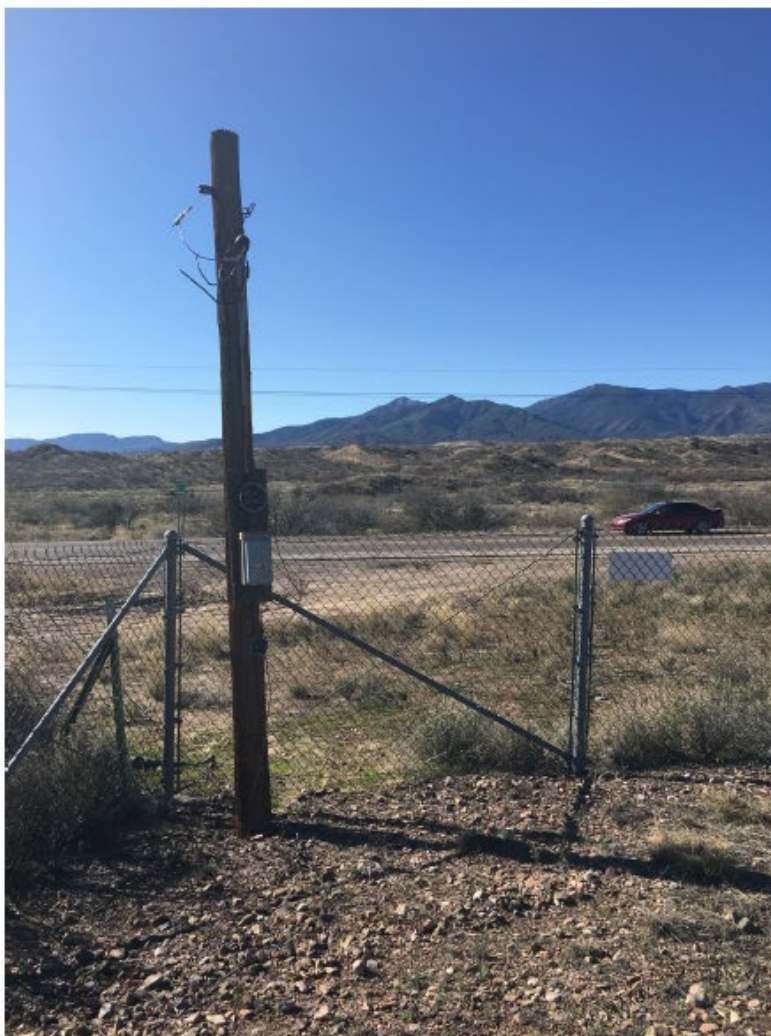
The cap covering the entire site was not noted to be damaged or show signs of erosion. It appears to be adequately protecting the site. A power pole and meter remain in the southernmost corner of the site, remnants of a previous air monitoring station. This pole and associated equipment could be removed. No trash was noticed at the site.

Figure 11 – Power pole and meter, disconnected

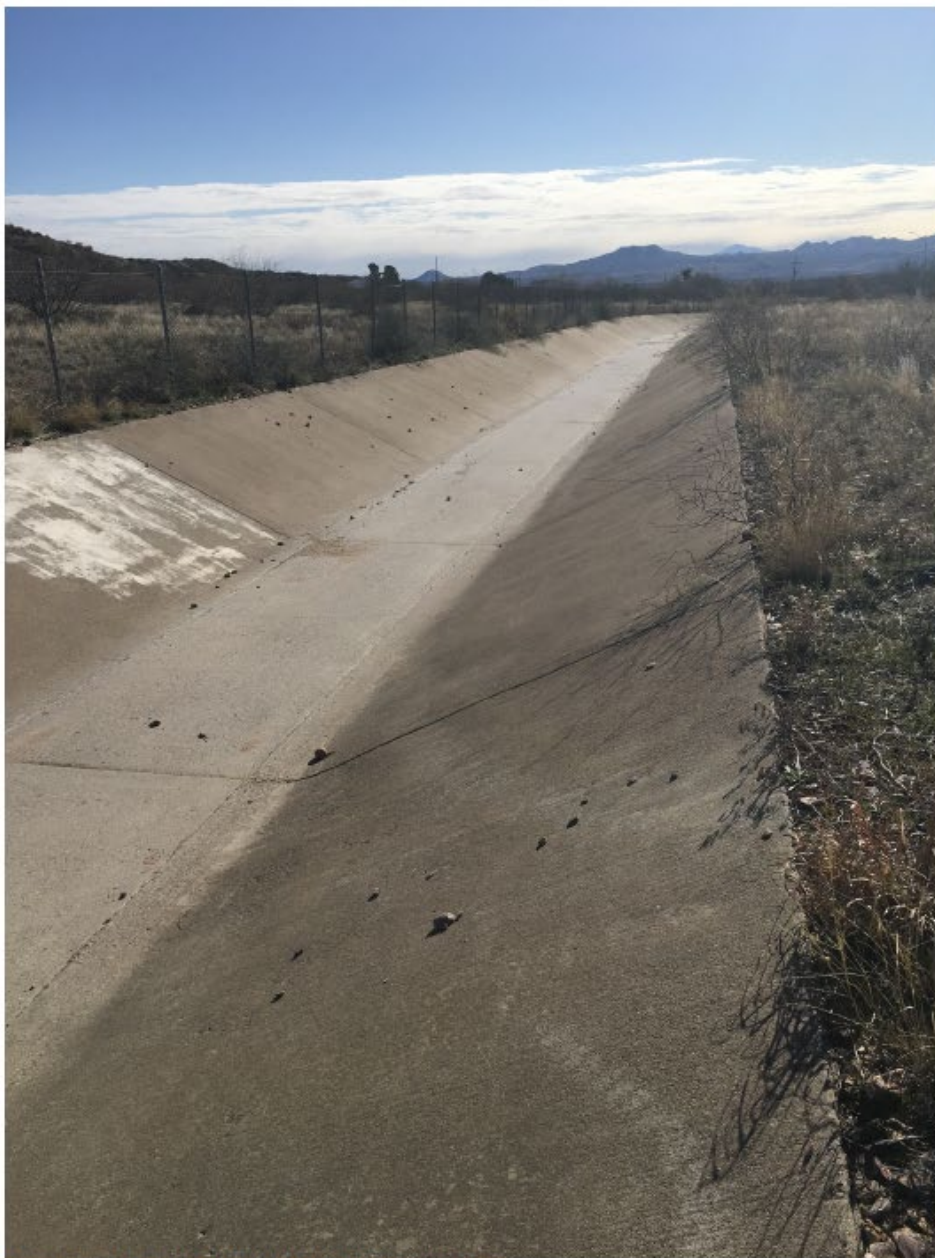
Figure 15 – Concrete lined channel facing downstream

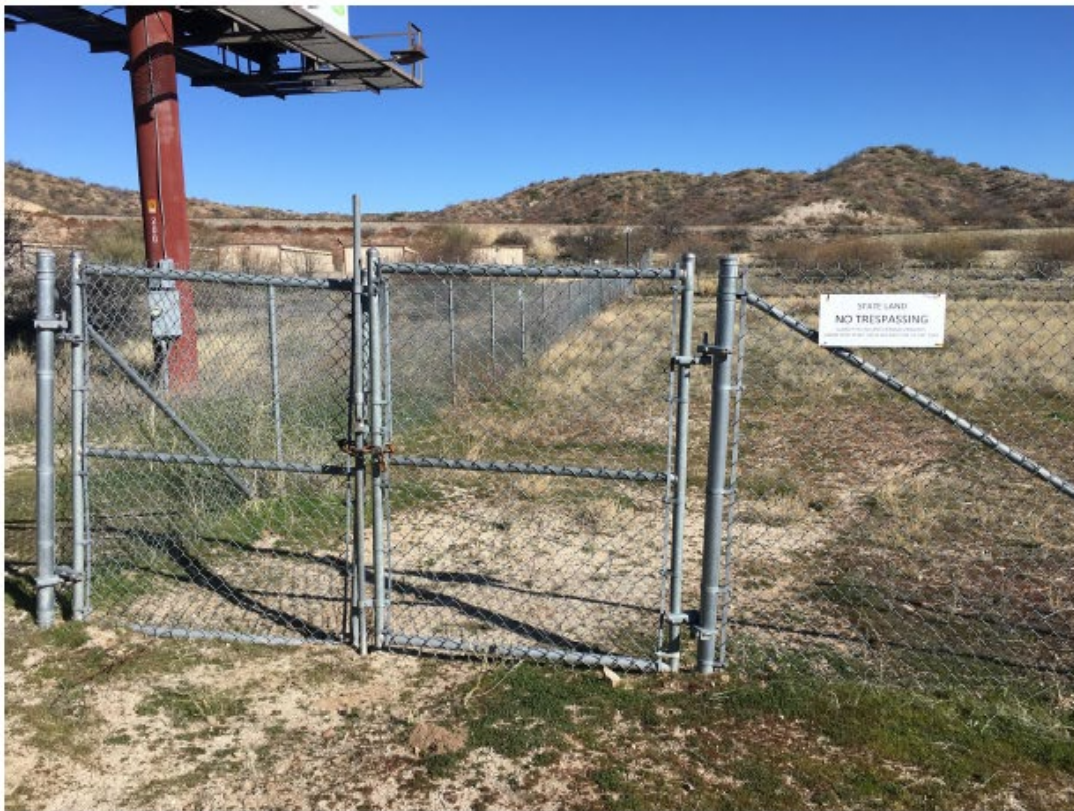
Figure 16 – Secured gate to small parcel
