FIFTH FIVE-YEAR REVIEW REPORT
FOR
HASSAYAMPA LANDFILL SUPERFUND SITE
MARICOPA COUNTY, ARIZONA

PREPARED BY
U.S. Army Corps of Engineers, Seattle District

FOR
U.S. Environmental Protection Agency

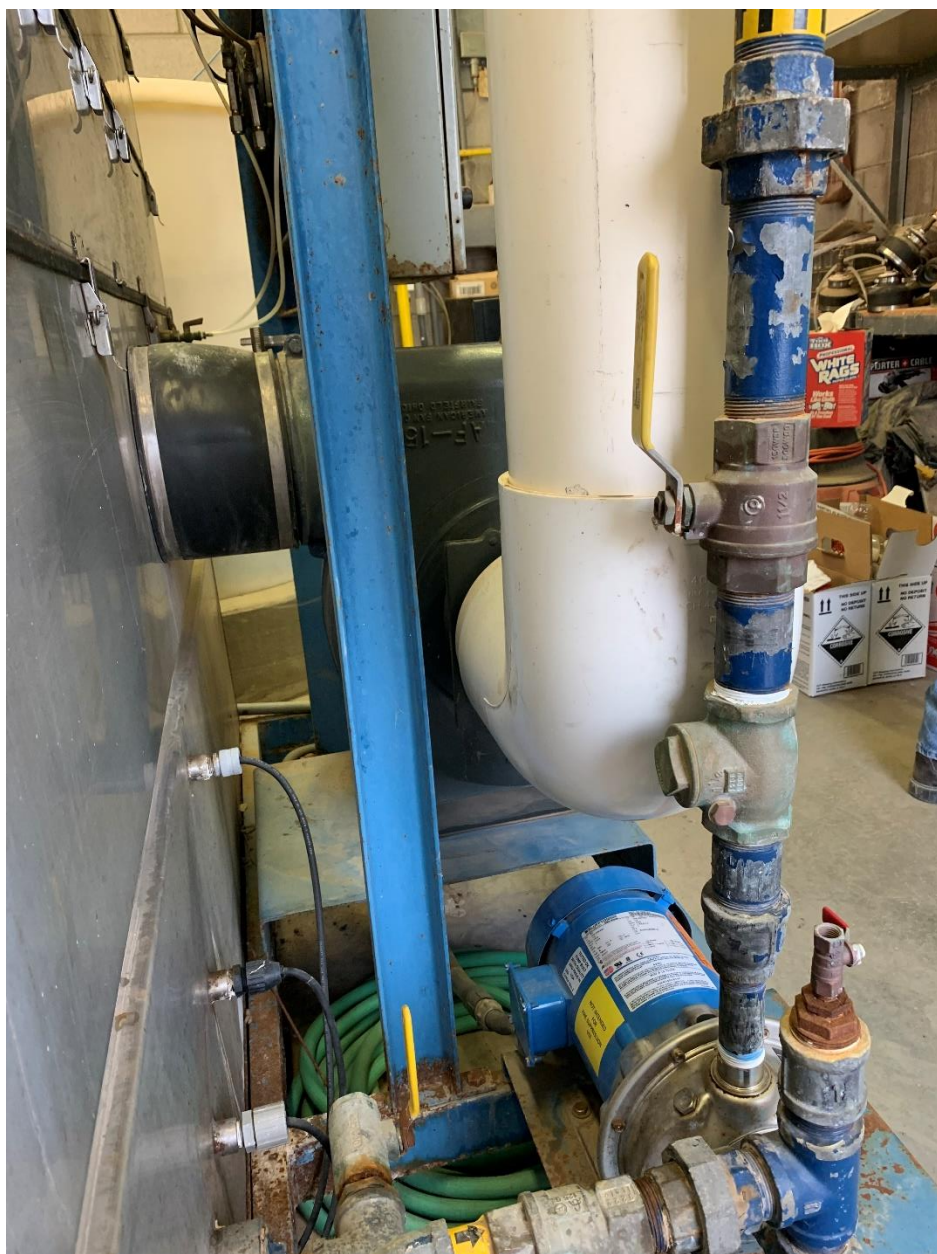
Photo 13 – View of replaced effluent check valve (center right of photo)

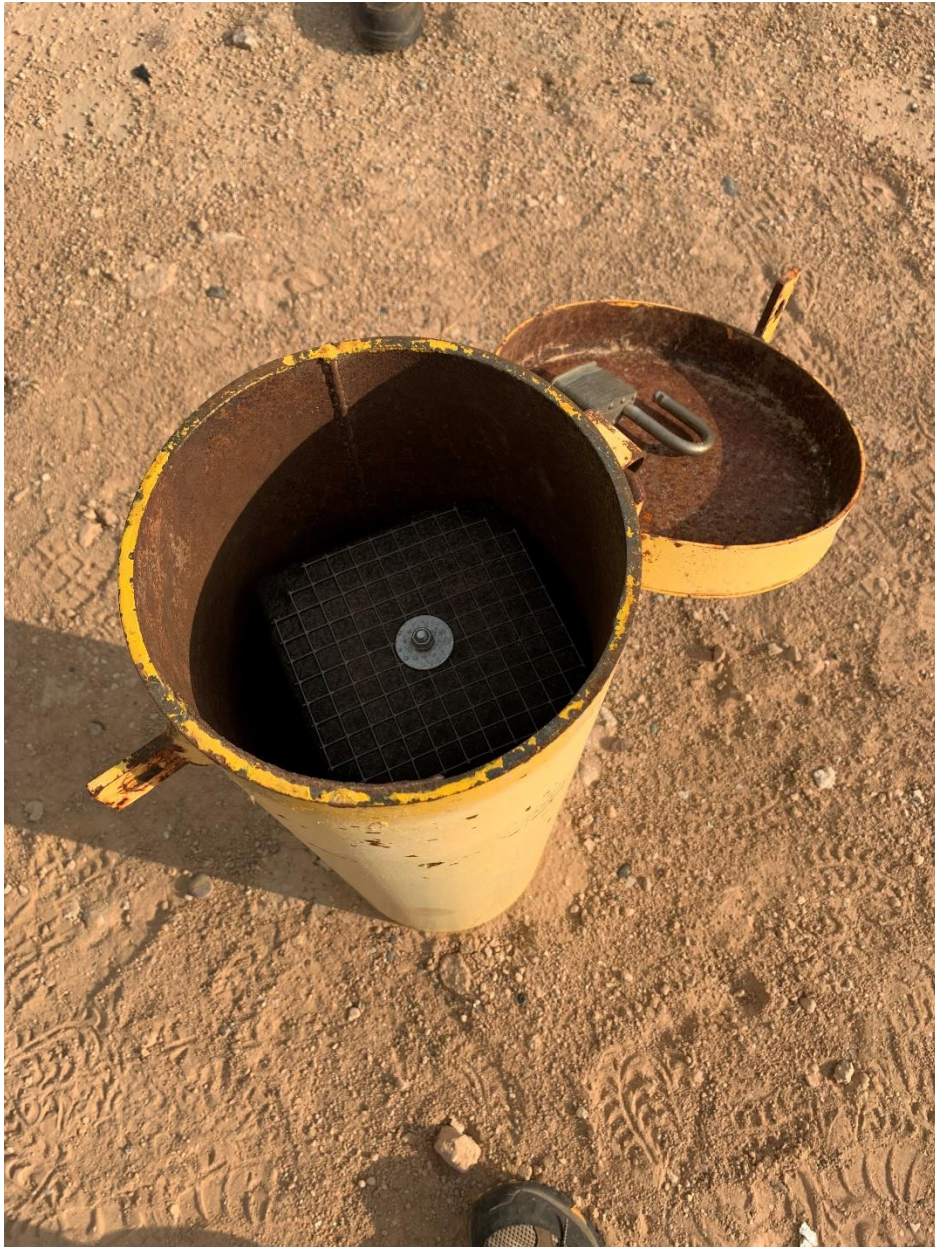
Two monitoring wells (MW-6UA and MW-19UA) located between Pit 1 and the extraction wells had increasing trends during this five-year review period. The greatest increase in concentration was at MW-06UA which had 1,1-DCE increase from 1,700 µg/L in April 2015 to 4,340 µg/L in July 2020. The reason for the increasing trends is not completely understood however it may be caused by groundwater contamination migrating from Pit 1 towards the extraction wells. The wells with increasing trends are within the capture zone so the contamination is expected to be removed by the pump and treat system. The plume migration will continue to be monitored to ensure it does not migrate past the extraction wells.

Photo 19 – Well MW-19UA with hanging passive diffusion bag

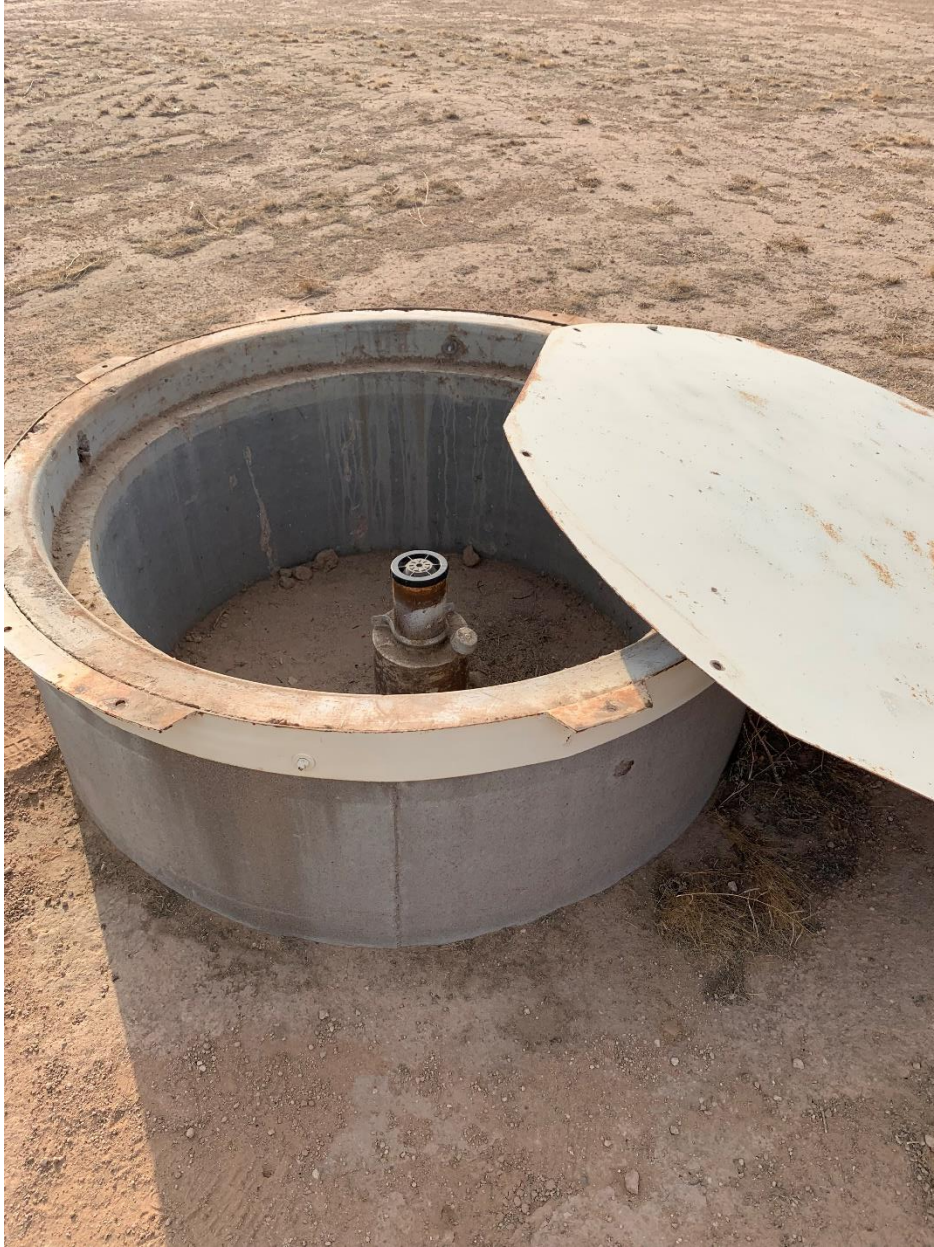
Photo 20 – Well MW-6UA

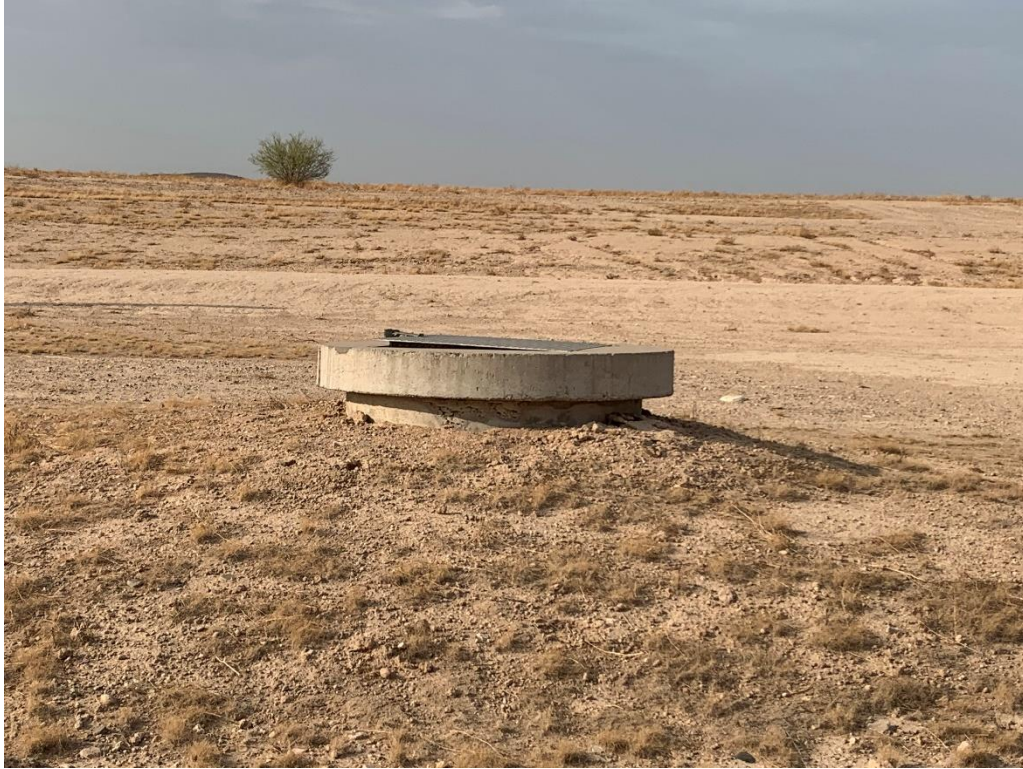
Photo 22 – Extraction well EW-2UA, showing partially closed lid

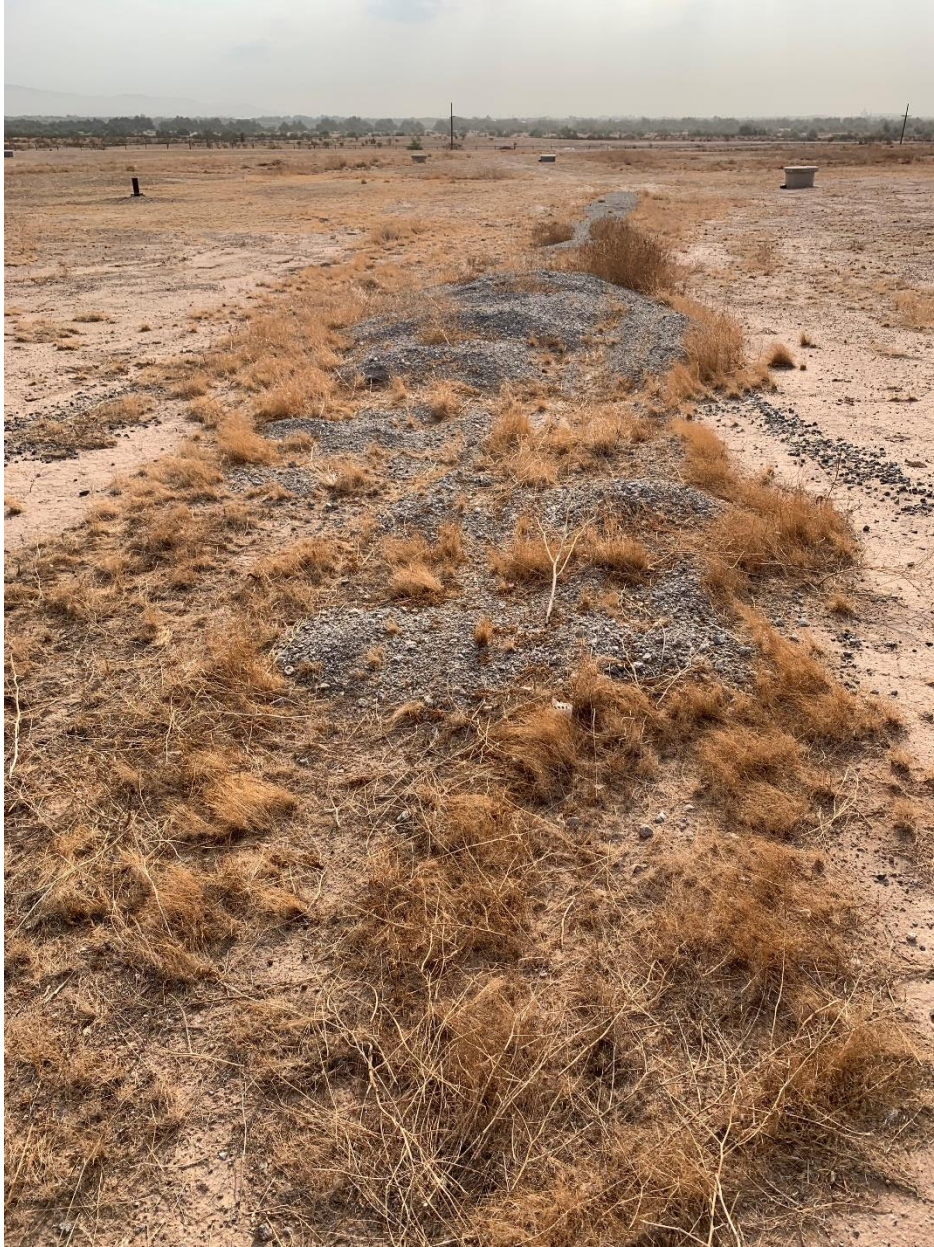
Routine inspections of the cap were performed according to the maintenance requirements to ensure the integrity of the cap such as to identify potential damage by erosion and monitor rodent control measures. Minor recurring erosion issues were identified near the main gate of the Site in 2020. As in the past, this issue has been addressed in a reasonable timeframe by the County who assists the Hassayampa Steering Committee with minor repairs. These areas of recurring erosion are related to runoff from the adjacent closed municipal solid waste landfill area during major rain events and efforts to find a permanent solution are ongoing. Pest control was conducted monthly for the Site, and additional measures were taken if needed to address periodic rodent activity.

Photo 25- Gravel placed over minor erosion area, downgradient of main gate, facing east

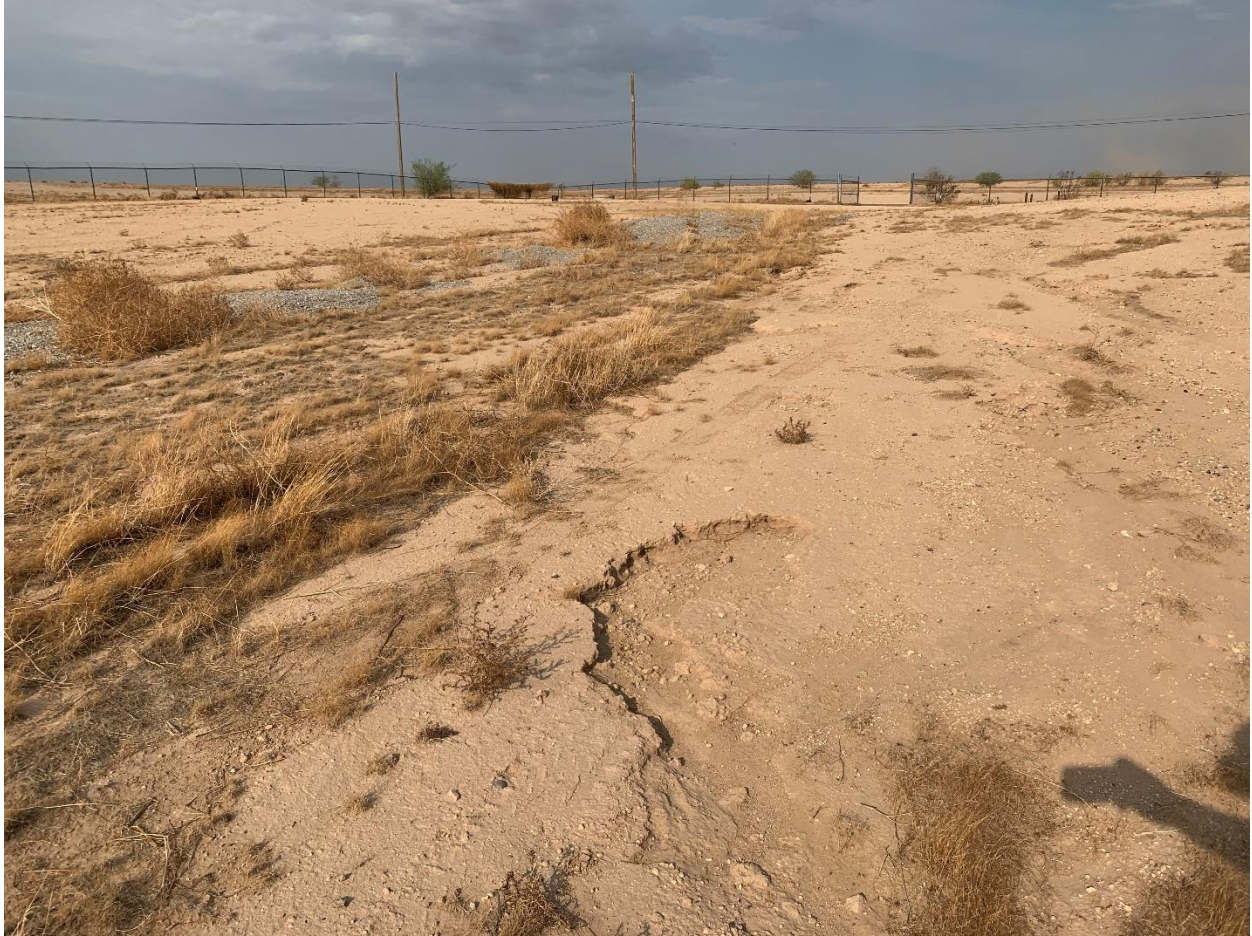
26- View towards main gate, facing west, showing minor erosion

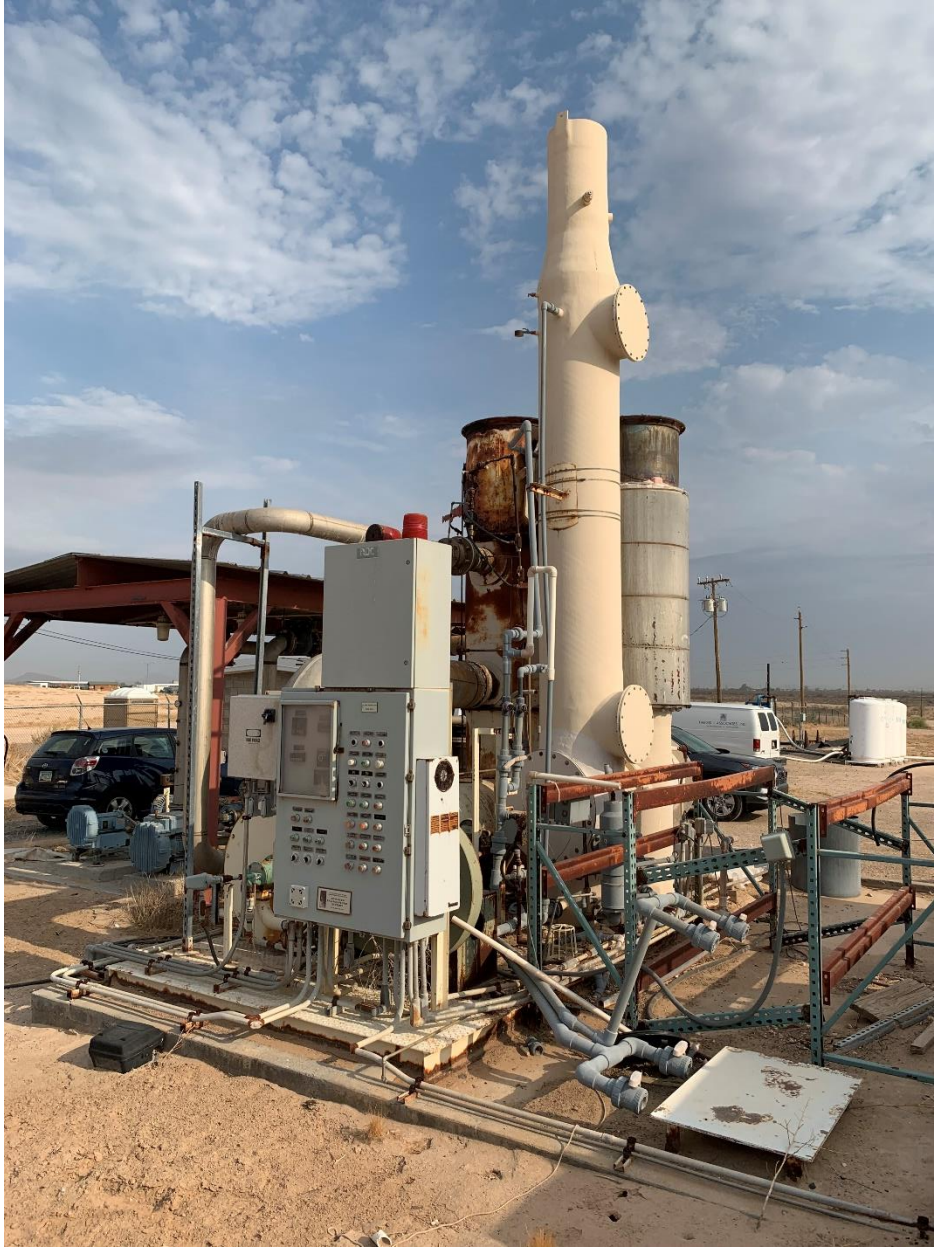
The Hassayampa Steering Committee operated the first soil vapor extraction system intermittently between 1996 to September 1998. In March 1999, the thermal oxidation treatment system was shut down after it failed several compliance tests for destruction efficiency (contaminant destruction) the previous year. Approximately 3,700 pounds of volatile organic compound contaminants were removed from the subsurface soils between 1996 and 1998.

27- Formerly used thermal oxidation system
