**THIRD FIVE-YEAR REVIEW REPORT FOR
INDIAN BEND WASH SUPERFUND SITE
MARICOPA COUNTY, ARIZONA**

U.S. Army Corps of Engineers

U.S. Environmental Protection Agency

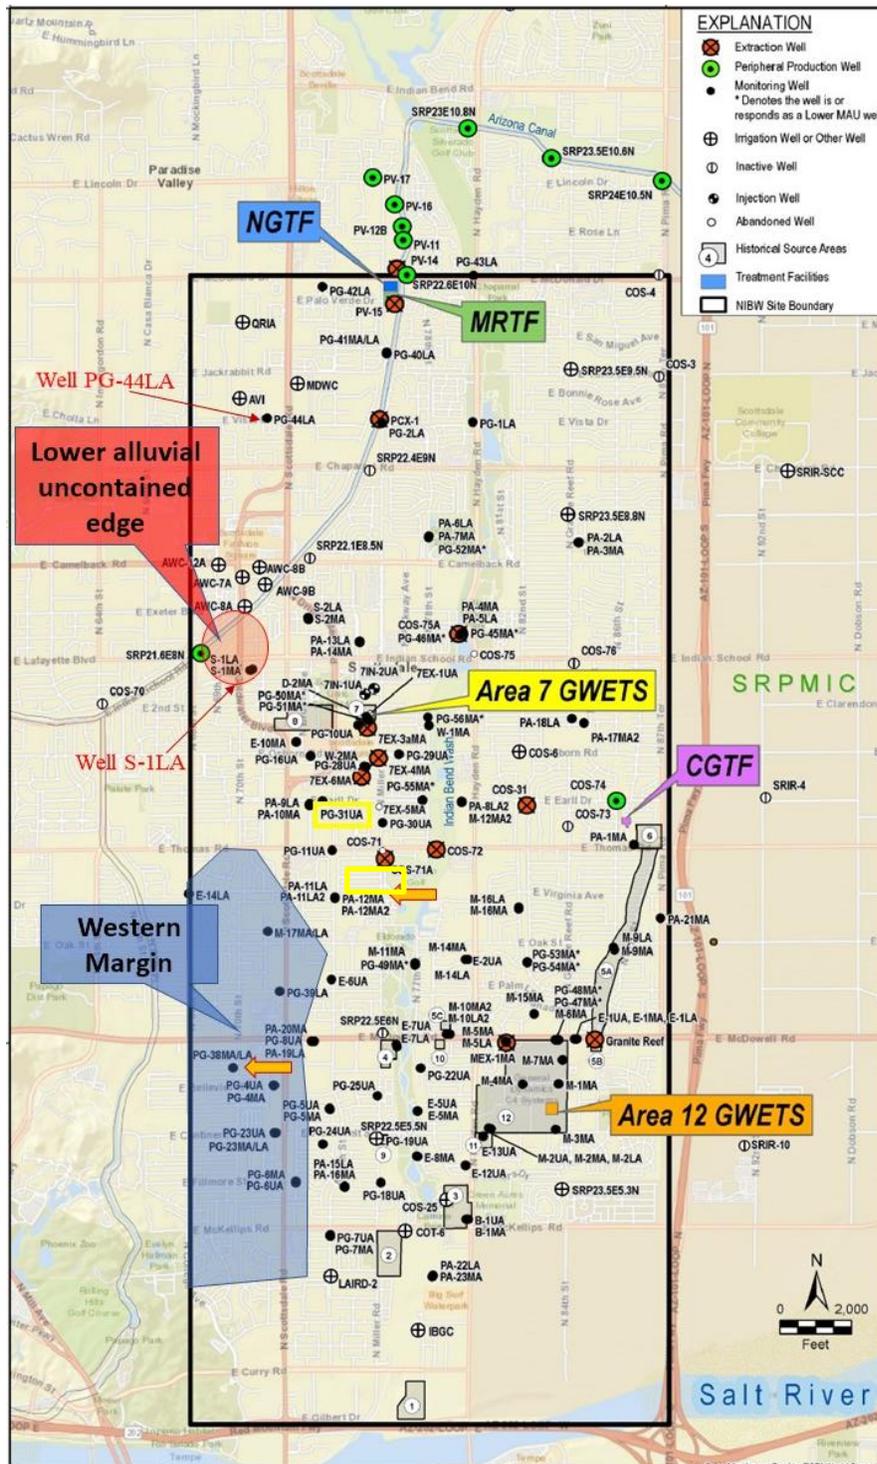
Figure 7.Regions of Possible Lack of Plume Containment at North Indian Bend Wash

The areas where concentrations are increasing are either in the Western Margin region of the Site or the western edge of the lower alluvial unit. During this five-year reporting period, the US Army Corps of Engineers performed Mann-Kendall trend analyses for several select monitoring wells (See Appendix D). The trend analyses identified increasing PCE concentrations at wells PA-10MA, PG-38MA, and S-1LA, although PA-10MA and PG-38MA are still below EPA drinking water standards. All of these wells are located within the Western Margin. PG38-MA is located near PG-4-UA where there is another PCB source unrelated to the North Indian Bend Wash plume. PA-10MA is outside of the currently reduced Area 7 capture zone, where PCE from this location may migrate to the western margin. Monitoring well S-1LA has increasing PCE concentrations ranging from 21 to 48 µg/L and is also located on the western margin of the plume near groundwater production wells for the Salt River Project and Arcadia Water Company, which are being used for irrigation. Monitoring well S-2LA is to the northeast and downgradient of S-1LA and also has increasing TCE concentrations. The western edge of the lower alluvial unit does not appear to be fully contained by the currently operating extraction well network. Groundwater in this area is poorly defined due inadequate monitoring well network along the periphery of the Western Margin, as shown in Figure 7. Additional characterization is warranted given the proximity of the production wells. Groundwater iso-concentration maps have demonstrated a gradual westward shift over time, as shown on Figure 8.

Note: Regions of possible lack of plume containment in the North Indian Bend Wash (red and blue areas). Modified map from 2020 NBIW groundwater report. Orange arrows indicate increasing wells in the middle alluvial unit.

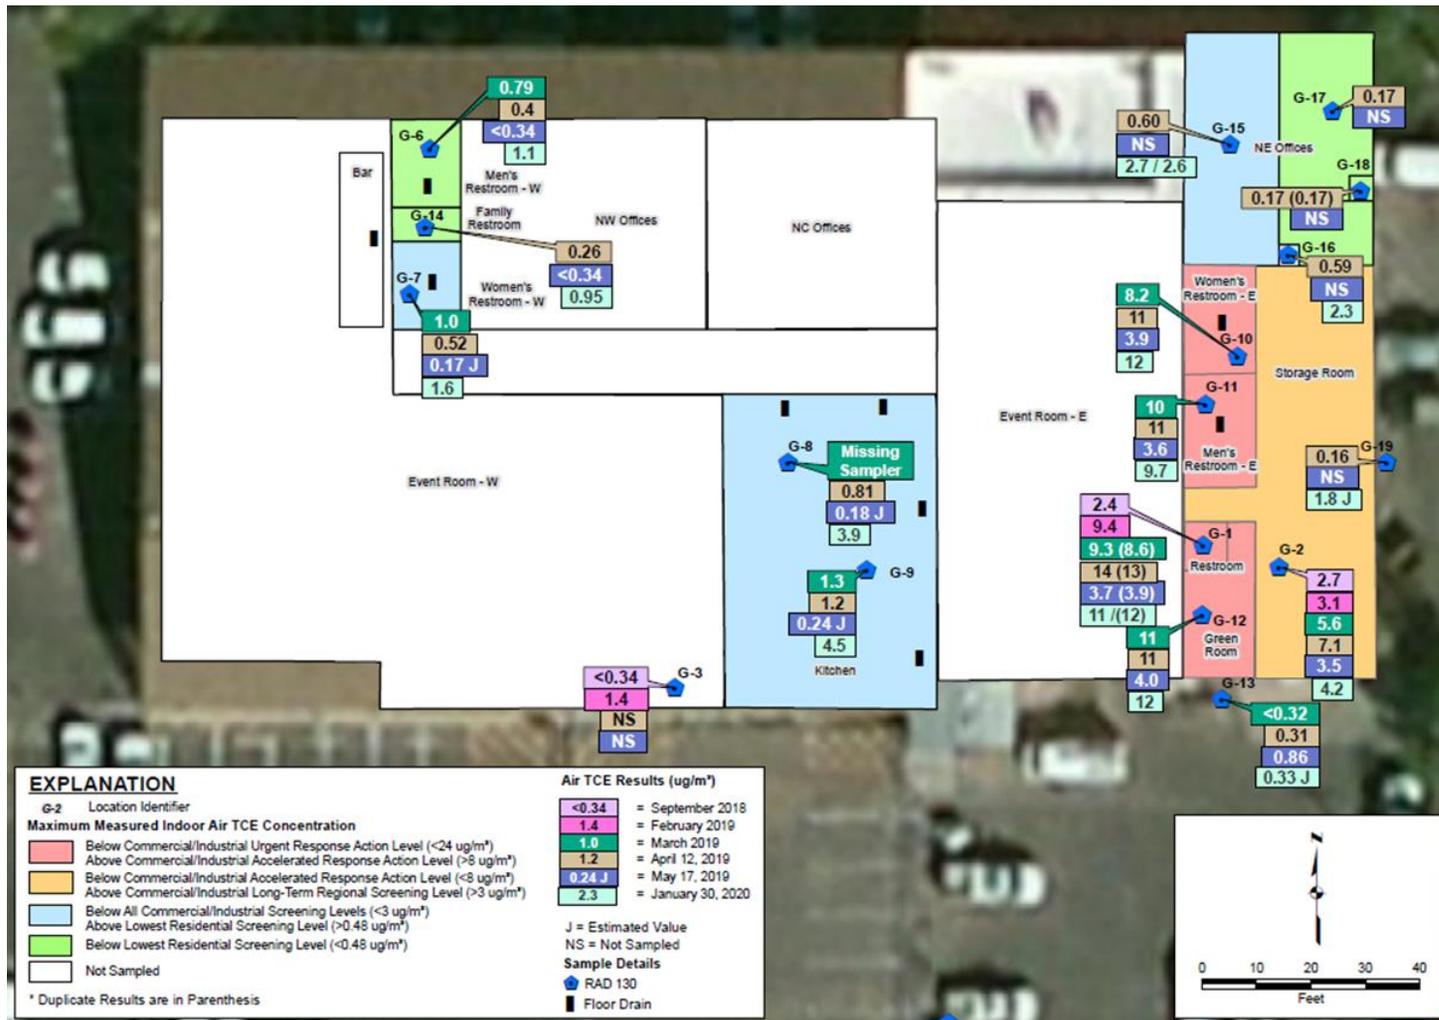
Figure 9. Indoor Air Concentrations in Events Center

In August 2021, EPA contacted the event center owner who told EPA that center is now open but has had very few events. The green room generally is not being used, and events often take place with the rollup doors open. Otherwise, the owner runs the HVAC fans all the time during events. EPA provided information on sub-slab depressurization systems and will work with him to install appropriate long-term mitigation measures.

Soil gas investigations found a significant source of mass still remains at Area 7, and vapor intrusion was identified in the adjoining apartment building and event center. In April 2018, a sub-slab depressurization system was installed beneath the apartment building, and subsequent sampling in 2018 and 2019 indicate that the mitigation system was working as intended. The indoor air sampling at the event center indicated unacceptable risk of TCE inhalation in two event room bathrooms and green room . In 2019, EPA was working with the owner to implement short-term HVAC adjustments and long-term mitigation measures. The event center shutdown in 2019 due to restrictions imposed during COVID-19 pandemic. The event center has recently reopened for a few events. EPA confirmed that the owner is operating the HVAC system during those events to mitigate risk, and EPA has resumed working with the owner for more permanent measures.

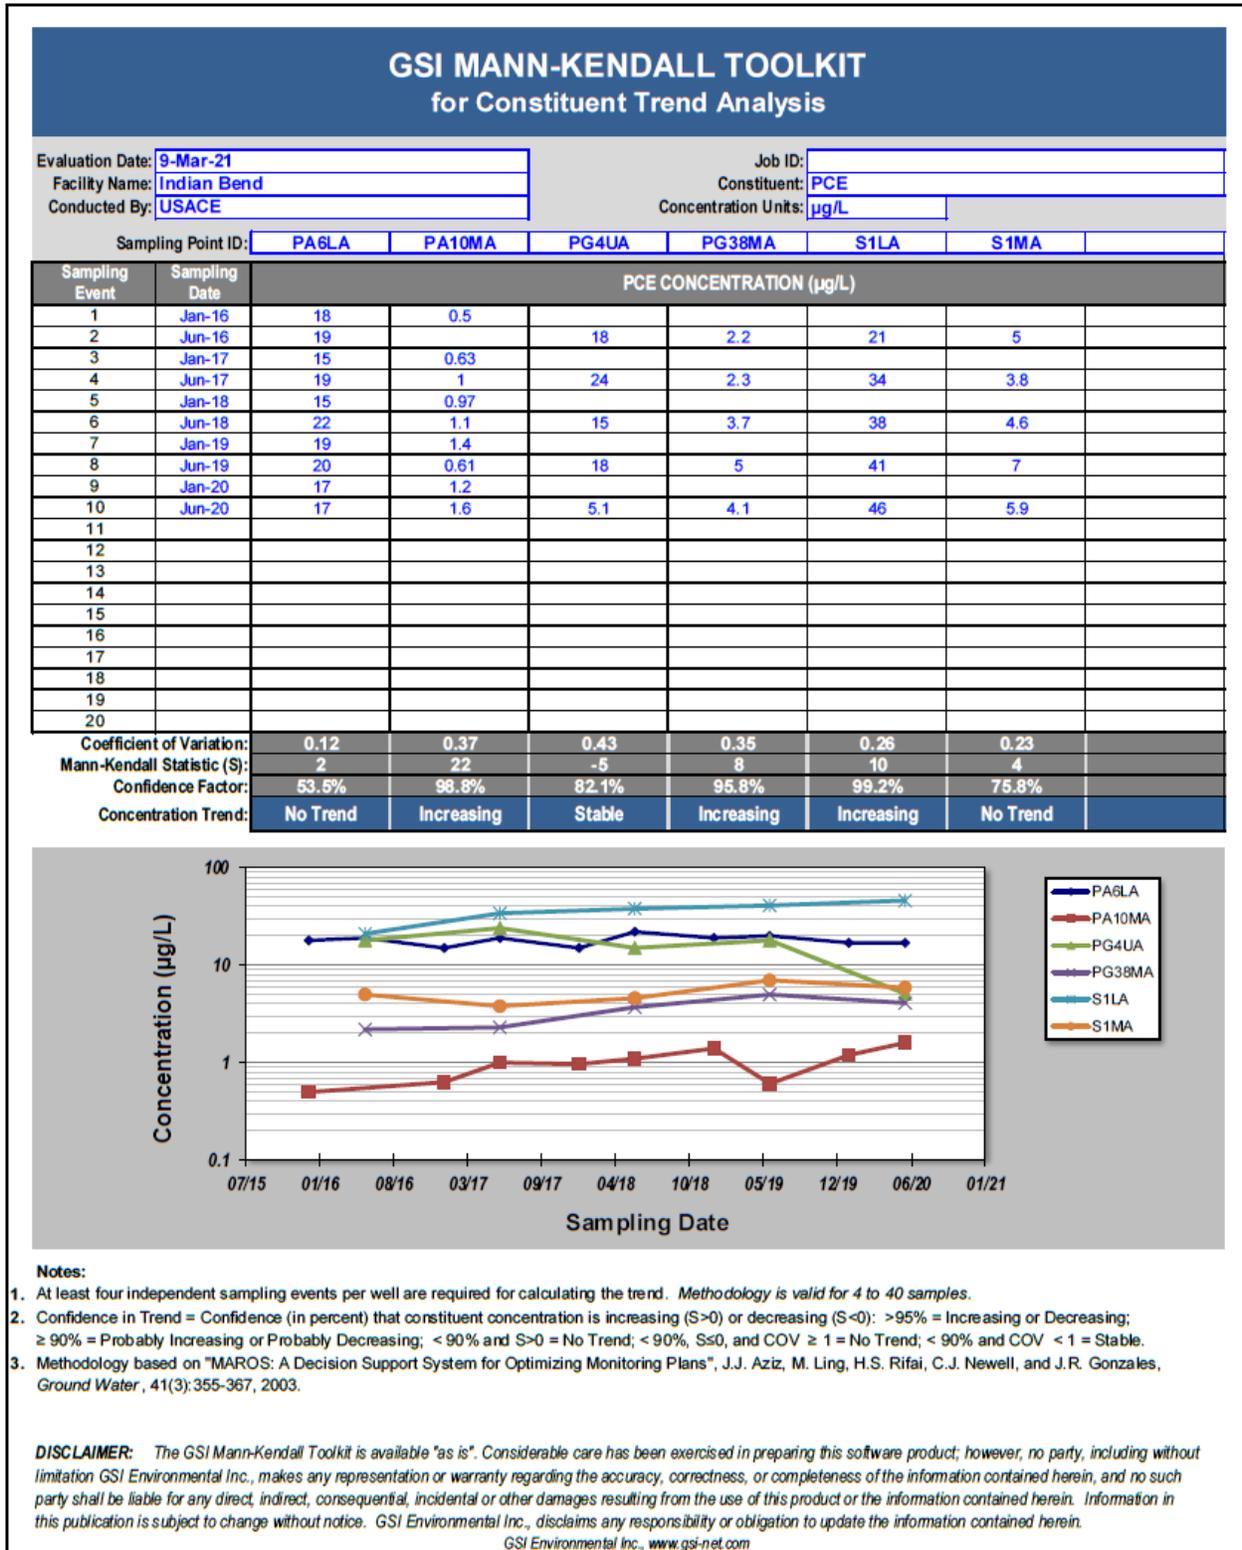
During this five-year reporting period, Mann-Kendall trend analyses show PCE concentrations increasing at three of six monitoring wells shown in Figure D-3, below. These six monitoring wells are aligned north-south along the western portion of the sites. Two of the six monitoring wells with increasing trends, PA-10MA and PG-38MA were at or below the EPA drinking water Maximum Contaminant Level (MCL) for

PCE of 5 µg/L. As shown on Figure D-2, PG38-MA is located on the far Western Margin, and although PCE concentrations are below MCLs (Figure D-3) this well is located near vicinity of PG-4UA. PG-4UA is located within a PCE source area unrelated to the Superfund site. PA-10MA may not be captured by the reduced CGTF Area 7 capture zone following removal of 7EX-4MA and COS-71A from the extraction program and PCE contamination from this well migrates towards the Western Margin. Monitoring well S-1LA is located on the northwest edge of the plume near groundwater production wells for the Salt River Project and Arcadia Water Company. Northeast and down gradient of S-1LA is monitoring well S-2LA with increasing TCE concentrations (see TCE discussion below).

Figure D-3. PCE concentration trend plot since the previous five-year review of middle and lower alluvial wells. Three wells are increasing in PCE concentrations, with S1LA as one of the wells that may indicate the plume is not bounded in the west. The Federal drinking water standard for PCE is 5µg/L.

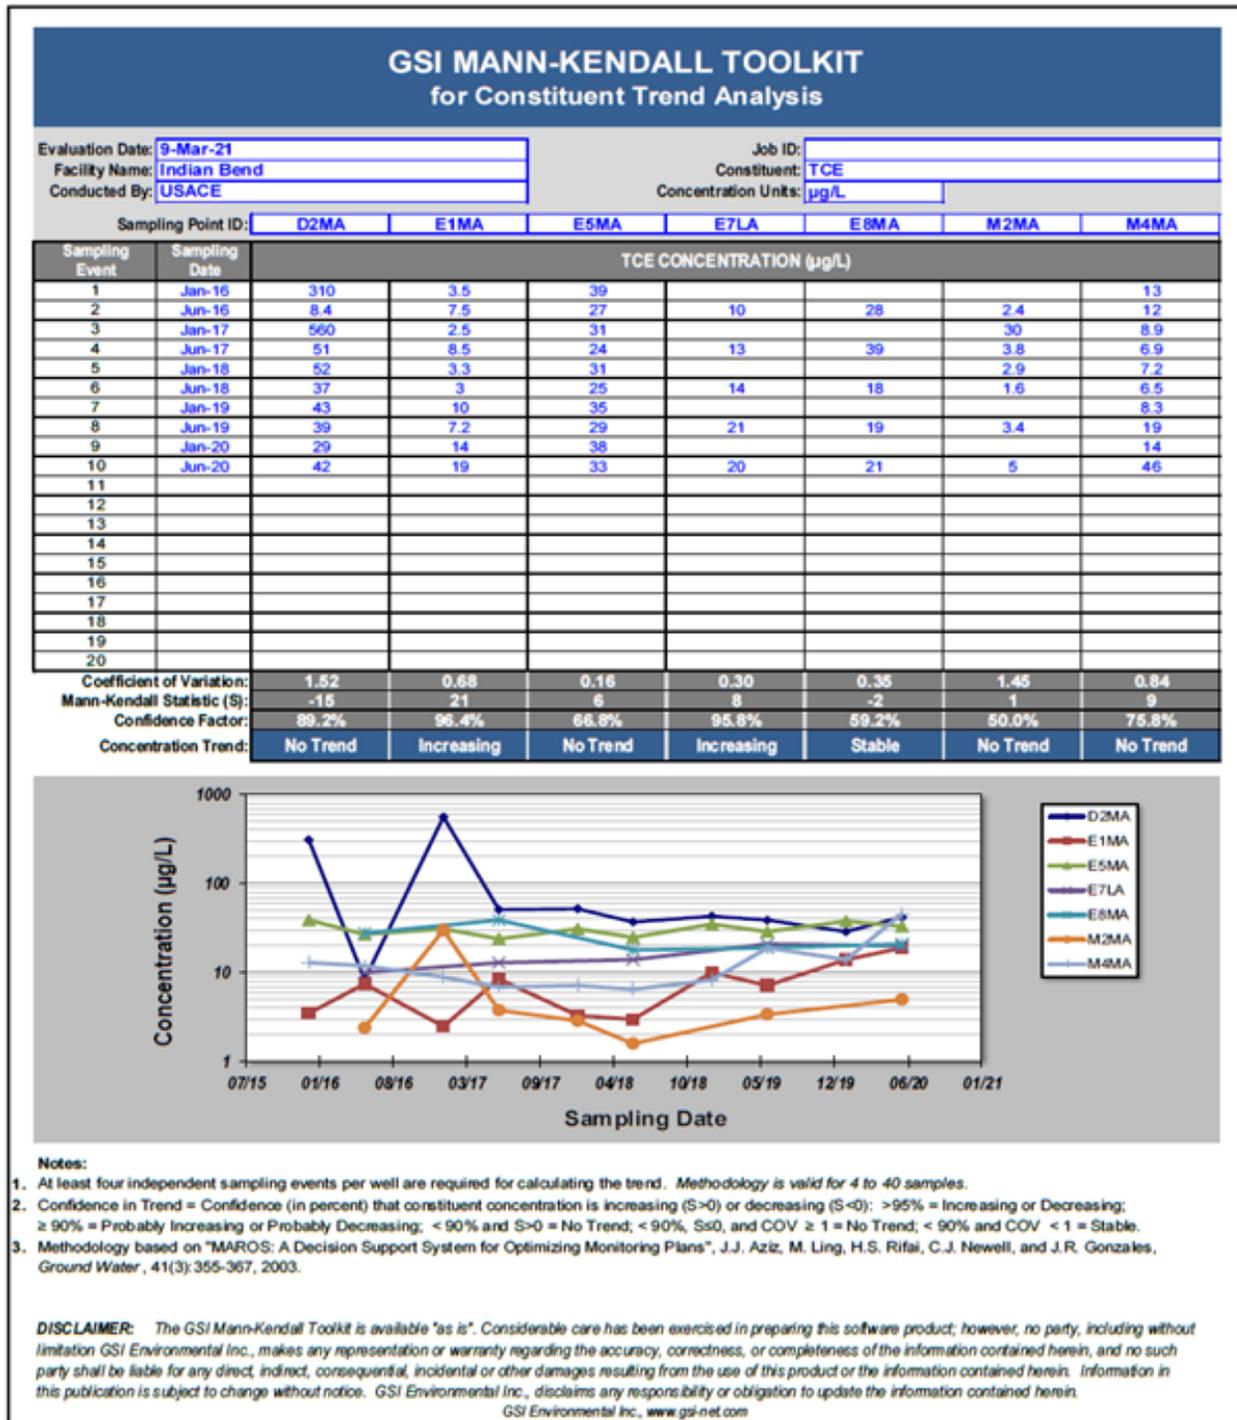
Figure D-4. TCE concentration trend plot since the previous five-year review of middle and lower alluvial wells. Two wells are increasing in TCE concentrations, but both wells are near extraction well systems. The Federal drinking water standard for TCE is 5µg/L.

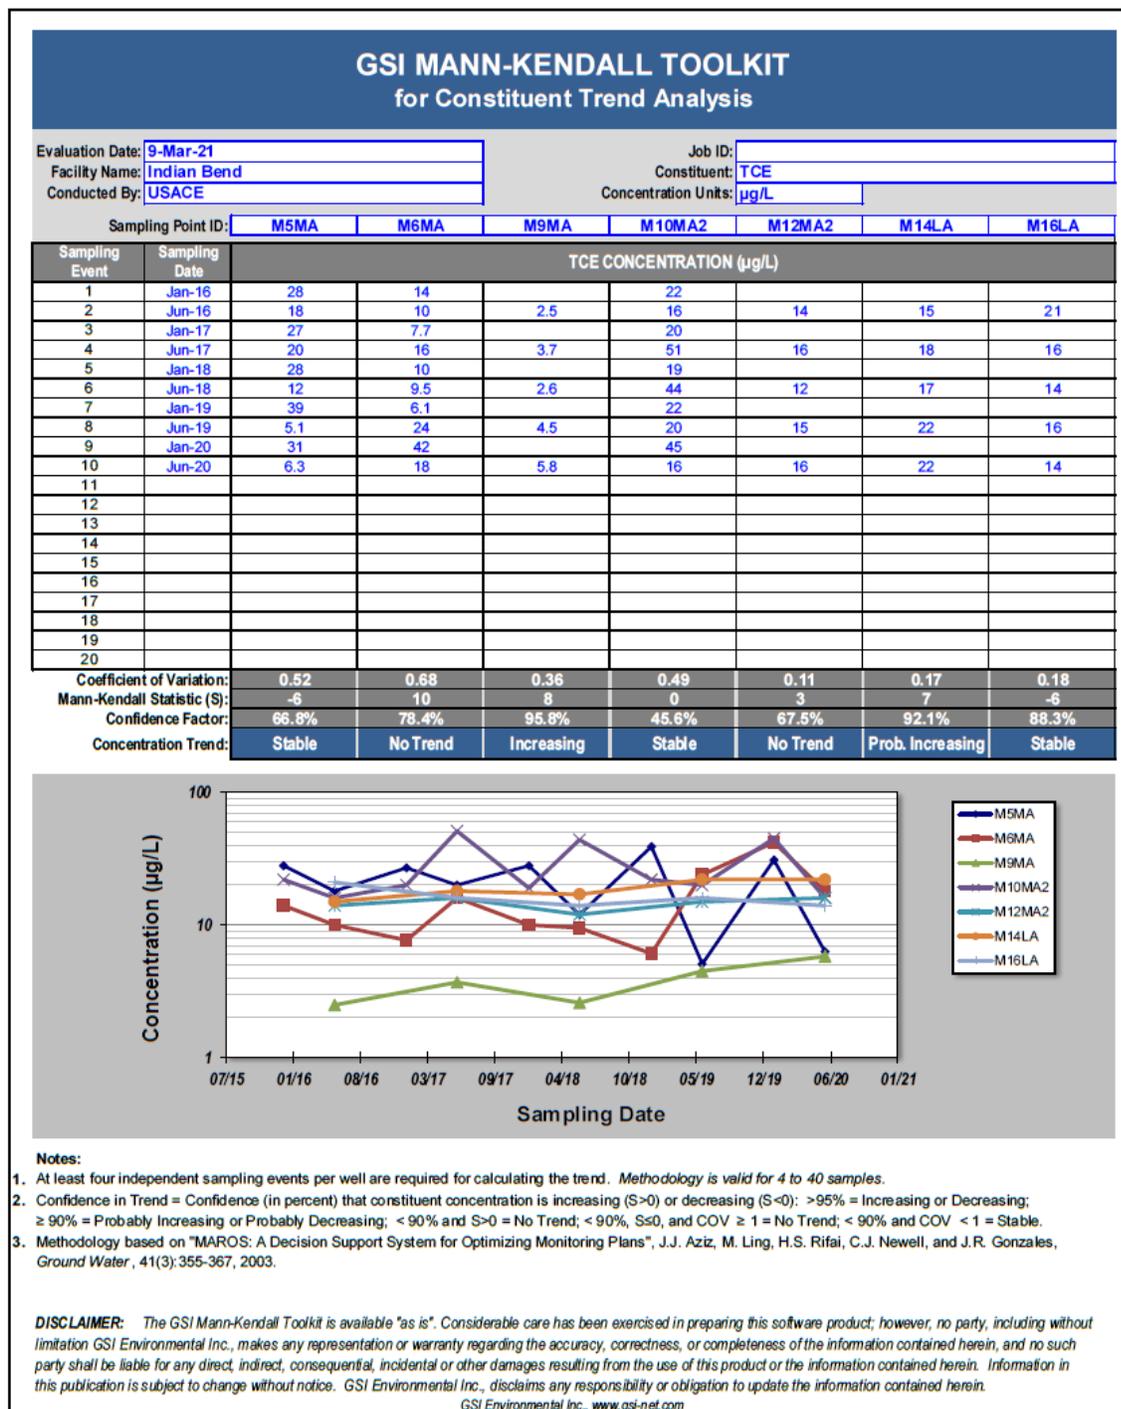
Figure D-5. TCE concentration trend plot since the previous five-year review of middle and lower alluvial wells. Two wells are increasing in TCE concentrations, but M14LA is upgradient from an extraction well and M9MA is upgradient of the Granite Reef extraction well. The Federal drinking water standard for TCE is 5µg/L.

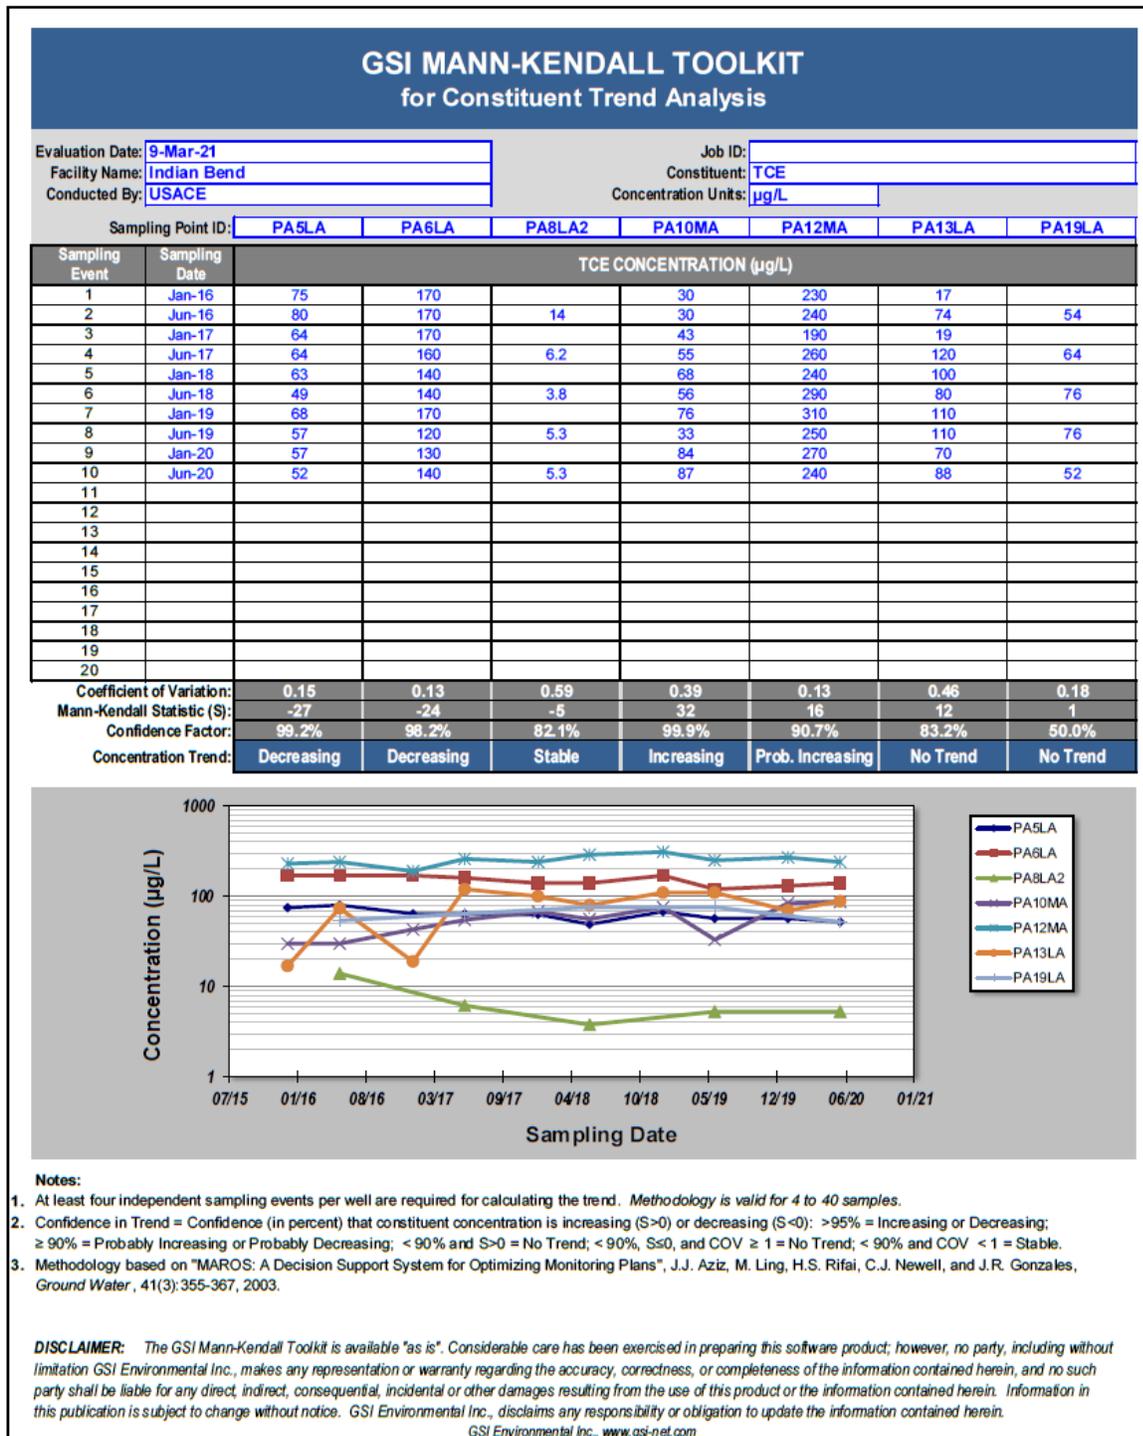
Figure D-6. TCE concentration trend plot since the previous five-year review of middle and lower alluvial wells. Two wells are increasing in TCE concentrations, PA12MA is downgradient from an extraction well, indicating a possible weakness in COS71 and PA10MA is downgradient and cross gradient to two extraction wells. The Federal drinking water standard for TCE is 5µg/L.

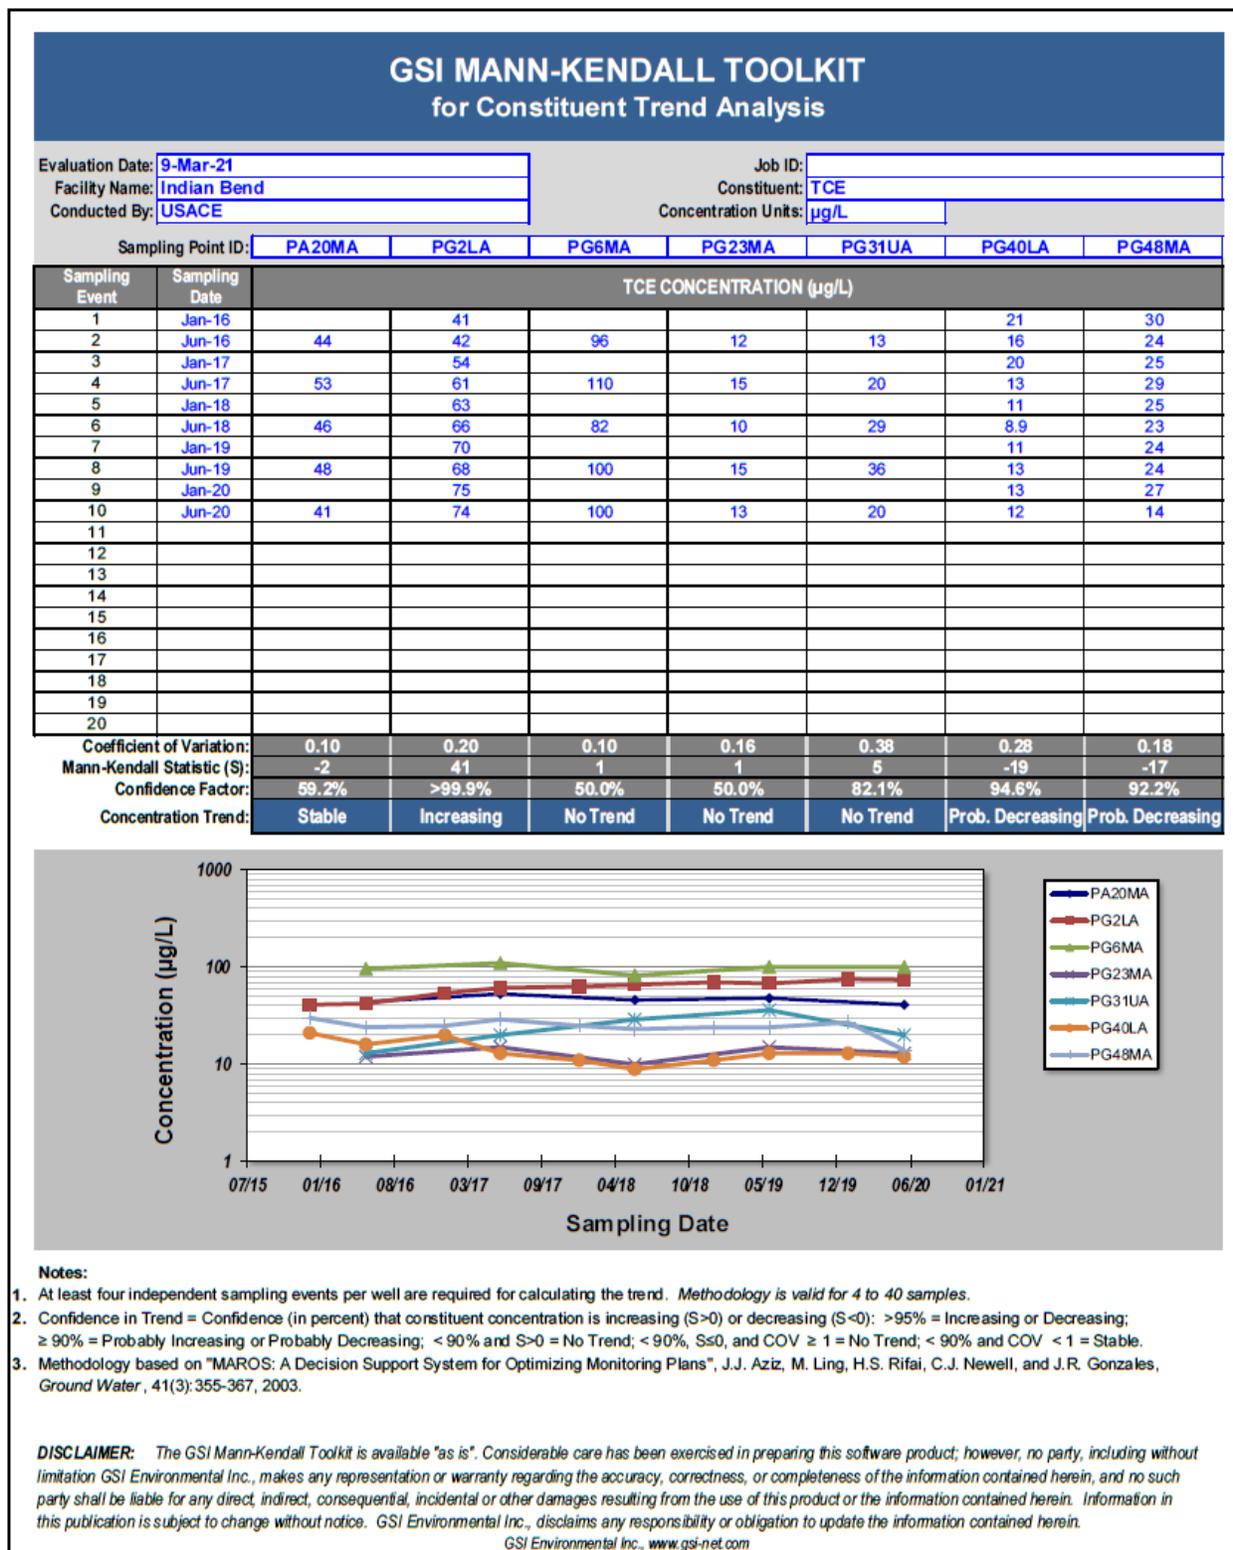
Figure D-7. TCE concentration trend plot since the previous five-year review of upper, middle, and lower alluvial wells. One well is increasing in TCE concentration, PG2LA is near an extraction well, so it is expected to be increasing. The Federal drinking water standard for TCE is 5µg/L.

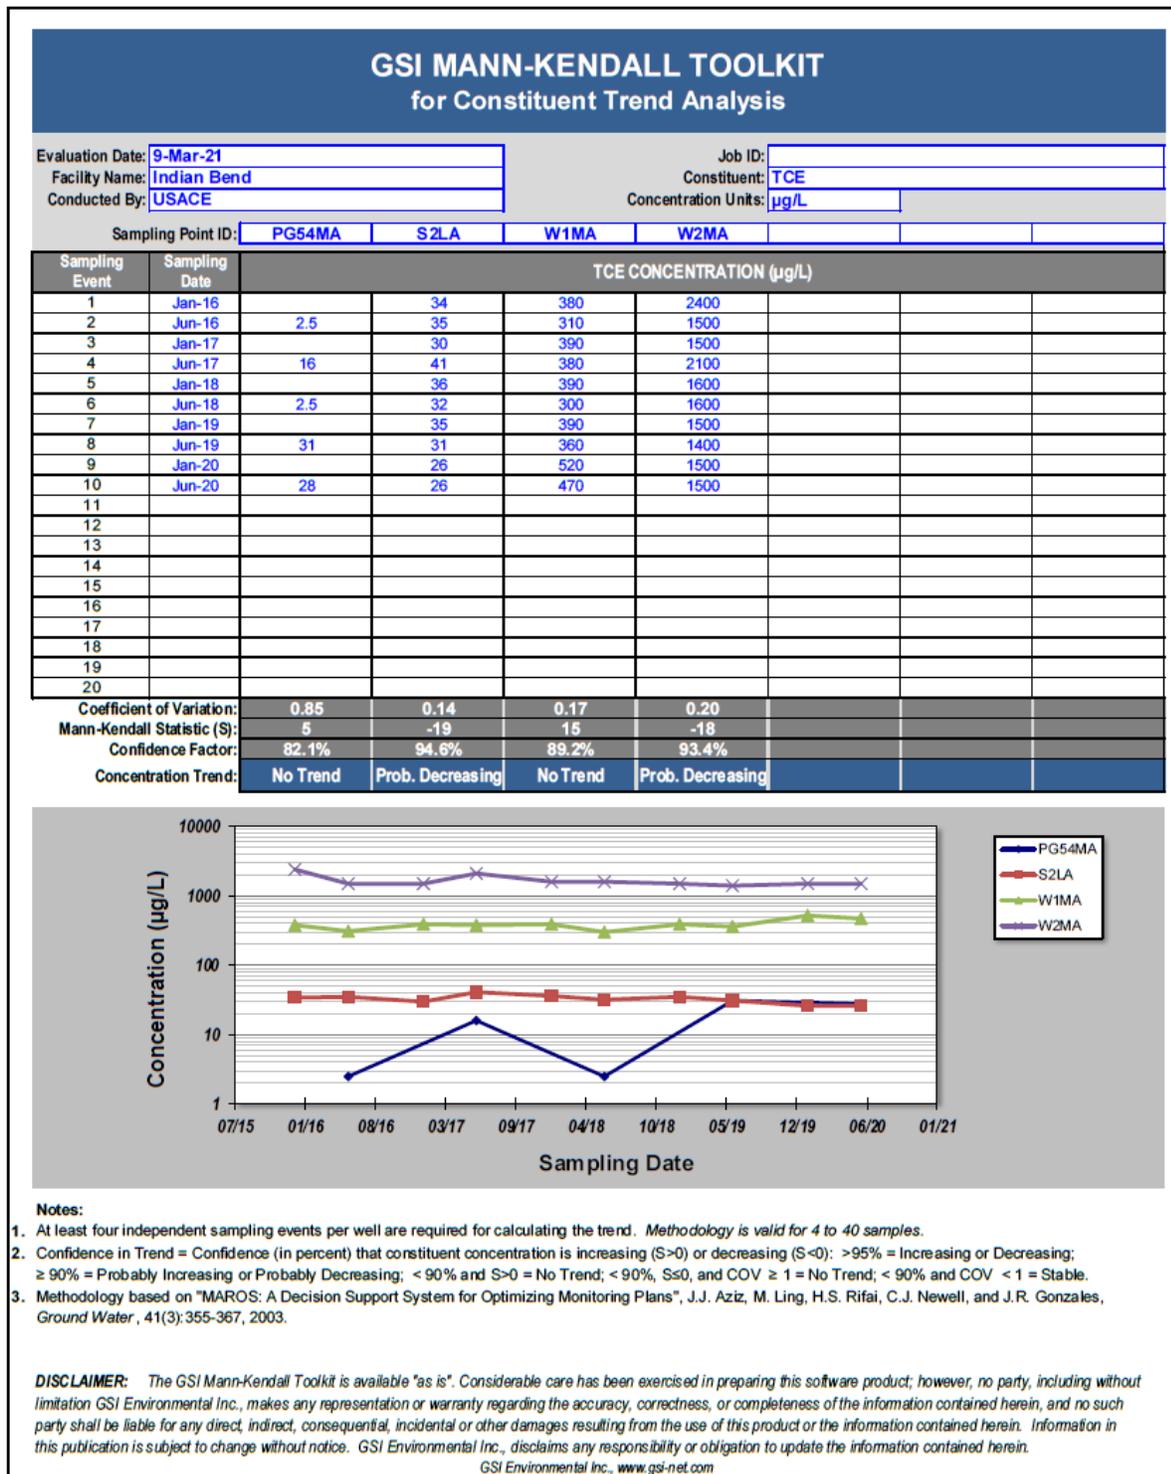
Figure D-8 TCE concentration trend plot since the previous five-year review of middle and lower alluvial wells. These wells are near the Area 7 groundwater extraction treatment systems and extraction wells and have some of the highest TCE values recorded across the Site. The Federal drinking water standard for TCE is 5µg/L.

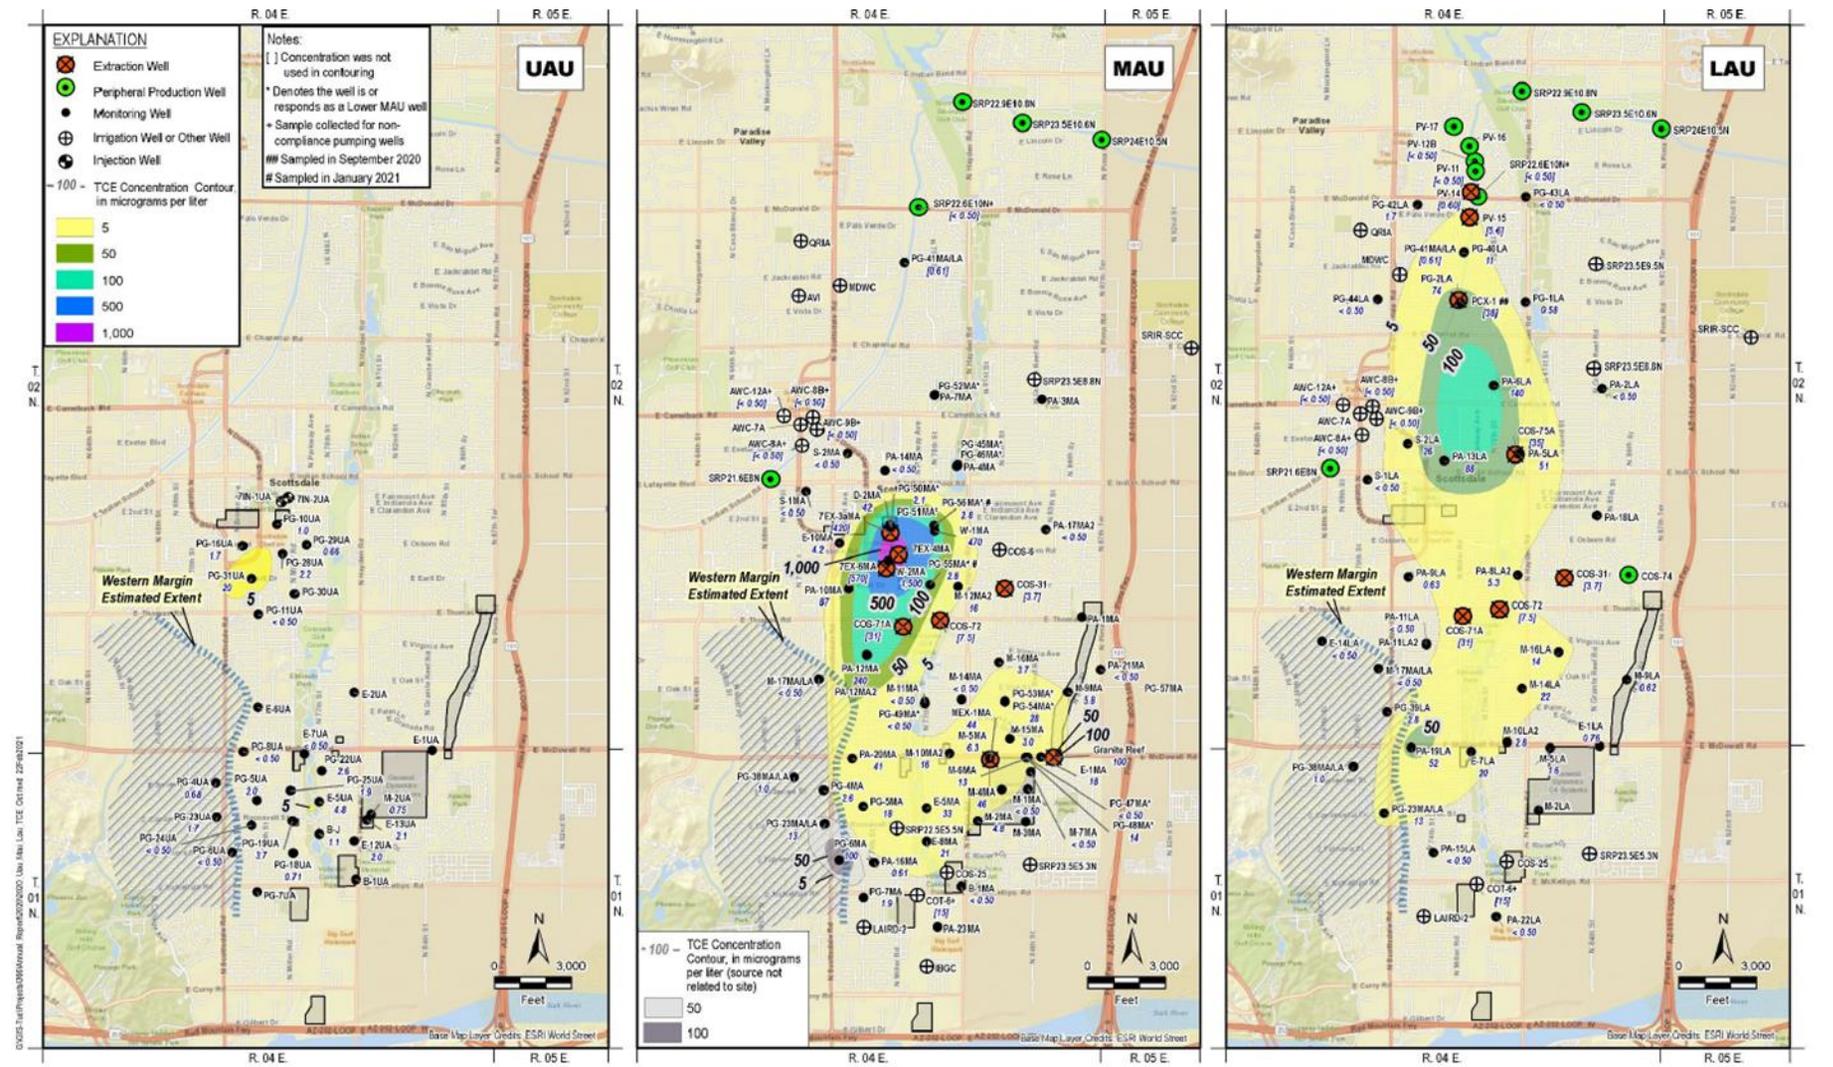
Figure D-10 TCE concentrations in the Upper (UAU), Middle (MAU) and Lower (LAU) Alluvial Units

Figure D-10 shows that groundwater within the upper alluvial unit has the lowest TCE concentrations, with a maximum of 36 µg/L in well PG-31 UA. The highest TCE concentrations are in the middle alluvial unit, particularly within the Area 7 capture zone where concentrations exceed 1000 µg/L. The highest concentrations of TCE occur at wells W-1MA and W-2MA with concentrations of 520 and 2100 µg/L respectively for this reporting period. (Figures D-8 and D-10). In the Area 12 capture zone near the Granite Reef extraction well TCE concentrations were approximately 150 µg/L in 2019. Groundwater in the lower alluvial unit has the second highest TCE concentrations, ranging up to 170 µg/L at PA-6LA for this five-year reporting period. Groundwater in the middle alluvial unit has the highest contaminant concentrations of the three aquifer units, particularly near Area 7 extraction wells, where concentrations are greater than 1,000 µg/L in a localized area. A very small area of higher concentrations in the middle alluvial unit is present near the Area 12 Granite Reef extraction well, with concentrations around 150 µg/L in 2019. Groundwater in most of the middle alluvial unit TCE plume is now between 5 and 50 µg/L. The lower alluvial unit TCE plume ranges from 5 to 50 µg/L.
