THIRD FIVE-YEAR REVIEW REPORT

PAPAGO PARK MILITARY RESERVATION PHOENIX, ARIZONA

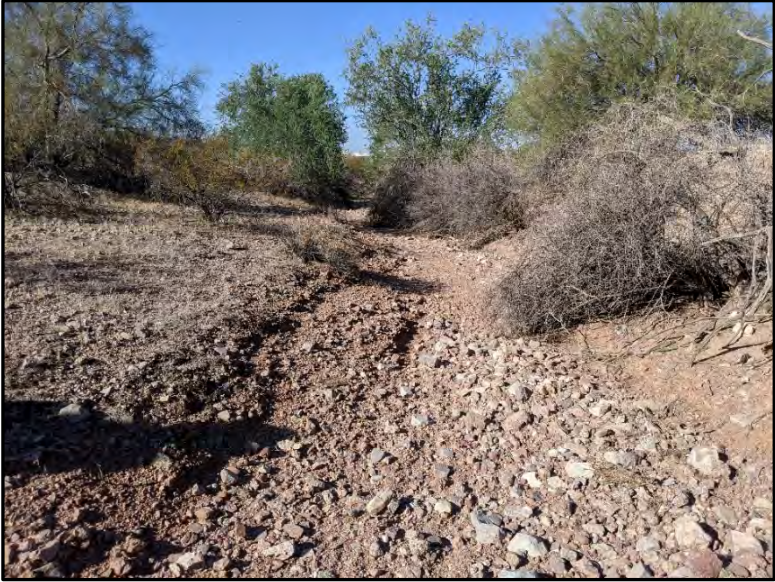
Photograph 1

Location: Papago Park Military Reservation	
Date: October 15, 2020	
Description: Drainage channel in Site S, facing west.	
Photograph 2

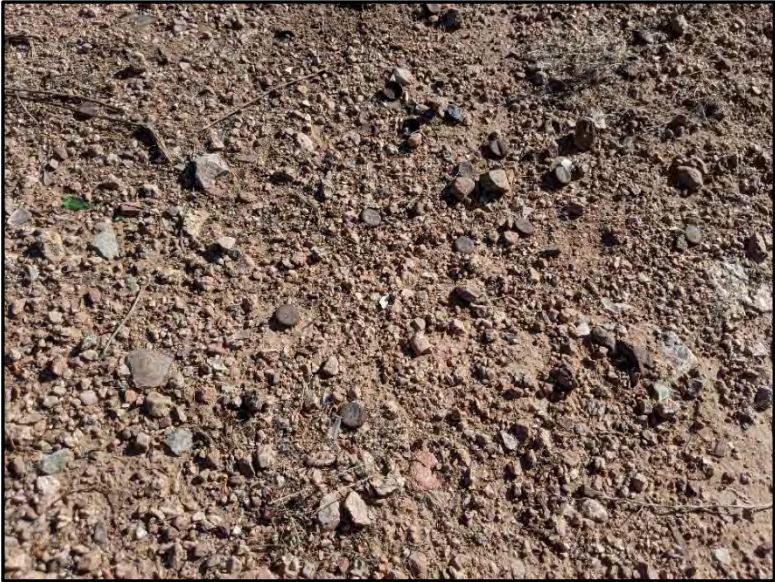
Location: Papago Park Military Reservation	
Date: October 15, 2020	
Description: Approximately 0.75 inch-diameter clay target disc remnants and bottlecaps.

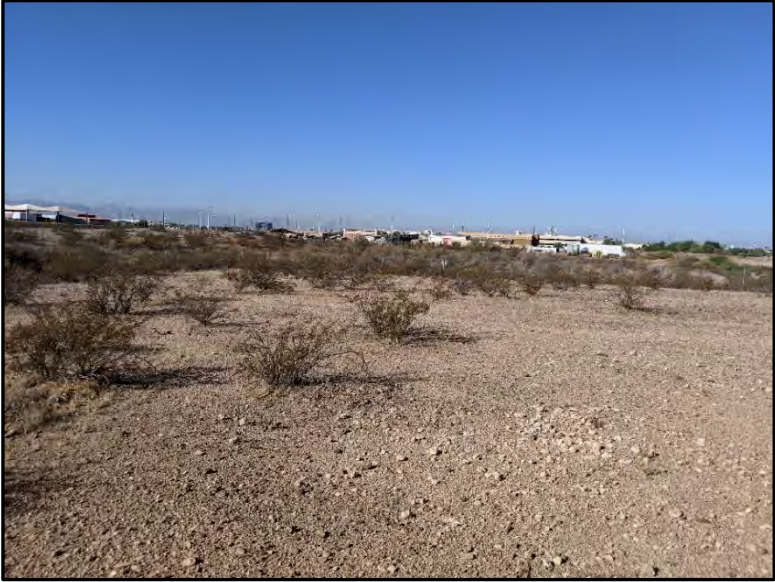
Photograph 3

Location: Papago Park Military Reservation	
Date: October 15, 2020	
Description: Current site conditions, facing west.	
Photograph 4

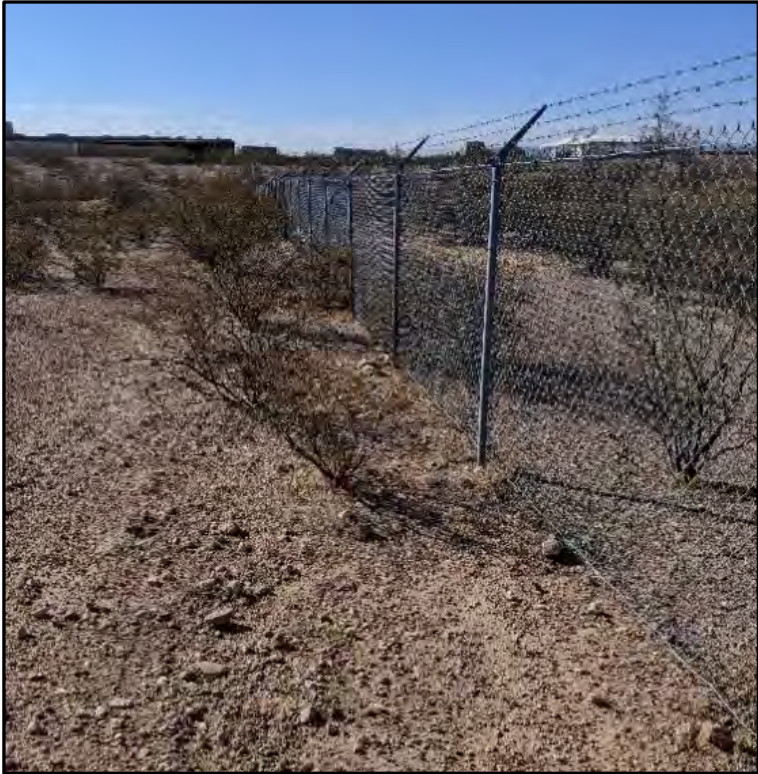
Location: Papago Park Military Reservation	
Date: October 15, 2020	
Description: Northern boundary fence, facing west.

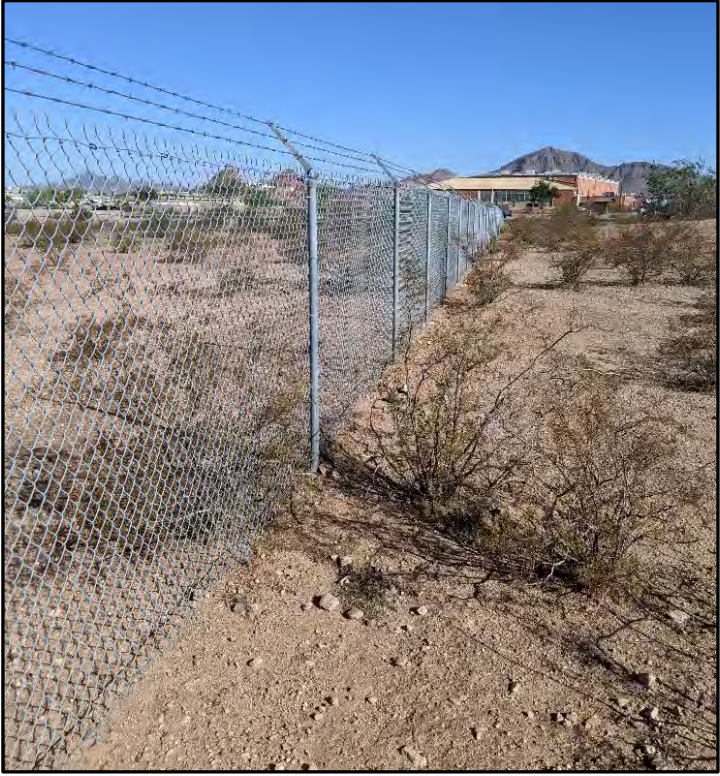
Photograph 5

Location: Papago Park Military Reservation	
Date: October 15, 2020	
Description: Northern boundary fence, facing east.	
Photograph 6

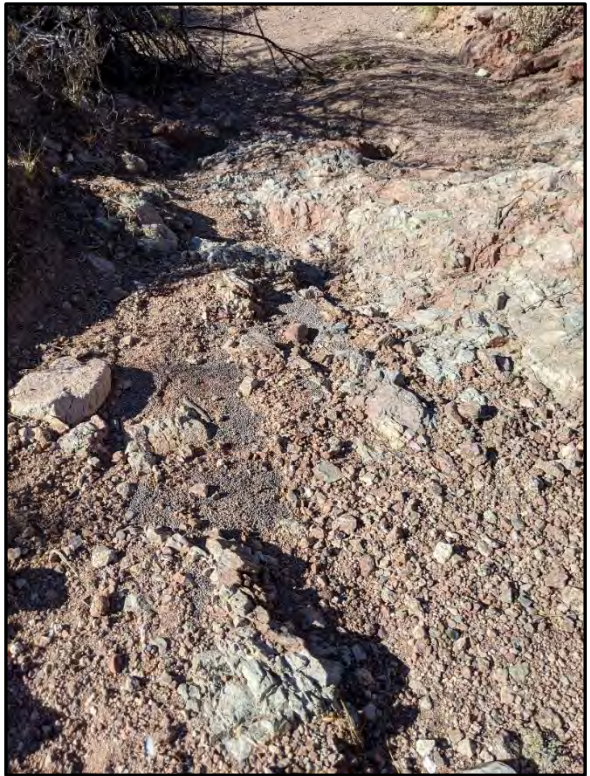
Location: Papago Park Military Reservation	
Date: October 15, 2020	
Description: Bedrock with lead shot remnants.

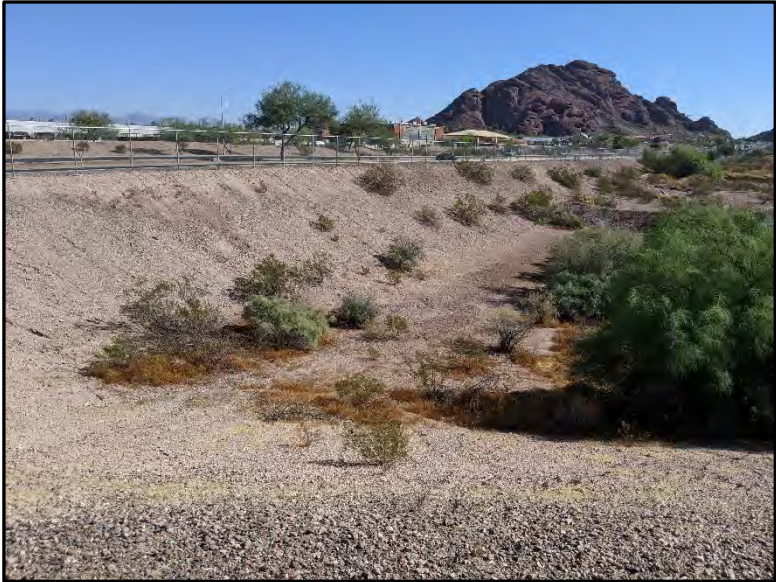
Location: Papago Park Military Reservation	
Date: October 15, 2020	
Description: Storm water retention basin, facing east.

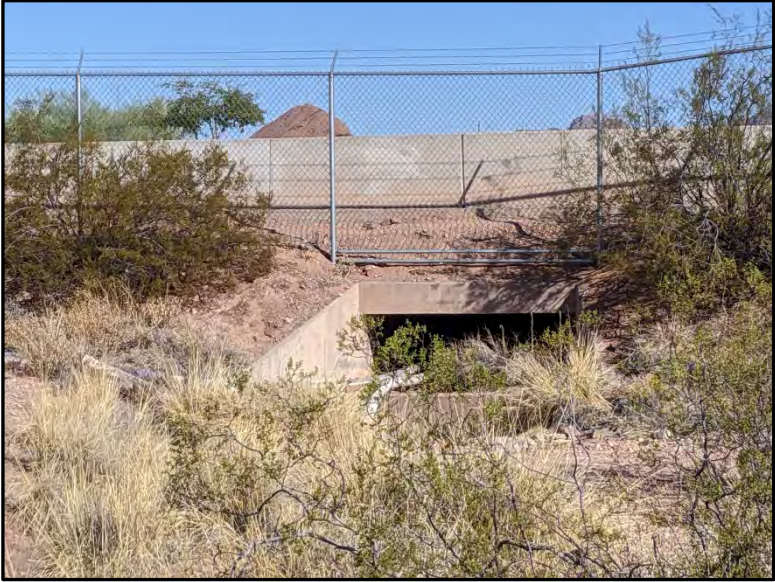
Photograph 9

Location: Papago Park Military Reservation	
Date: October 15, 2020	
Description: Drainage culvert, facing north.	
Photograph 10

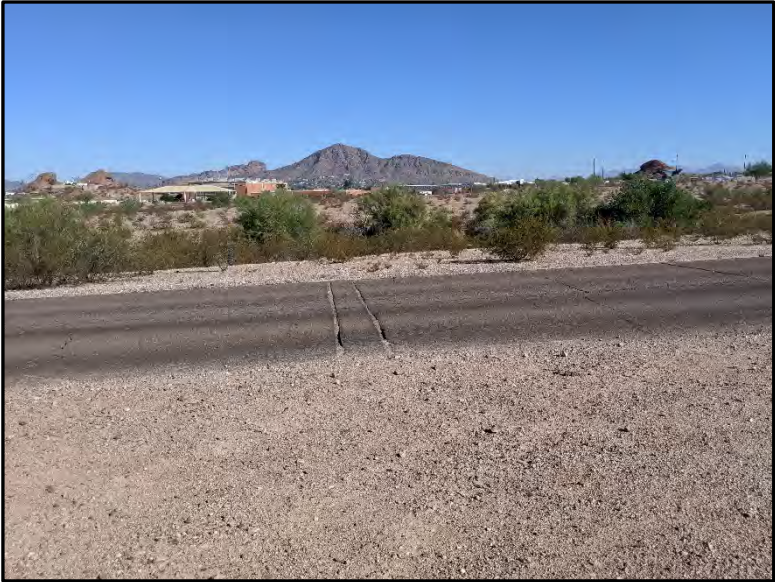
Location: Papago Park Military Reservation	
Date: October 15, 2020	
Description: Current site conditions, facing north. Asphalt access road.

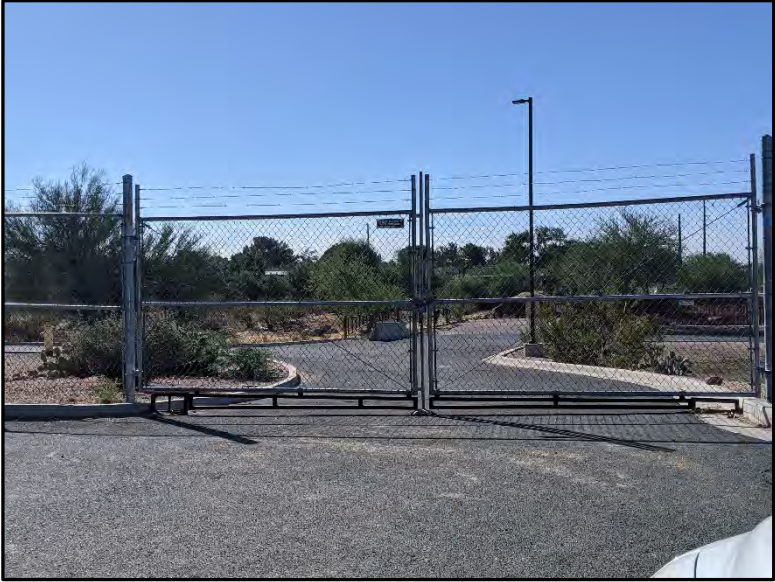
Photograph 11

Location: Papago Park Military Reservation	
Date: October 15, 2020	
Description: Locked access gate, facing south.	
Photograph 12

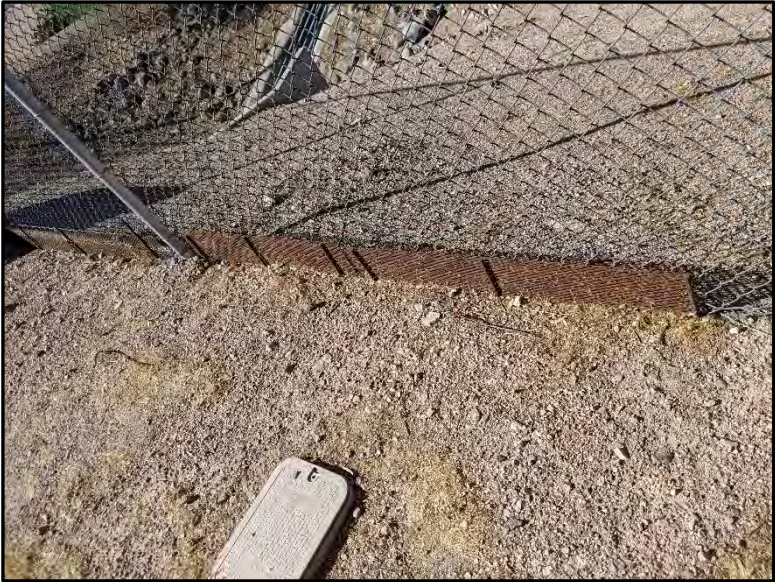
V. ACCESS AND INSTITUTIONAL CONTROLS <input checked="" type="checkbox"/> Applicable <input type="checkbox"/> N/A	
A. Fencing	
1.	Fencing damaged <input type="checkbox"/> Location shown on site map <input checked="" type="checkbox"/> Gates secured <input type="checkbox"/> N/A Remarks: <u>Fencing around Site S included the south Papago Park Military Reservation installation perimeter fencing. Fencing was observed to be in good condition at the time of inspection. A homeless encampment was observed exterior to the northern fence boundary; however, there was no evidence of trespass or waste interior to the installation perimeter fence (Photograph 23). Barbed or razor wire was observed atop fence lines in high foot traffic to prevent access (Photographs 13 – 16). No access points were observed that would allow for human trespassing. The addition of rebar, silt fences, rip rap, and metal patching to cover gaps along the fence bottom were observed to manage areas subject to erosion (Photographs 7, 12, 19, and 20)</u>

Location: Papago Park Military Reservation	
Date: October 15, 2020	
Description: Fence repairs along the western boundary fence line.

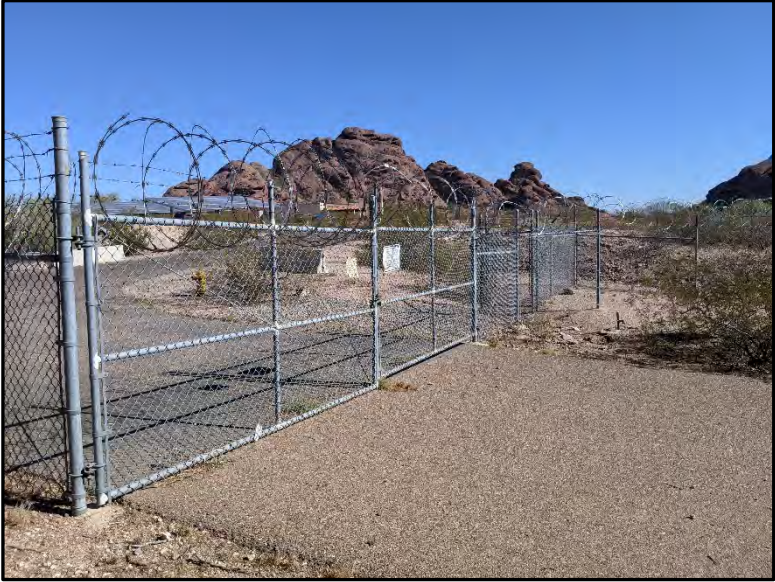
Photograph 13

Location: Papago Park Military Reservation	
Date: October 15, 2020	
Description: Locked access gate at the southwest entrance. Fencing with barbed wire.	
Photograph 14

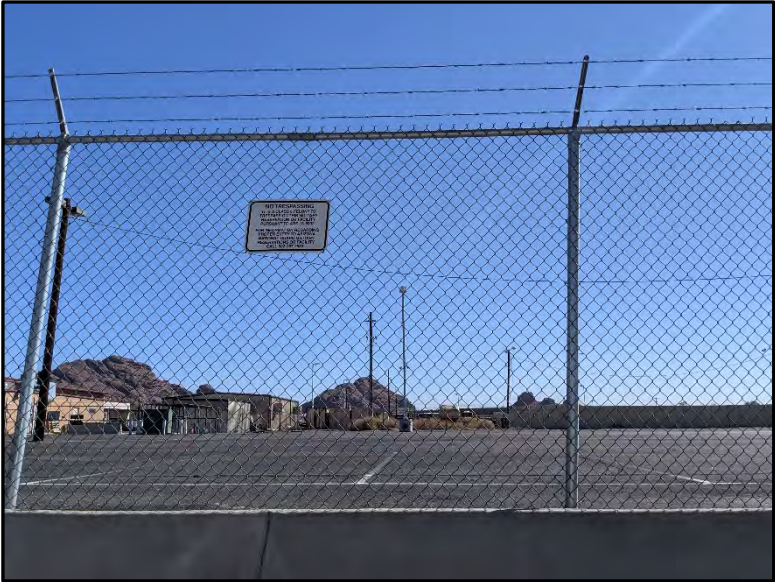
B. Other Access Restrictions	
1.	Signs and other security measures <input type="checkbox"/> Location shown on site map <input type="checkbox"/> N/A Remarks: <u>The Site Inspection Team also observed approximately 15 signs posted on the Papago Park Military Reservation perimeter fence at approximately 50-foot intervals and 100- to 200-foot intervals. Signage was legible and in good condition at the time of the Site Inspection (Photographs 14, 17, and 18).</u>

Location: Papago Park Military Reservation	
Date: October 15, 2020	
Description: Western boundary fence line, barbed wire, and signage.

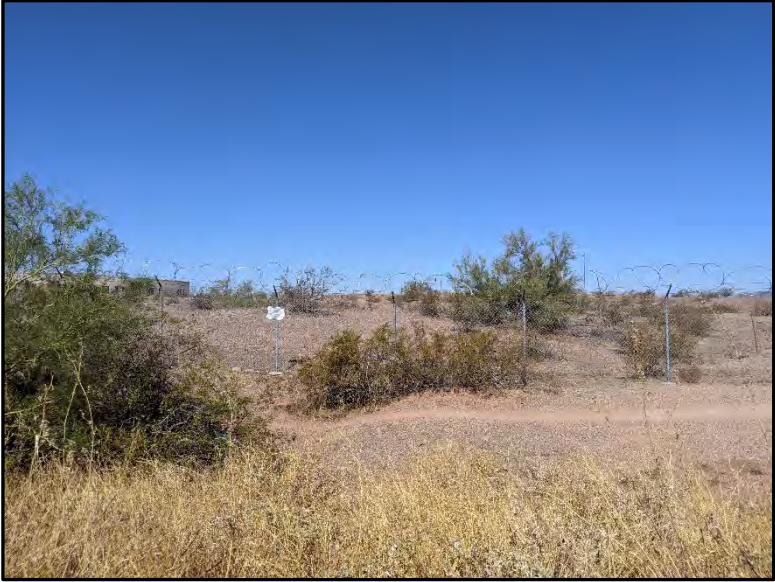
Photograph 15

Location: Papago Park Military Reservation	
Date: October 15, 2020	
Description: Southern boundary fence line, barbed wire, and signage.	
Photograph 16

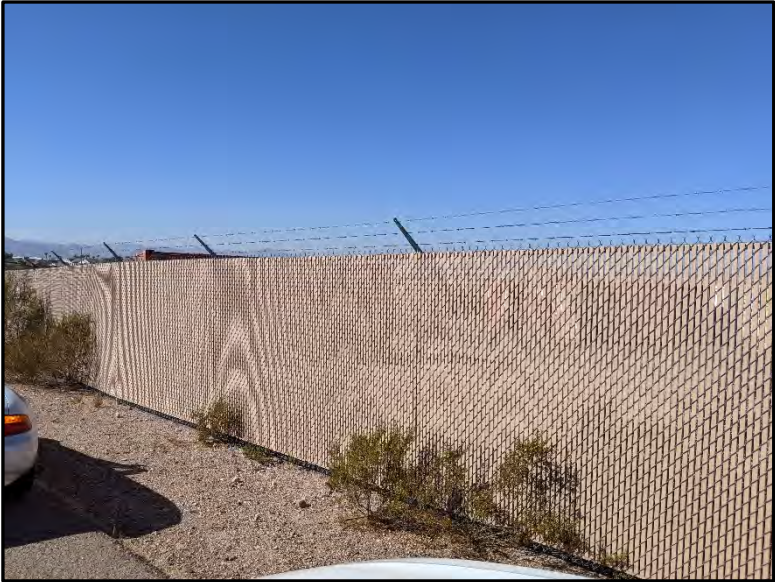
Location: Papago Park Military Reservation	
Date: October 15, 2020	
Description: Southern boundary fence line, privacy fencing, and barbed wire.

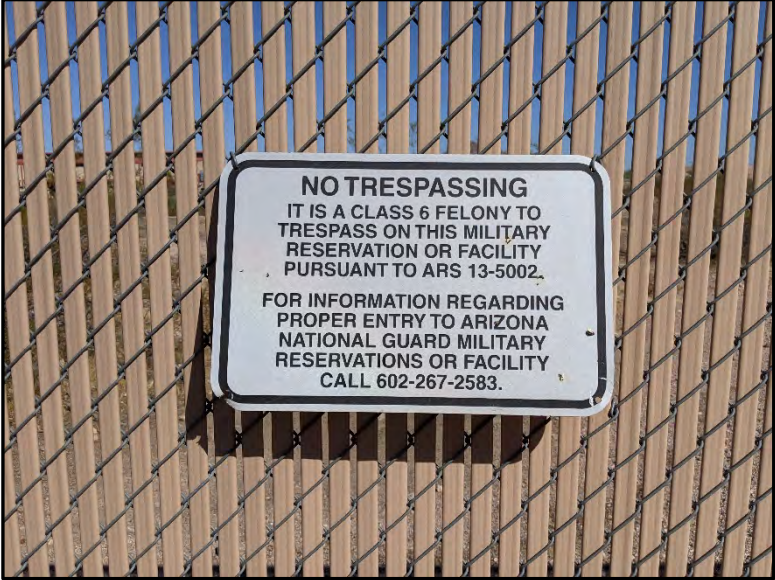
Photograph 17

Location: Papago Park Military Reservation	
Date: October 15, 2020	
Description: "No Trespassing" signage along the southern boundary fence line.	
Photograph 18

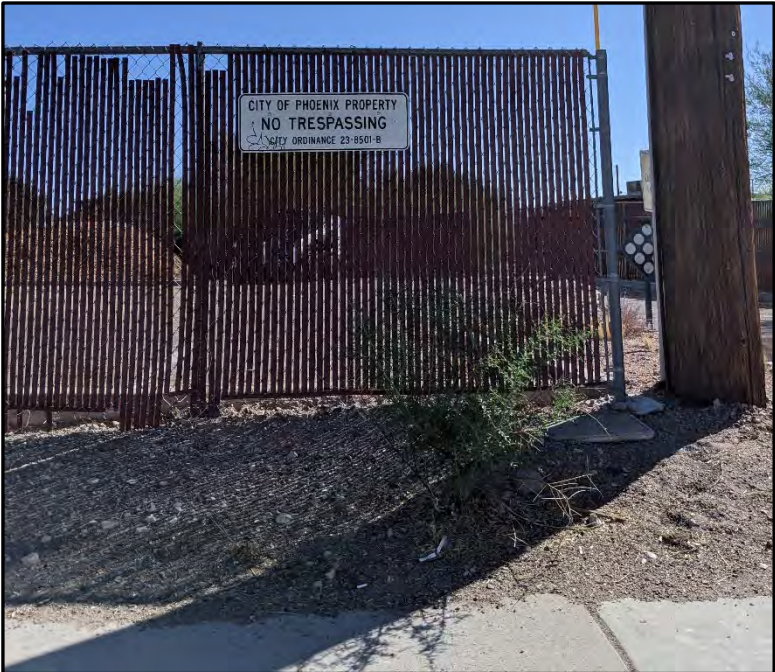
Location: Papago Park Military Reservation	
Date: October 15, 2020	
Description: "No Trespassing" signage along the western boundary fence line.

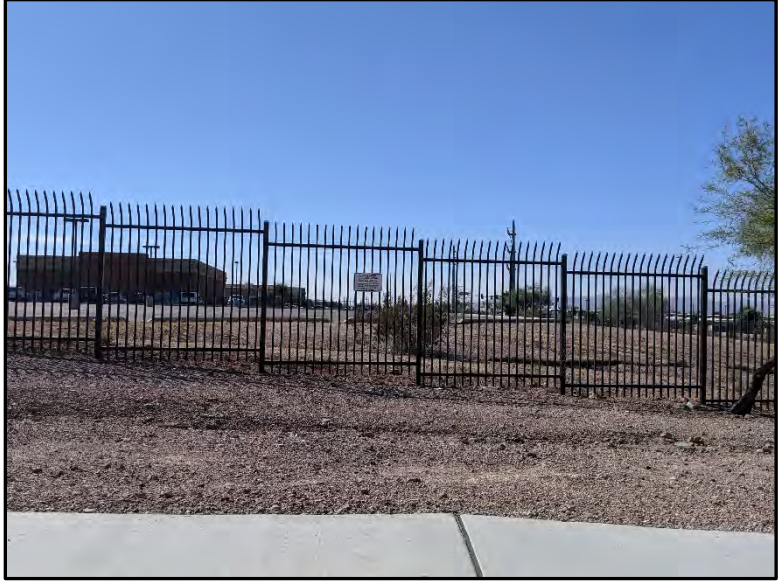
Photograph 21

Location: Papago Park Military Reservation	
Date: October 15, 2020	
Description: Northern boundary fence line and access control signage.	
Photograph 22

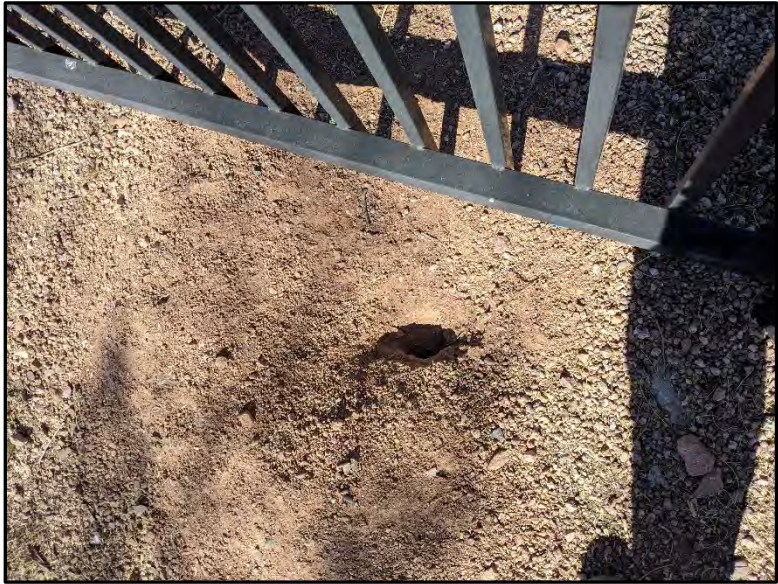
Location: Papago Park Military Reservation	
Date: October 15, 2020	
Description: Small animal burrow along the northern fence line, interior to the fence. Burrow direction was interior to the installation and shallow.

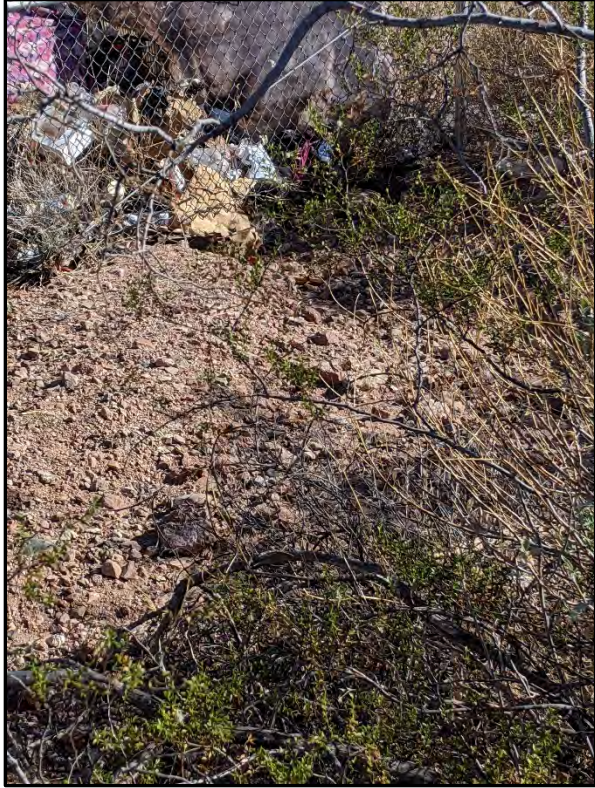
Photograph 23

Location: Papago Park Military Reservation	
Date: October 15, 2020	
Description A homeless encampment was observed on the northern installation fence line, near the Site S Former Skeet Range area. The Site Inspection Team observed trash and residences along the fence exterior, but did not observe any evidence of trespass or breach of the fence line.
