APPENDIX K
VERTICAL AND HORIZONTAL EXTENT OF REFUSE
BROADWAY NORTH LANDFILL
REMEDIAL INVESTIGATION REPORT
GROUNDWATER OPERABLE UNIT (STANTEC 2012)

APPENDIX B
VERTICAL AND HORIZONTAL EXTENT OF REFUSE,
BROADWAY NORTH LANDFILL
REMEDIAL INVESTIGATION REPORT
GROUNDWATER OPERABLE UNIT
Arizona Department of Environmental Quality
Broadway-Pantano Water Quality Assurance Revolving Fund Site
June 1, 2012

BROADWAY NORTH LANDFILL— VERTICAL AND HORIZONTAL EXTENT OF REFUSE

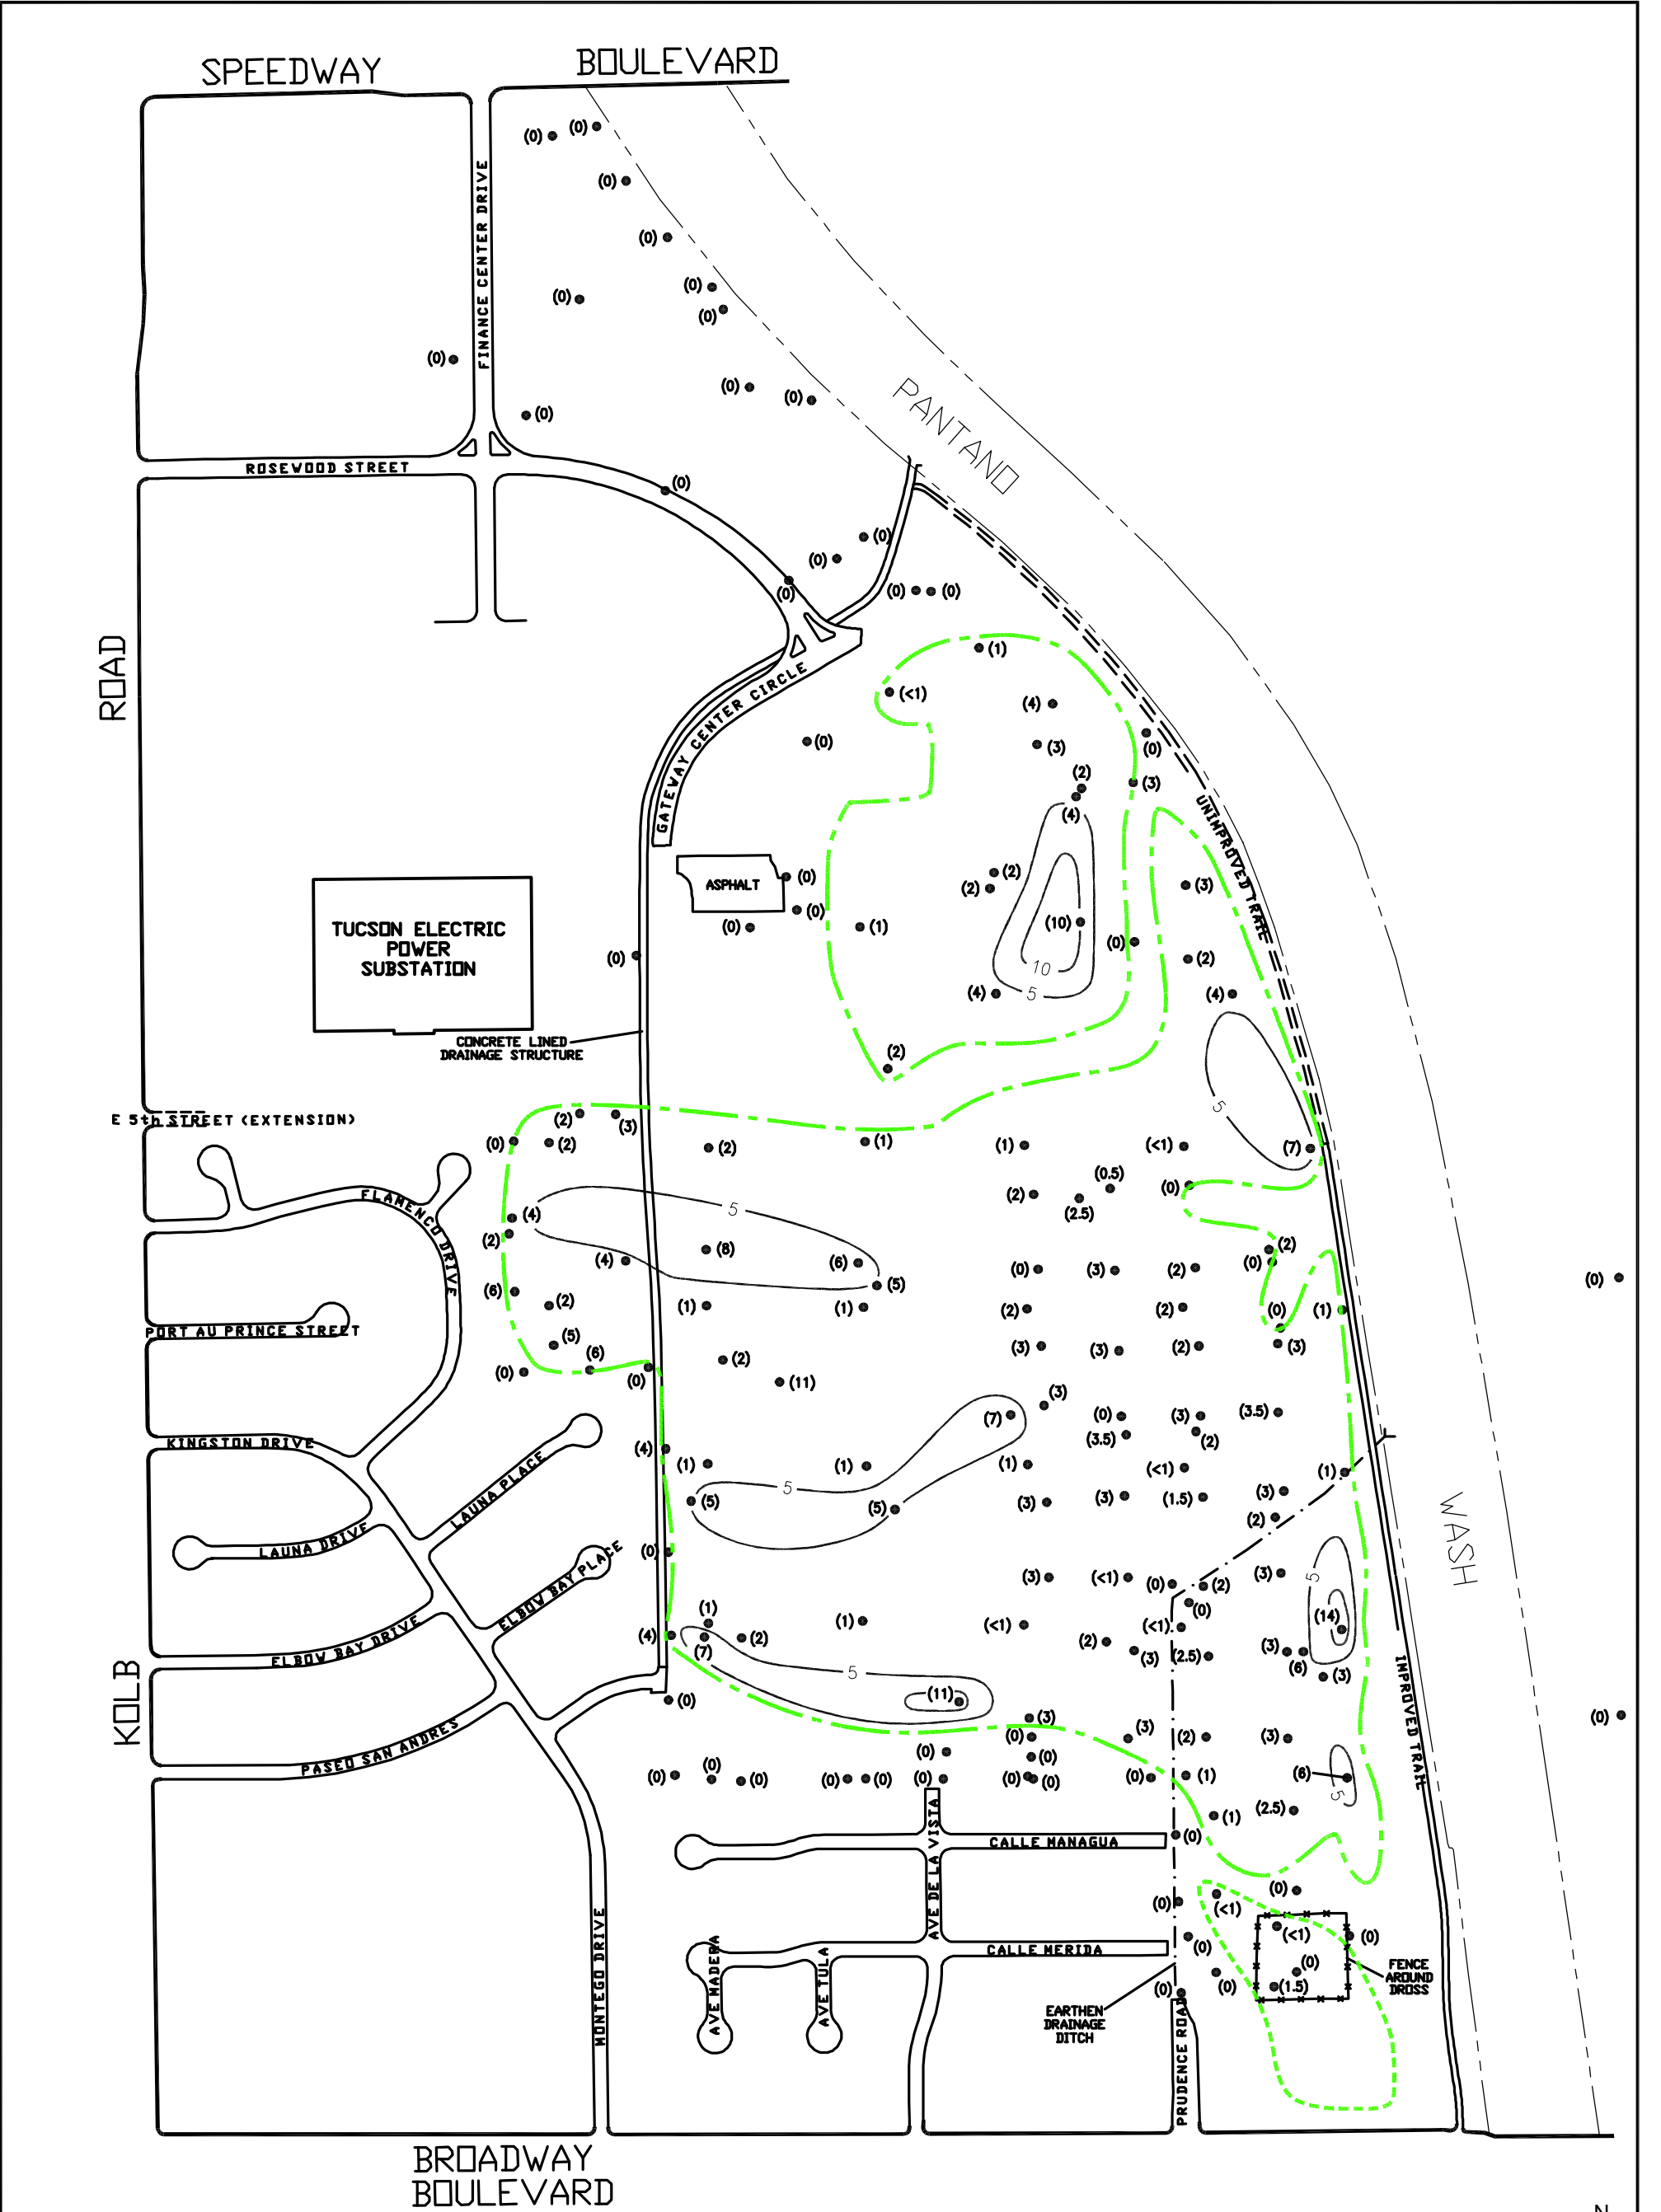
- The thickness of the cover material typically is less than 3 feet over the majority of the BNL (Figure B-1). After sustained rainfall events, saturated cover material can develop “sinkholes” that can propagate following the rainfall events. One such sinkhole developed beside the SVE/AI treatment compound during 2002.

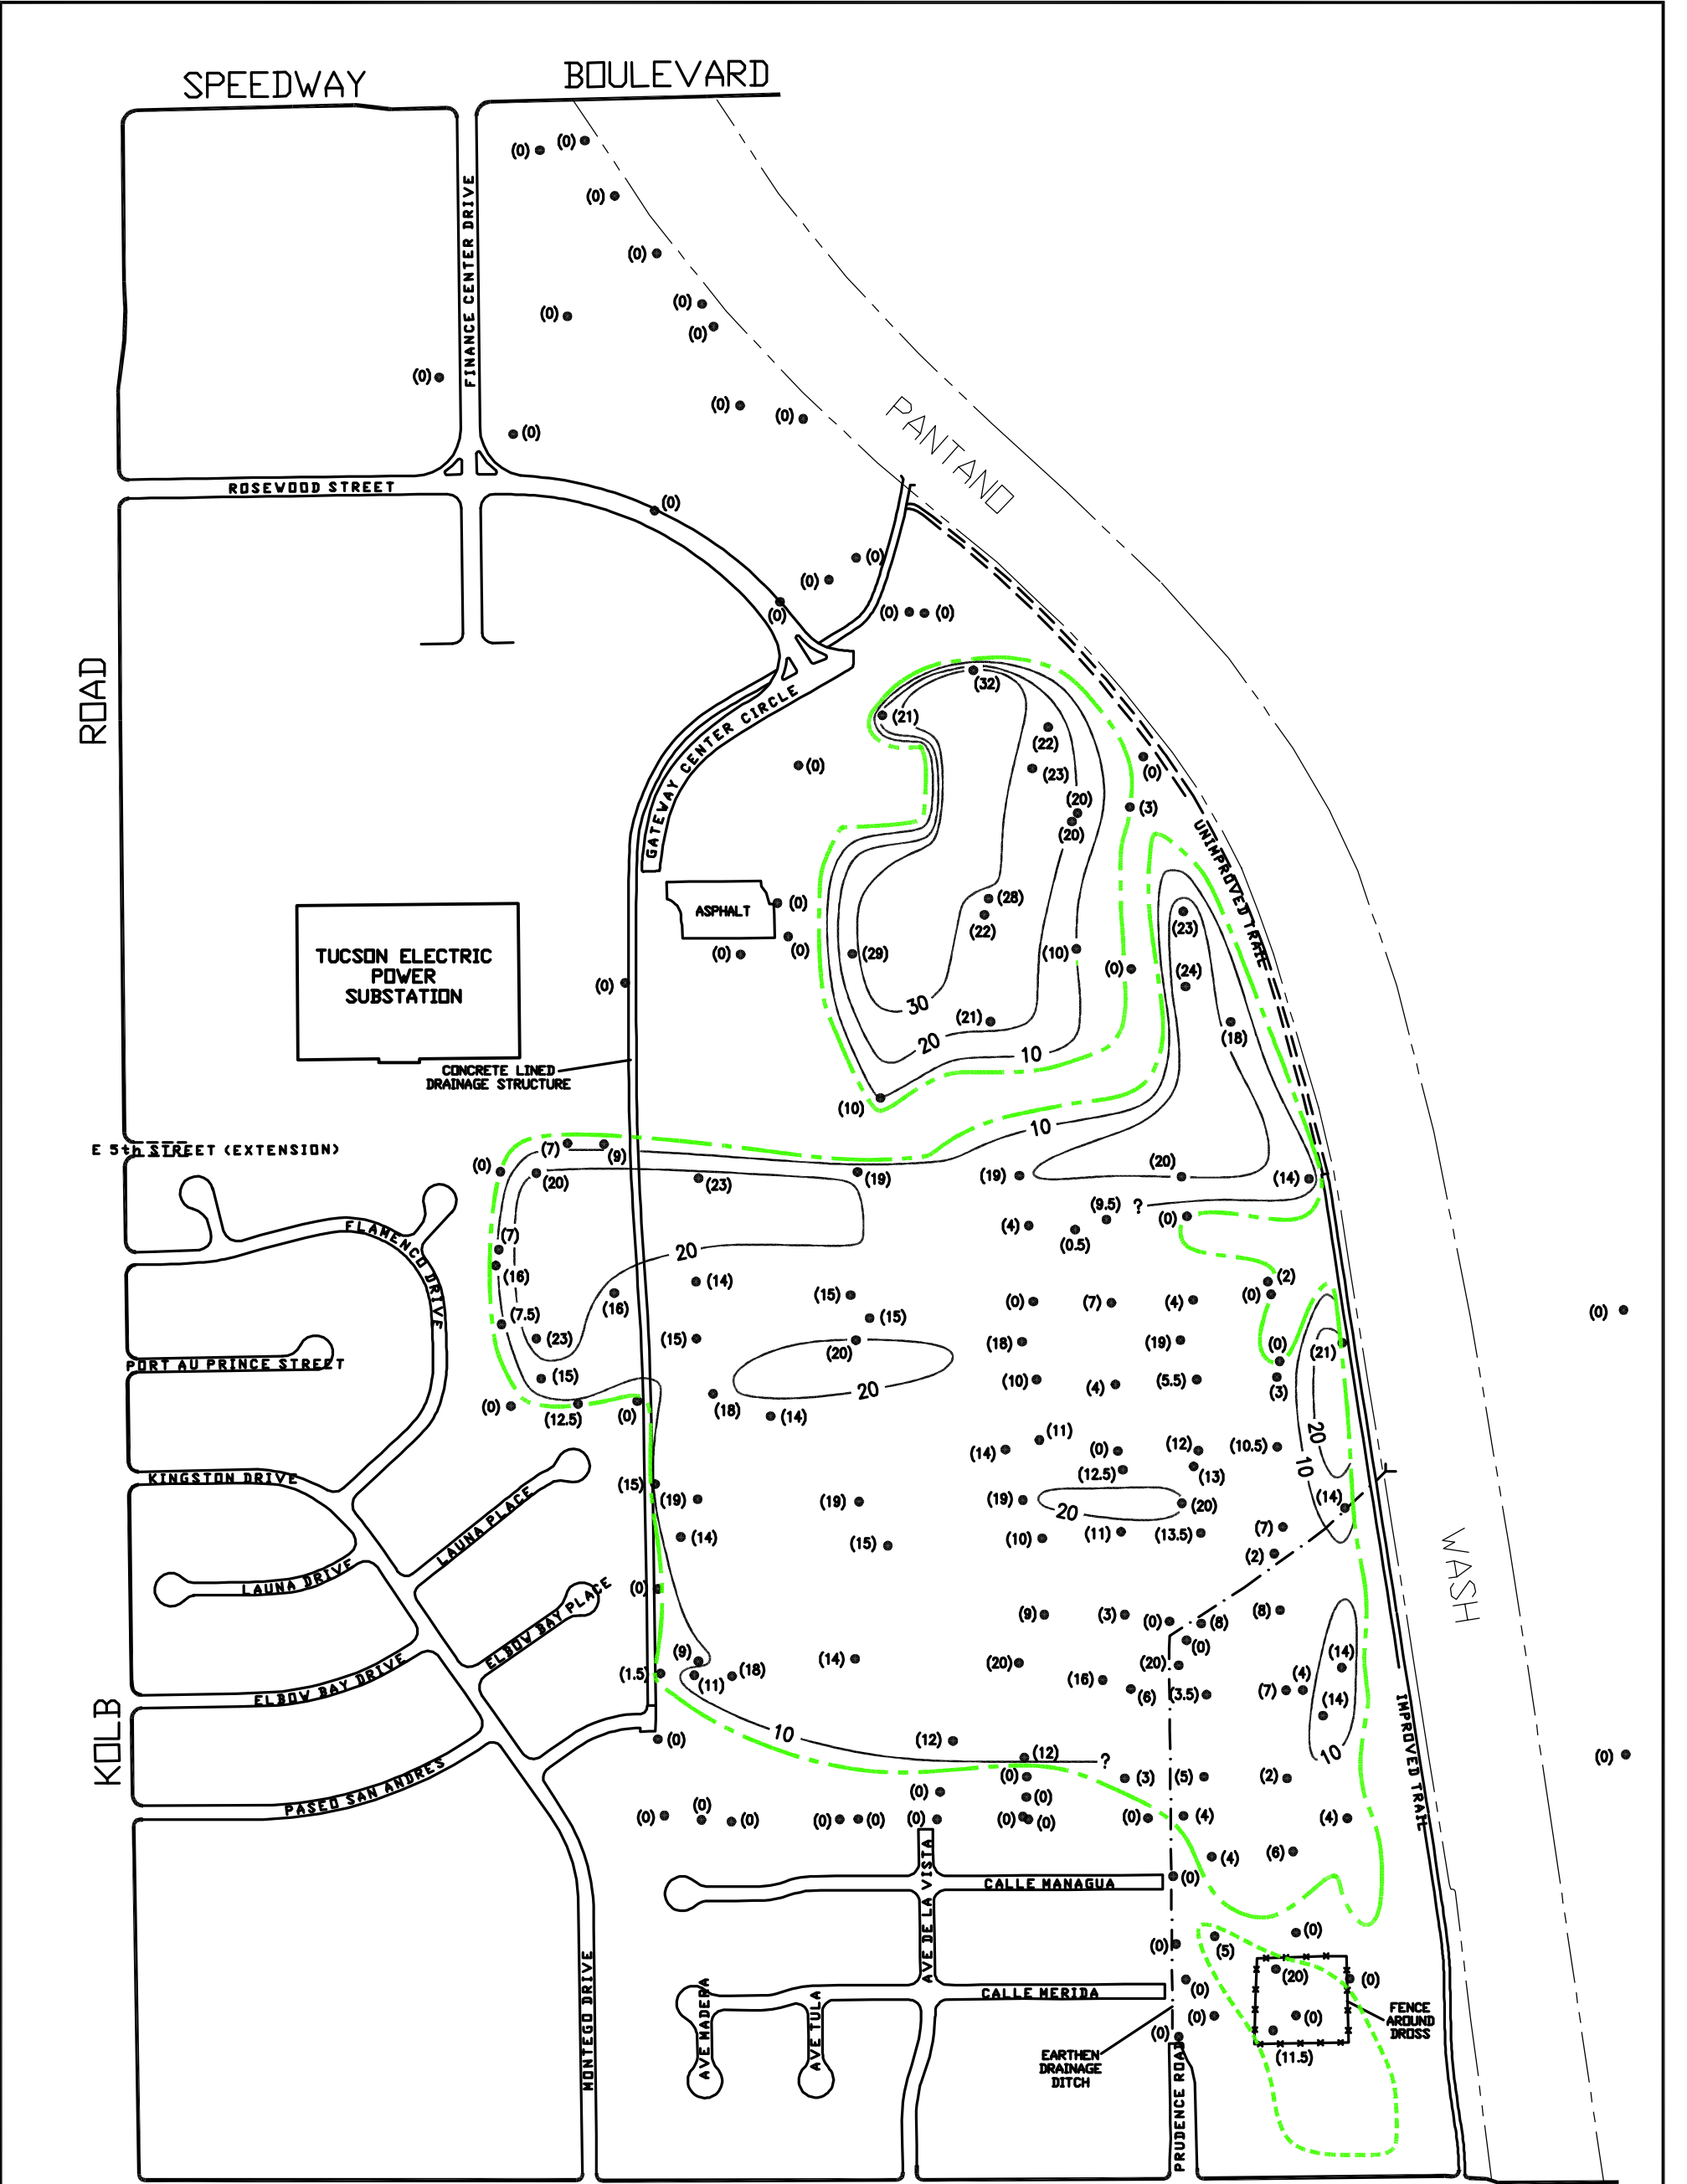
- The maximum refuse thickness likely occurs in portions of the landfill located: (1) to the north of the 5th Street Extension and west of the north trending TEP electrical transmission line poles; (2) between Pantano Wash and the north-trending electrical transmission line poles; and (3) immediately east of the residences, located on the east side of Flamenco Drive (Figure B-2).

- There does not appear to be any refuse placed in the large, deep pit located near the intersection of Rosewood Street and Gateway Center Circle) or the area in the vicinity of the existing asphalt-paved area east of the TEP substation (Figures B-1 and B-2).

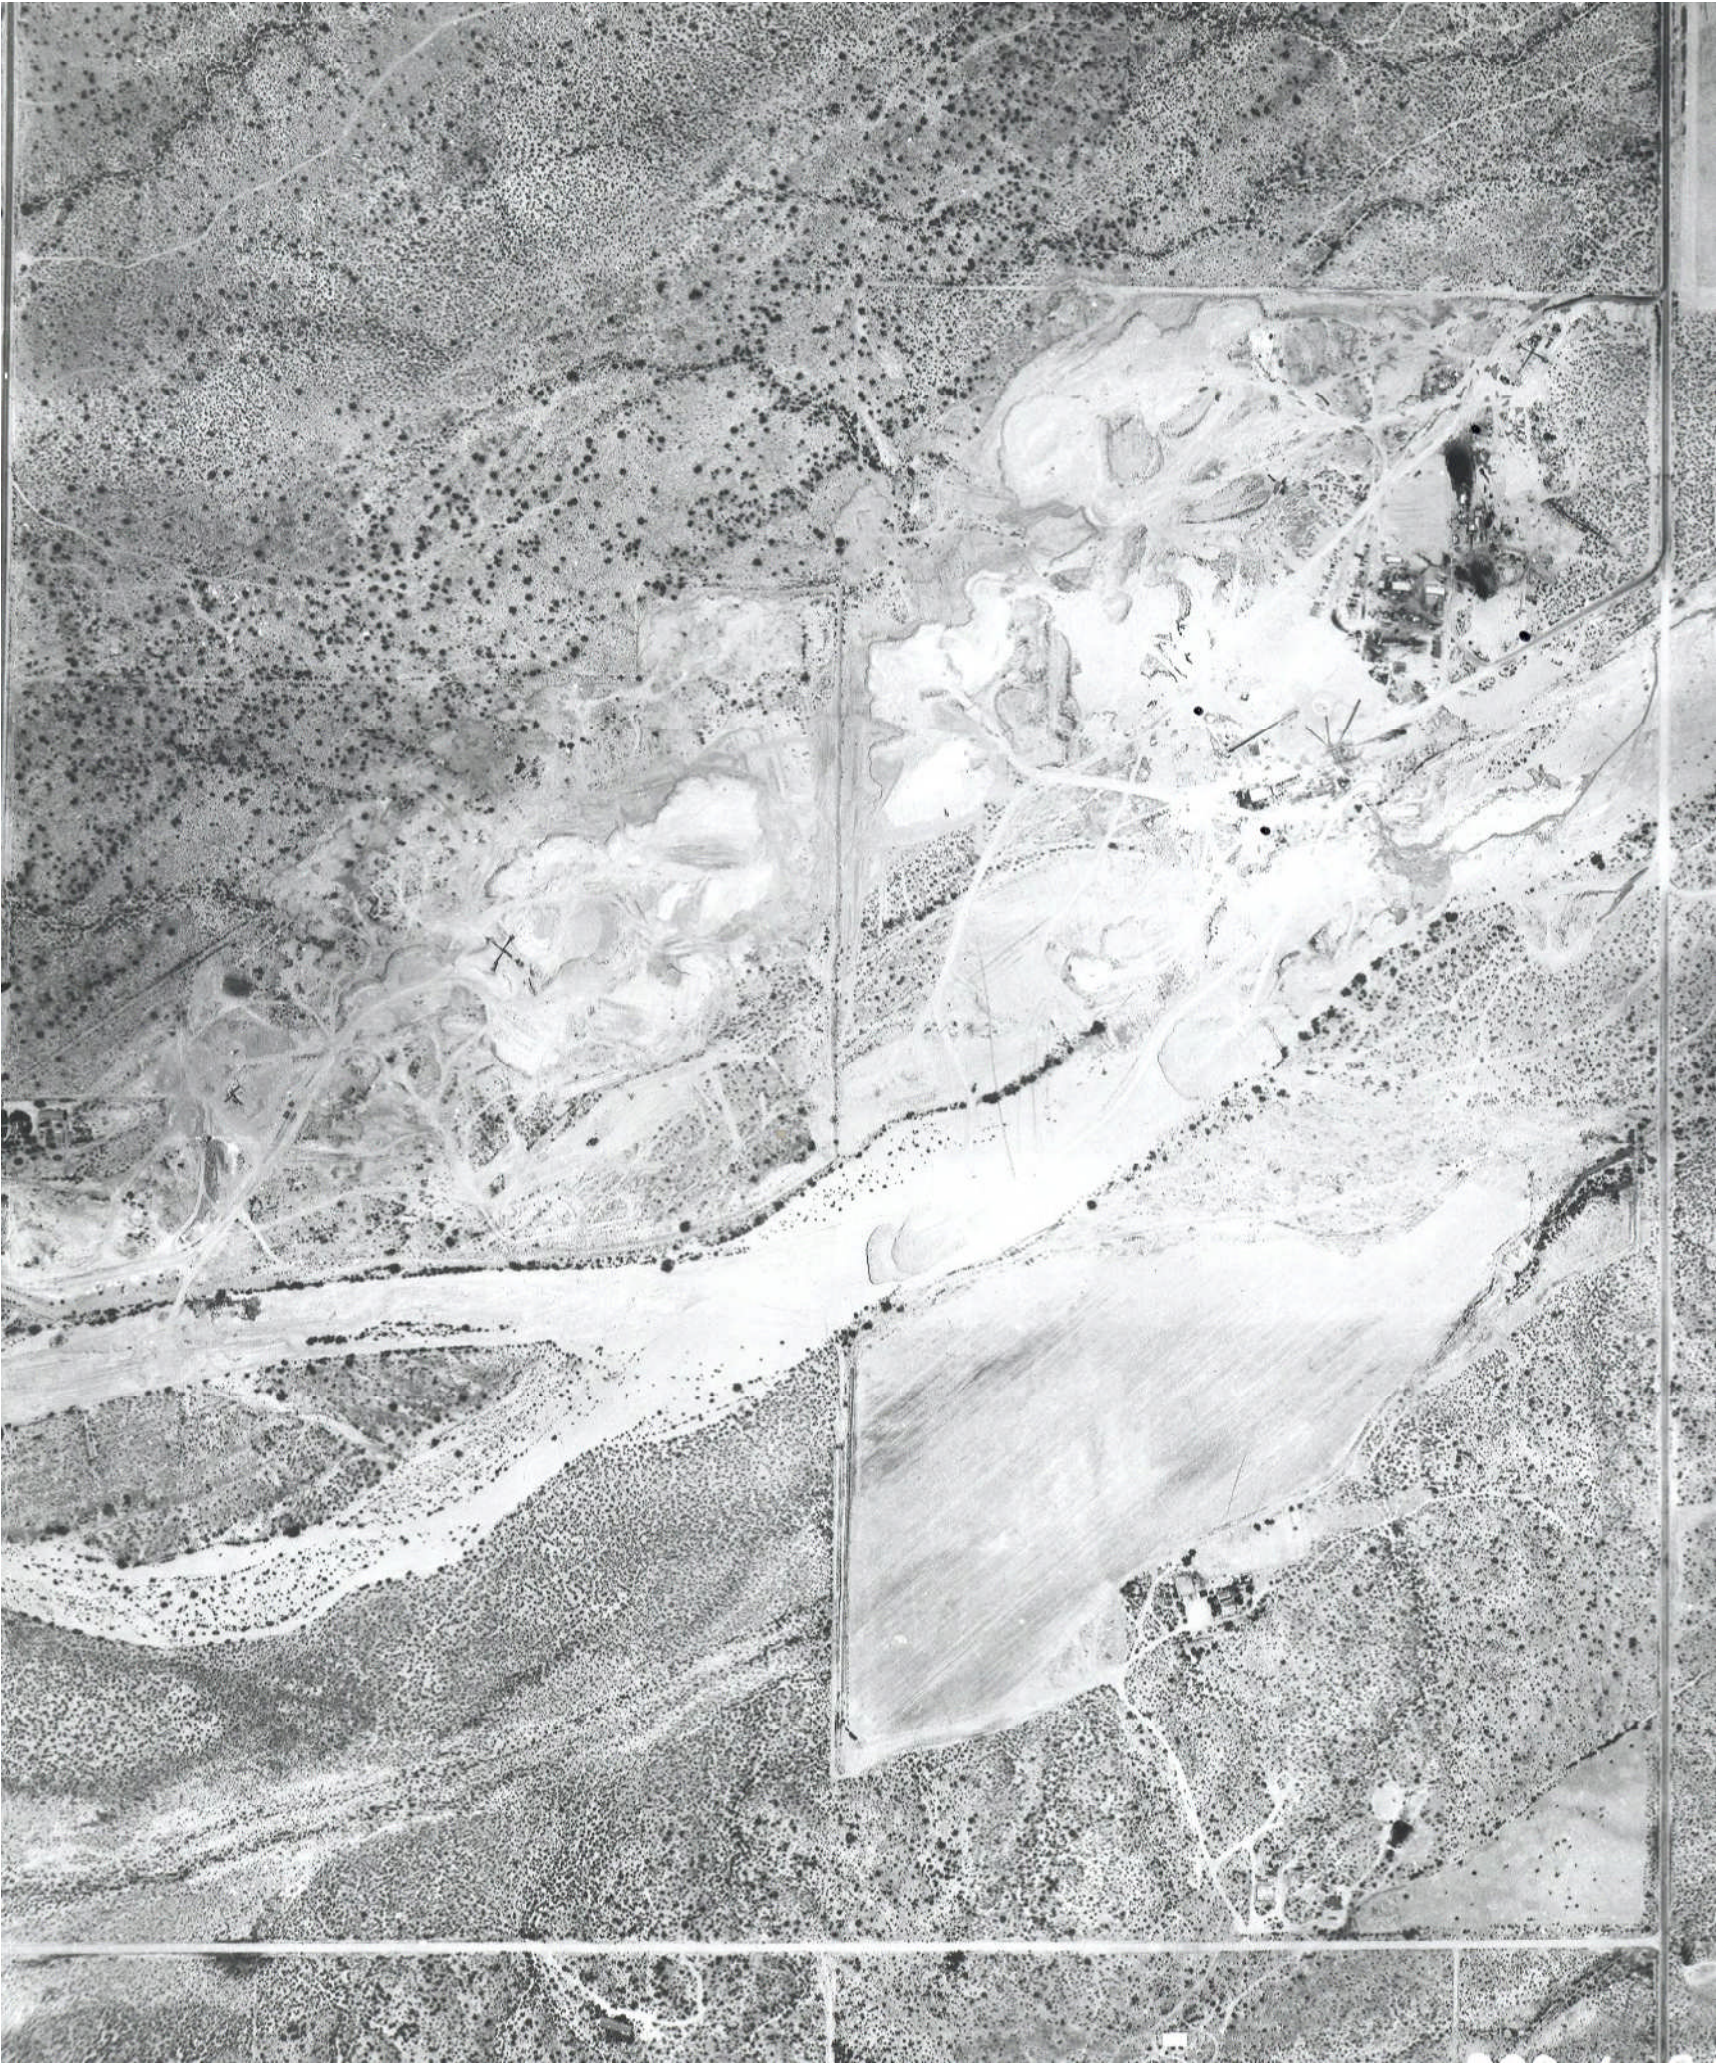
1953 (Figure B-9): The sand and gravel operation is active on the west side of Pantano Wash, south of the present day 5th Street Extension, and on the west side and portions of the wash on the north side of the present day 5th Street Extension. The maintenance areas, offices, batching plants, and a possible hot batch (asphalt) plant are visible to the southeast of the present day intersection of Speedway Boulevard and Kolb Road. The Gollob house and outbuildings are visible near the northeast corner of present day Broadway Boulevard and Prudence Road. Figure B-10 illustrates the site conditions observed on the 1953 aerial photographs.

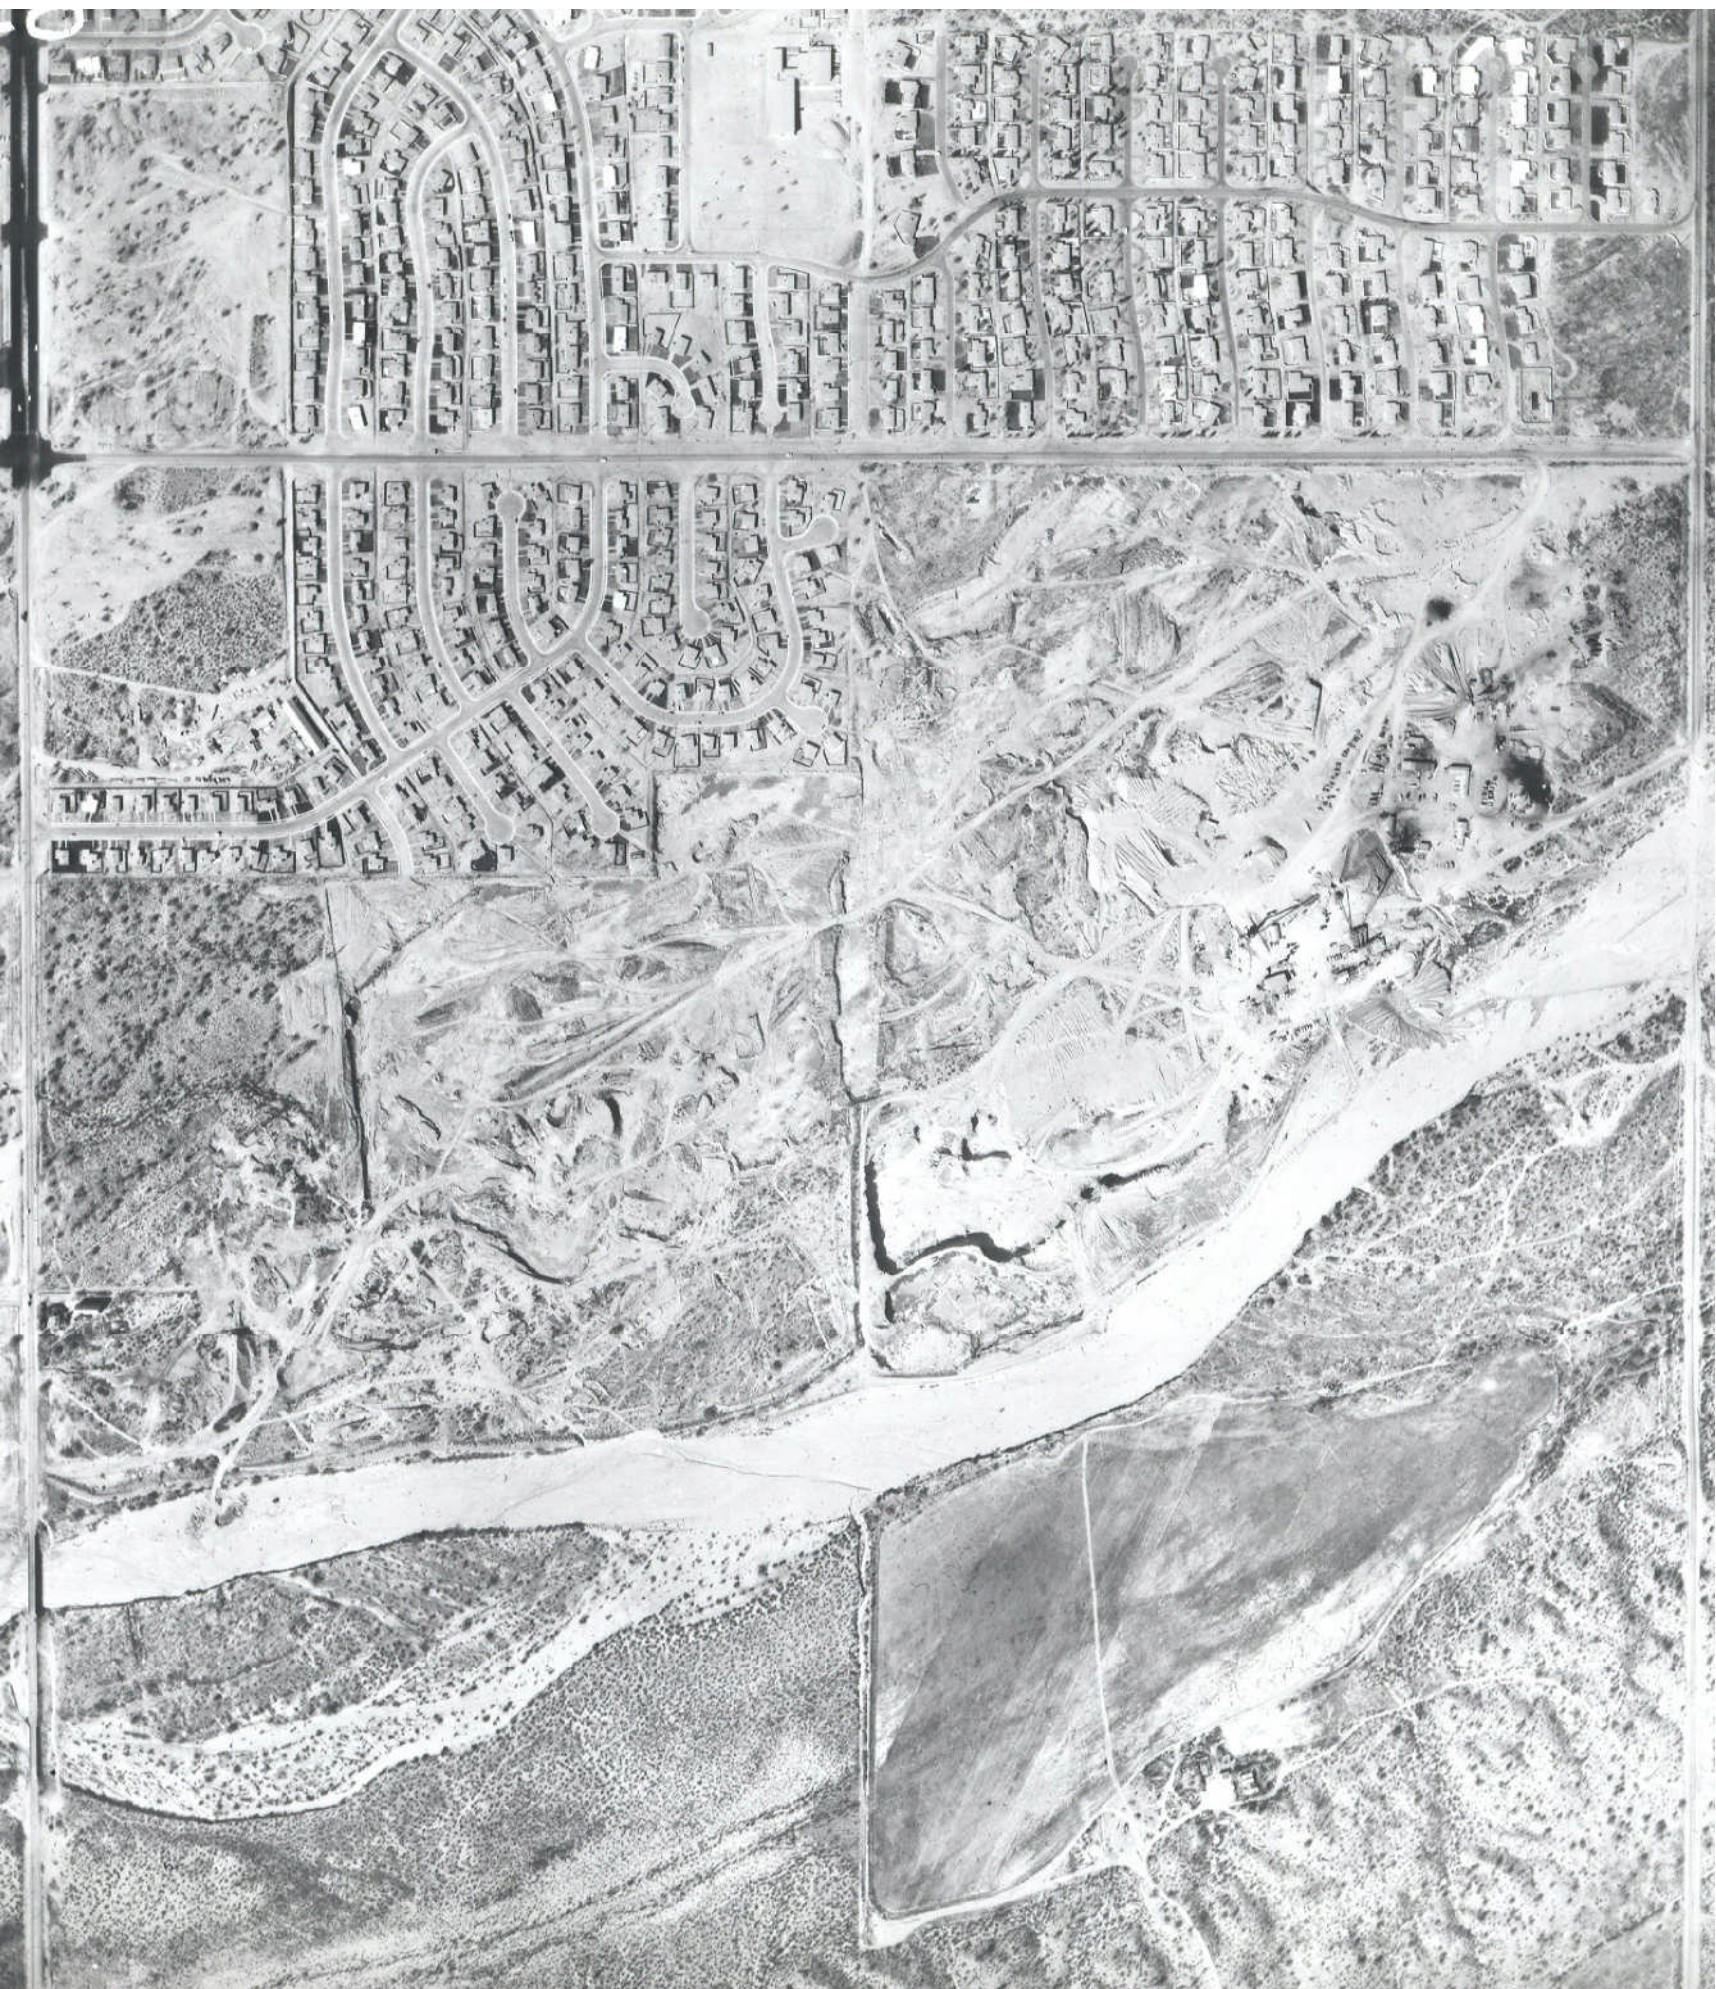
1960 (Figure B-11): Figure B-12 depicts the site conditions observed on the 1960 aerial photograph. The absence of conveyors on the portion of the sand and gravel operation south of the present day 5th Street Extension suggests mining operations have ceased in this area. Active mining is visible north of the 5th Street Extension. A residential development is apparent on the east side of Kolb Road and south of the 5th Street Extension. The Gollob structures are still intact. Of note is the near vertical cut along the east side of the residential development, and approximately 1,000 feet north and parallel to Broadway Boulevard. Based on the aerial photographs, the depth of the former sand and gravel operation excavations in this area could approach 25 to 30 feet below the ground level of the residential development. There does not appear to be any landfilling operations underway at the time the aerial photographs were taken.

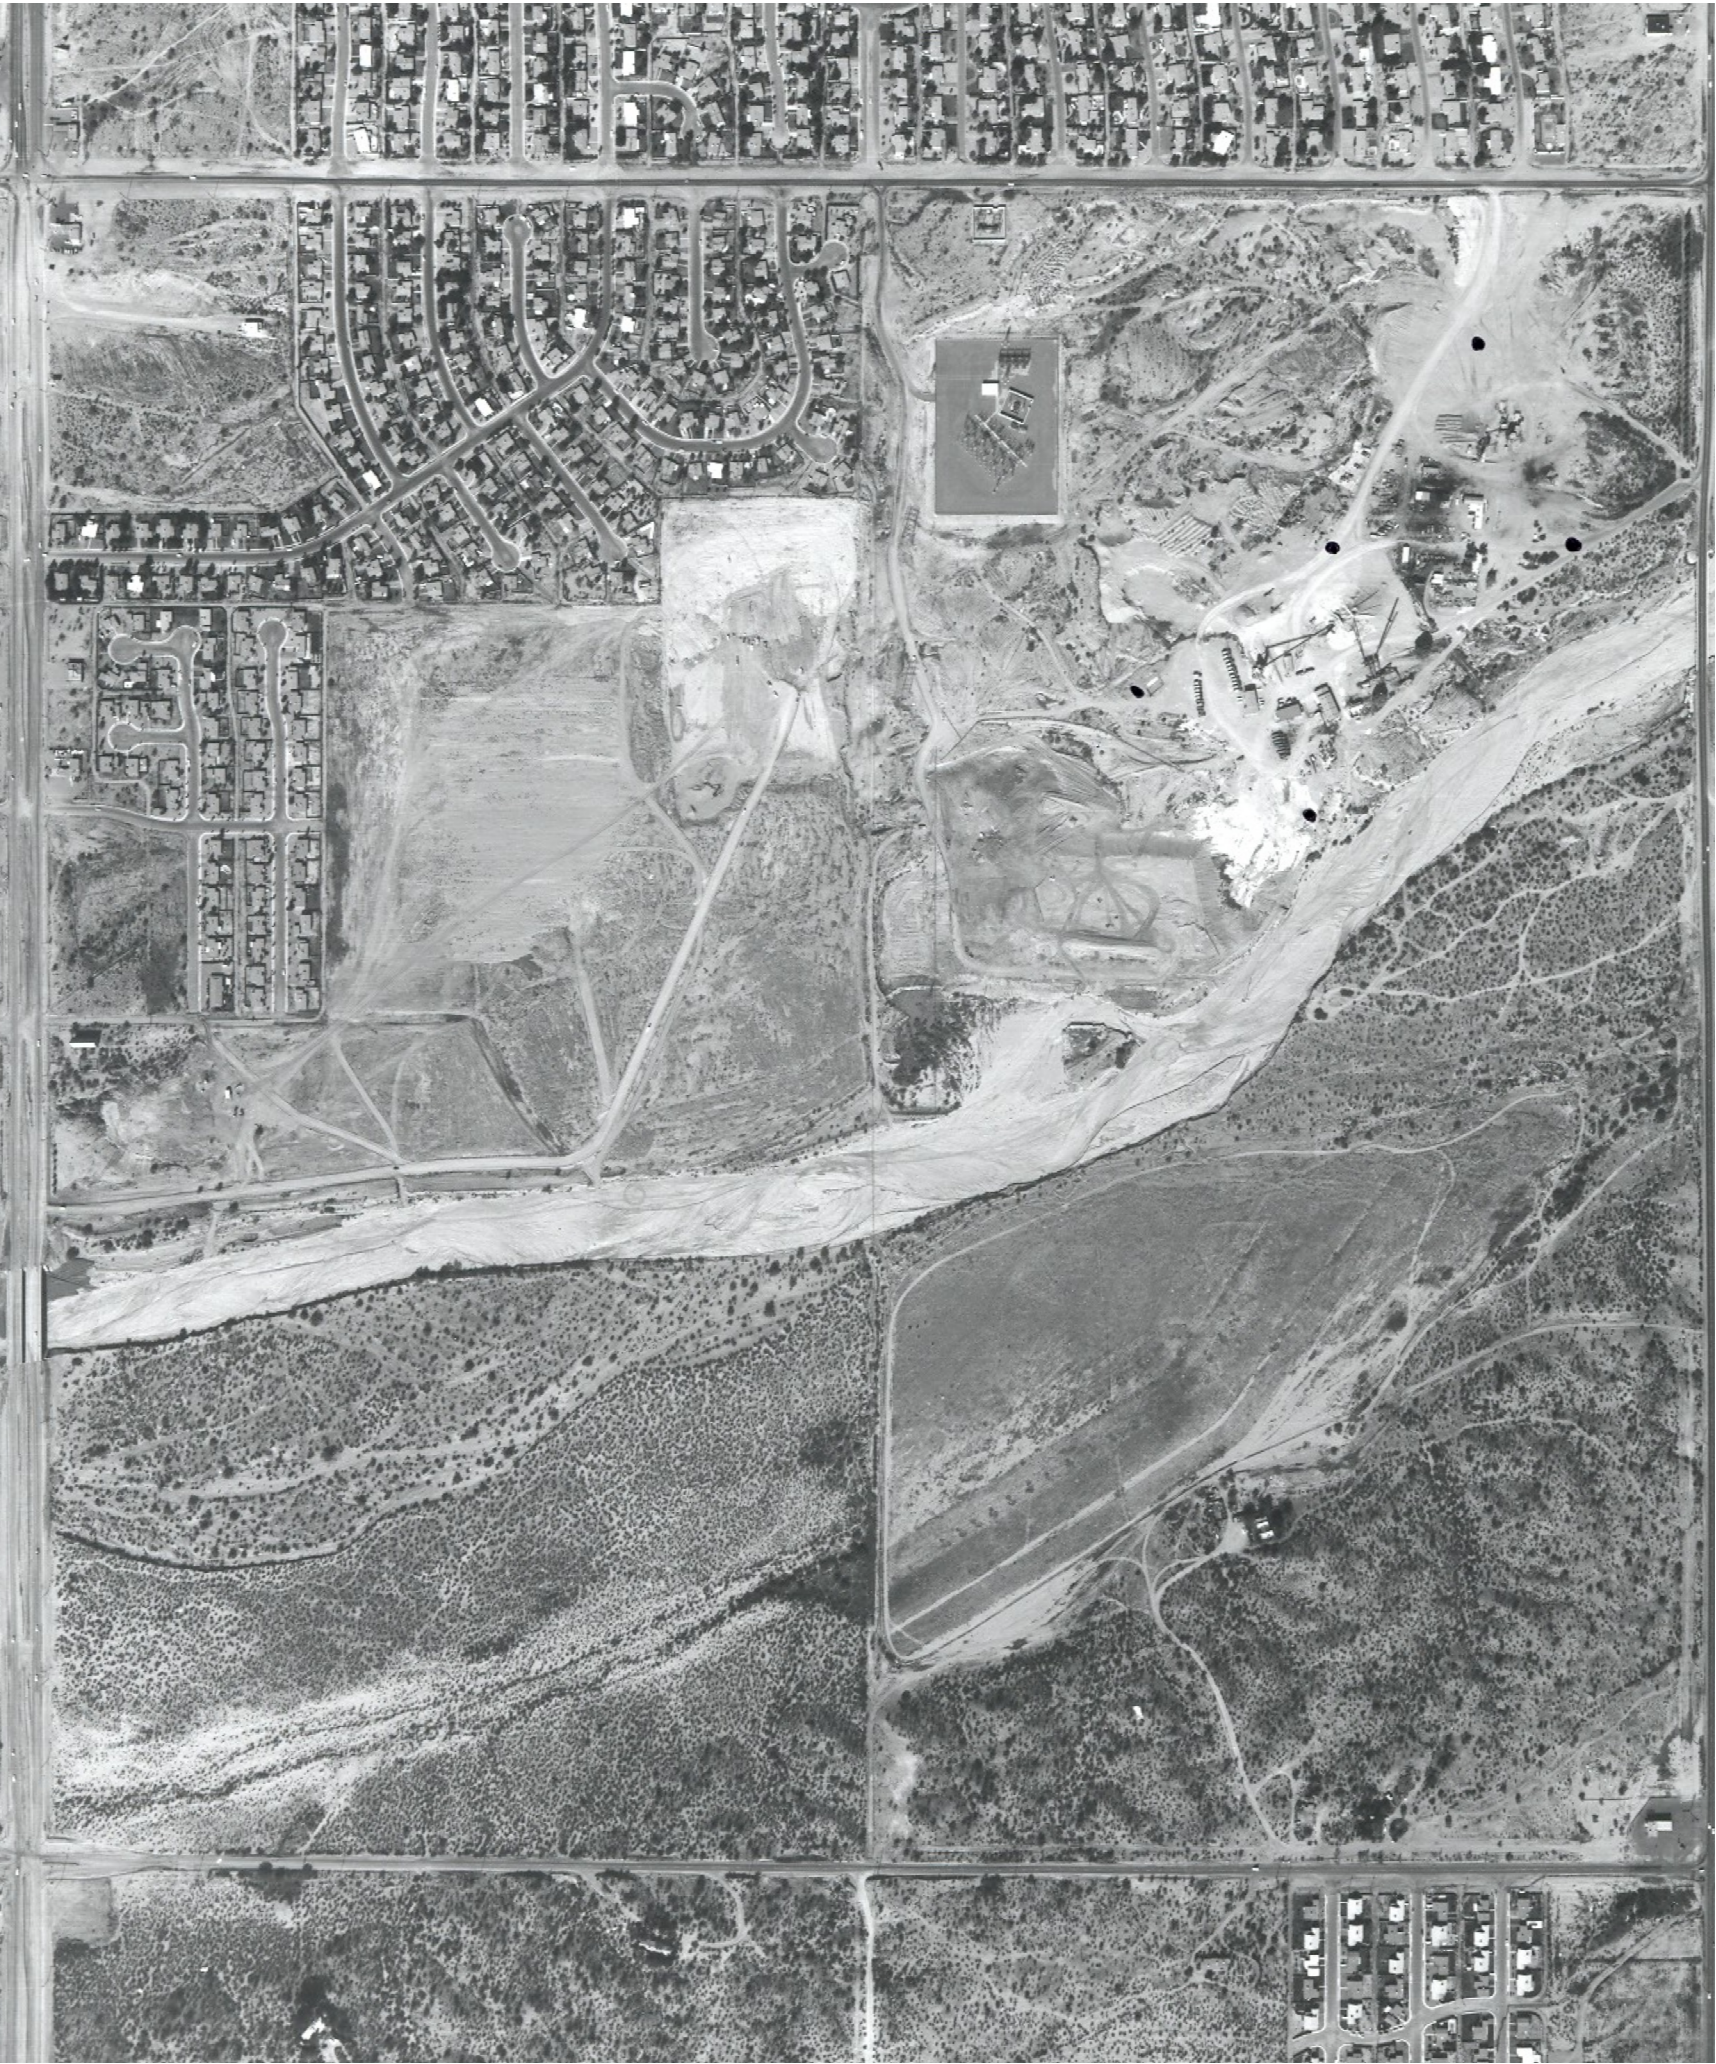
1967 (Figure B-17): Figure B-18 depicts the site conditions observed on the 1967 aerial photographs. There are two active fill areas on the southern portion of the landfill. The landfill areas near the residential development boundaries appear to be filled to present day grade. The area to the east of the intact Gollob structures appears to be nearly filled to present day grade. The active mining area of the sand and gravel operation has been reduced considerably in aerial extent. Active landfilling operations are underway to the north of the 5th Street Extension and west of Pantano Wash. The TEP substation is complete and electrical transmission line poles are evident leading east along the 5th Street Extension and then to the north on the east side of the landfill operation north of the 5th Street Extension.

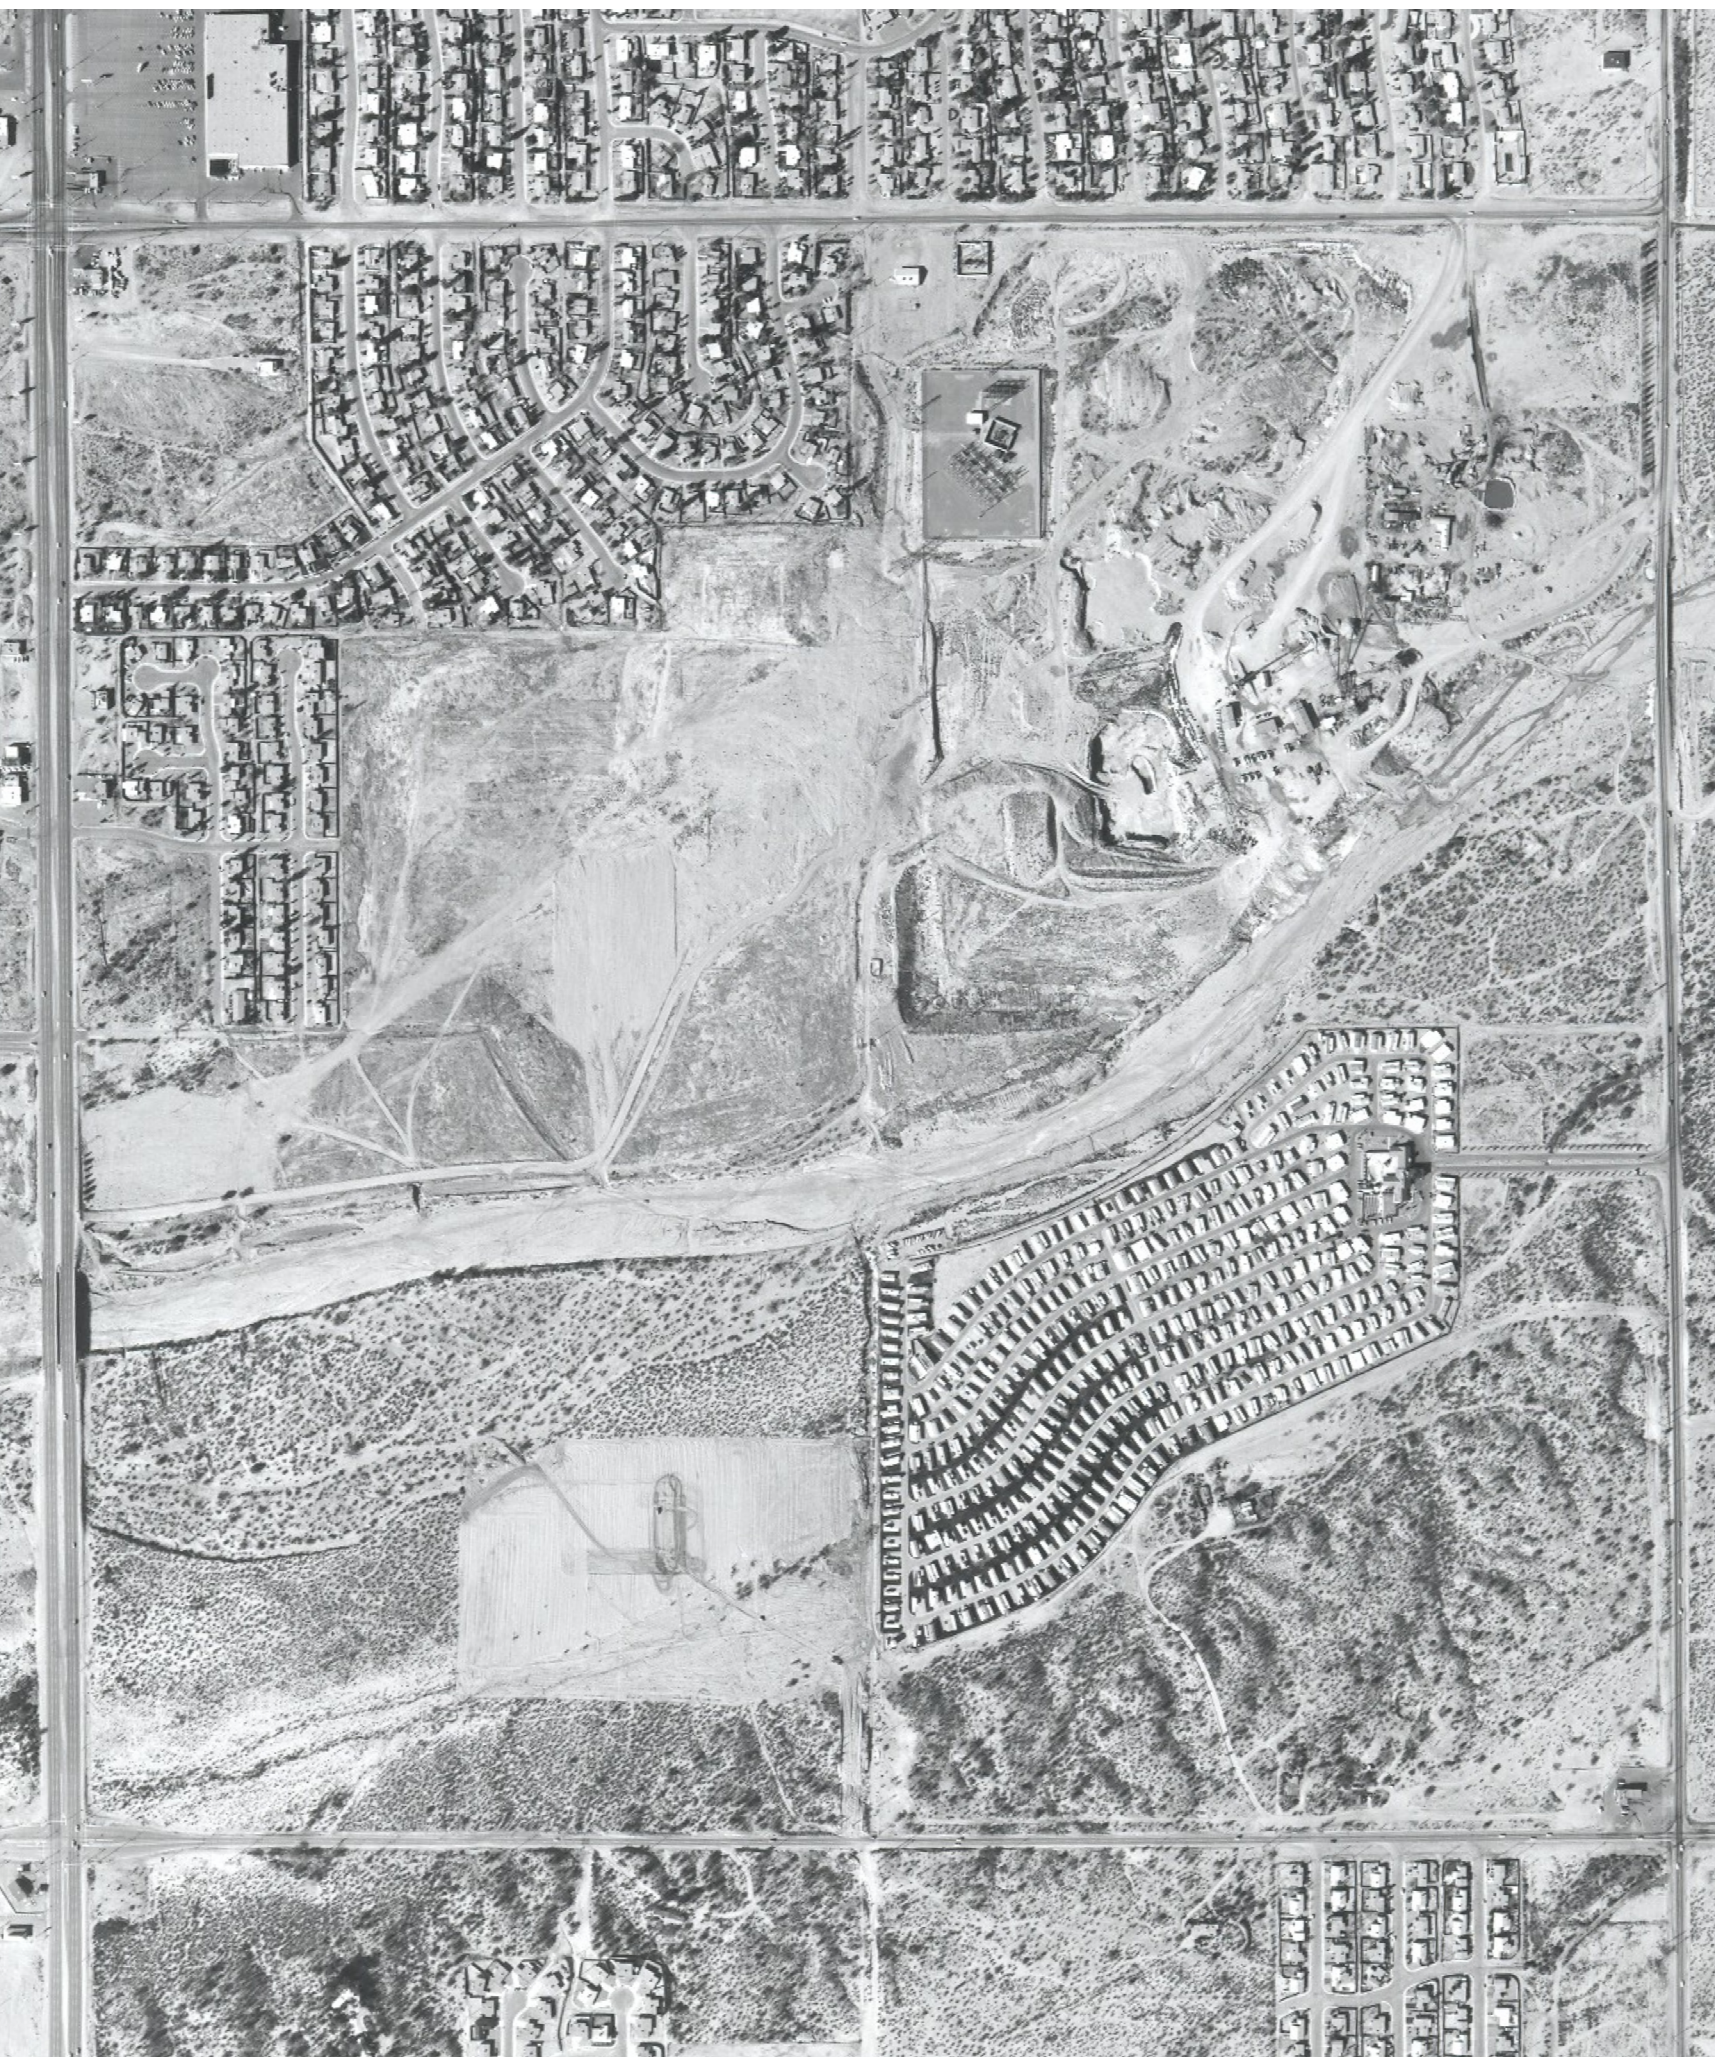
1971 (Figure B-21): Based on the relatively flat surface and sparse vegetation visible in the 1971 aerial photograph (Figure B-22), the landfill appears to be filled to present day grade and inactive. The Gollob structures have been removed, and the sand and gravel operation appears to be active.
