APPENDIX K
VERTICAL AND HORIZONTAL EXTENT OF REFUSE
BROADWAY NORTH LANDFILL
REMEDIAL INVESTIGATION REPORT
GROUNDWATER OPERABLE UNIT (STANTEC 2012)

APPENDIX B
VERTICAL AND HORIZONTAL EXTENT OF REFUSE,
BROADWAY NORTH LANDFILL
REMEDIAL INVESTIGATION REPORT
GROUNDWATER OPERABLE UNIT
Arizona Department of Environmental Quality
Broadway-Pantano Water Quality Assurance Revolving Fund Site
June 1, 2012

BROADWAY NORTH LANDFILL— VERTICAL AND HORIZONTAL EXTENT OF REFUSE

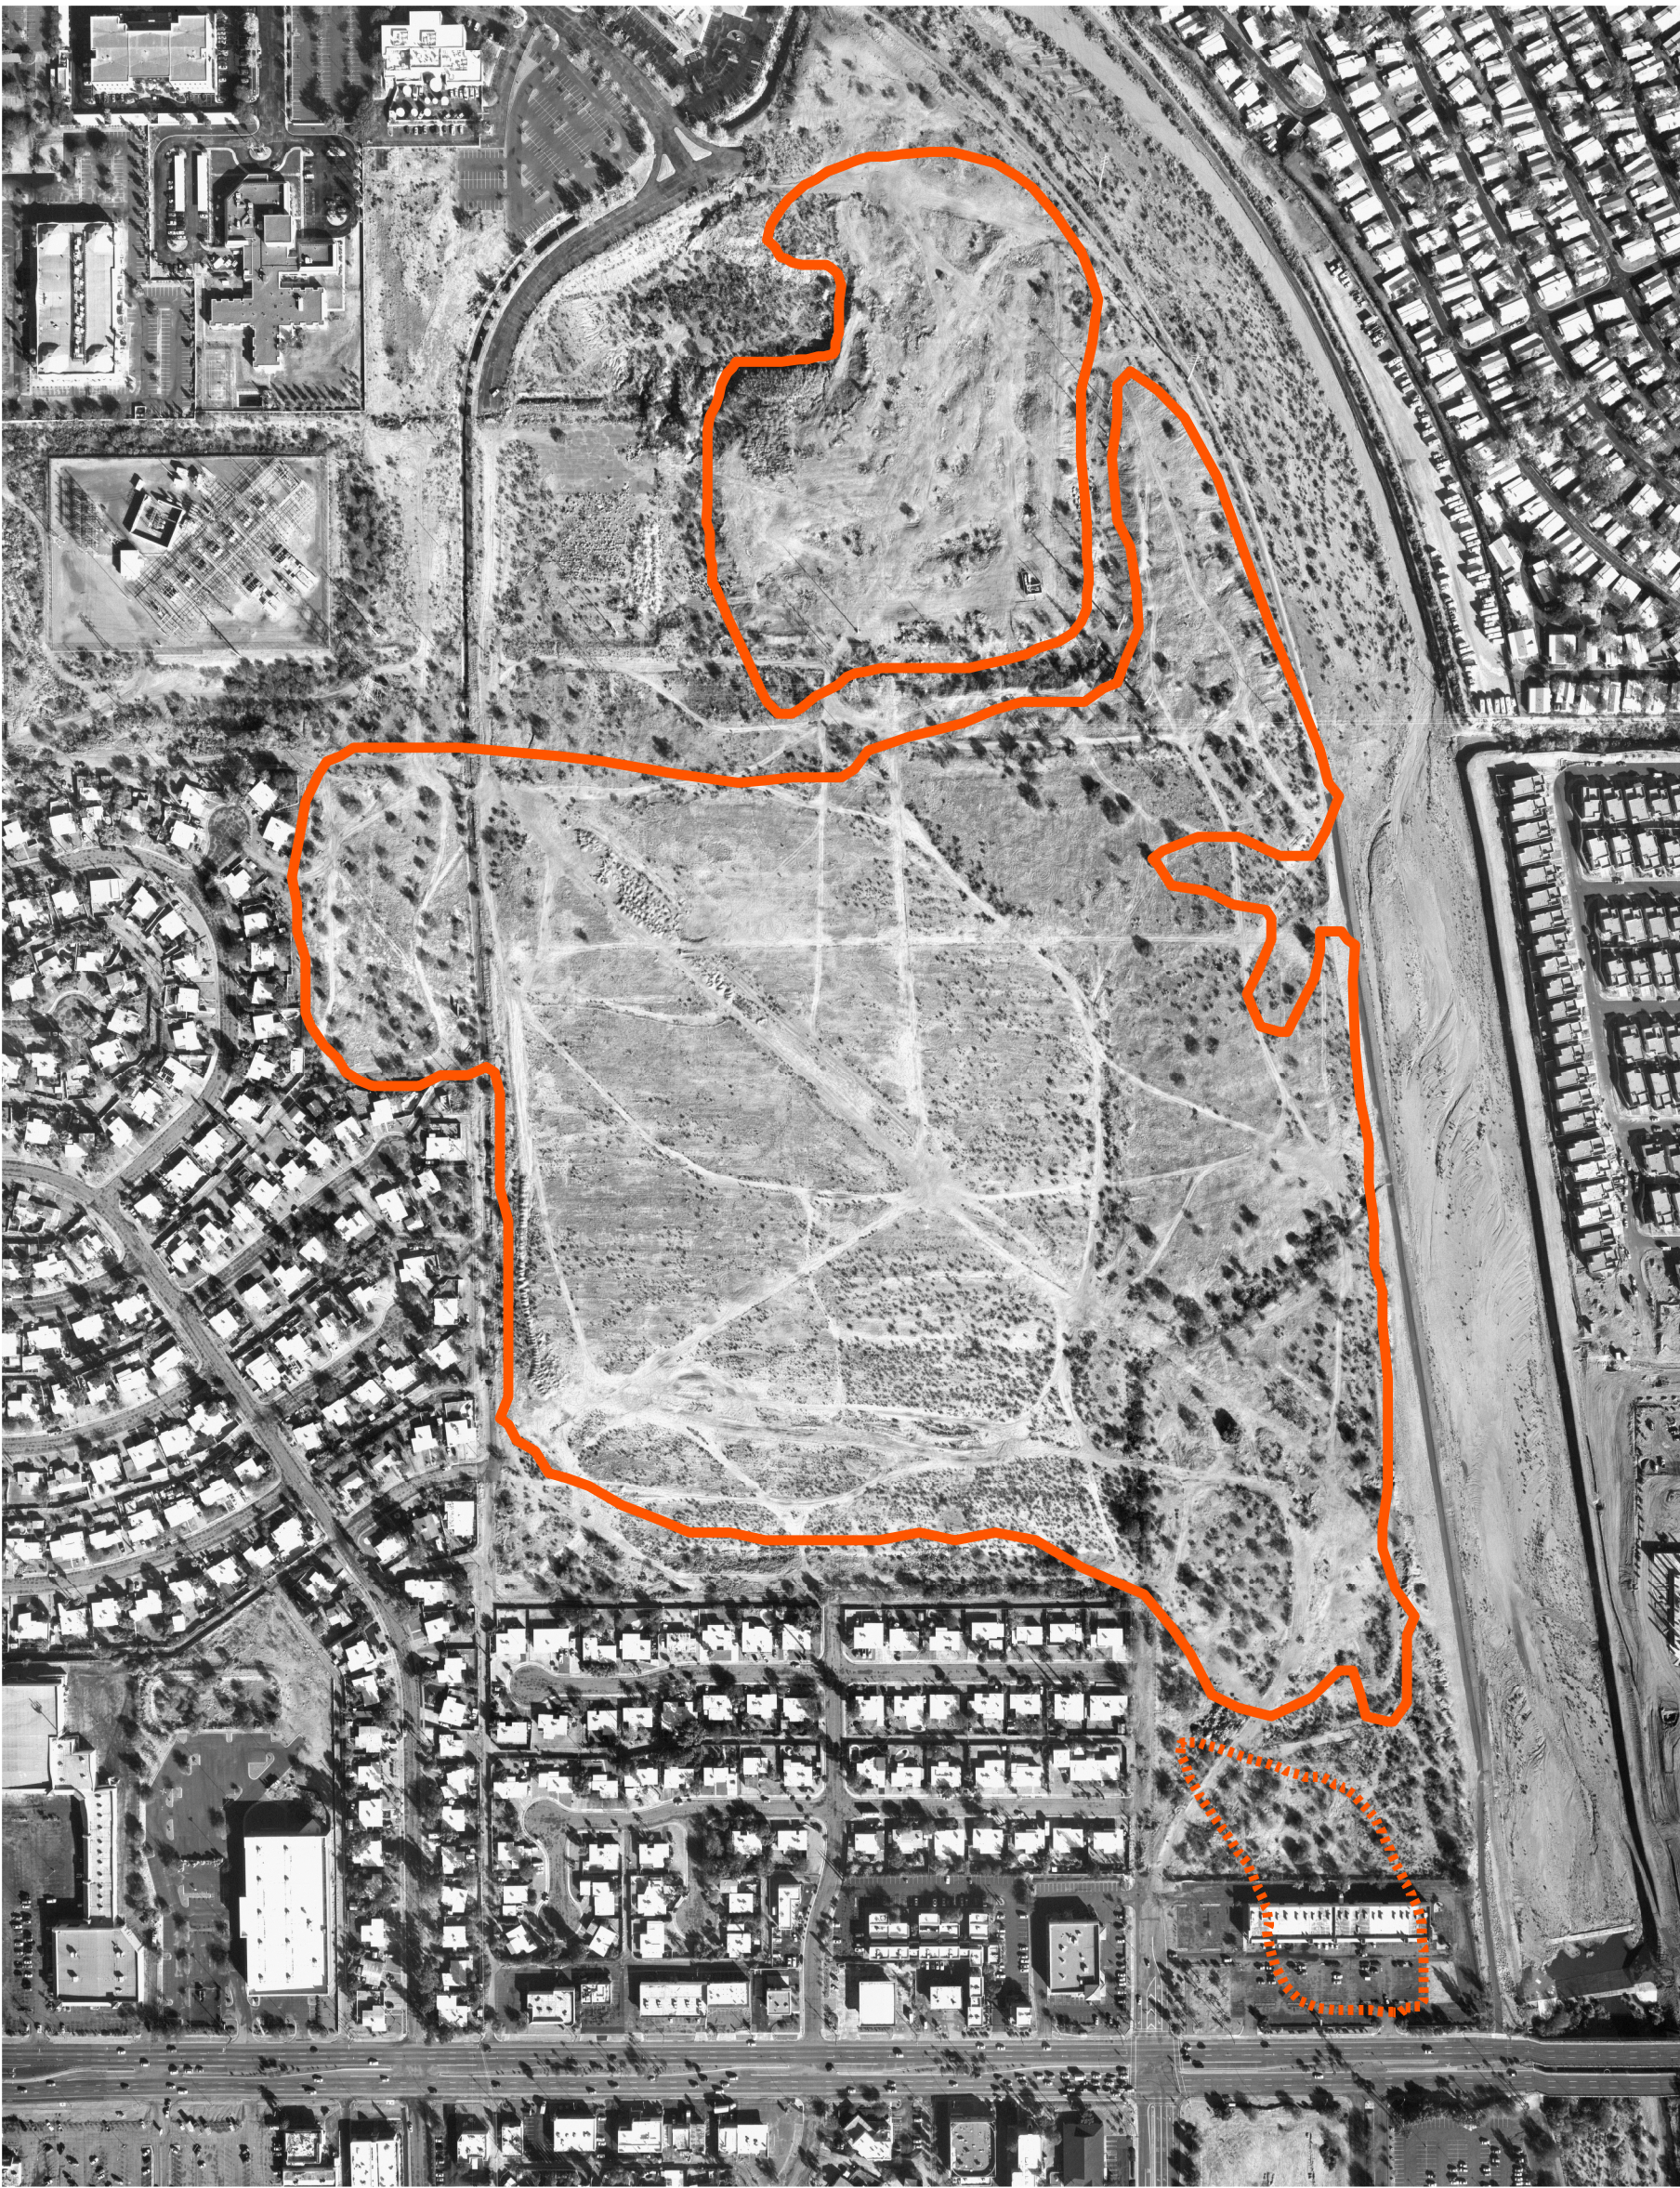
- Although poorly delineated, there does appear to be separation between the municipal and construction debris refuse on the southernmost portion of the landfill (Figures B-23 and B-2).
