# 16<sup>th</sup> Street and Camelback WQARF Site

Kevin Snyder, Project Manager

March 11, 2015 5:30pm

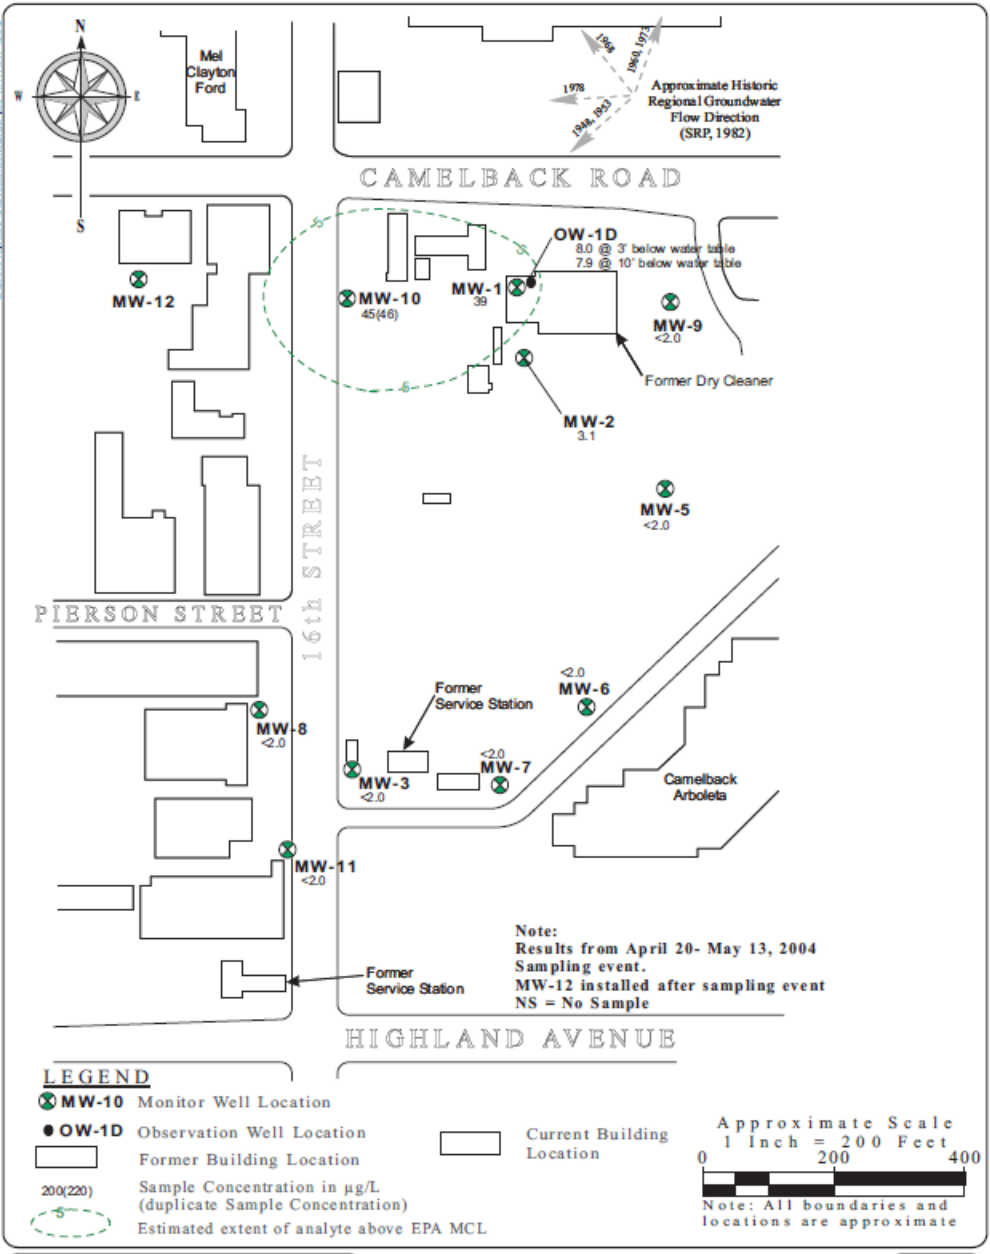
PLATE  
**5**

**ISOCONCENTRATION  
CONTOUR MAP FOR PCE**

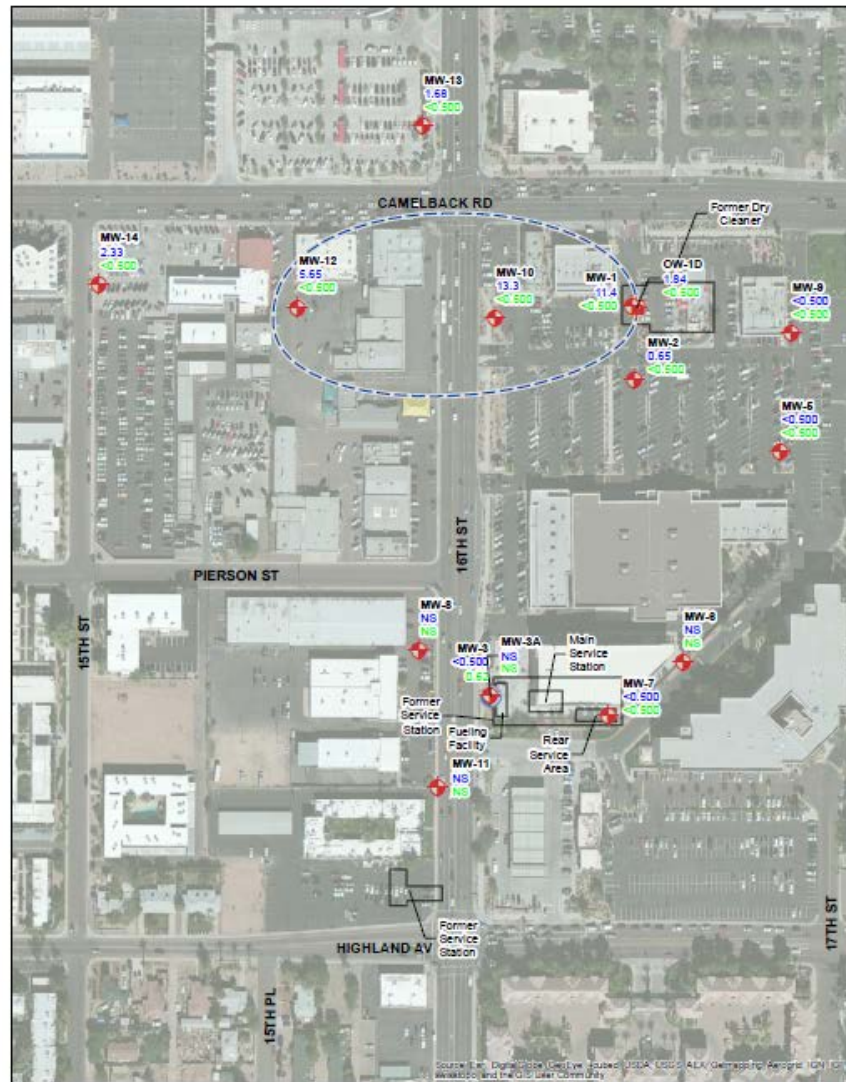
**Figure 10**  
**APRIL 2014 PCE**  
**CONCENTRATIONS**  
**IN GROUNDWATER**  
**REMEDIAL INVESTIGATION**  
**SUMMARY REPORT**  
**16TH STREET AND CAMELBACK WQRF SITE**  
**PHOENIX, ARIZONA**

- PCE is currently the only contaminant of concern detected in groundwater at the site at concentrations greater than the Aquifer Water Quality Standard (AWQS).
- Contaminants appear to have naturally attenuated.
