**7th Avenue & Bethany Home Road/Central & Camelback
Water Quality Assurance Revolving Fund (WQARF) Site
Community Advisory Board (CAB) Meeting**

Wednesday, July 23, 2014

7th Avenue & Bethany Home Road Water Quality Assurance Revolving Fund Site

Central and Camelback WQARF Site

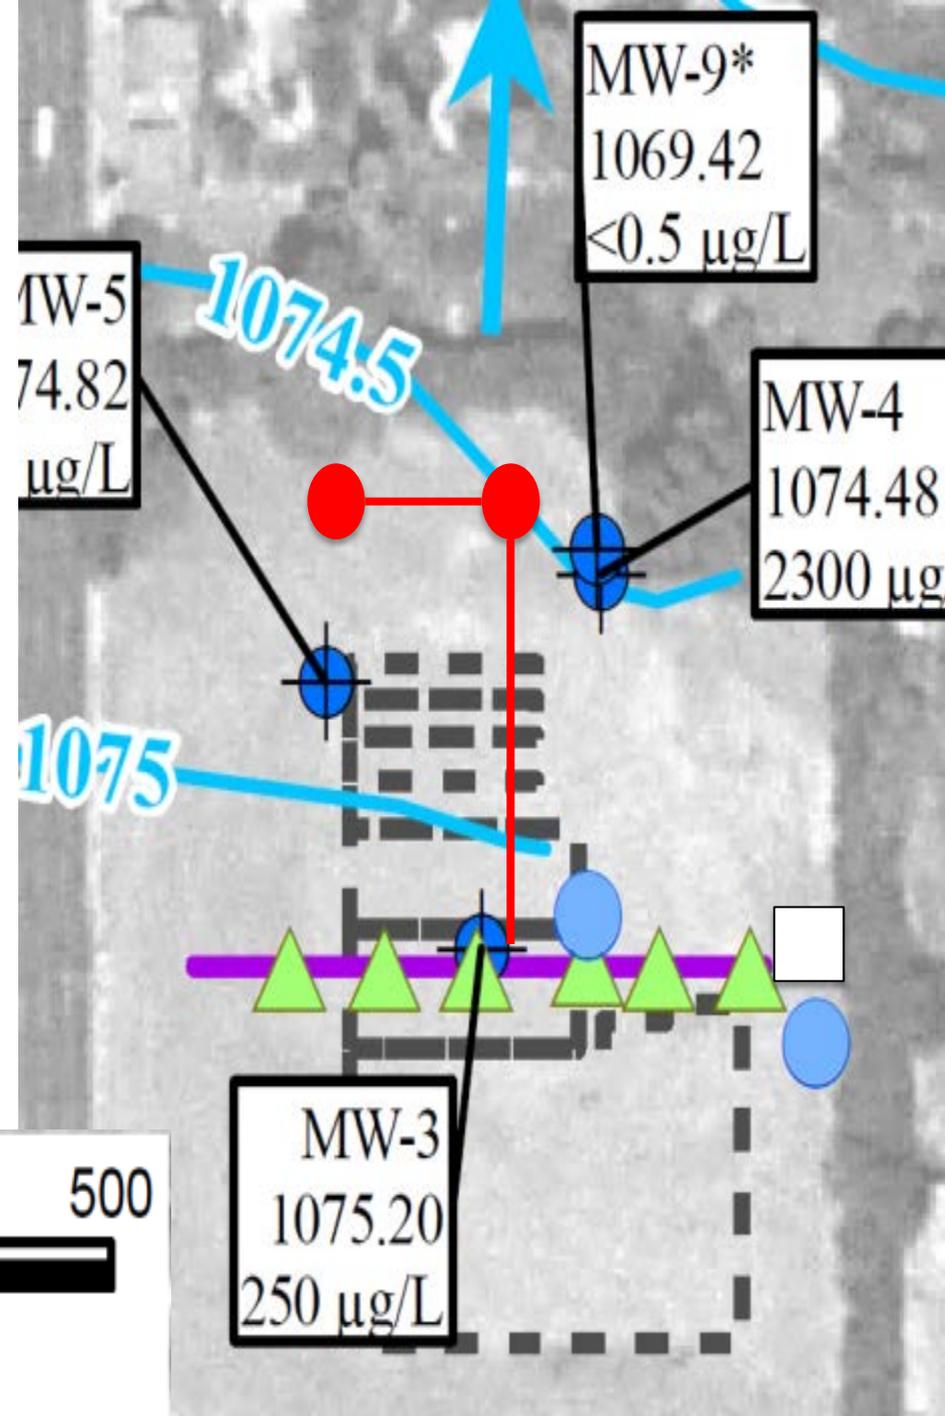
Alternative 1 from FFS – Phase 1

- Phase 1 includes:
 - a transect of injection wells at the source area combined with two down gradient extraction wells; and
 - one injection well at former dry cleaner on west side of 7th Avenue.
 - Estimated costs are just over \$1M dollars.

Incorporate Extraction wells
into Alternative 1

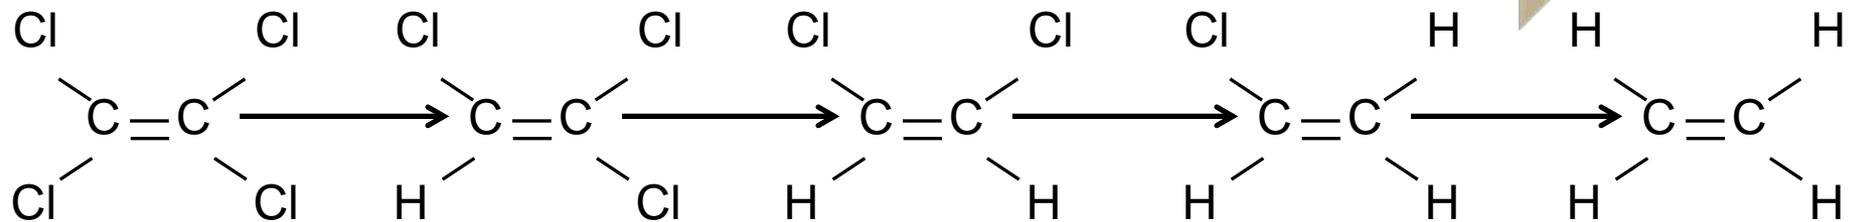
Reductive dechlorination

PCE
Tetrachloroethene

TCE
Trichloroethene

Cis-1,2-DCE
Cis-1,2-dichloroethene

VC
Vinyl Chloride

Ethene/Ethane

Dominant pathway for reductive dechlorination of chlorinated ethenes. Other compounds may include trans-1,2-dichloroethene or 1,1-dichloroethene

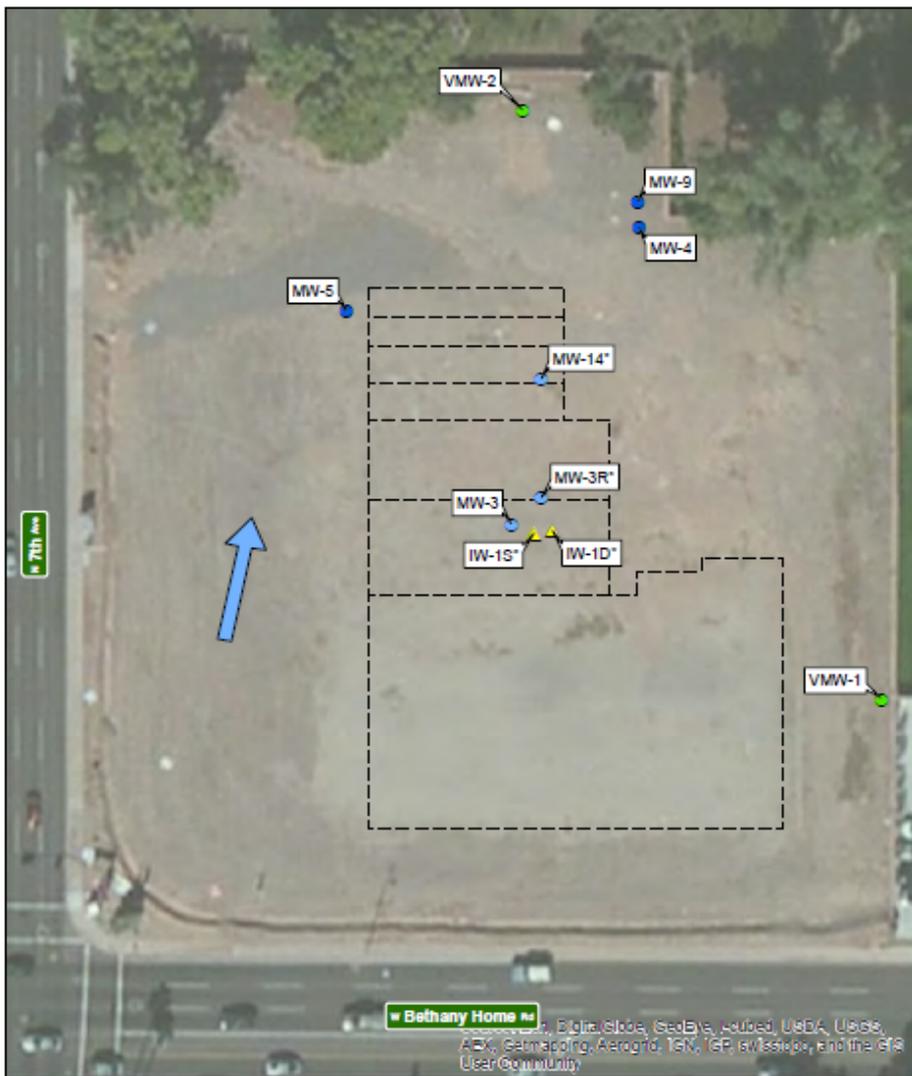
BAYLESS PROPERTY WELL NETWORK

- Groundwater monitor well
- Groundwater monitor well (pilot test network)
- Vapor Monitoring Well (Approximate Location)
- ▲ Groundwater injection well
- Former building
- ➔ Approximate direction of groundwater flow

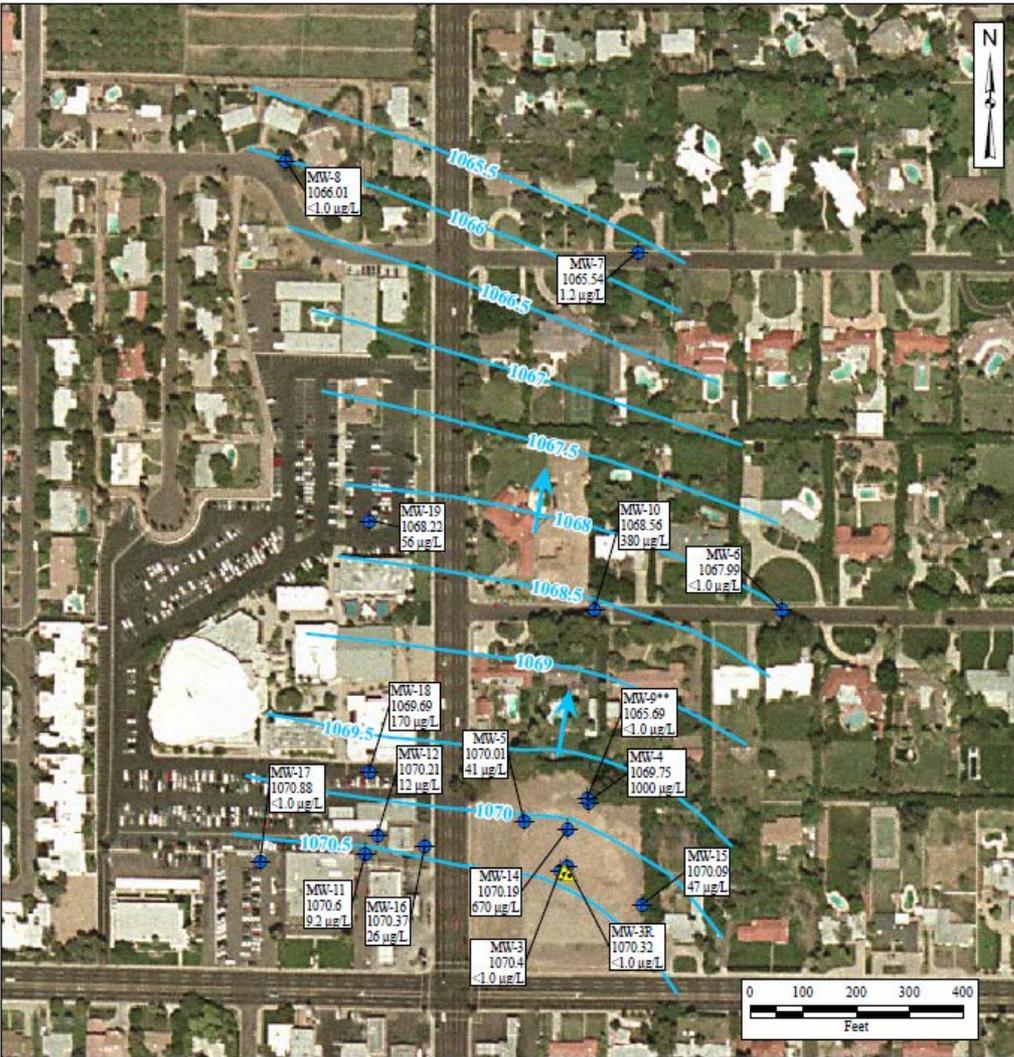
Figure 2

* MW-9 GW elevation not used for contouring. MW-9 is approximately 10 feet north of MW-4

- Injection Well
- Monitor Well
- March 2014 Groundwater Elevation Contours (ft amsl)
- Monitor Well Name
March 18, 2014 Groundwater Elevation (ft amsl)
PCE Concentration ($\mu\text{g/L}$)
- General Groundwater Direction

Groundwater Elevations
March 18, 2014
7th Ave & Bethany Home Rd
WQARF Site

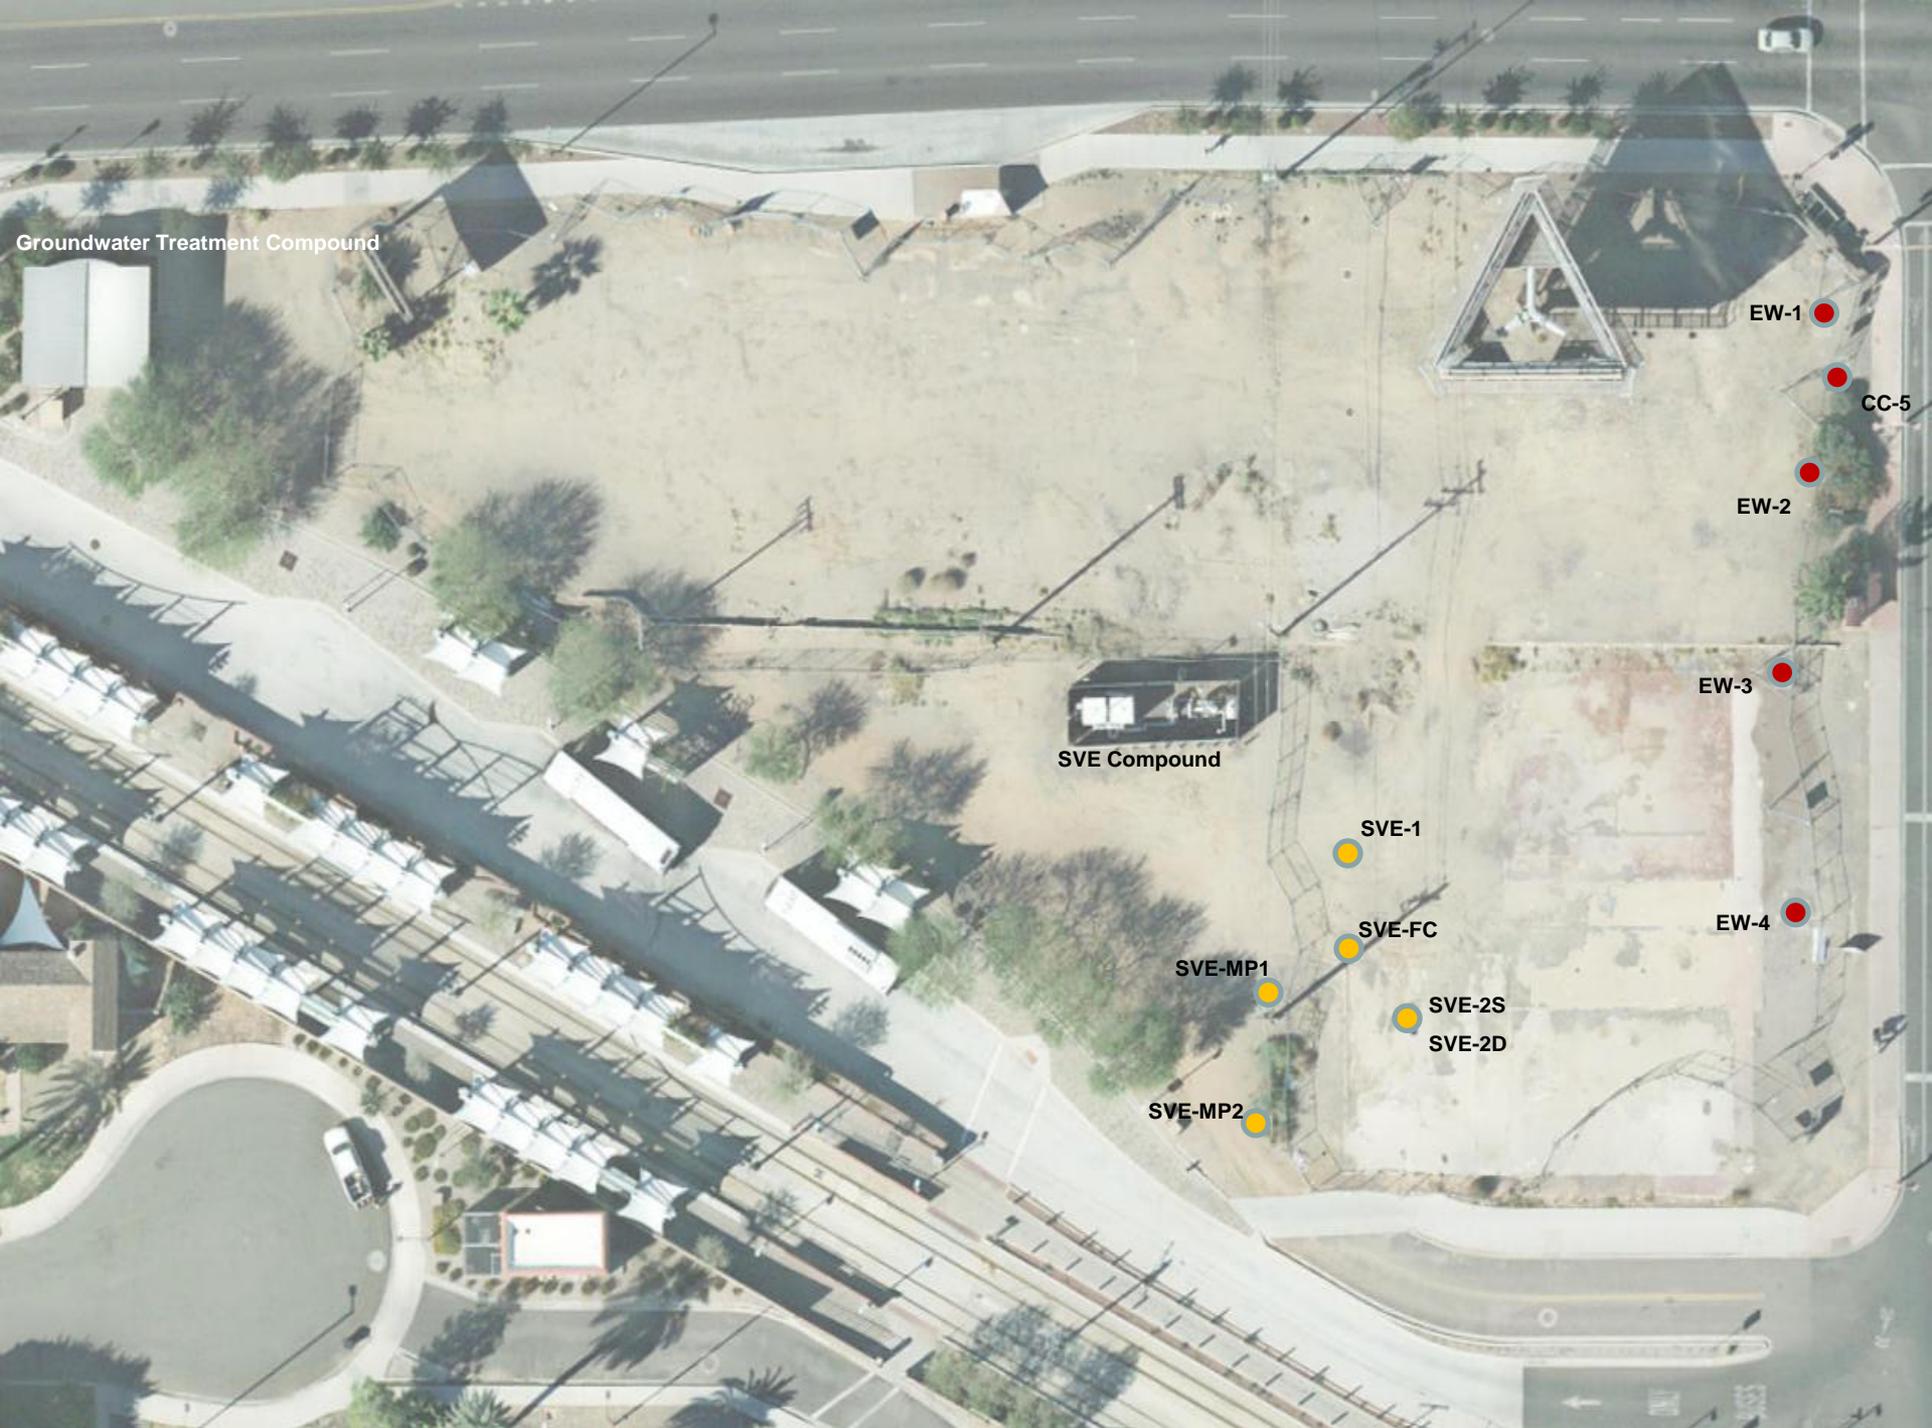
Figure 1

SITE MAP

Groundwater Treatment Compound

SVE Compound

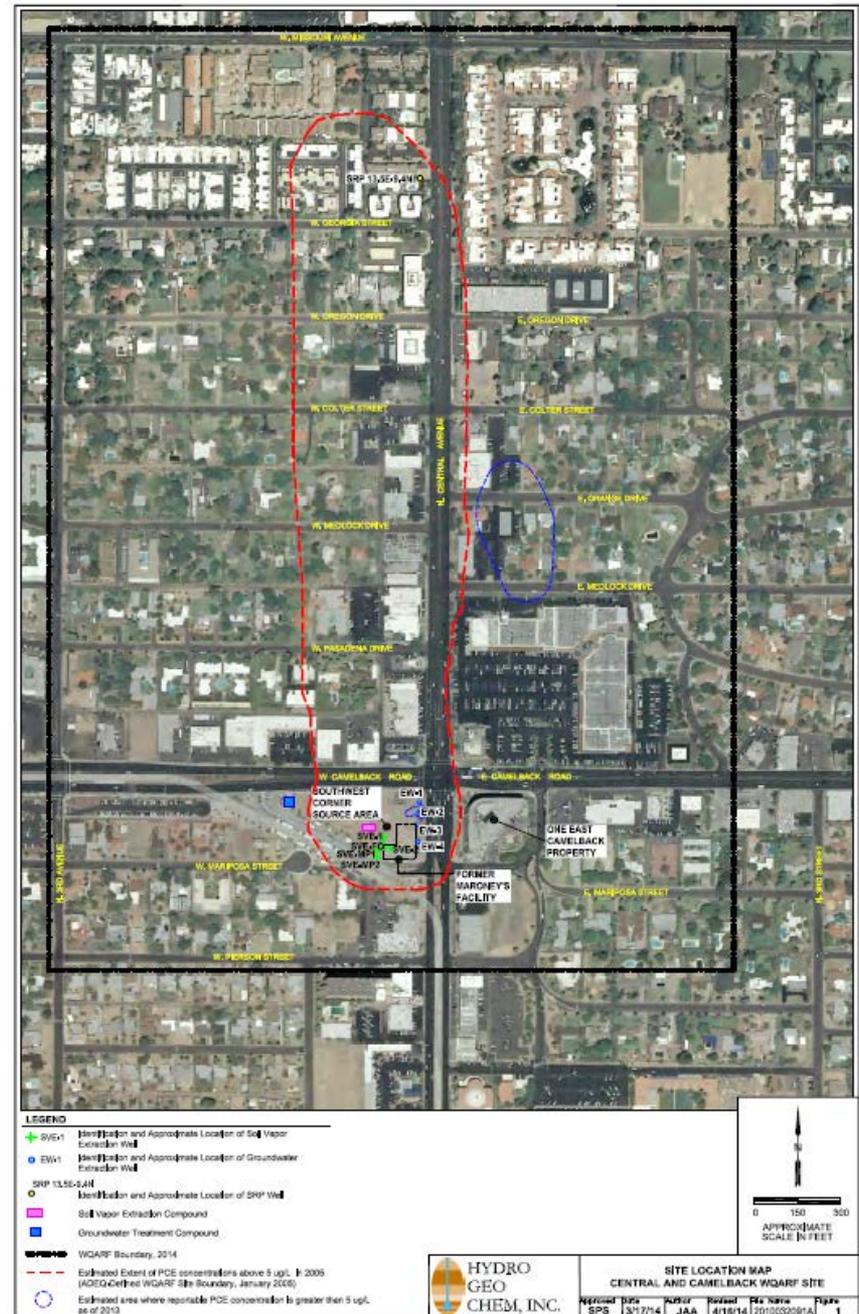
- Red dashed line represents estimated PCE plume at start of investigation.
- Blue dashed line represents estimated PCE plume as of last sampling event.

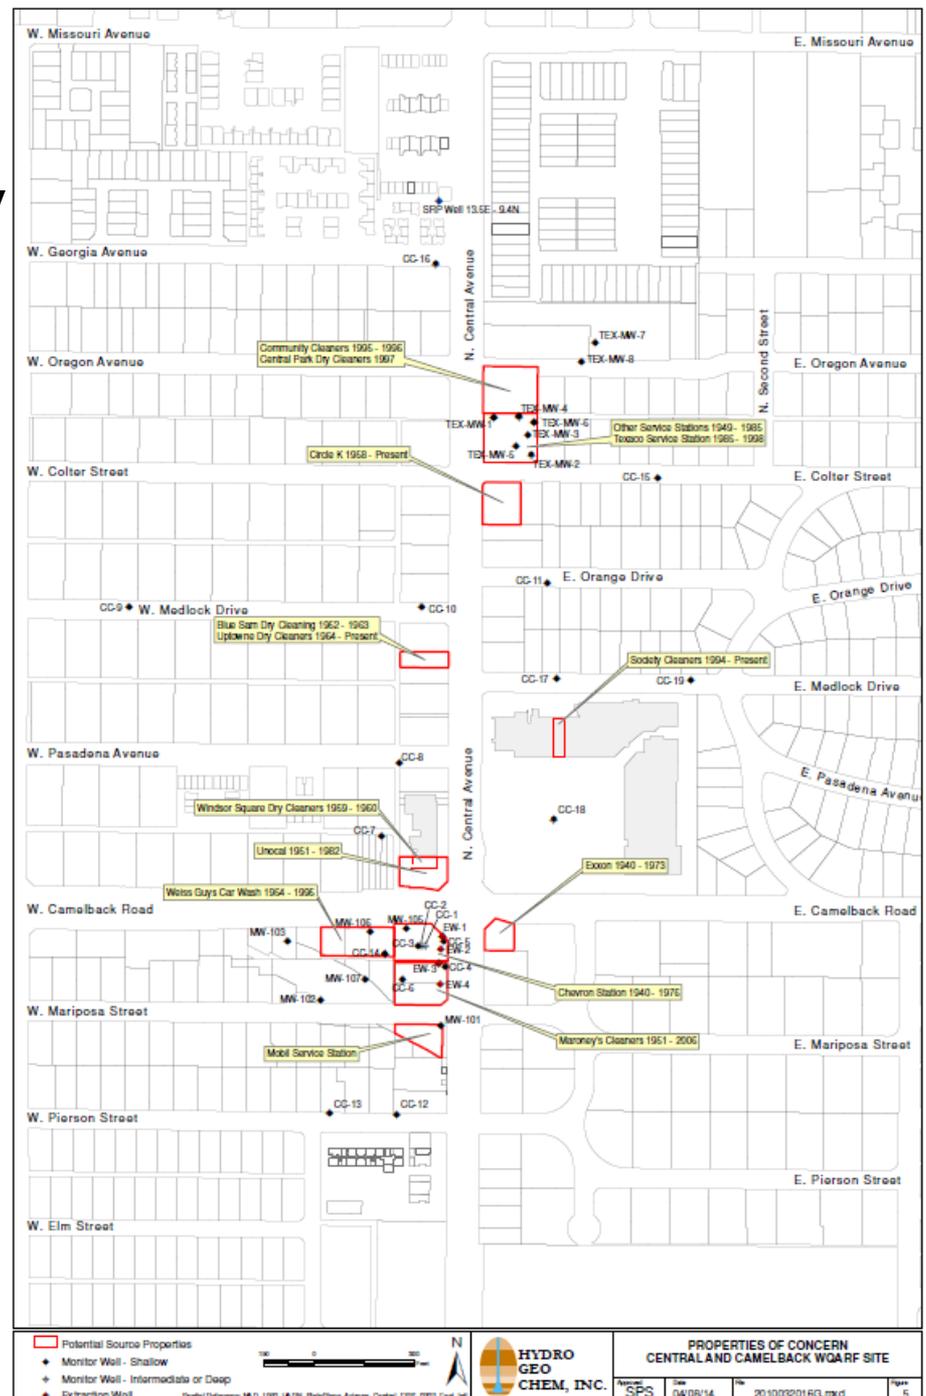
- Facilities reviewed/investigated by ADEQ.

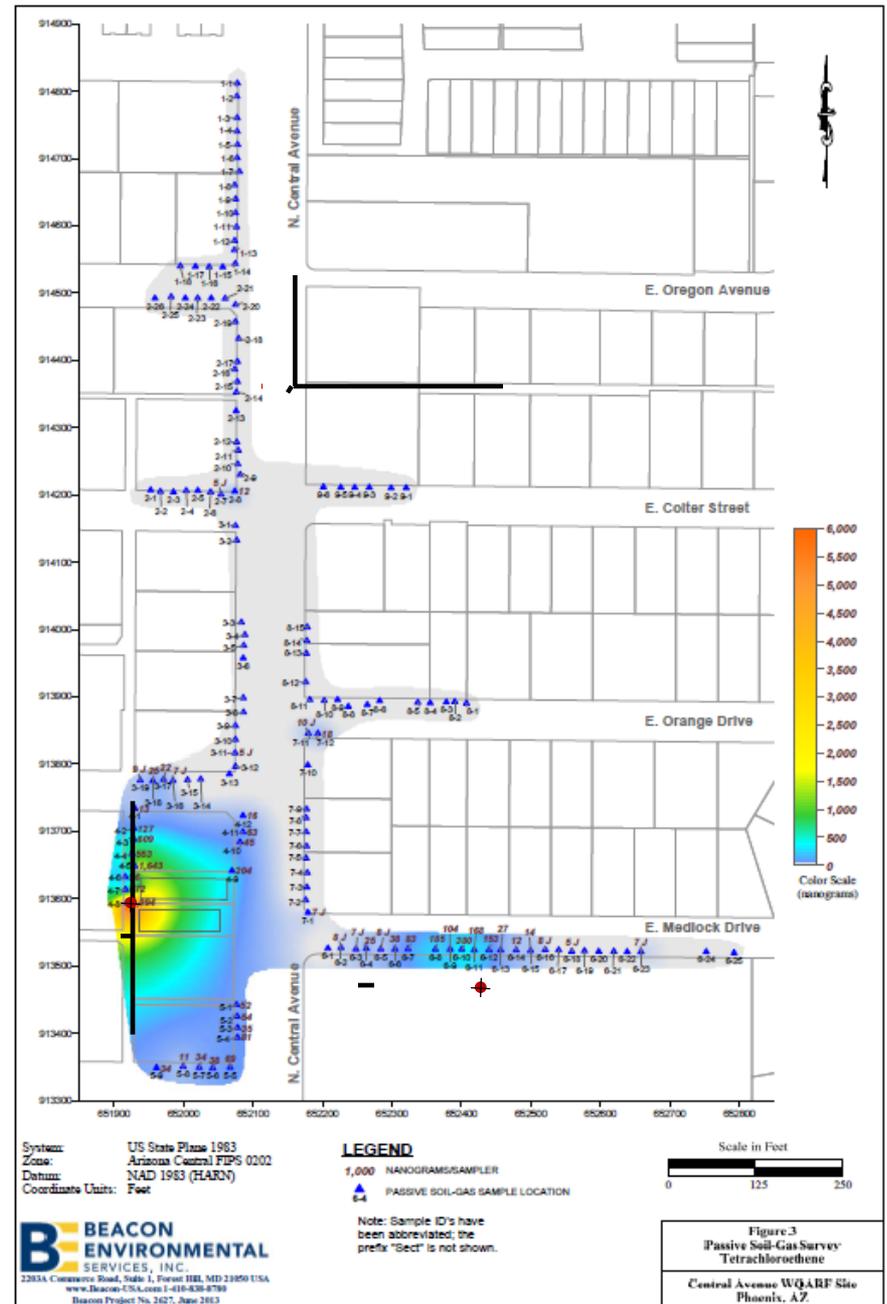
- Recent investigations by ADEQ.

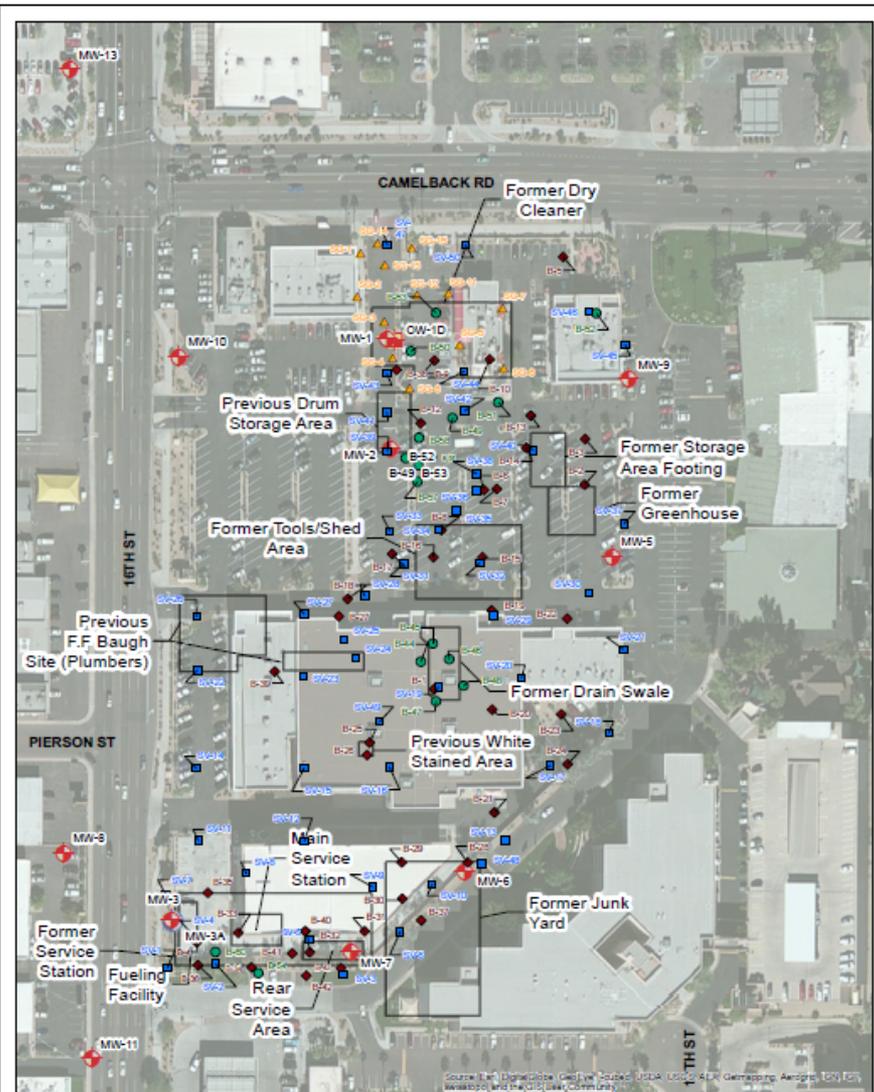
Figure 4
RI SAMPLING LOCATION MAP
 REMEDIAL INVESTIGATION
 SUMMARY REPORT
 16TH STREET AND CAMELBACK WQRF SITE
 PHOENIX, ARIZONA

- SOIL VAPOR SAMPLE (LAW, 1993a)
- ◆ SOIL VAPOR SAMPLE (LAW, 1993a)
- ▲ SOIL VAPOR SAMPLE (LAW, 1993b)
- ▲ SOIL VAPOR SAMPLE (ADEQ, 2005)
- ◆ MONITOR WELL
- OBSERVATION WELL
- REPLACEMENT MONITOR WELL
- FORMER BUILDING OR AREA OF CONCERN

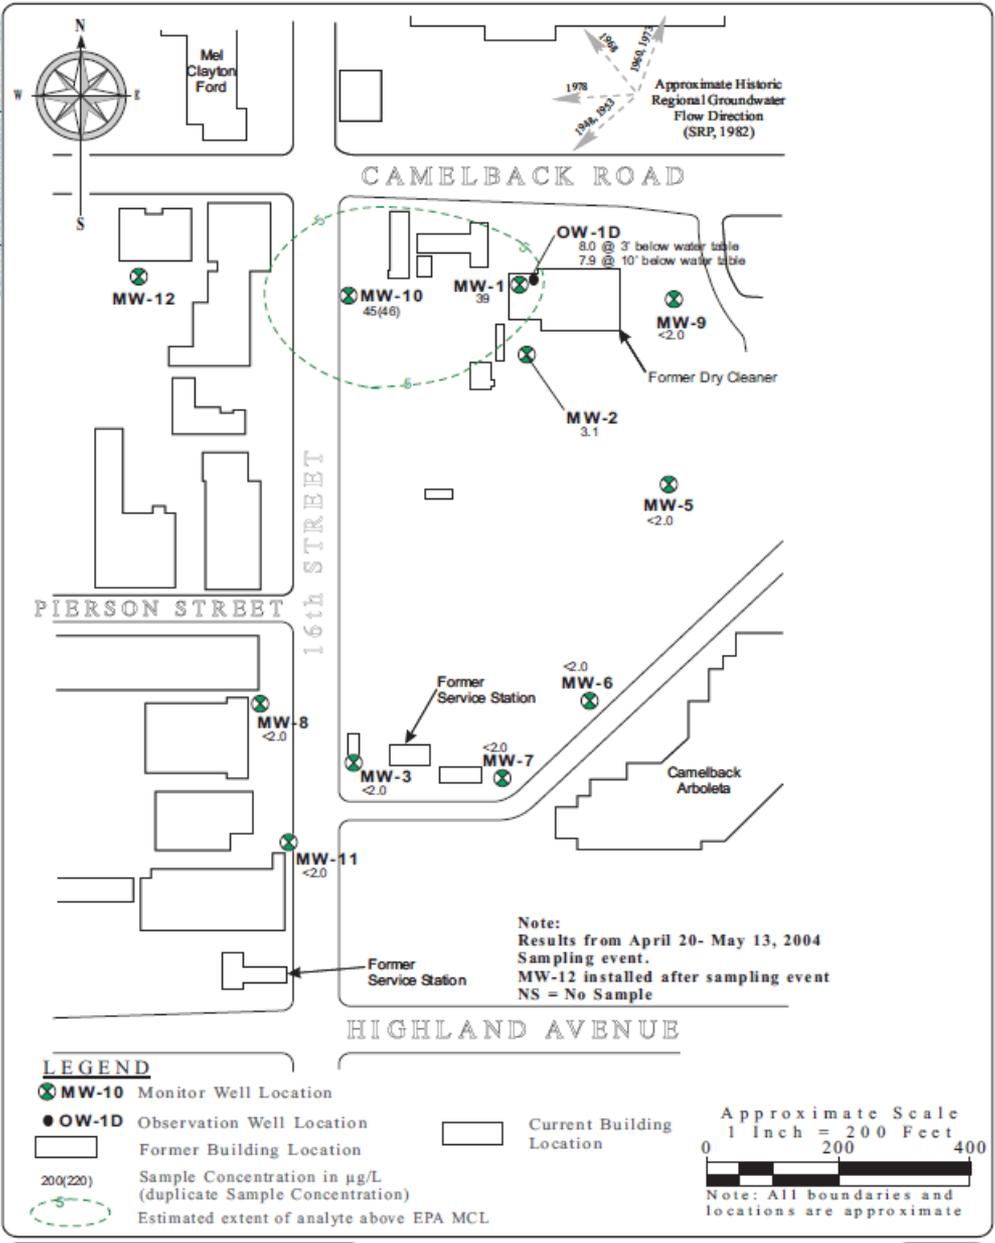
PLATE
5

**ISOCONCENTRATION
 CONTOUR MAP FOR PCE**

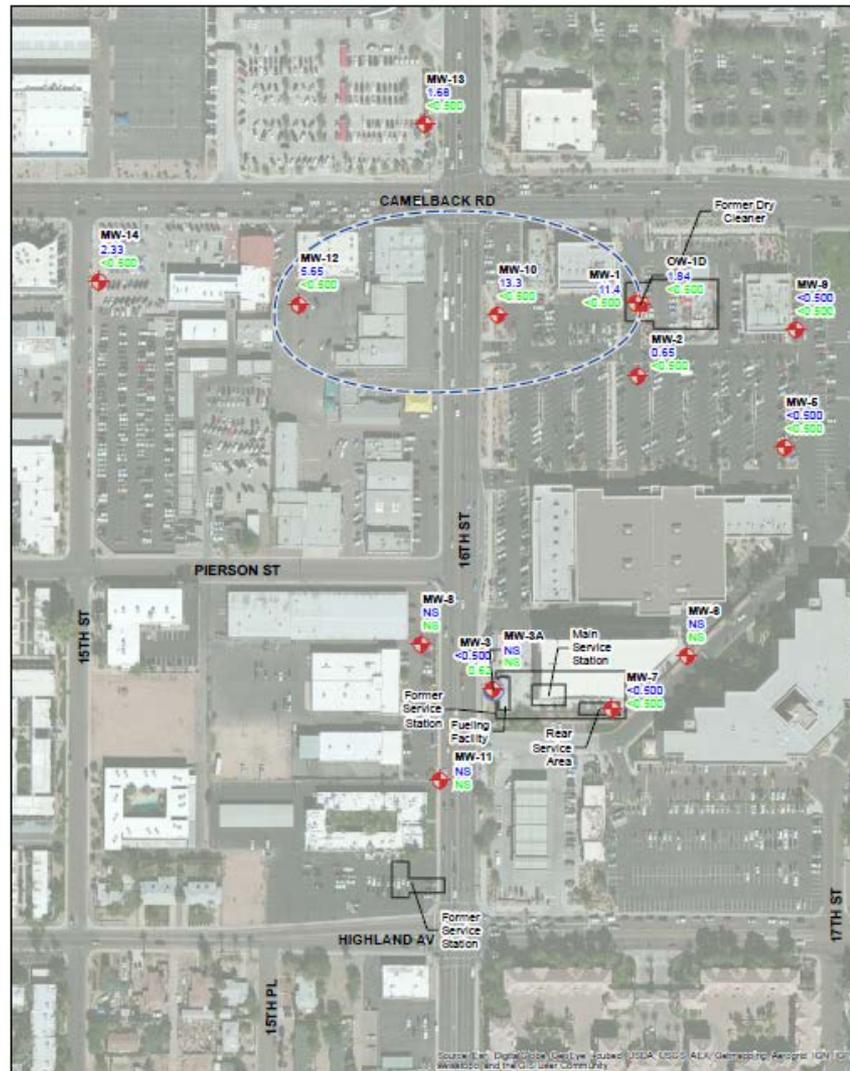
Figure 10
APRIL 2014 PCE
CONCENTRATIONS
IN GROUNDWATER
REMEDIAL INVESTIGATION
SUMMARY REPORT
16TH STREET AND CAMELBACK WQRF SITE
PHOENIX, ARIZONA

- PCE is currently the only contaminant of concern detected in groundwater at the site at concentrations greater than the Aquifer Water Quality Standard (AWQS).
- Contaminants appear to have naturally attenuated.

- MONITOR WELL
- MW-1**
5.90 (PCE, ug/L)
<0.500 (1,2-DCCA, ug/L)
NS = Not Sampled
- APPROXIMATE LOCATION OF 5 UG/L ISOCNTRATION CONTOUR FOR PCE

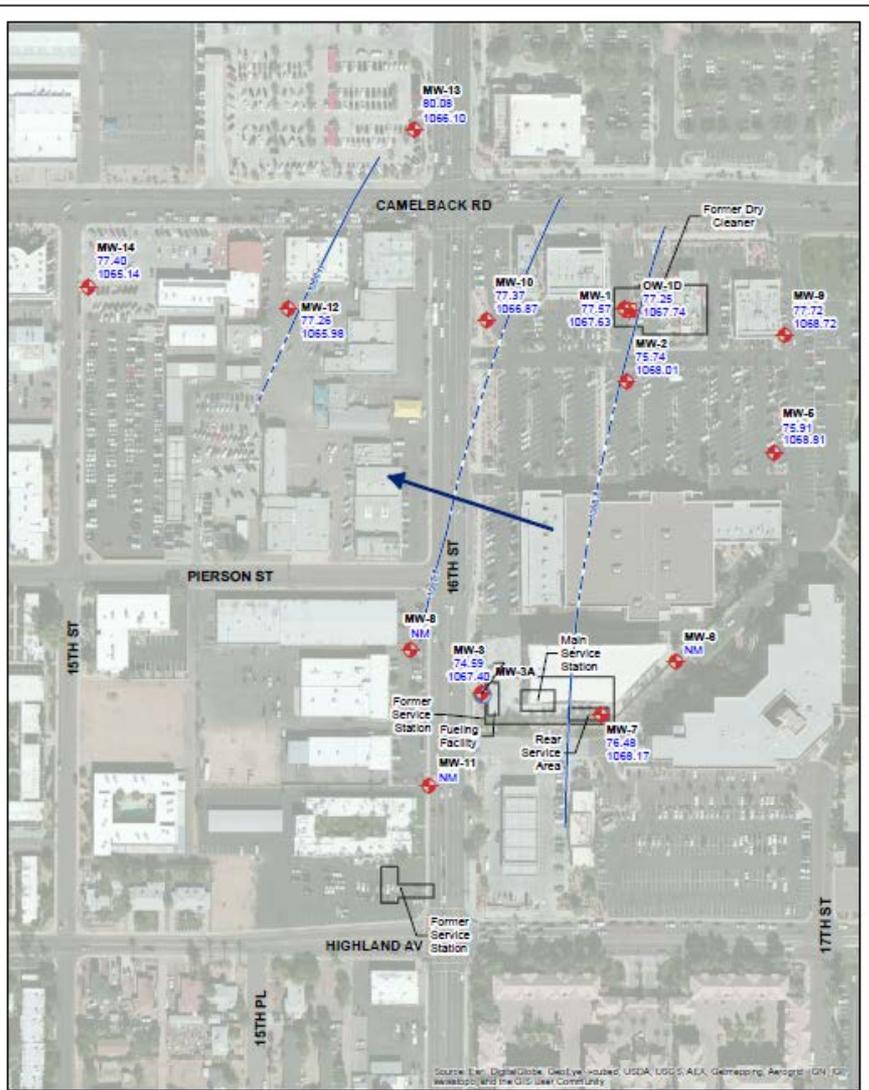
Figure 9
APRIL 2014
GROUNDWATER ELEVATION
MAP
 REMEDIAL INVESTIGATION
 SUMMARY REPORT
 16TH STREET AND CAMELBACK WQRF SITE
 PHOENIX, ARIZONA

- MONITOR WELL
- OBSERVATION WELL
- REPLACEMENT MONITOR WELL
- GROUNDWATER ELEVATION CONTOUR (Dashed where inferred)
- DIRECTION OF GROUNDWATER FLOW
- DTW - DEPTH TO WATER
- AMSL - ABOVE MEAN SEA LEVEL
- MP - MEASURING POINT
- NM - NOT MEASURED

Note: Measuring Point = North side top of casing, DTW measured April 3, 2014.
