Air Quality Field Inspection Report

Company Name: Minerals Research Inc.	Inspection Report No.: 453994
Place Name: Cottonwood Slag Crushing-Recycling Place ID No.: 137664	Inspector(s): Cameron Collins
County: Yavapai	Arrival Date and Time: 9/5/2024 7:30 AM
Physical Location: 705 E Birch St., Cottonwood, AZ 86326	Reason for Inspection: <input type="checkbox"/> Complaint Complaint No.: <input type="checkbox"/> Full Inspection <input checked="" type="checkbox"/> Partial Inspection <input type="checkbox"/> Follow-Up Original Inspection Report No.:
Mailing Address: 4620 S Coach Dr., Tucson, AZ 8714	
Coordinates (for new locations): Latitude: Longitude:	
Permit No.: Pending Air Permit Application LTF: 100924 Permit Expiration Date: N/A	Was Inspection Announced? <input type="checkbox"/> Yes <input checked="" type="checkbox"/> No
Onsite Contact Person(s)/Title(s)/Number(s): Chelsea Wagner / Plant Coordinator Carl Harris / Plant Superintendent · Stephane Gosselin / Plant Manager	Operational Status: Not Operating

Type of Source: Copper Slag Processing/Recycling
Other Names for Site/Facility:	Last Inspection: 8/14/2024
Inspection Report Issued: Via email from ADEQ office	Facility Initial: A

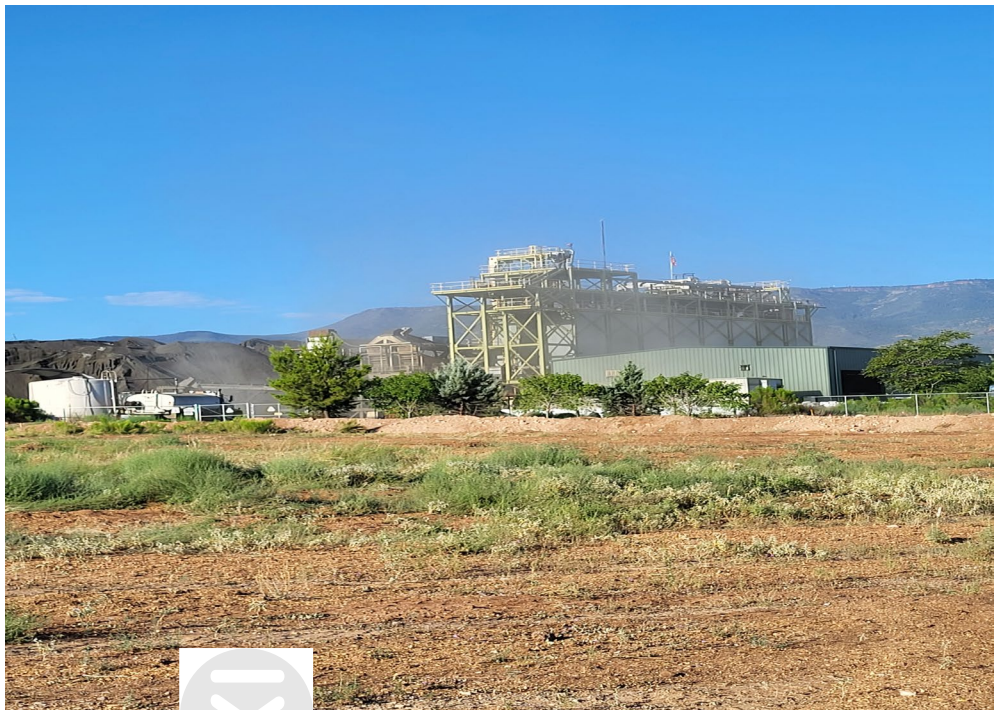
Photo No. 2	Date: 9/5/2024
Direction Photo Taken: Southwest	
Photo Description: Zoomed in view of the plant prior to entry.

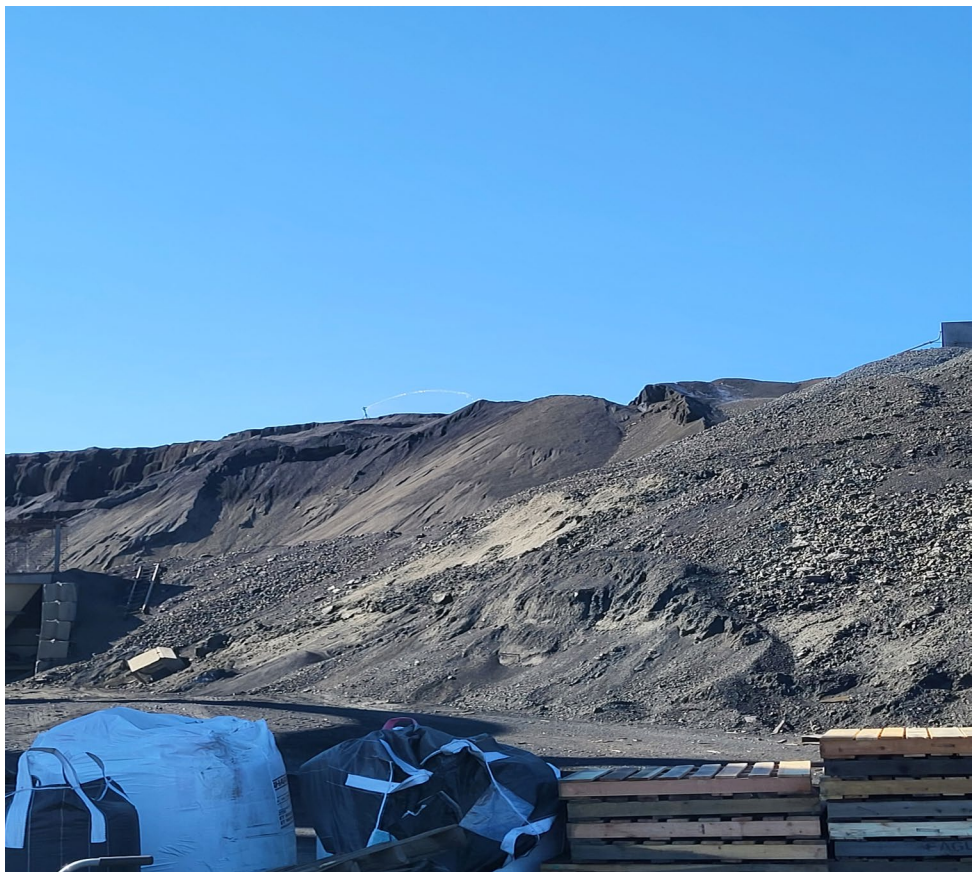
Photo No. 3	Date: 9/5/2024
Direction Photo Taken: Southeast	
Photo Description: View of Sprinklers operating onto storage piles.

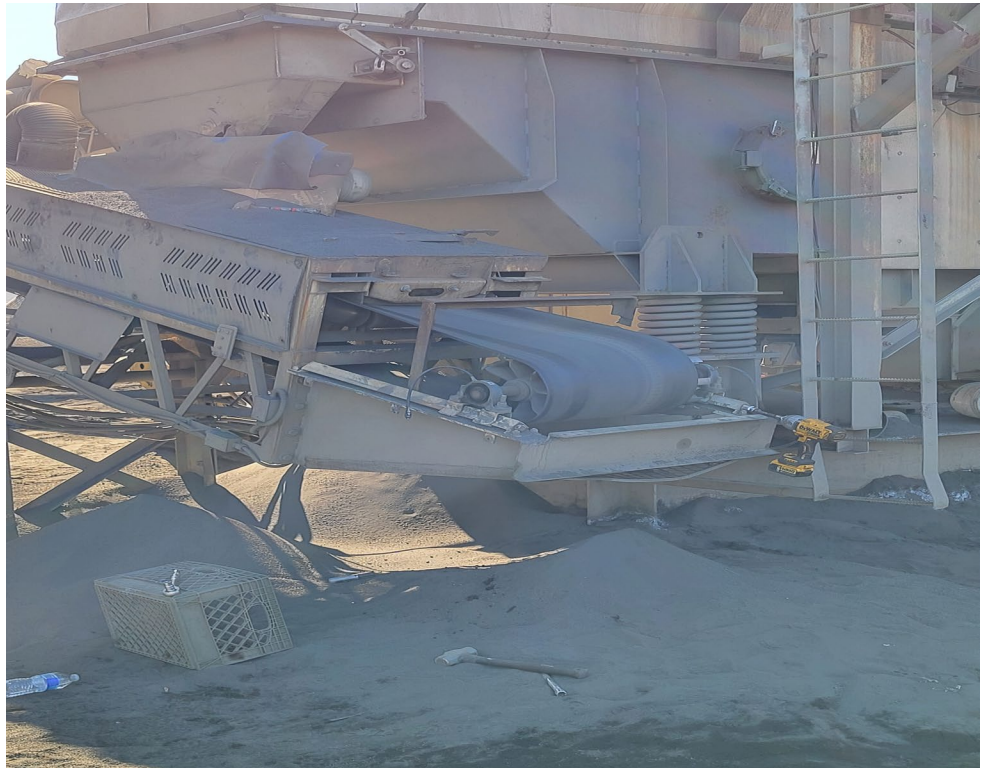
Following the records review, Mr. Collins conducted a facility tour with Mr. Gosselin. Mr. Collins observed parts taken off of one of the conveyers along with parts removed from the secondary screen. Mr. Collins also observed workers conducting varying degrees of maintenance activities around the plant. Some moisture was observed around the floor of the plant but overall, Mr. Collins observed the haul road and interior portion of the plant appeared dry but was not producing any fugitive emissions at the time of the walk through. Mr. Collins did observe the facility had sprinklers operating over the storage piles. The weather at the time of inspection was clear skies, calm winds, with an outside temperature of 87 degrees Fahrenheit. Mr. Collins left the facility around 9:00am after concluding the facility tour.

Photo No. 4	Date: 9/5/2024
Direction Photo Taken: Down	
Photo Description: Conveying being worked on.

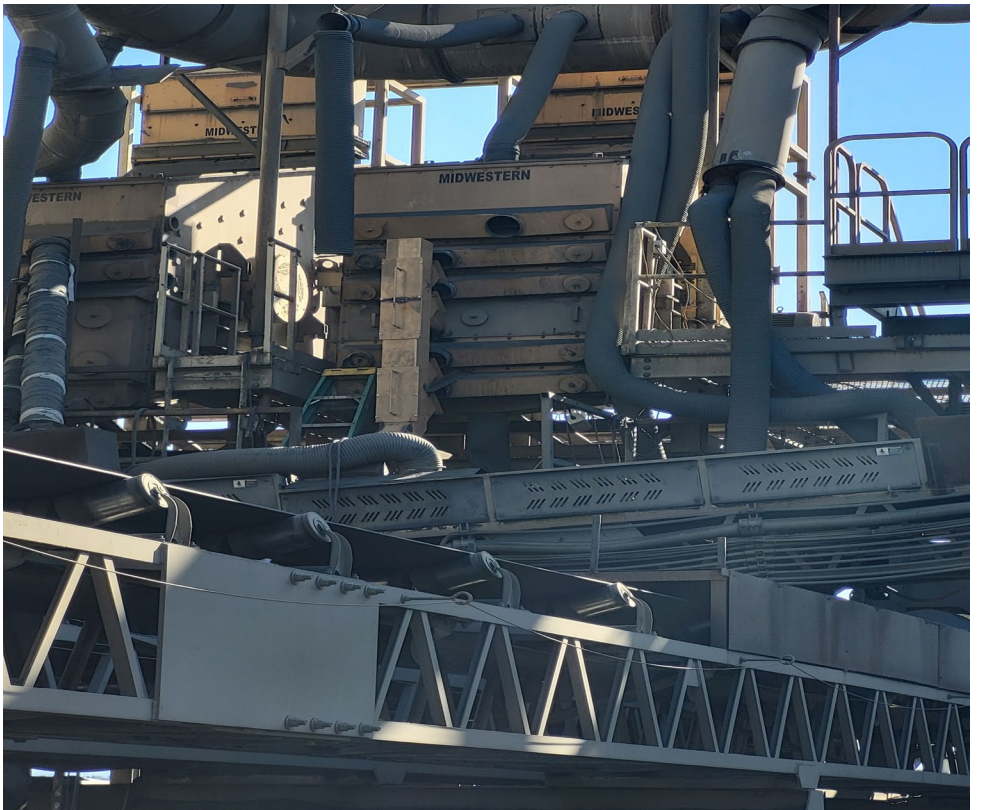
Photo No. 5	Date: 9/5/2024
Direction Photo Taken: East	
Photo Description: View of Missing Ducts from secondary screen. This is the portion of the plant that Mr. Gosselin and Mr. Harris stating is being repaired.

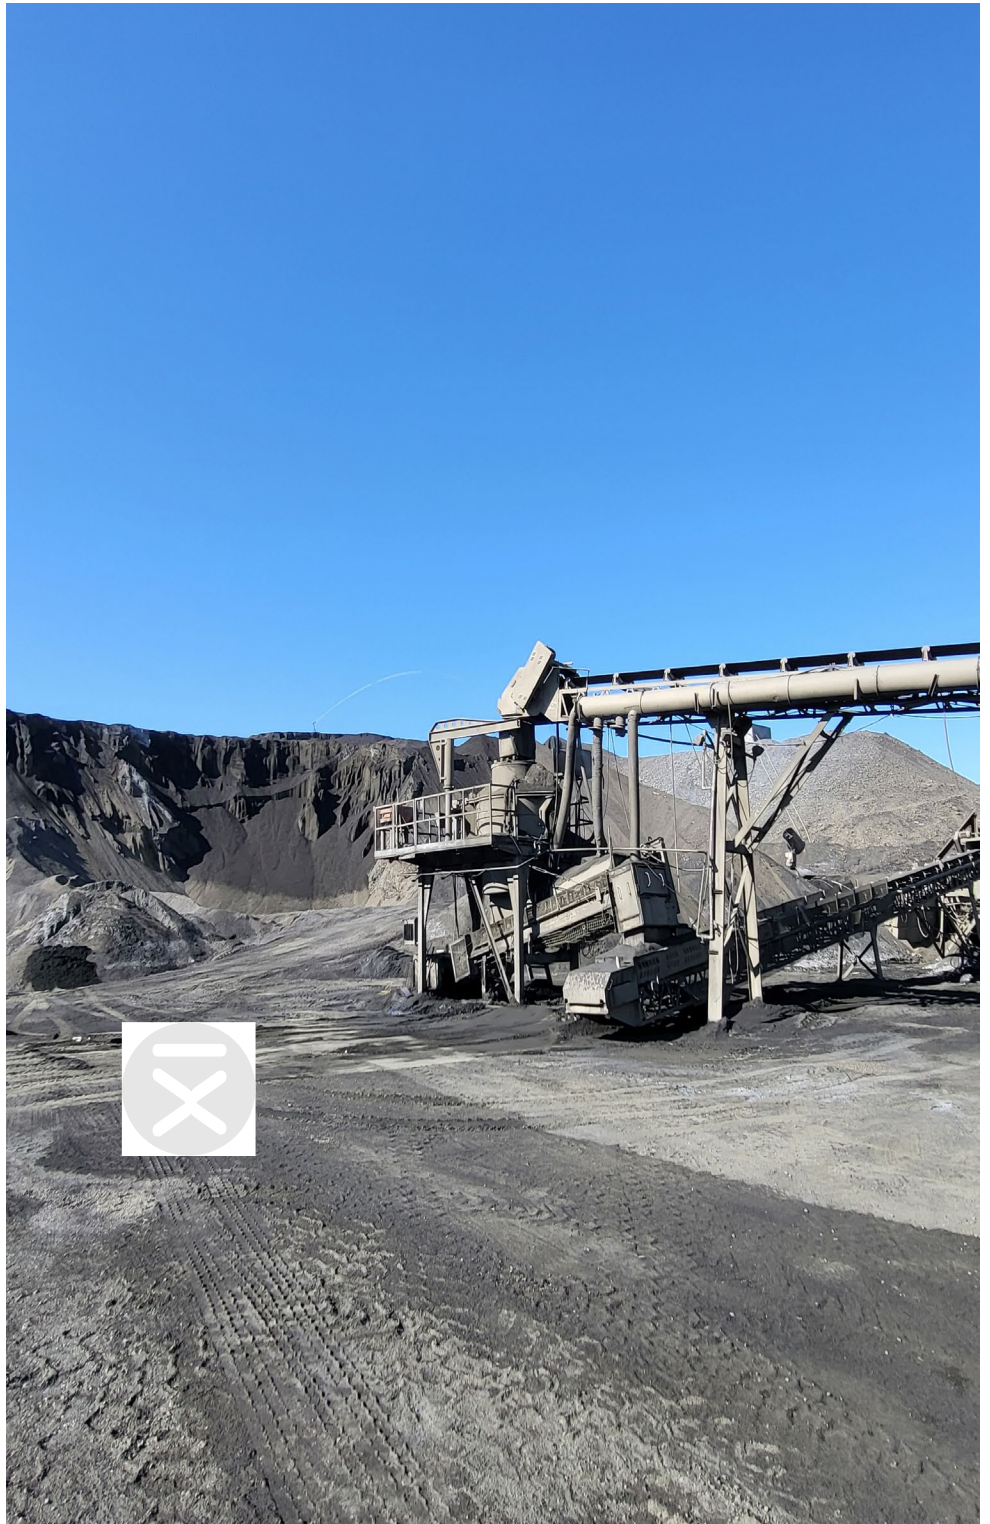
Photo No.
6

Photo Description:
View of Cone crusher

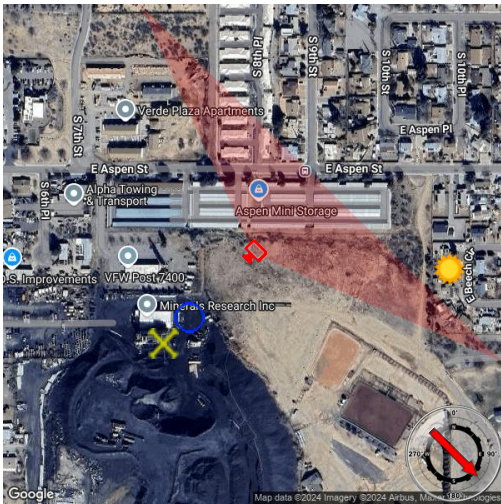
After returning to his office, Mr. Collins uploaded the DOCS observation on September 6, 2024. The DOCS was analyzed that day with results displaying 22.29% opacity for the plant. The observation is subject to non-point source emission standards due to Mr. Collins not being able to identify a point source for the visible emissions along with facility personnel stating the plant was not operating. The A.A. limits fugitive non-point source emissions to no greater than 40% opacity, making the 22.29% opacity D tion within the allowable limit. The full DOCS report is attached to this report for a more detailed review.

Comments
1	45	70	55	55	
2	50	50	55	40	
3	35	30	35	10	Avg Opacity = 22.29
4	5	0	0	0	
5	0	0	0	0	
6	0	0	0	0	
7	0	0	0	0	
8					
9					
10					
11					
12					
13					
14					
15					
16					
17					
18					
19					
20					
21					
22					
23					
24					
25					
26					
27					
28					
29					
30					
31					
32
