## Air Quality Field Inspection Report

<b>Company Name:</b> Minerals Research Inc.	<b>Inspection Report No.:</b> 455312
<b>Place Name:</b> Cottonwood Slag Crushing-Recycling <b>Place ID No.:</b> 137664	<b>Inspector(s):</b> Cameron Collins
<b>County:</b> Yavapai	<b>Arrival Date and Time:</b> 10/1/2024 8:00 AM
<b>Physical Location:</b> 705 E Birch St., Cottonwood, AZ 86326	<b>Reason for Inspection:</b> <input type="checkbox"/> Complaint Complaint No.: <input type="checkbox"/> Full Inspection <input checked="" type="checkbox"/> Partial Inspection <input type="checkbox"/> Follow-Up Original Inspection Report No.:
<b>Mailing Address:</b> 4620 S Coach Dr., Tucson, AZ 8714	
<b>Coordinates (for new locations):</b> Latitude: Longitude:	
<b>Permit No.:</b> Pending Air Permit Application LTF: 100924 <b>Permit Expiration Date:</b> N/A	<b>Was Inspection Announced?</b> <input type="checkbox"/> Yes <input checked="" type="checkbox"/> No
<b>Onsite Contact Person(s)/Title(s)/Number(s):</b> Carl Harris / Plant Superintendent Chelsea Wagner / Plant Coordinator	<b>Operational Status:</b> Operating

## Air Quality Field Inspection Photograph Log

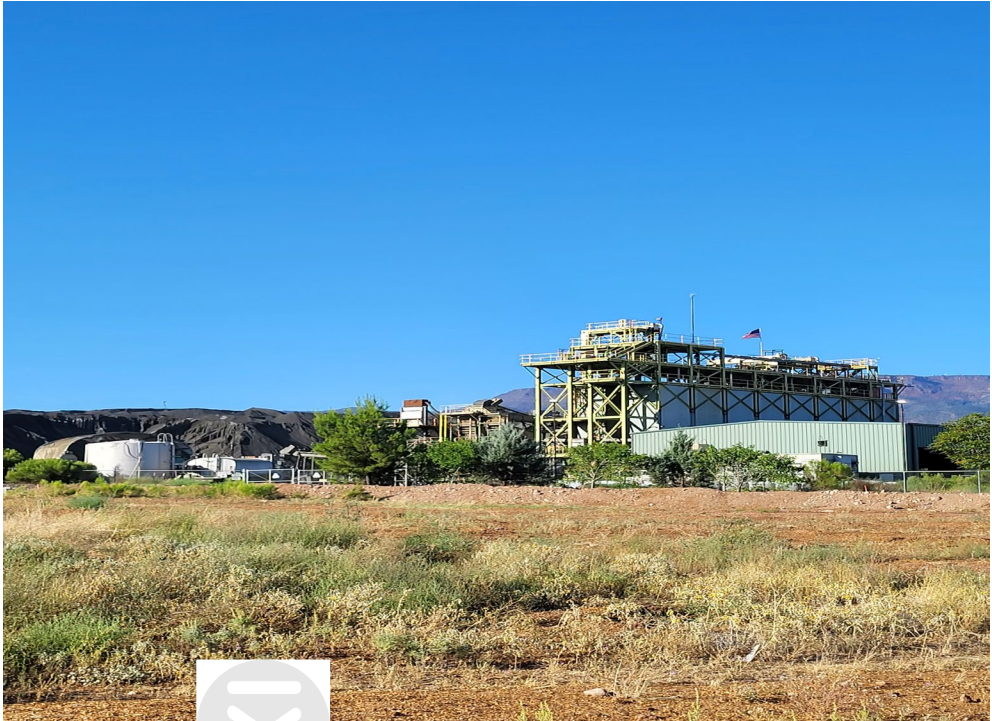
<b>Photo No.</b> 1	<b>Date:</b> 10/1/2024		
<b>Direction Photo Taken:</b> Southwest			
<b>Photo Description:</b> View of Plant from Cottonwood Park prior to entry.

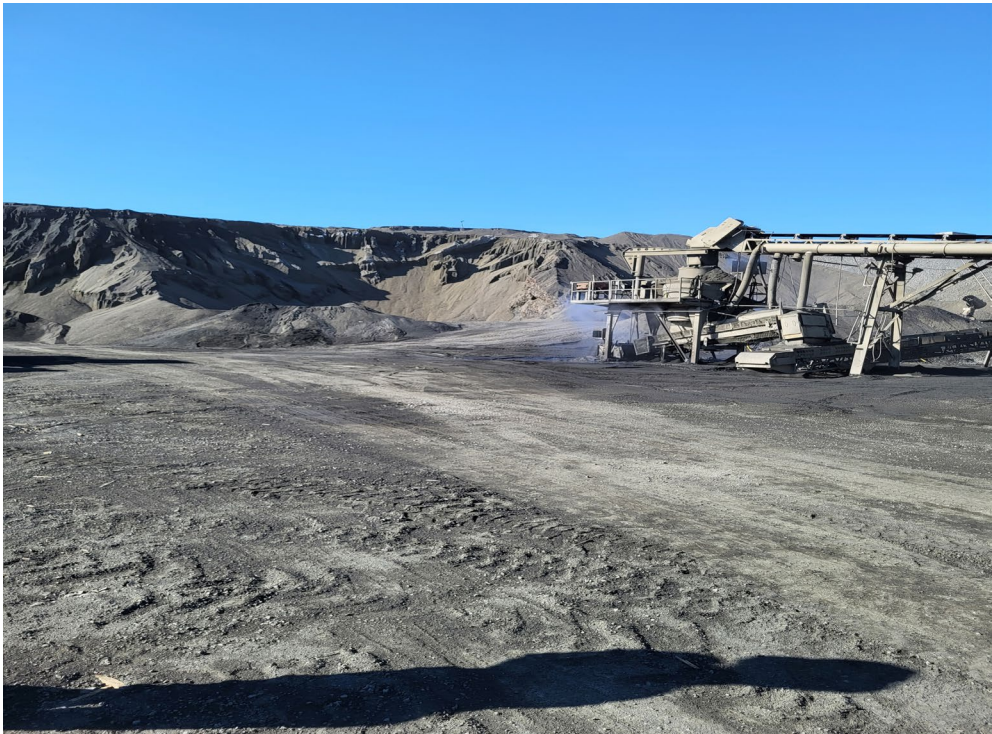
<b>Photo No.</b> 2	<b>Date:</b> 10/1/2024

<b>Direction Photo Taken:</b> Southwest		
<b>Photo Description:</b> View of cone crusher with water controls. (Operating)

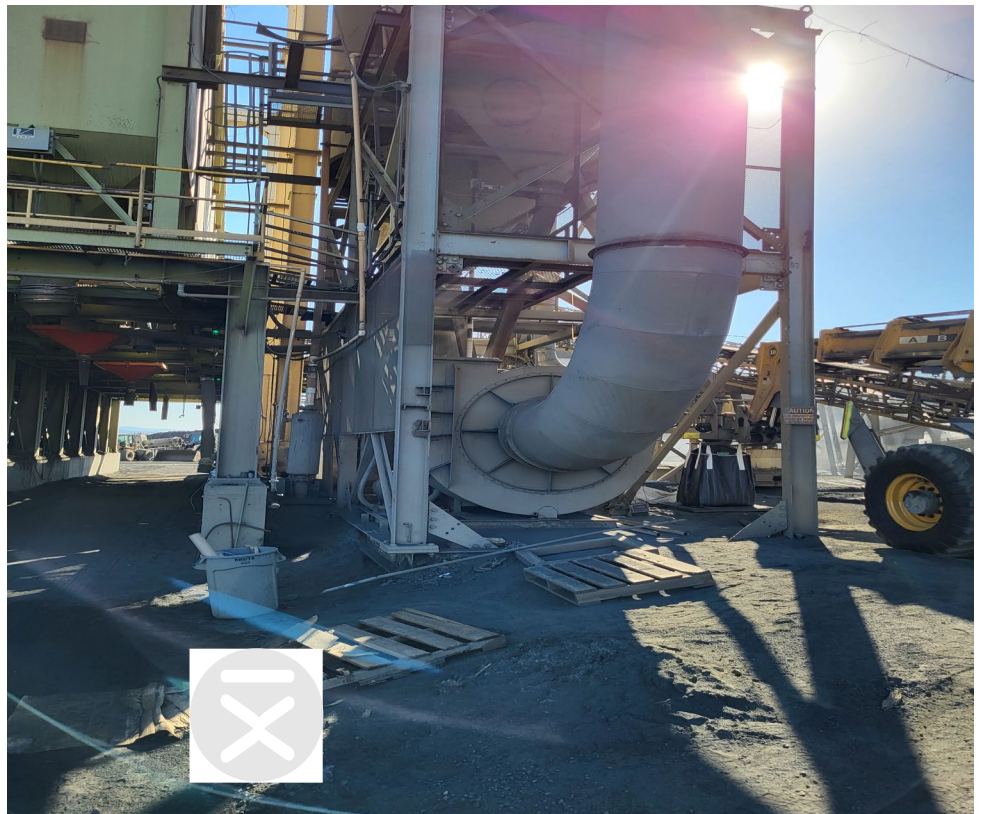
<b>Photo No.</b> 3	<b>Date:</b> 10/1/2024
<b>Direction Photo Taken:</b> East	
<b>Photo Description:</b> View of Baghouse Fan outlet. (Operating)

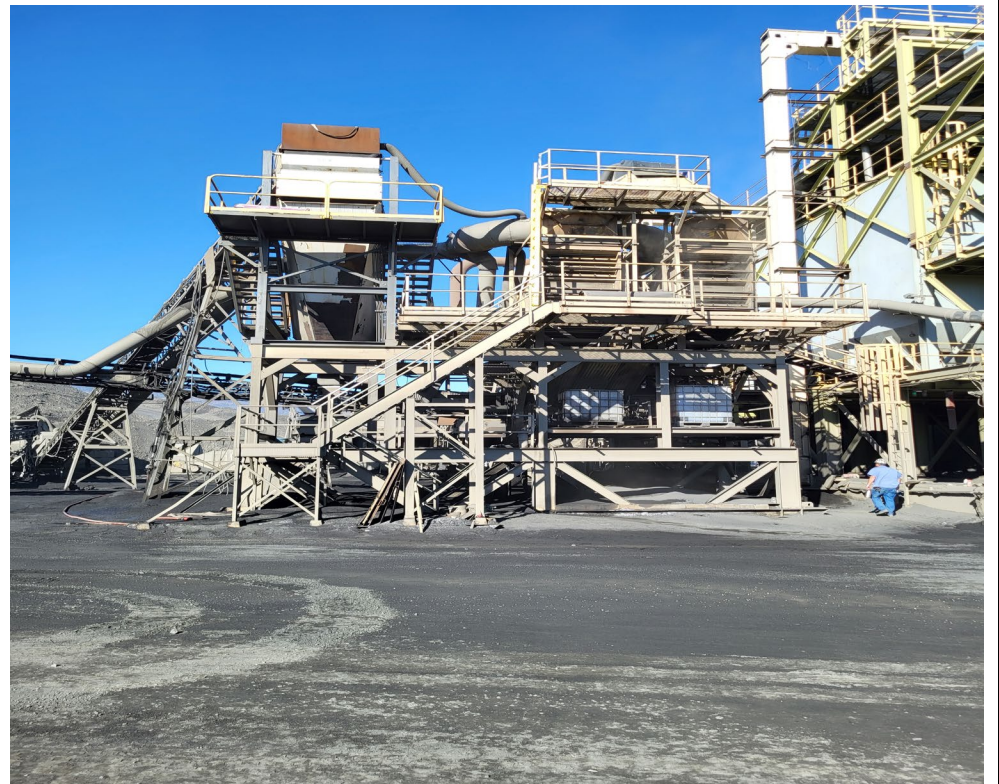
After uploading and analyzing the DOCS Observations, the results showed 25.83 percent opacity for the secondary screen observation and 0.21 percent opacity for the cone crusher observation. The secondary screen observation was compared to the A.A.C. R18-2-614 non-point source emission limit of 40% due to a lower confidence in the DOCS observation. The lower confidence in the secondary screen observation was due to the path length of dust cloud extending with the wind away from the camera along with multiple emission points that could have possibly been included in the observation. The cone crusher observation was well below opacity limits. The full DOCS observation report is attached below for a more detailed review.

<b>Photo No.</b> 4	<b>Date:</b> 10/1/2024
<b>Direction Photo Taken:</b> West	
<b>Photo Description:</b> View of east facing view of the plant. Emissions were observed to be emanating from the secondary screen on the right of the photo.

- Secondary screen baffling/flashing needs repair.
- DOCS observations were observed to be with applicable limits.

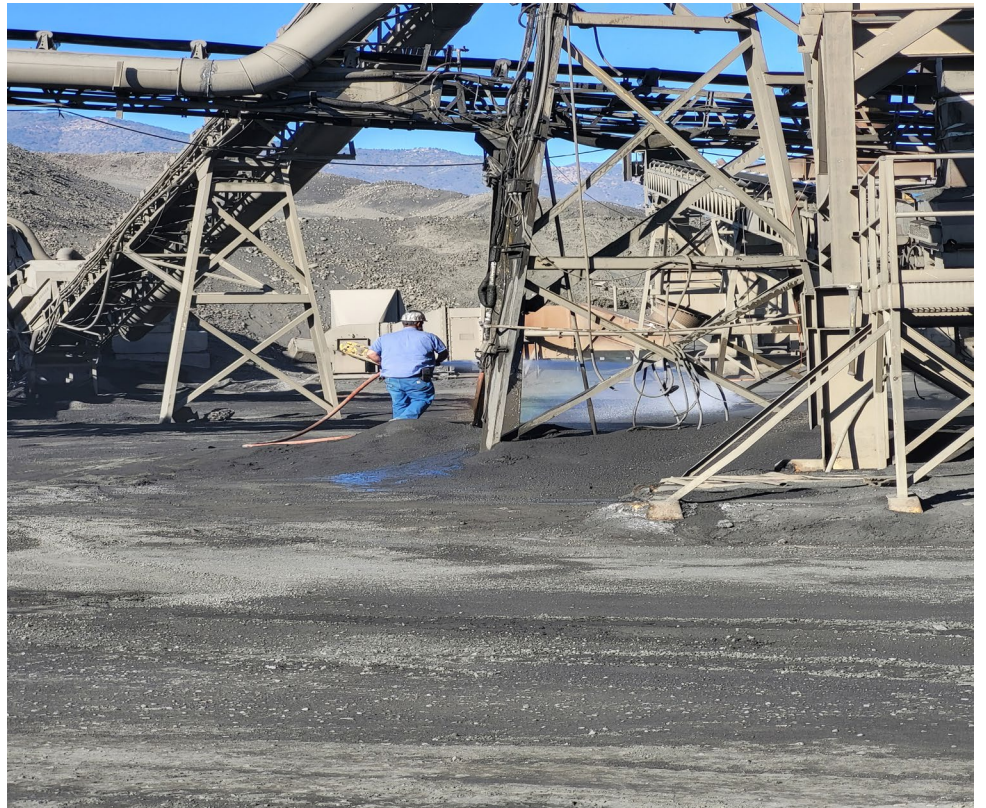
<b>Photo No.</b> 5	<b>Date:</b> 10/1/2024
<b>Direction Photo Taken:</b> West	
<b>Photo Description:</b> Worker manually wetting interior of the plant.

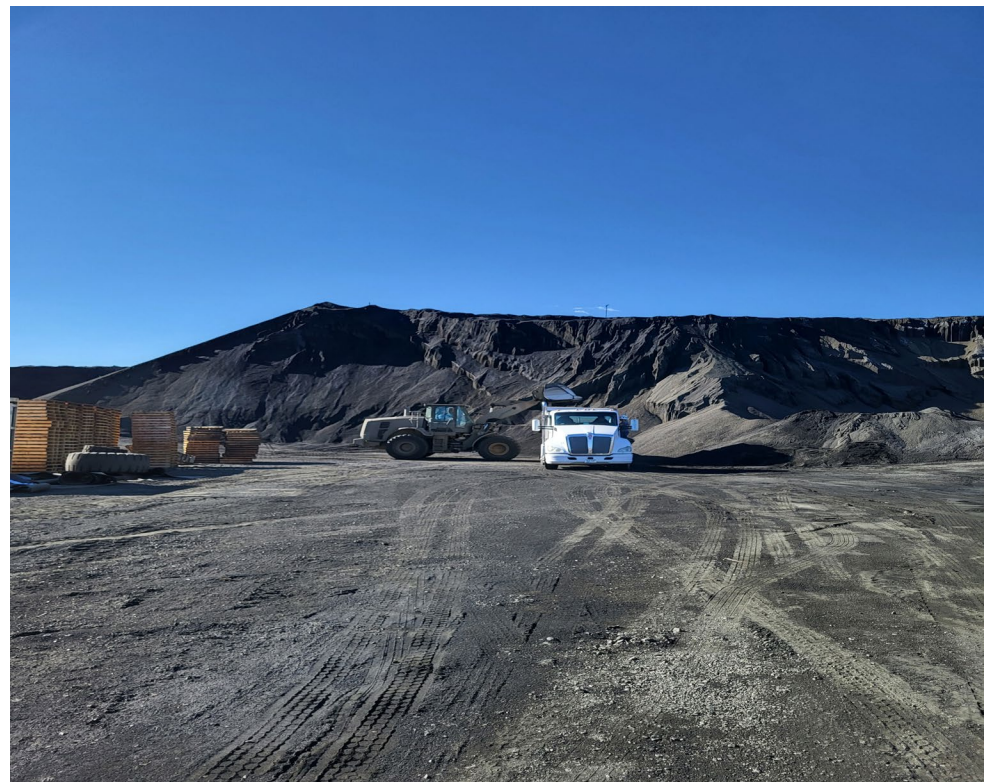
<b>Photo No.</b> 6	<b>Date:</b> 10/1/2024
<b>Direction Photo Taken:</b> South	
<b>Photo Description:</b> Front end loader loading haul truck.
