# Arizona Department of Environmental Quality

## AIR QUALITY FIELD INSPECTION REPORT

| <b>Place Name:</b> Cottonwood Slag Crushing-Recycling<br><b>Place ID No.:</b> 137664 (172594 portable place of air) | <b>Inspector(s):</b> Rob Verville |
| | <b>Type of Source:</b> Copper Slag Processing-Recycling |

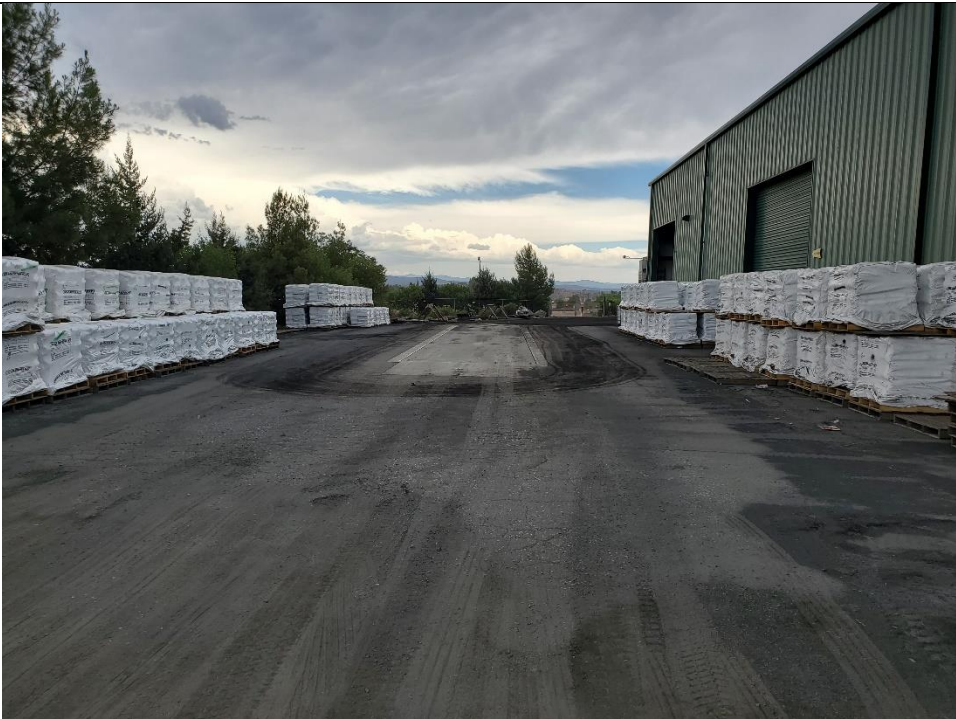
| <b>Photo Description:</b><br>Area around the truck scale had Durasoil applied. | |

The ADEQ inspector and Mr. Gosselin walked around the facility. Mr. Gosselin pointed out the area Soilworks, Durasoil product has been applied (photographs #16 - #18). The product darkens the area and is easily identifiable. Mr. Gosselin stated, the product was applied to the front area on June 6<sup>th</sup> and the back portion on June 12<sup>th</sup>. Mr. Gosselin stated the product appears to be working.

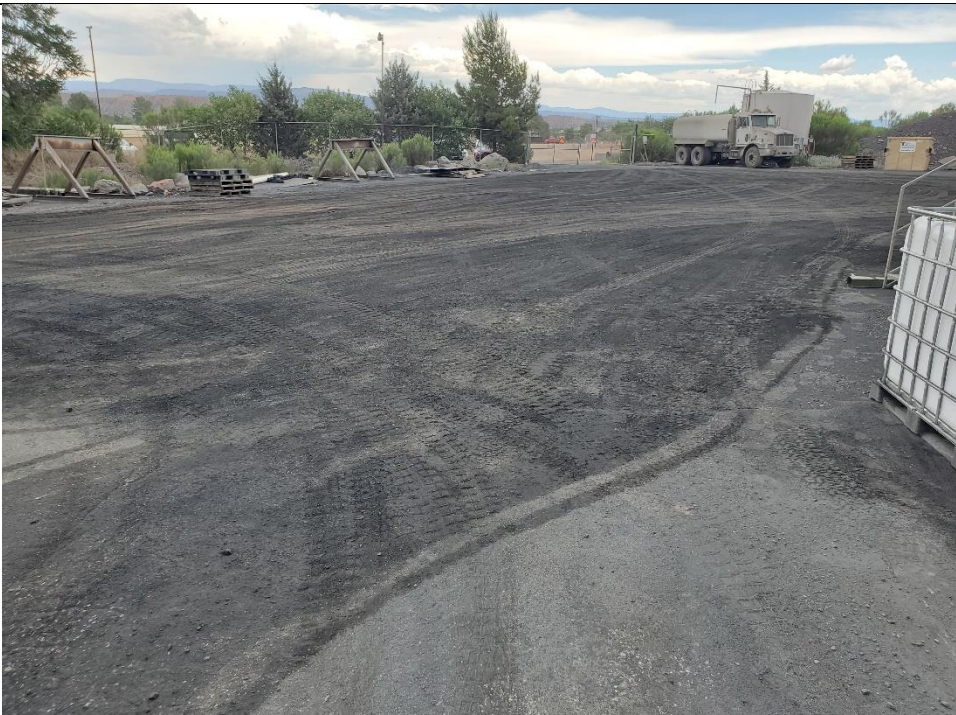
| <b>Photo No.</b><br>18 | <b>Date:</b><br>6/15/2026 |

| <b>Photo Description:</b><br>Back area with Durasoil applied. Durasoil makes the applied area darker. | |

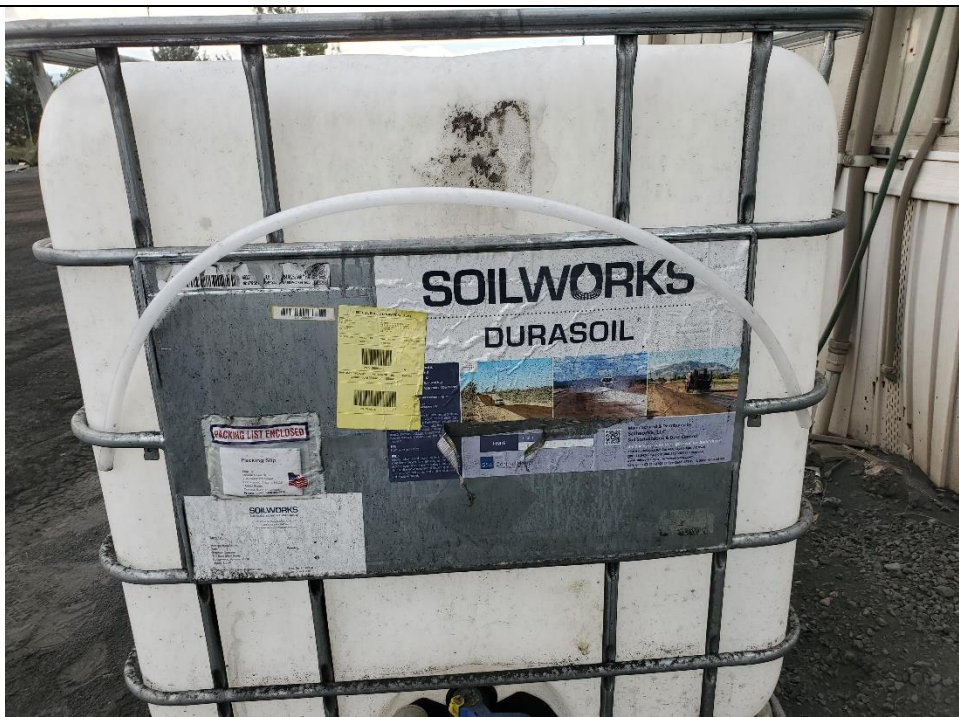
| <b>Photo No.</b><br>19 | <b>Date:</b><br>6/15/2026 |

| <b>Photo Description:</b><br>Container the dust control product Durasoil comes in. | |

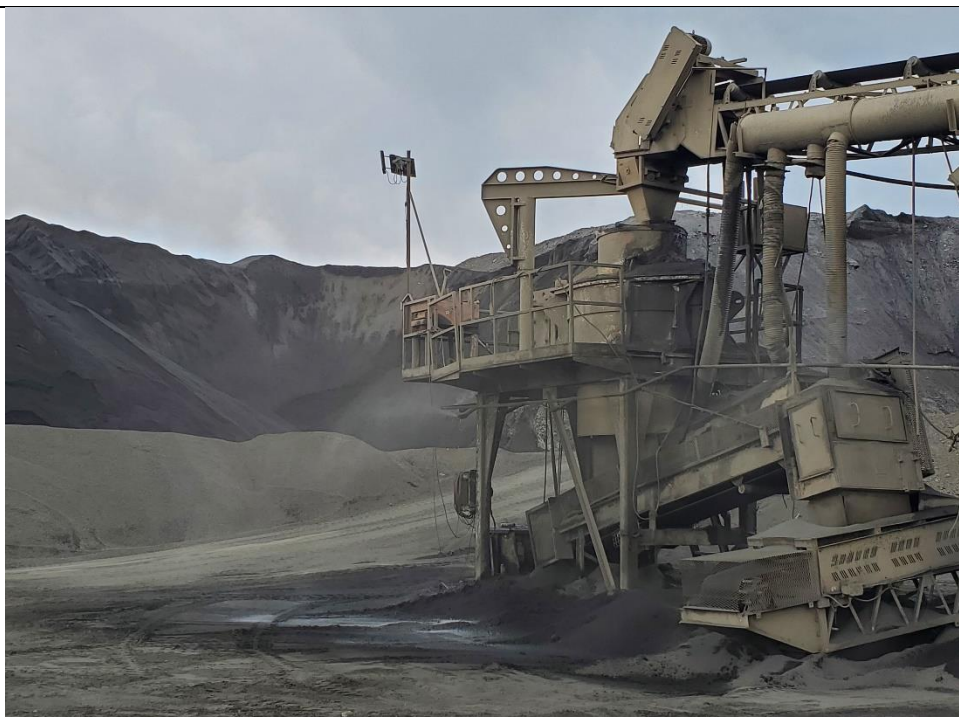
| <b>Photo No.</b><br>20 | <b>Date:</b><br>6/15/2026 |

While walking around the plant, the ADEQ inspector observed opacity from the cone crusher transfer point. The cone crusher has water sprays all around it (photograph #20). As the ADEQ inspector approached the area, the visible emissions was mixed with water spray. The ADEQ inspector was unable to collect a DOCS opacity observation because water and visible emissions cannot be analyzed. Mr. Gosselin looked into the unit and stated a sprayer was not operating and he requested the operator’s shutdown and clean the tips.

| <b>Photo Description:</b><br>Cone crusher with water sprays operating.<br><br>Visible emission observed from the transfer point, but sprayers were operating. | |

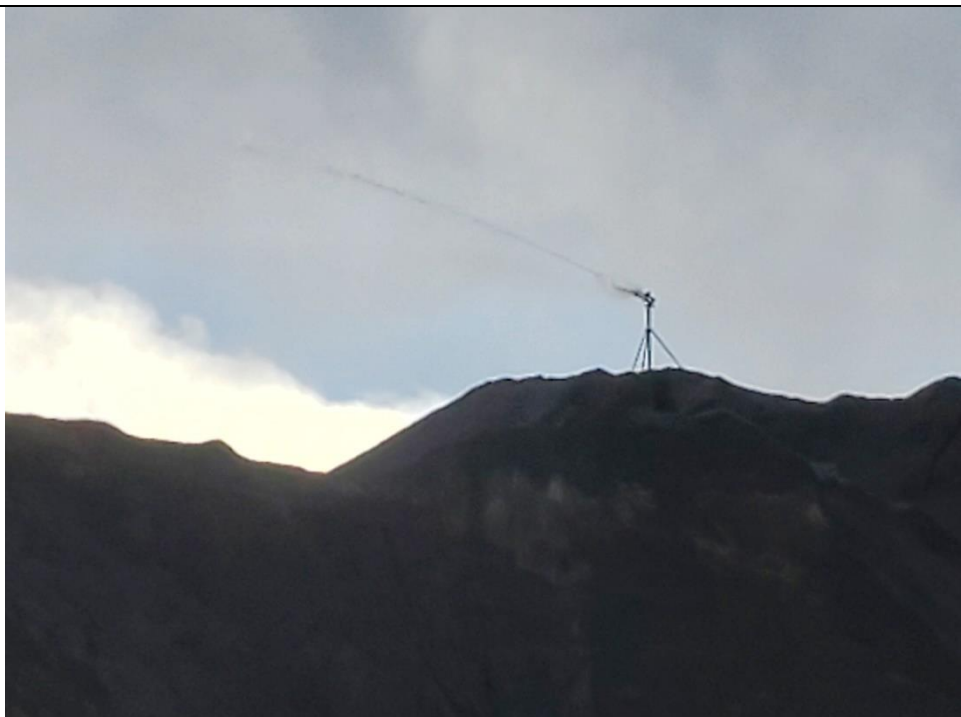
| <b>Photo No.</b><br>21 | <b>Date:</b><br>6/15/2026 |

| <b>Photo Description:</b><br>1 of 3 sprinklers operating on material piles. Mr. Gosselin state, the sprinklers are on timers. | |

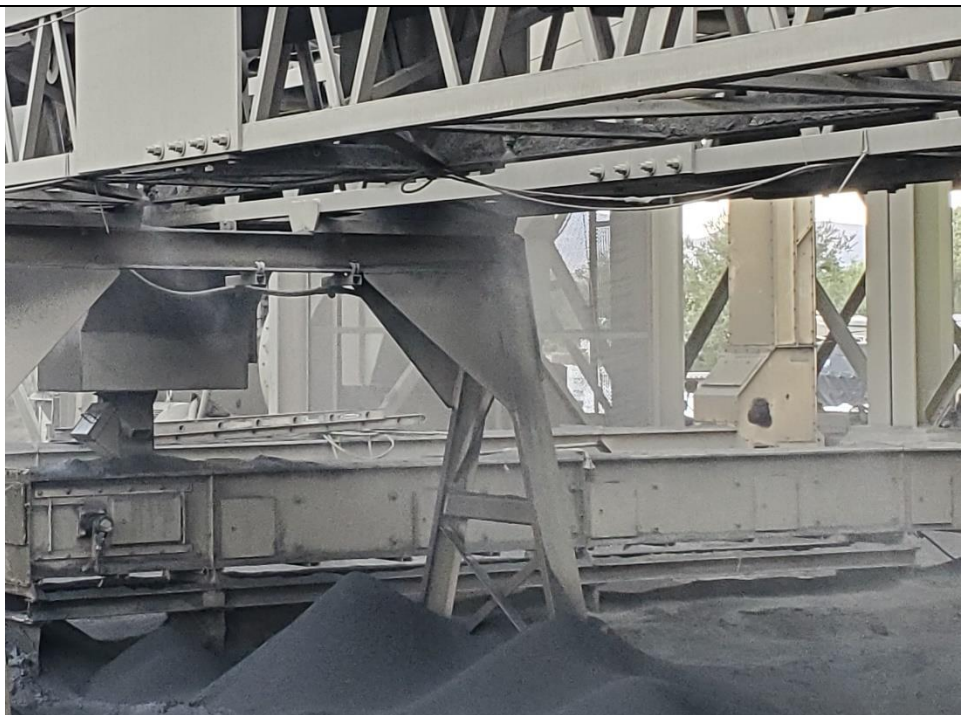
| <b>Photo No.</b><br>22 | <b>Date:</b><br>6/15/2026 |

Water sprays have been installed under a conveyor to control dust generation and the ground was wet under the conveyor (photograph #22 & #23).

| <b>Photo Description:</b><br>Water sprays attached and operating under the conveyor system. | |

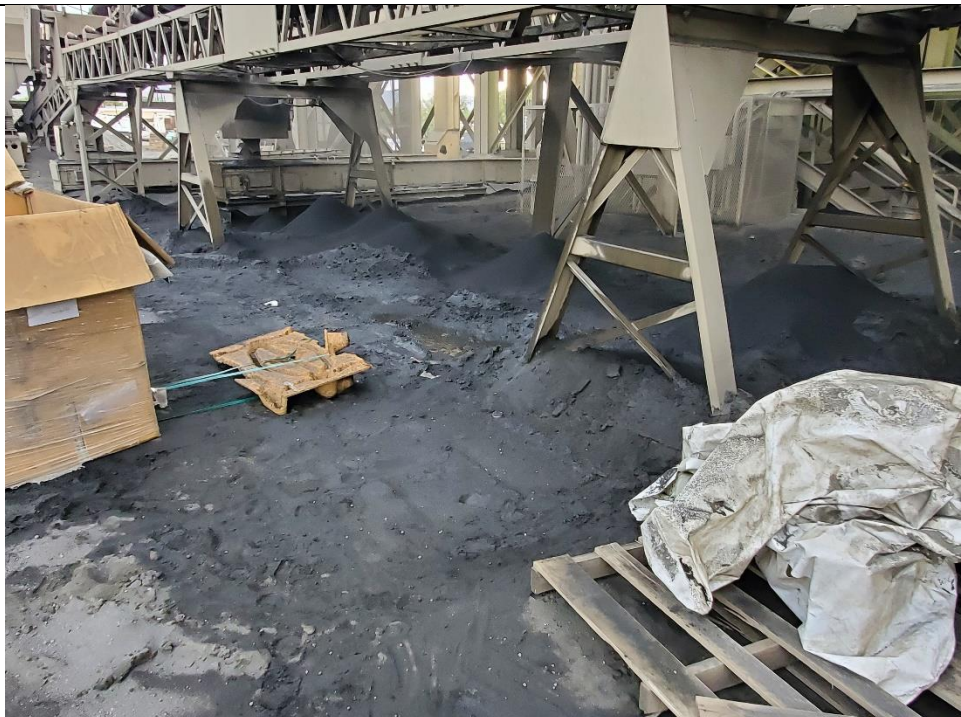
| <b>Photo No.</b><br>23 | <b>Date:</b><br>6/15/2026 |

| <b>Photo Description:</b><br>Significant moisture in material on ground under conveyor. | |

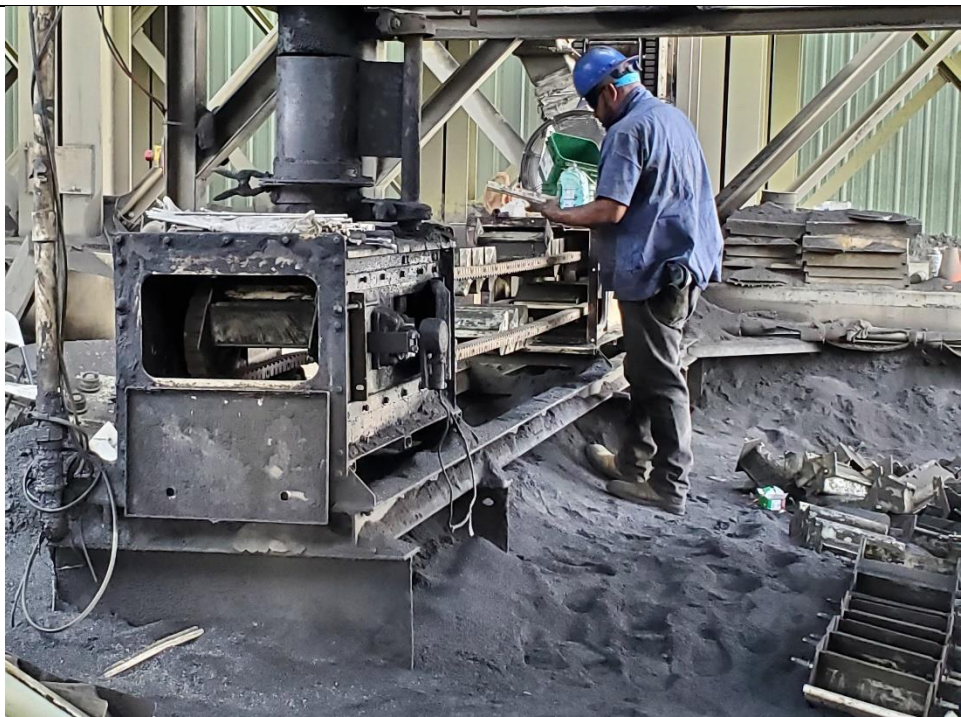
| <b>Photo No.</b><br>24 | <b>Date:</b><br>6/15/2026 |

A pan conveyor was disassembled and repairs were being conducted (photograph #24). Mr. Gosselin explained the conveyor repair issue.

| <b>Photo Description:</b><br>Pan conveyor disassembled and being repaired. | |

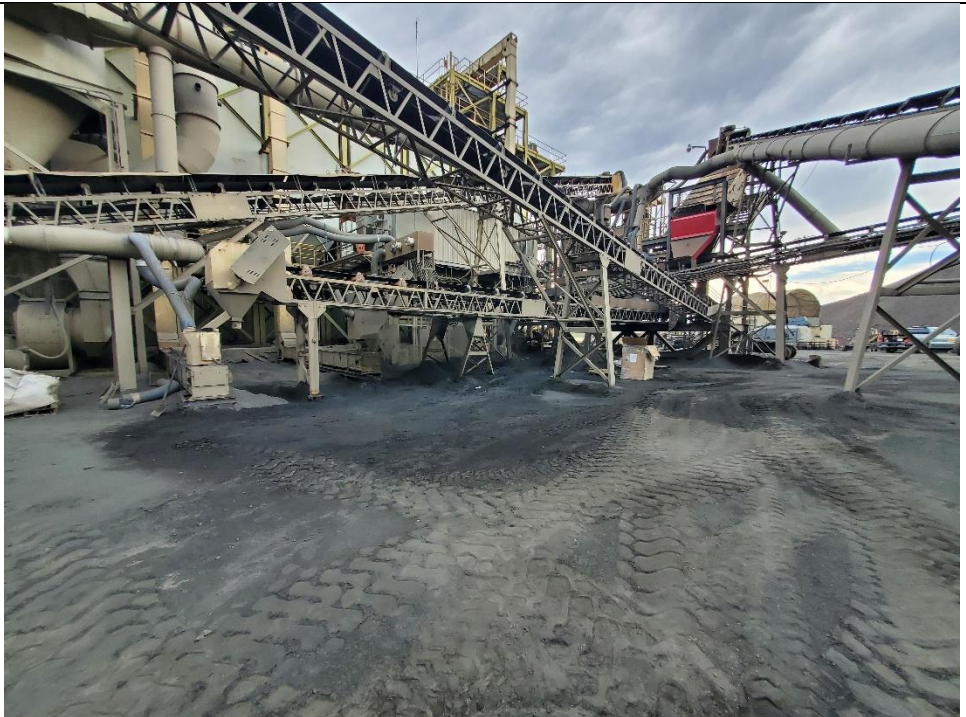
Walking through the internal portions of the plant, water sprays and wetted ground were observed (photographs #25 & #26).

| <b>Photo Description:</b><br>Internal portion of conveying and screening system.<br><br>Moisture visible in material on ground. | | |

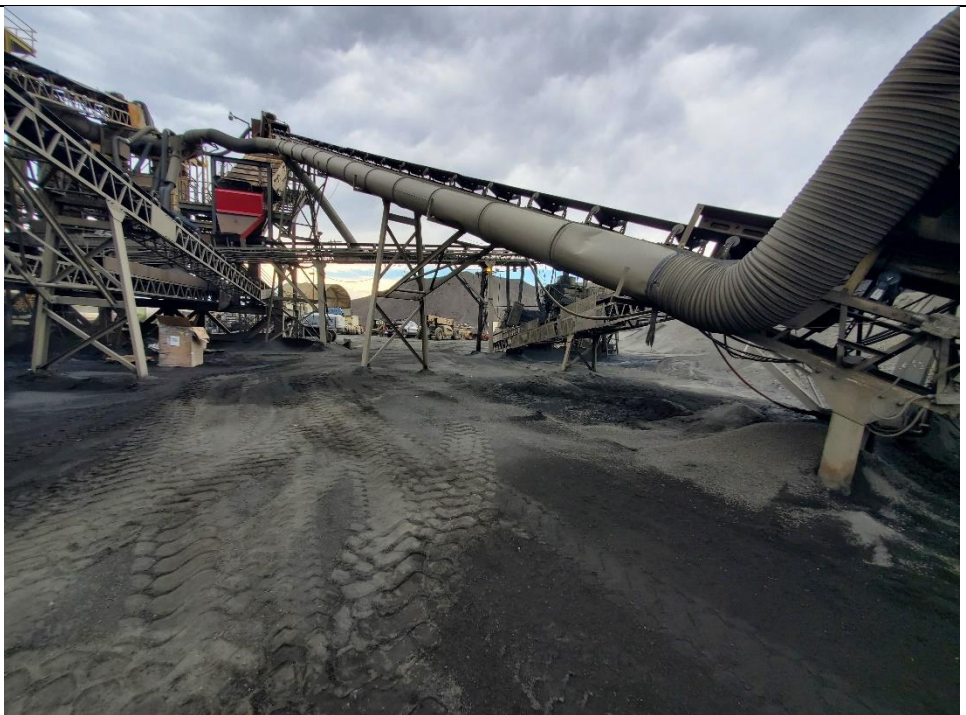
| <b>Photo Description:</b><br>Conveyor from feeder to the screen decks. Moisture visible in material on ground. | |

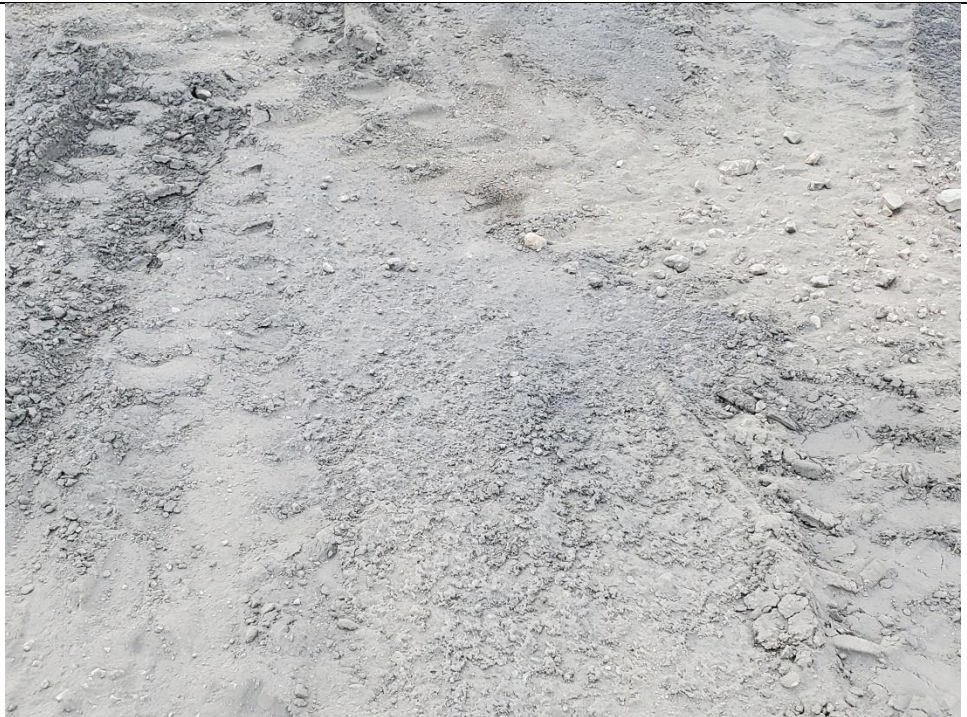
| <b>Photo No.</b><br>29 | <b>Date:</b><br>6/15/2026 |

In the area totes are filled from the material silos, and accumulation of granular material was observed on the ground. Mr. Gosselin grabbed a hand-held hose and wetted the area (photograph #28). As the ADEQ inspector looked around, crusting was observed in areas not driven over by equipment, showing evidence of previous wetting (photograph #29). No totes were being filled during the inspection (photograph #30).

| <b>Photo Description:</b><br>In the same area in Photo #28, with crusted material. Evidence of previous wetting. | |

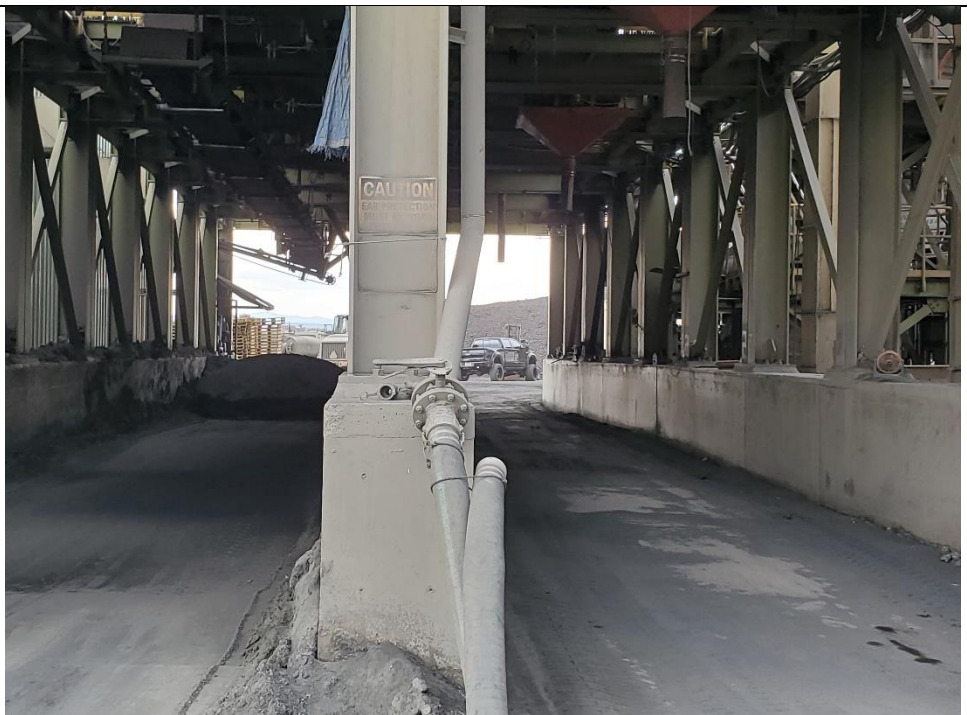
| <b>Photo No.</b><br>30 | <b>Date:</b><br>6/15/2026 |

| <b>Photo Description:</b><br>No bag or tote loading was occurring during the inspection. | |
