# Arizona Department of Environmental Quality

## AIR QUALITY FIELD INSPECTION REPORT

| <b>Company Name:</b> Minerals Research, Inc. RP: 37790 | <b>Inspection Report No.:</b> 502984 |
| <b>Place Name:</b> Cottonwood Slag Crushing-Recycling<br><b>Place ID No.:</b> 137664 (172594 portable place of air) | <b>Inspector(s):</b> Rob Verville, Feng Mao, Miguel Sandoval, Jordy Yepiz |

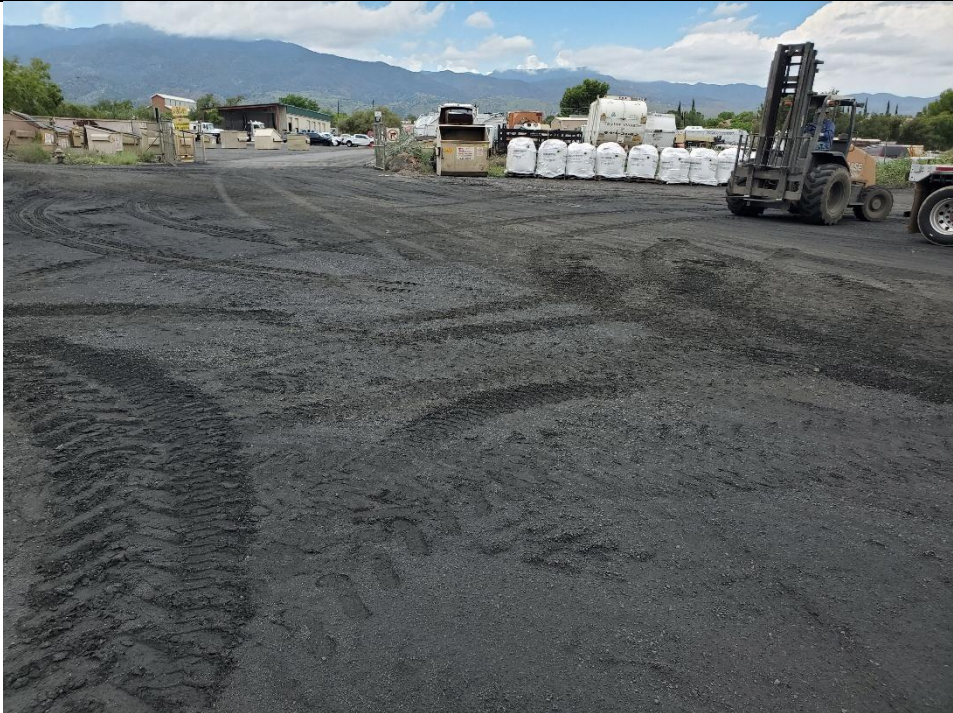
| <b>Photo No.</b><br>1 | <b>Date:</b><br>8/31/2026 | | |

| <b>Photo Description:</b><br>Moisture visible in the soil from front office to main gate. Area had Durasoil applied several month ago. | | | |

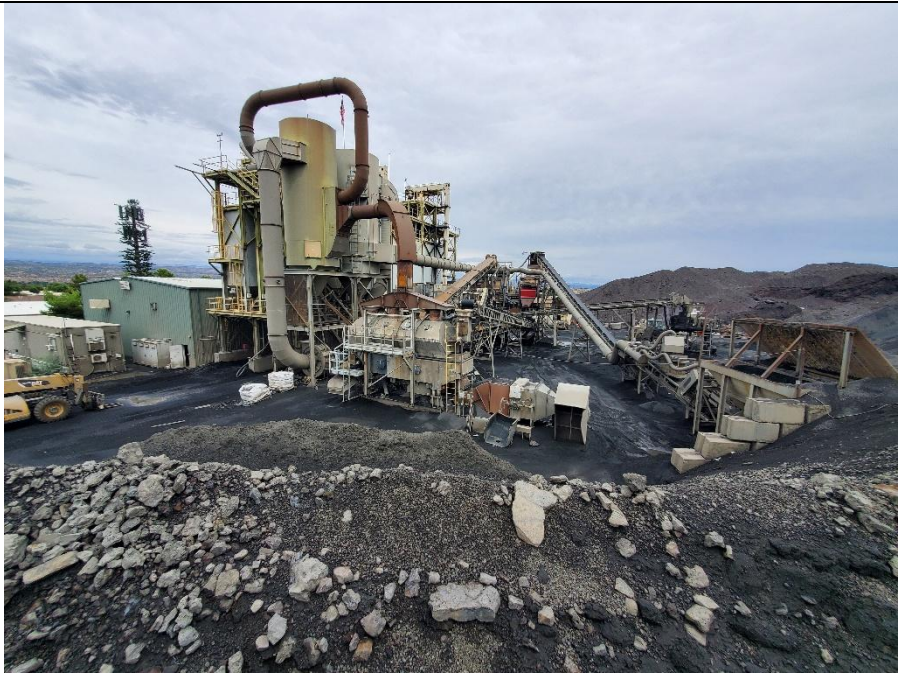
| <b>Photo No.</b><br>2 | <b>Date:</b><br>8/31/2026 | |

| <b>Photo Description:</b><br>Overall plant from slag pile access road. Panoramic with #3. | | |

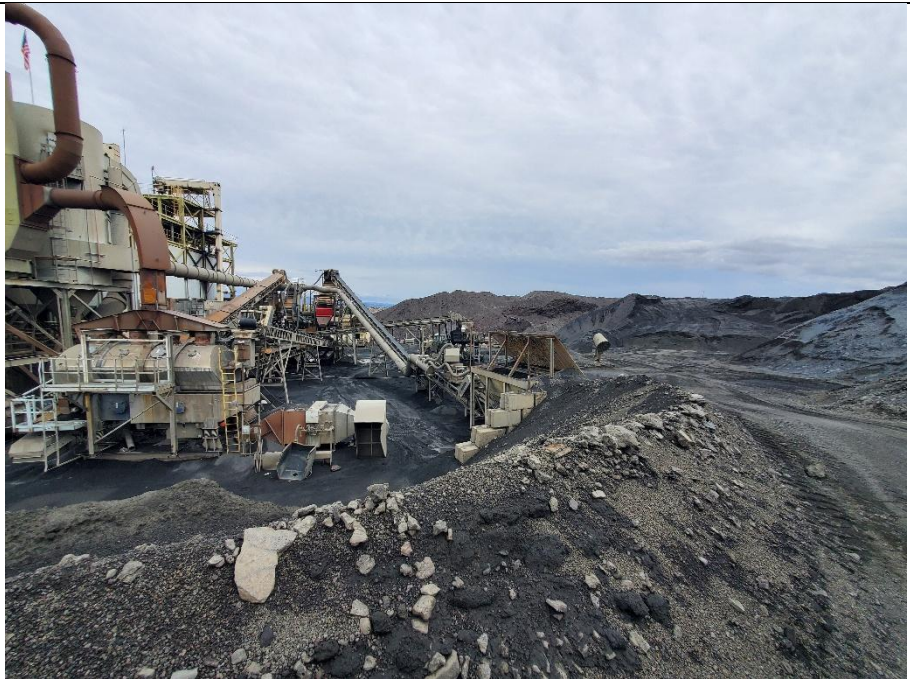
| <b>Photo No.</b><br>3 | <b>Date:</b><br>8/31/2026 |

| <b>Photo Description:</b><br>Overall plant and current material stockpile of crushed material south of plant. | |

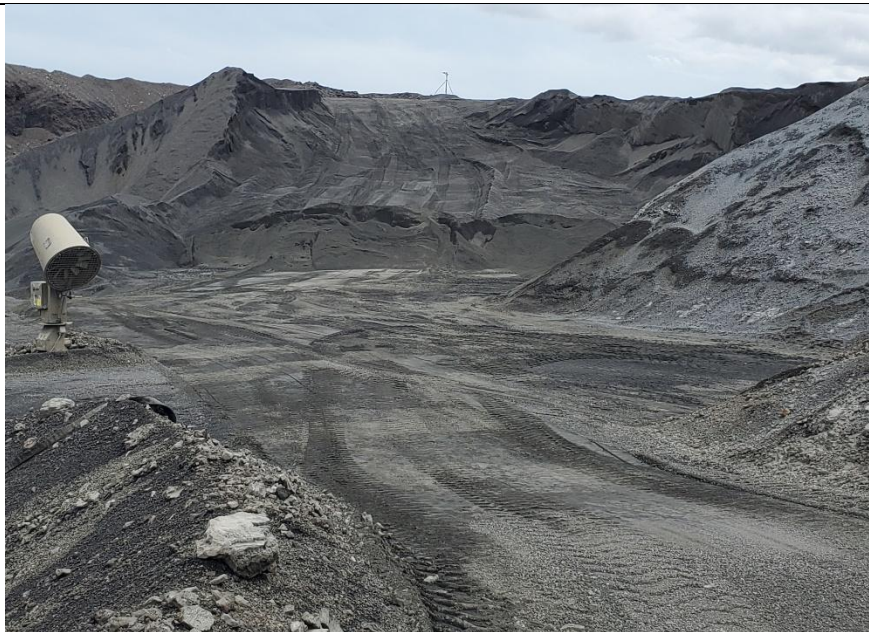
| <b>Photo No.</b><br>4 | <b>Date:</b><br>8/31/2026 | |

| <b>Photo Description:</b><br>Current material, in background, being used in process. | | |

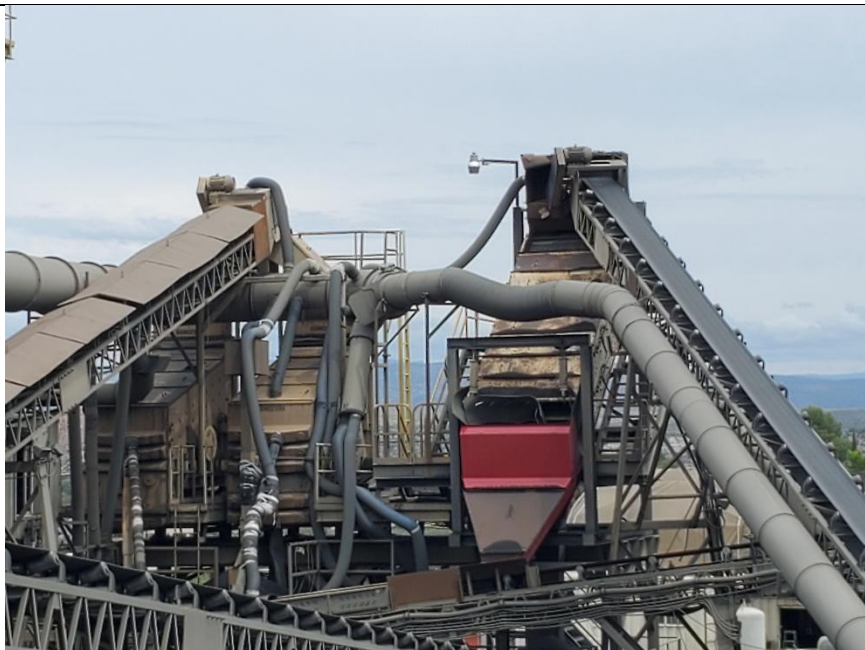
| <b>Photo Description:</b><br>Main screen on right. Two screens on left.<br><br>Wet material conveyor on right not covered.<br><br>Dry material conveyor on left covered. | |

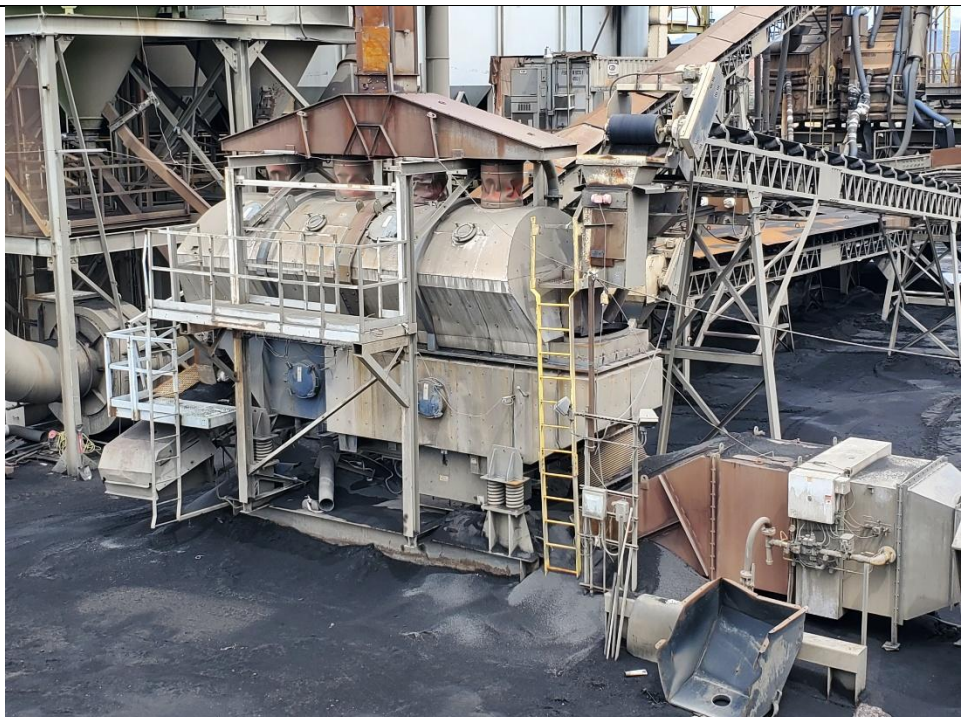
| <b>Photo No.</b><br>6 | <b>Date:</b><br>8/31/2026 |

| <b>Photo Description:</b><br>Fluid bed dryer and heater on right. | |

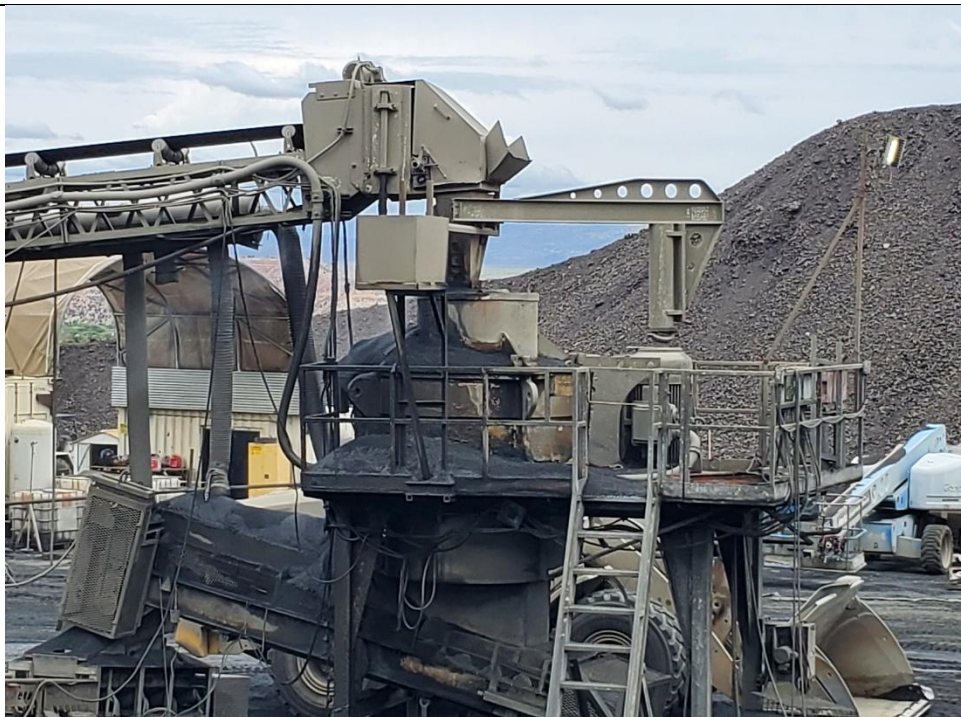
| <b>Photo No.</b><br>7 | <b>Date:</b><br>8/31/2026 | |

| <b>Photo Description:</b><br>Secondary crusher. | | |

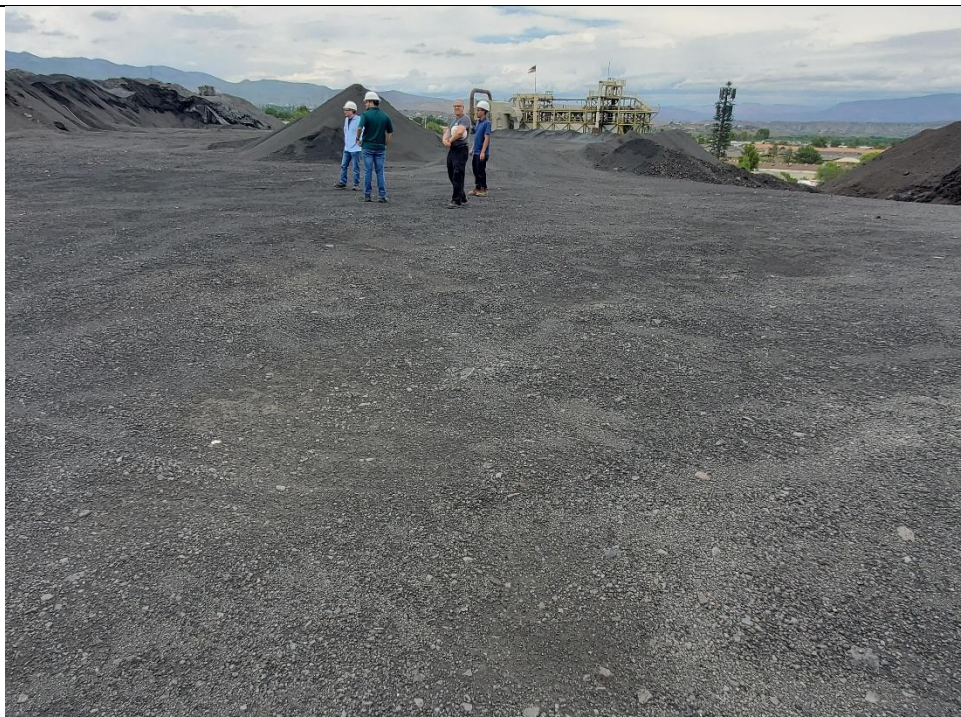
| <b>Photo Description:</b><br>Previous location of primary crushing plant on slag pile. | |

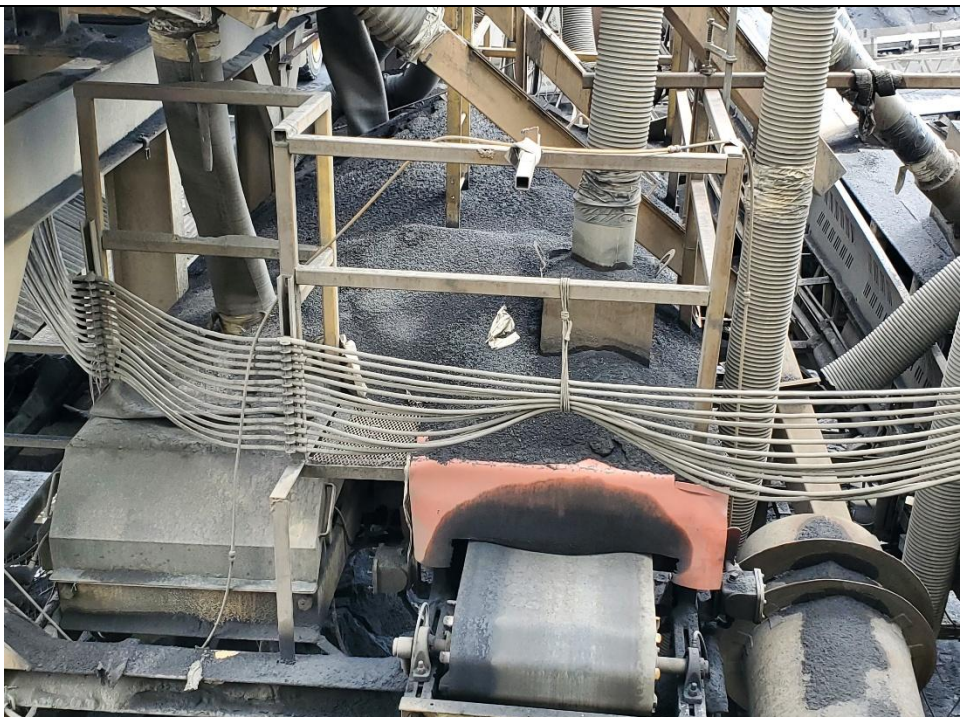
| <b>Photo No.</b><br>9 | <b>Date:</b><br>8/31/2026 |

| <b>Photo Description:</b><br>Granular material on top of conveyor covers. Material falls from screens above. | |

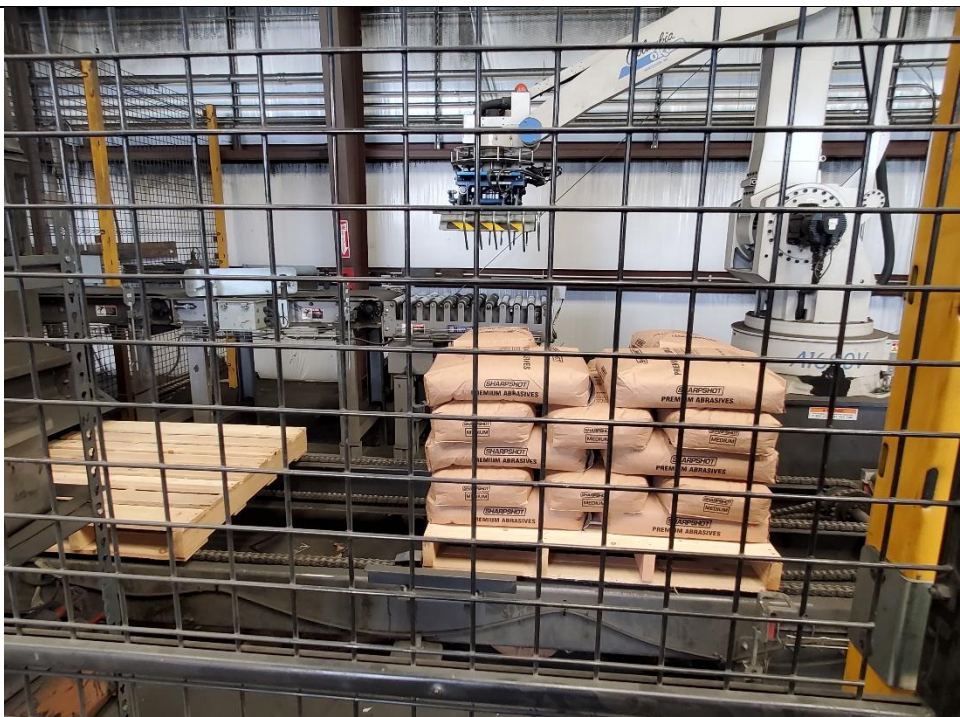
| <b>Photo No.</b><br>10 | <b>Date:</b><br>8/31/2026 |

| <b>Photo Description:</b><br>Bag pallet stacking unit. | |

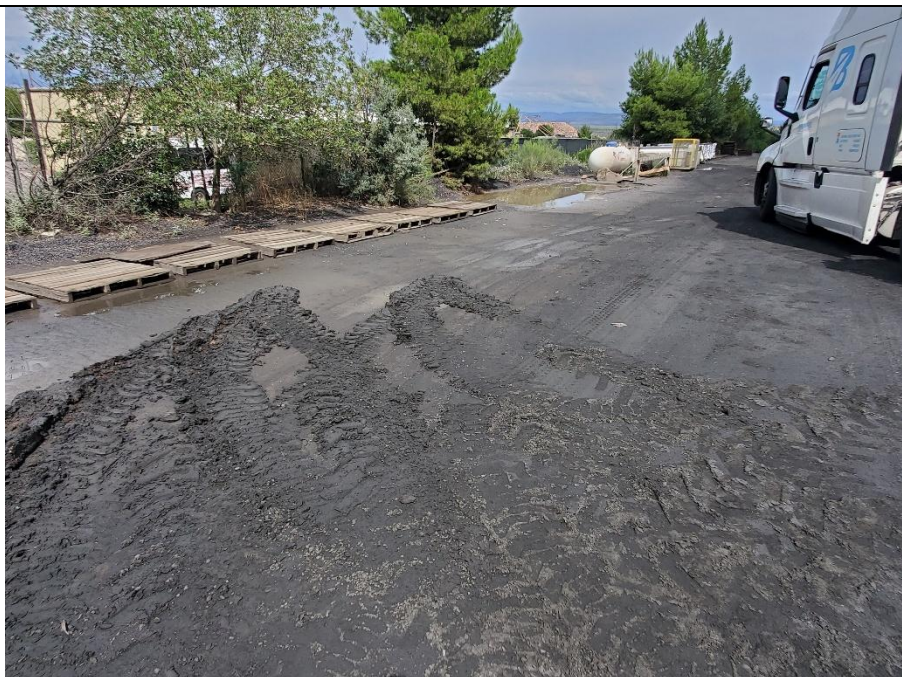
| <b>Photo No.</b><br>11 | <b>Date:</b><br>8/31/2026 |

| <b>Photo Description:</b><br>Mud and puddled water in driveway on northwest side. | |
