J. SOLID WASTE MANAGEMENT UNITS

**PHASE I ENVIRONMENTAL
SITE ASSESSMENT
LOT 7 DEER VALLEY COMMERCE
CENTER
2453 WEST PARKSIDE LANE
PHOENIX, ARIZONA
GEO TEK PROJECT No.: 1929-PH**

PHASE I ENVIRONMENTAL SITE ASSESSMENT

LOT 7 DEER VALLEY COMMERCE CENTER
2453 WEST PARKSIDE LANE
PHOENIX, ARIZONA

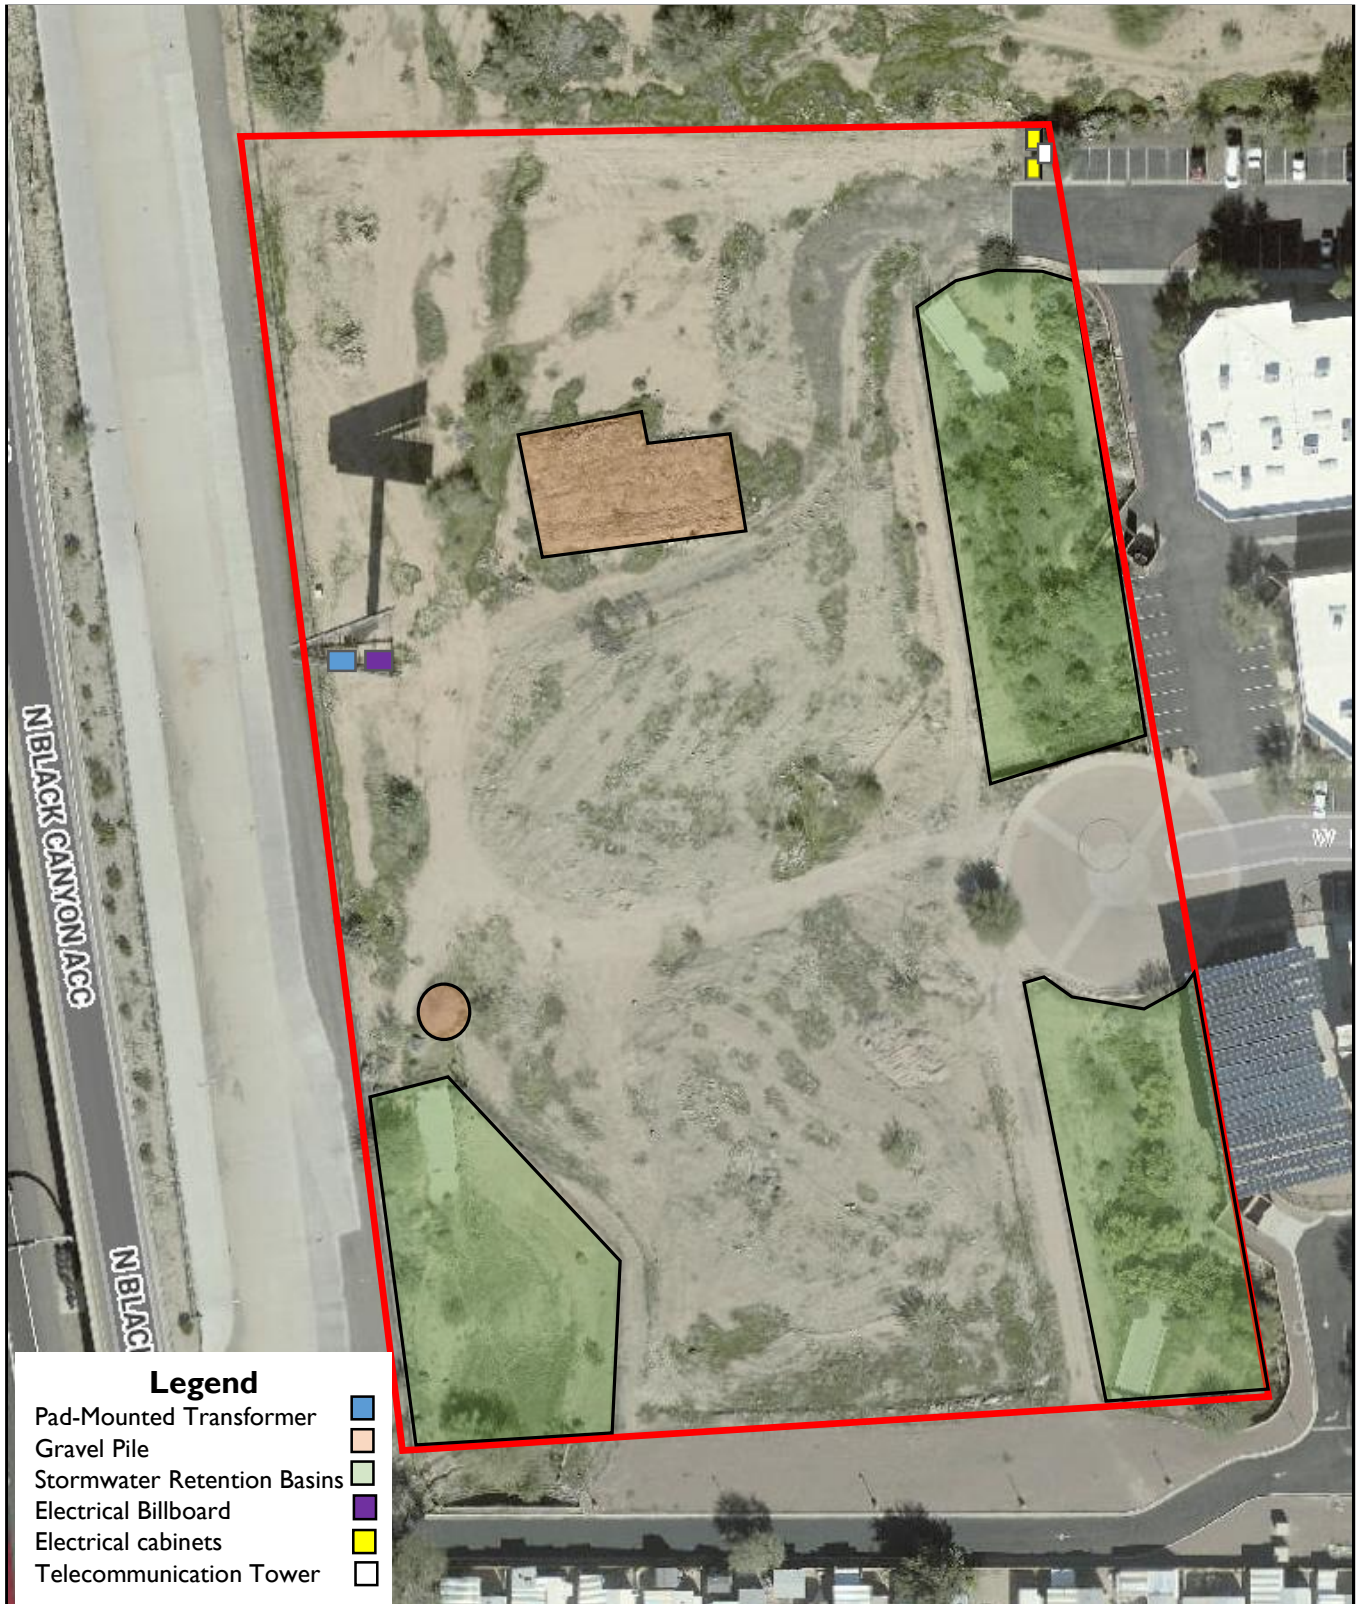
The Site was comprised of 5.55 acres of primarily partially graded, vacant land covered with native vegetation. As shown in Figure 3, a small area of an asphalt-paved section of the eastern adjoining parking lot and landscaped area was observed in the northeast corner of the Site. The paved area is lined with a curb.

Several gravel and cobble mounds were observed on the Site. The mounds were overgrown with vegetation and did not appear to be associated with mining activity. The approximate locations of these piles are shown in Figure 3. GeoTek did not observe staining or other possible indicators of impact from petroleum products or hazardous substances. Based on field observations, GeoTek concluded these mounds of gravel and cobbles were not RECs or indicators of RECs for the Site.

An electrical billboard was located in the northwest corner of the Site (see Figure 3) along with a transformer which was probably used to provide electricity to the billboard. A small telecommunication tower and an electrical cabinet were observed in the northeast corner of the Site. These electrical features appear to correlate with the eastern adjoining commercial buildings.

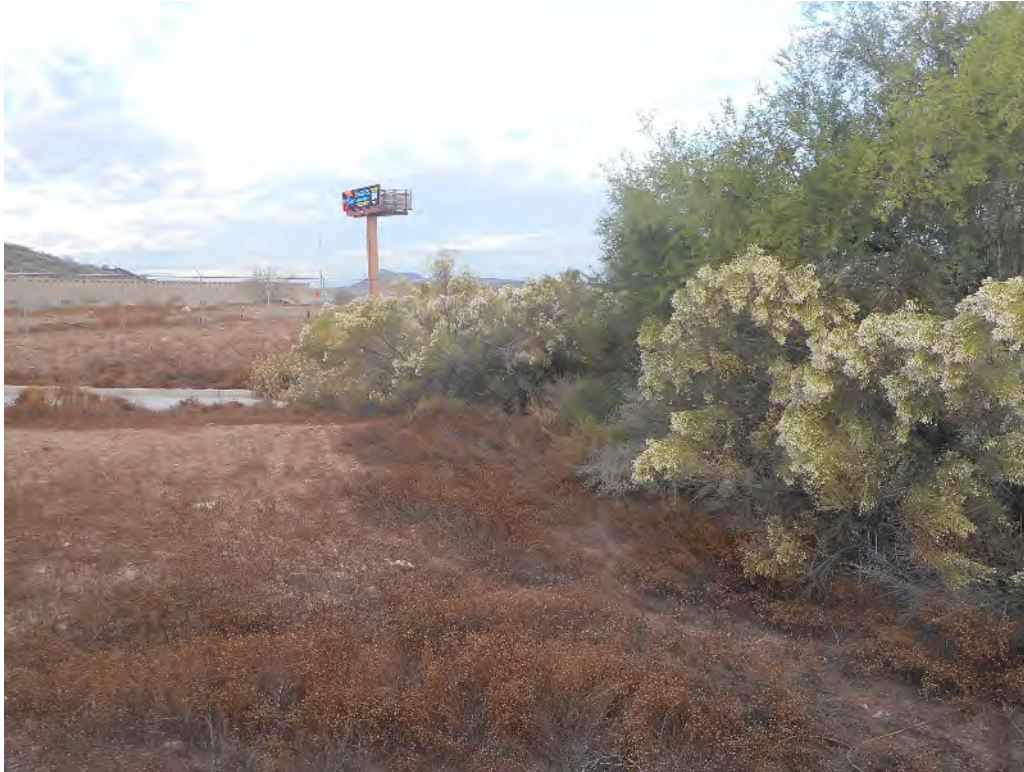
PHOTOGRAPH NO. 1

Southeastern area of Site, looking northwest, showing typical vegetation, vacant, undeveloped land, stormwater retention basin, and electrical billboard on the Site

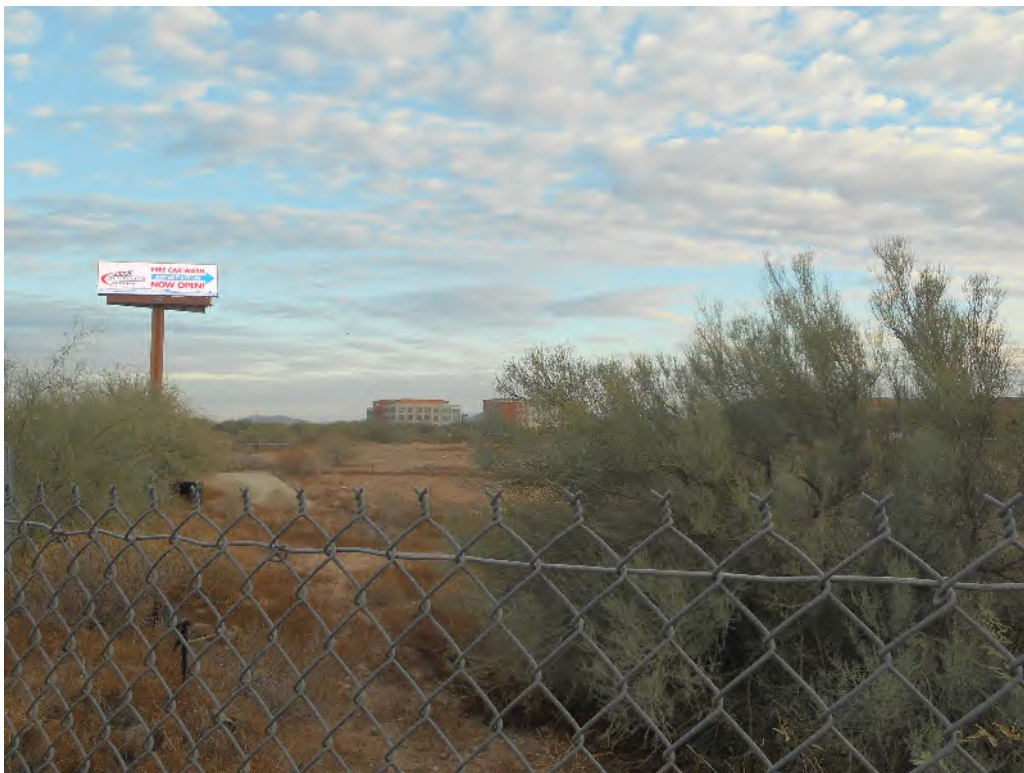
PHOTOGRAPH NO. 2

Southwestern area of Site, looking northeast, showing typical vegetation, stormwater retention basin, vacant, undeveloped land and electrical billboard on the Site

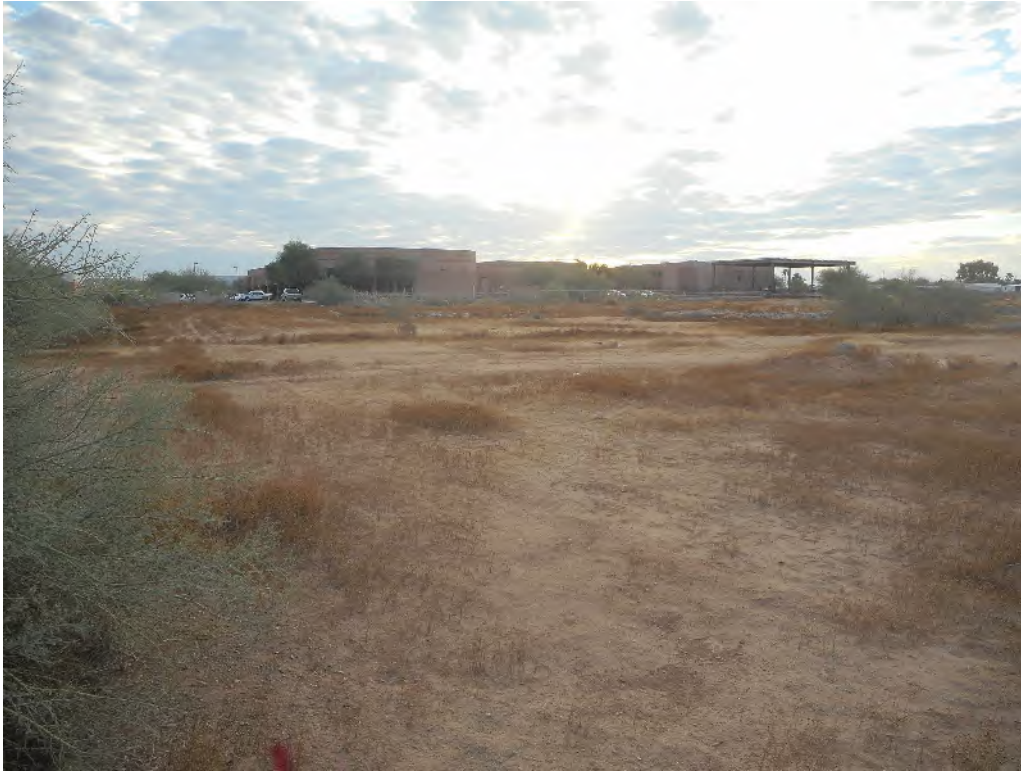
PHOTOGRAPH NO. 3

View from the northwestern portion of the Site, looking southeast, showing vegetation and vacant, undeveloped land typical of the Site

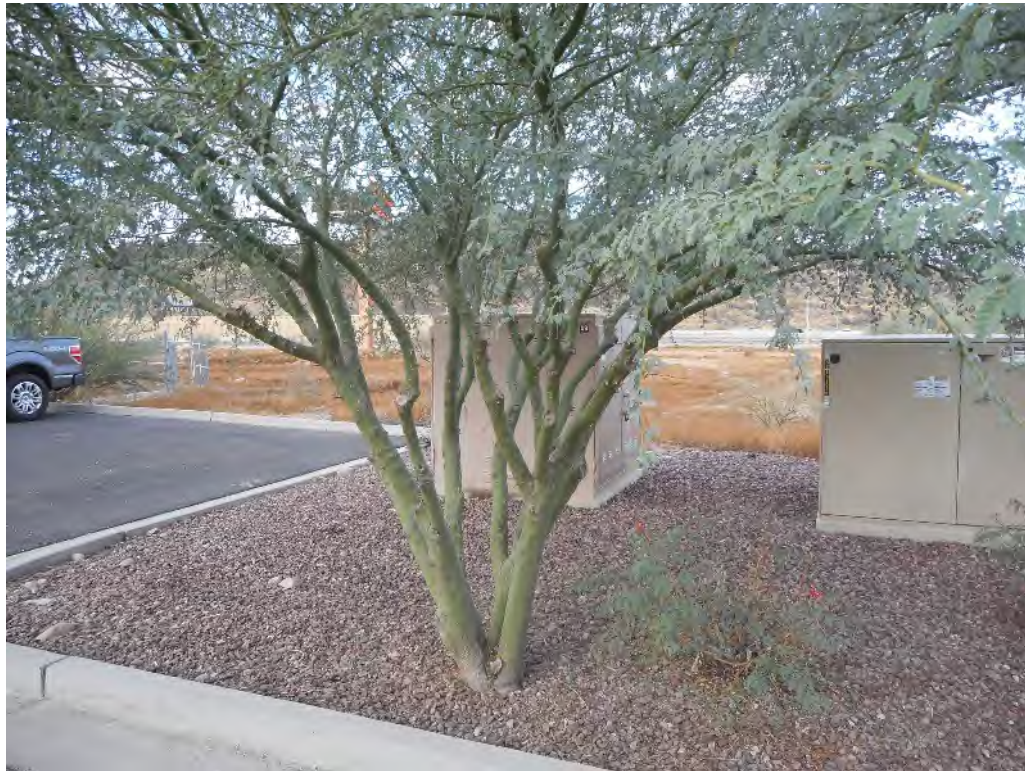
PHOTOGRAPH NO. 4

View from northeastern portion of the Site, looking southwest, showing landscaped area, paved parking lot, electrical cabinets, and vacant, undeveloped land in northeast area of the Site

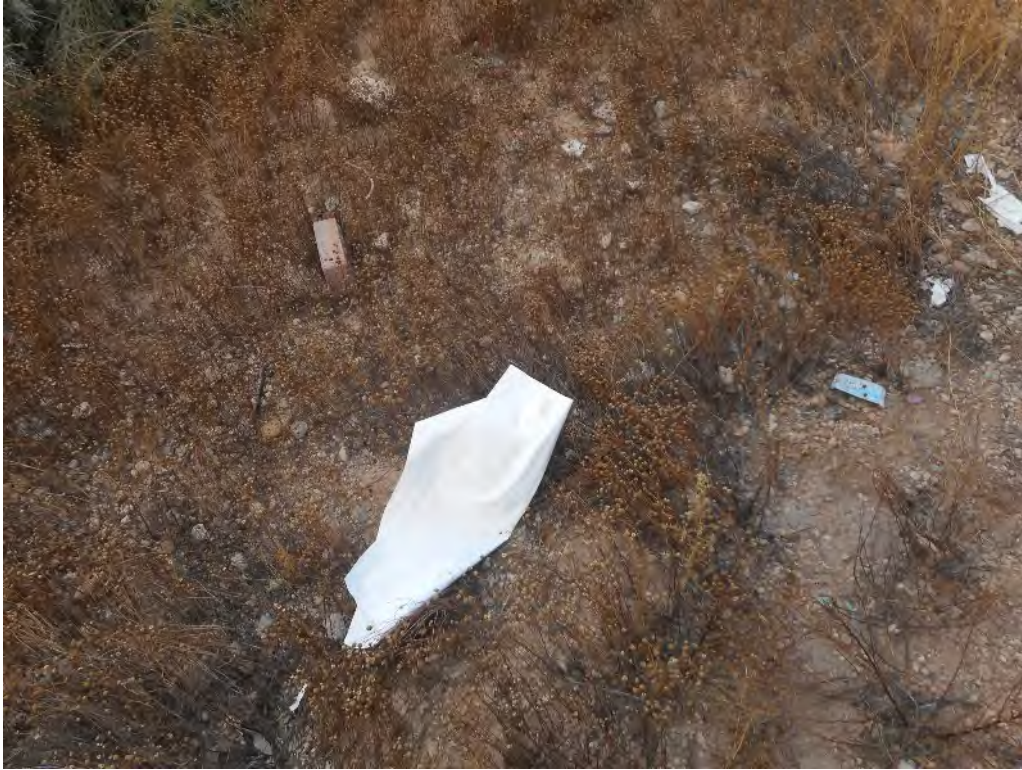
PHOTOGRAPH NO. 5

Throughout the Site, including the retention basins, GeoTek observed minor quantities of trash and debris. GeoTek did not observe indications of concentrated dumping on the Site and did not observe staining, detect chemical odors, or identify other possible indicators of impact from petroleum products or hazardous substances in the area of the debris observed. Based on field observations, GeoTek concluded the minimal trash observed on the Site was not a REC or an indicator of a REC for the Site.

Typical trash found throughout the Site and in stormwater retention basins on the Site

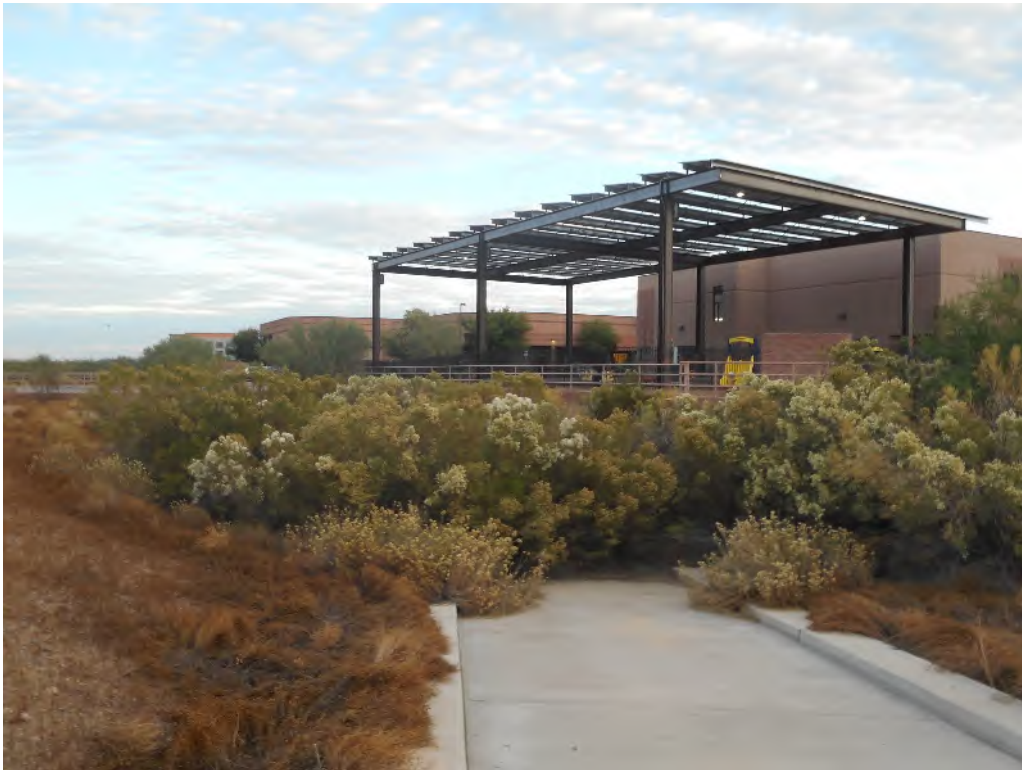
PHOTOGRAPH NO. 6

Stormwater retention basin on southeastern area of the Site, looking northwest showing the concrete spillway draining stormwater into the retention basin

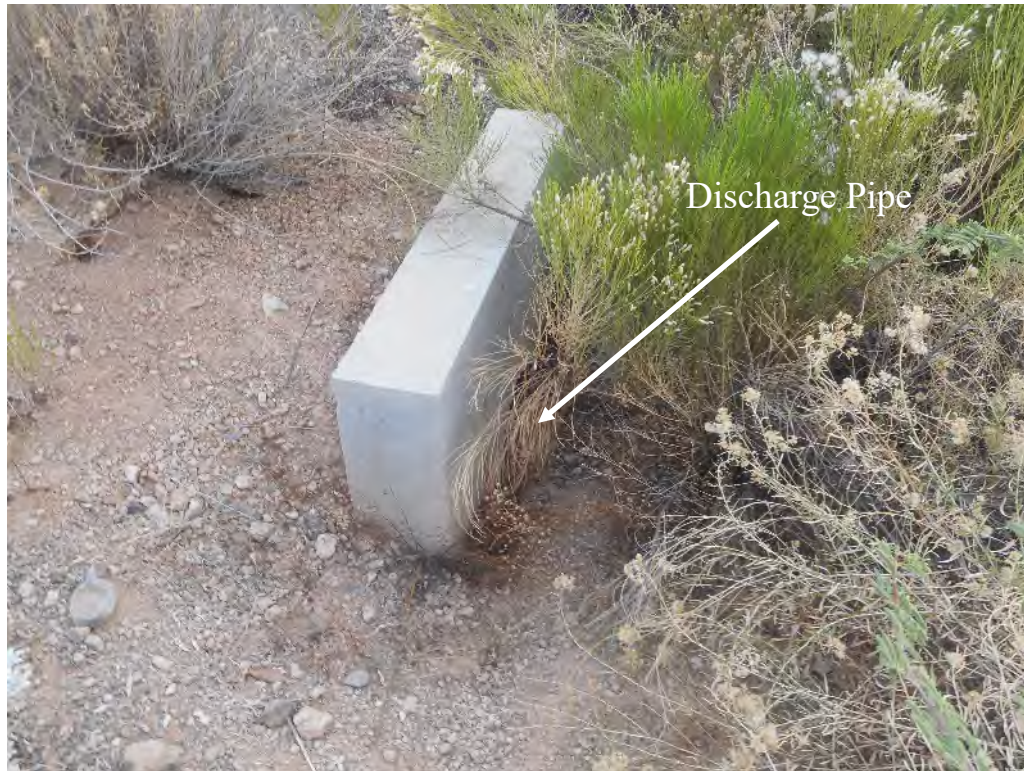
PHOTOGRAPH NO. 7

Drainage outlet located on northern portion of the southeastern retention basin

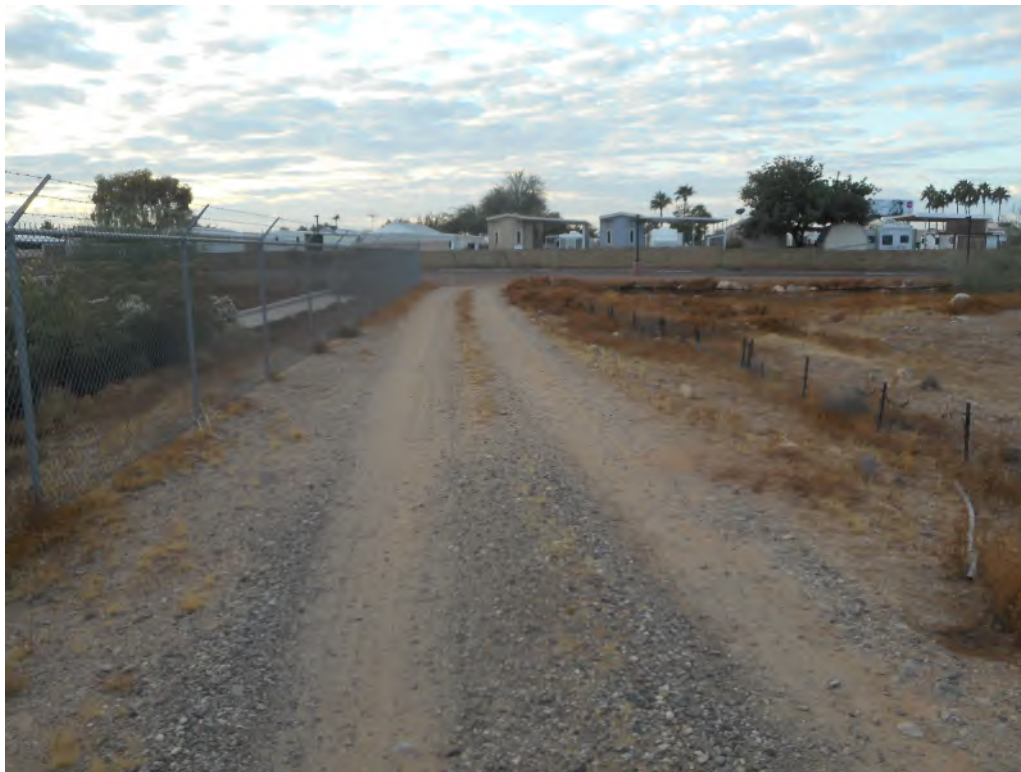
PHOTOGRAPH NO. 8

Some dirt roads were observed traversing the Site. These roads were probably used to access different areas on the Site and the billboard on the west side of the Site. At the time of the site reconnaissance, GeoTek did not observe concentrated dumping along the roadways or other possible indicators of environmental impact to the Site. Based on field observations, GeoTek concluded these roadways are not RECs or indicators of RECs for the Site.

Dirt road located on east side of Site beginning at approximate center of east Site boundary, running northwest to southeast

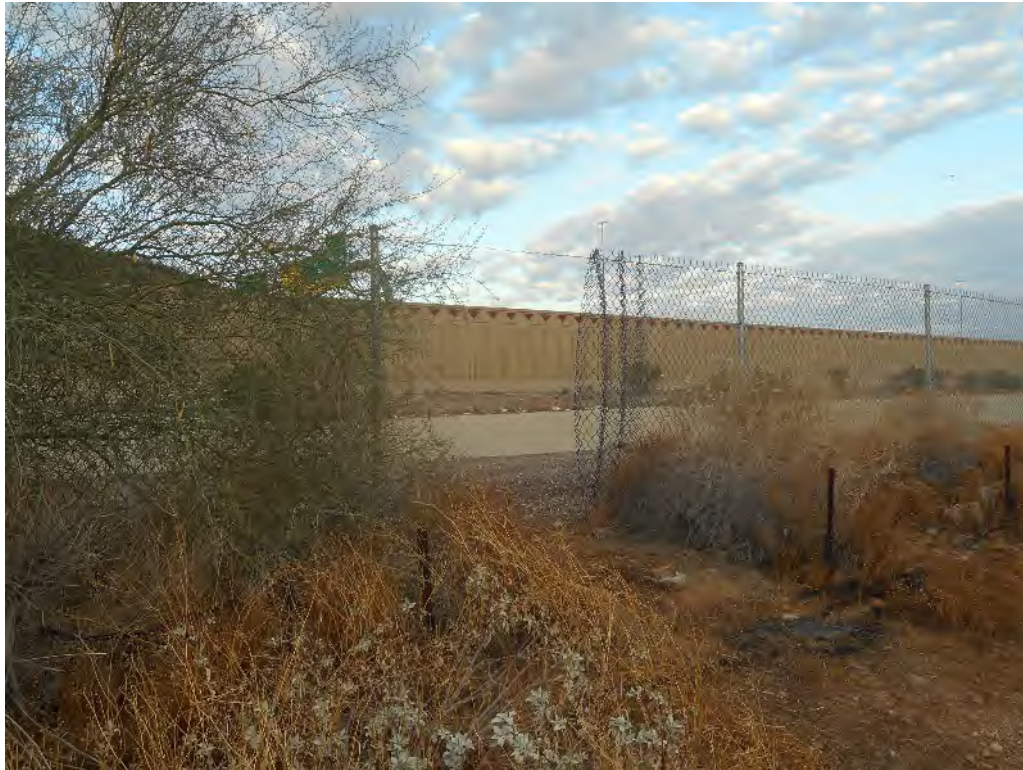
PHOTOGRAPH NO. 9

Broken fencing located in the southwestern stormwater retention basin

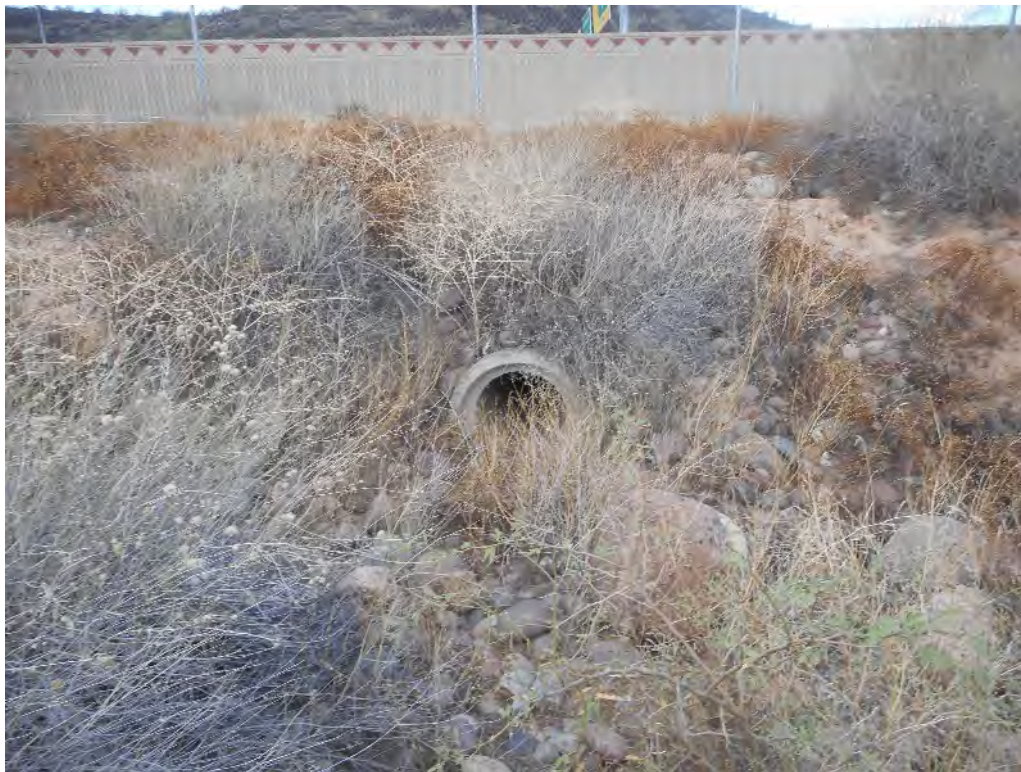
PHOTOGRAPH NO. 10

Drainage pipe located in the southwestern stormwater retention basin leading to eastern adjoining stormwater canal bordering the I-17 frontage road

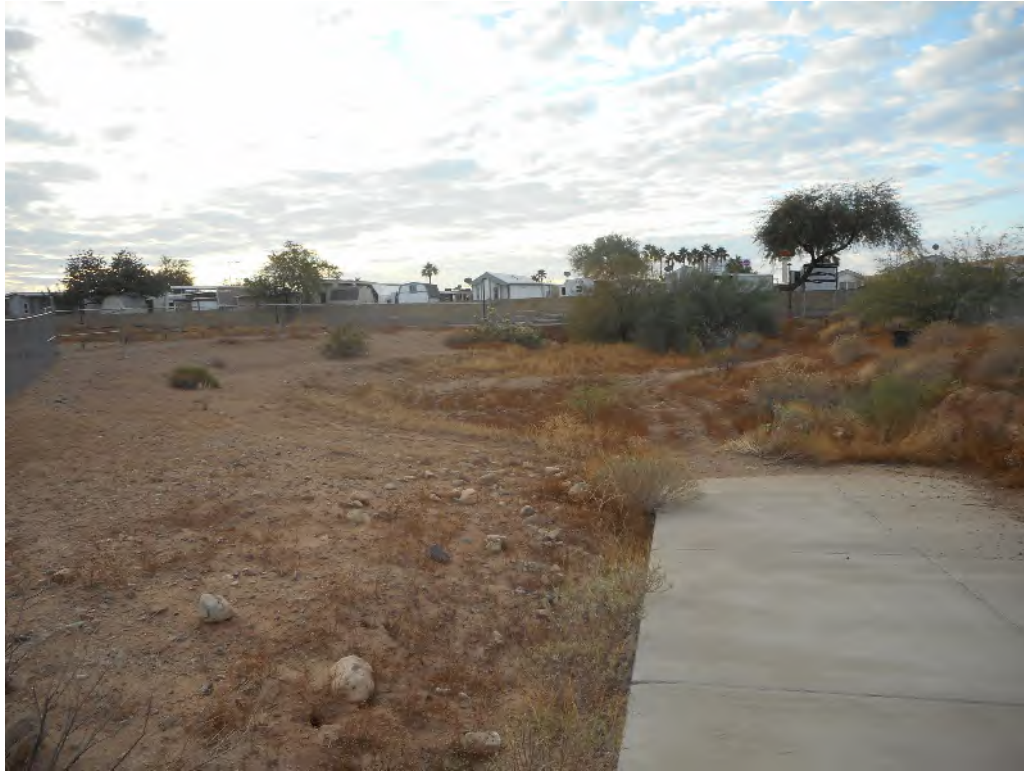
PHOTOGRAPH NO. 11

North end of southeastern retention stormwater retention basin looking south showing typical stormwater retention basin on the Site

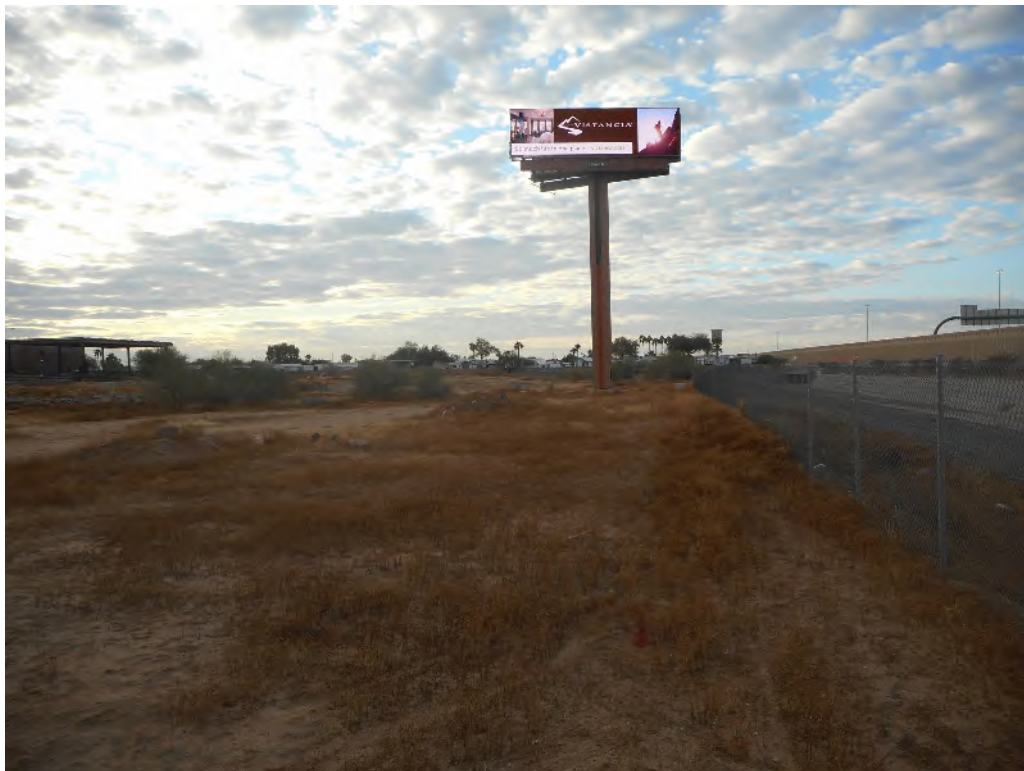
PHOTOGRAPH NO. 12

Electrical billboard located middle western boundary of the Site

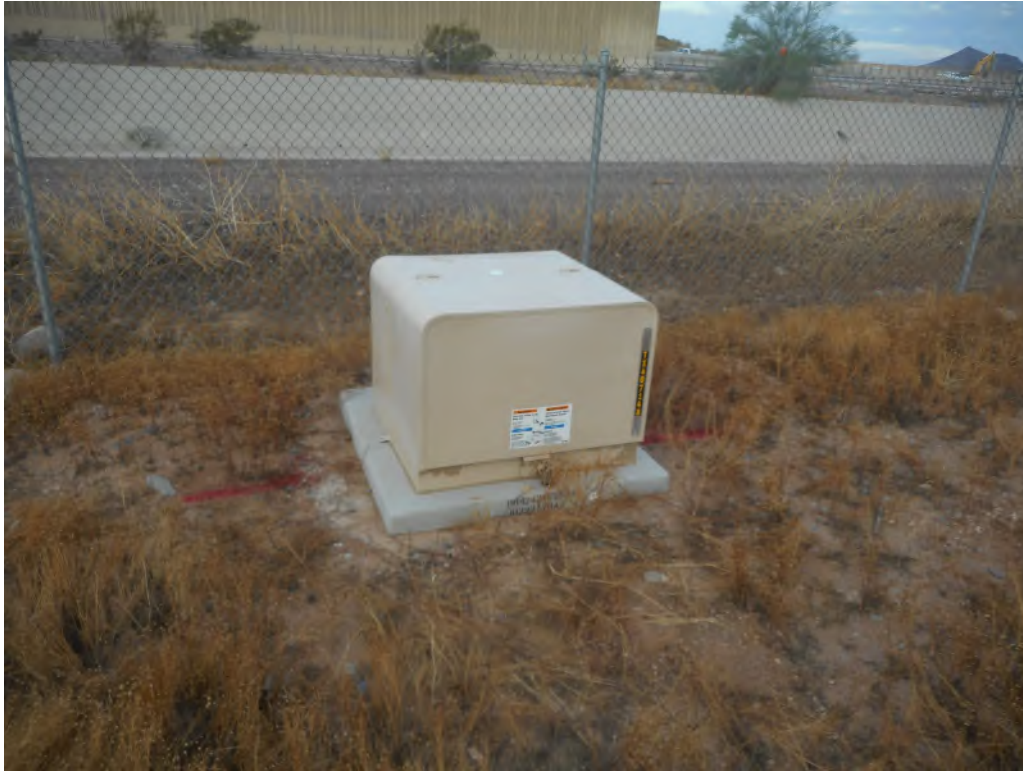
PHOTOGRAPH NO. 13

Single-phase, pad-mounted transformer located next to the electrical billboard on the middle western border of the Site

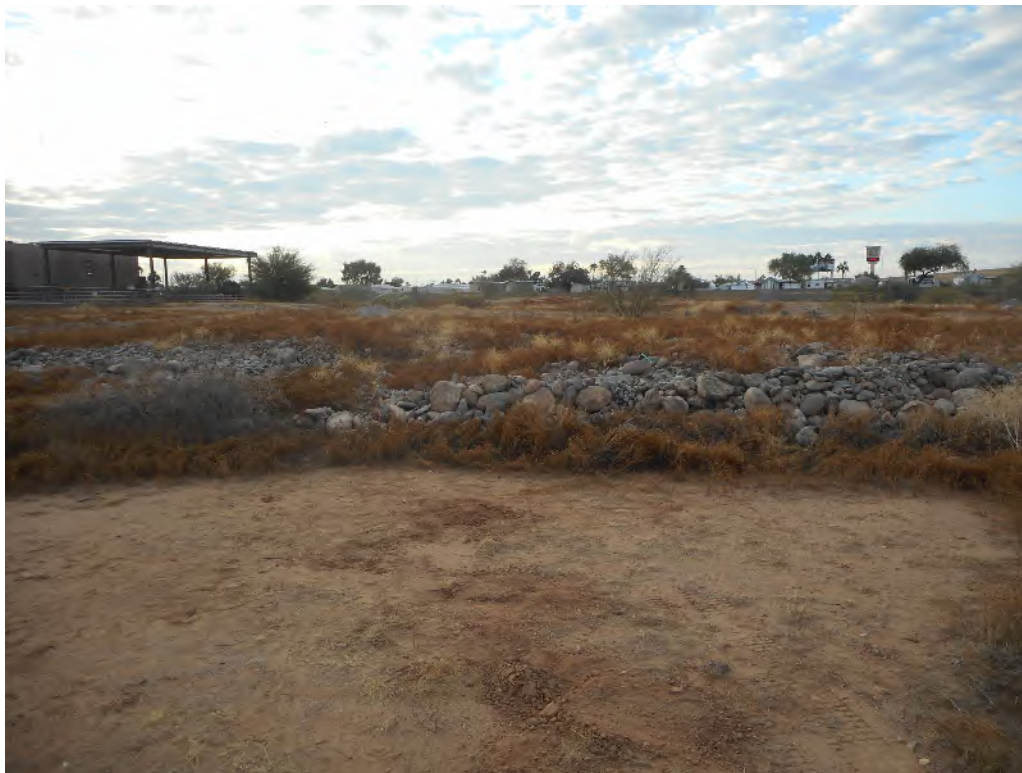
PHOTOGRAPH NO. 14

Piles of cobbles and gravel located in the approximate center of the Site

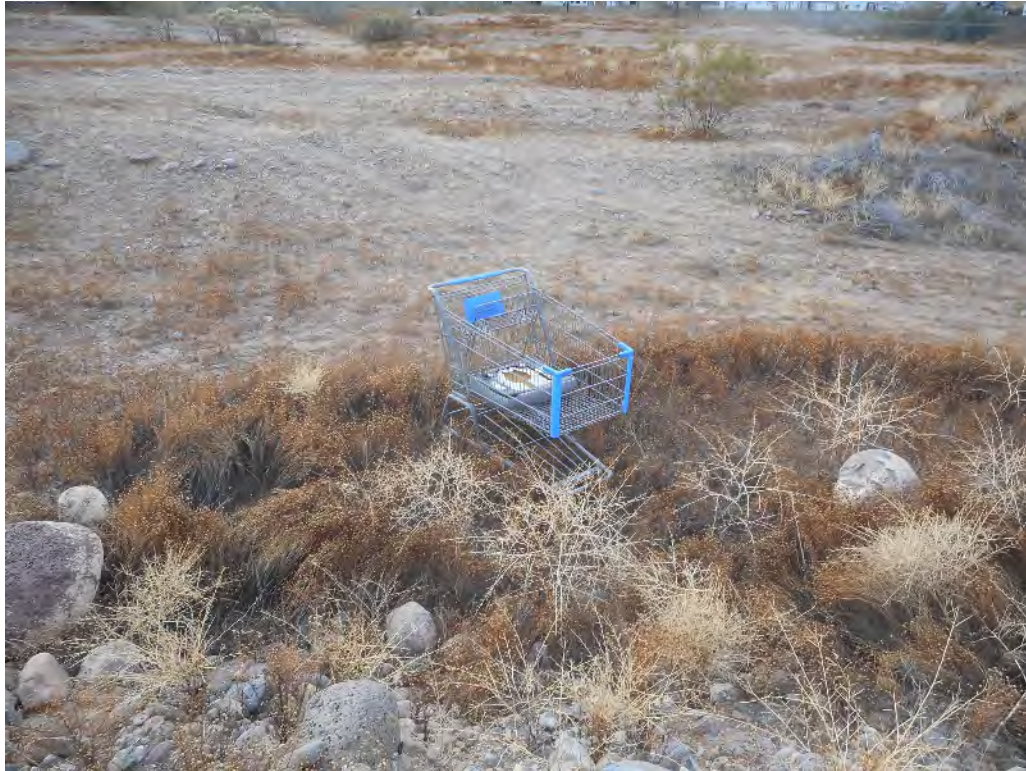
PHOTOGRAPH NO. 15

Shopping cart and trash located in the approximate center of the Site

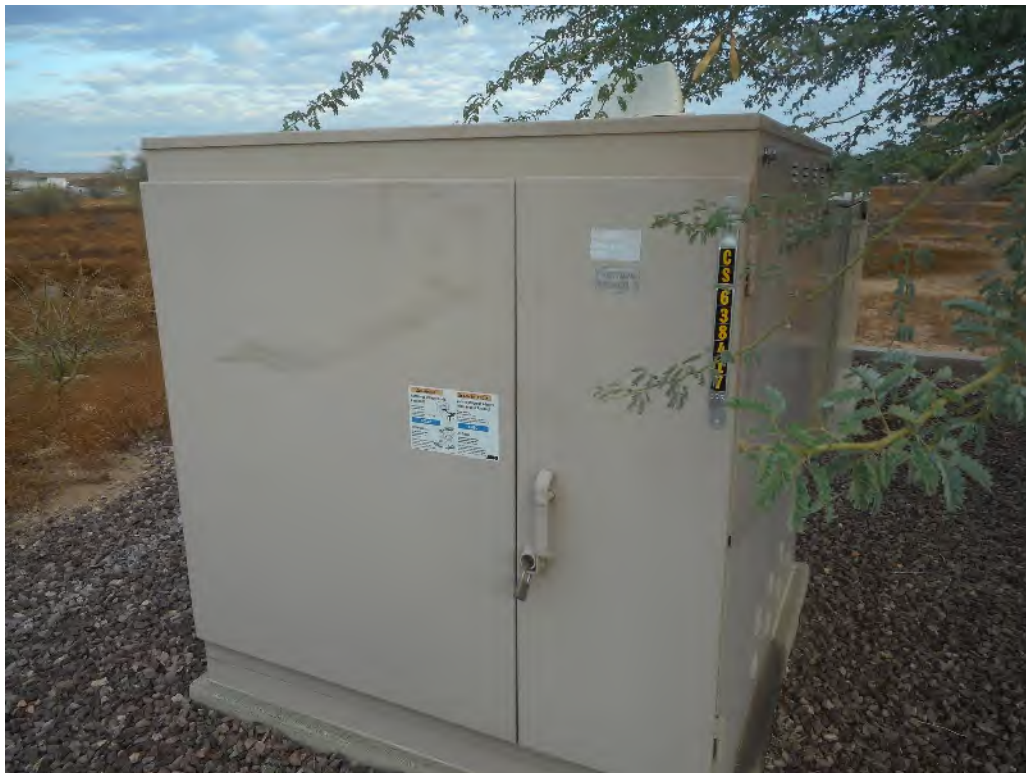
PHOTOGRAPH NO. 16

Electrical cabinet in the northeastern corner of the Site

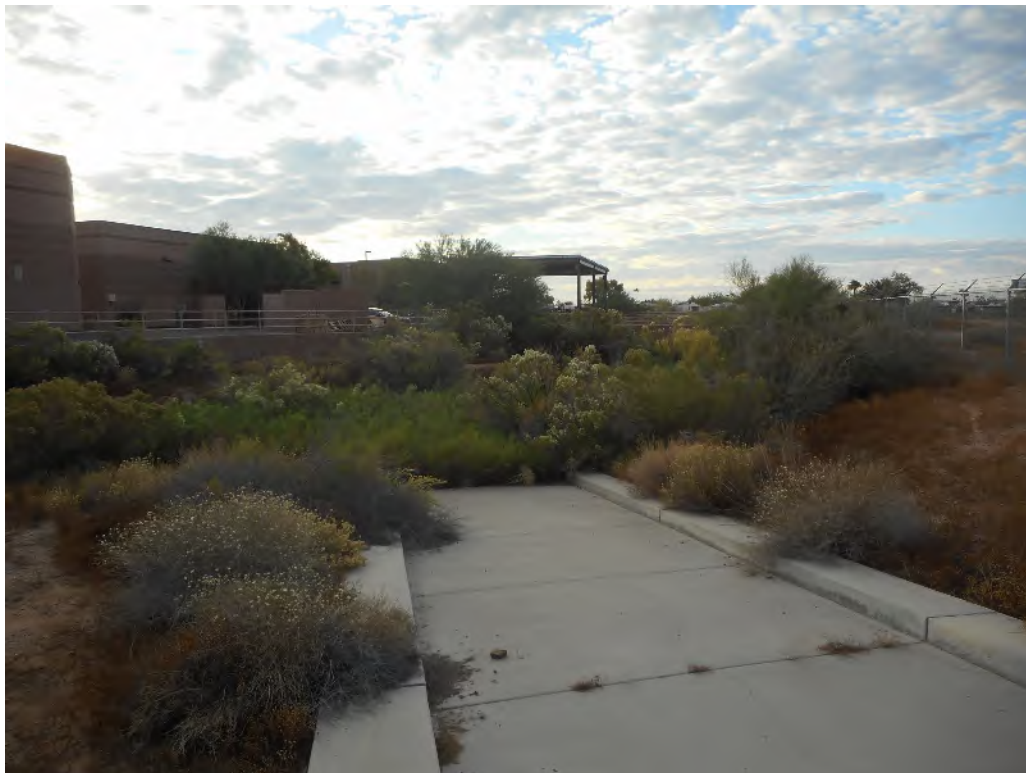
PHOTOGRAPH NO. 18

Stormwater retention basin located on the northeast portion of the Site, looking southwest showing the concrete spillway discharging to stormwater retention basin

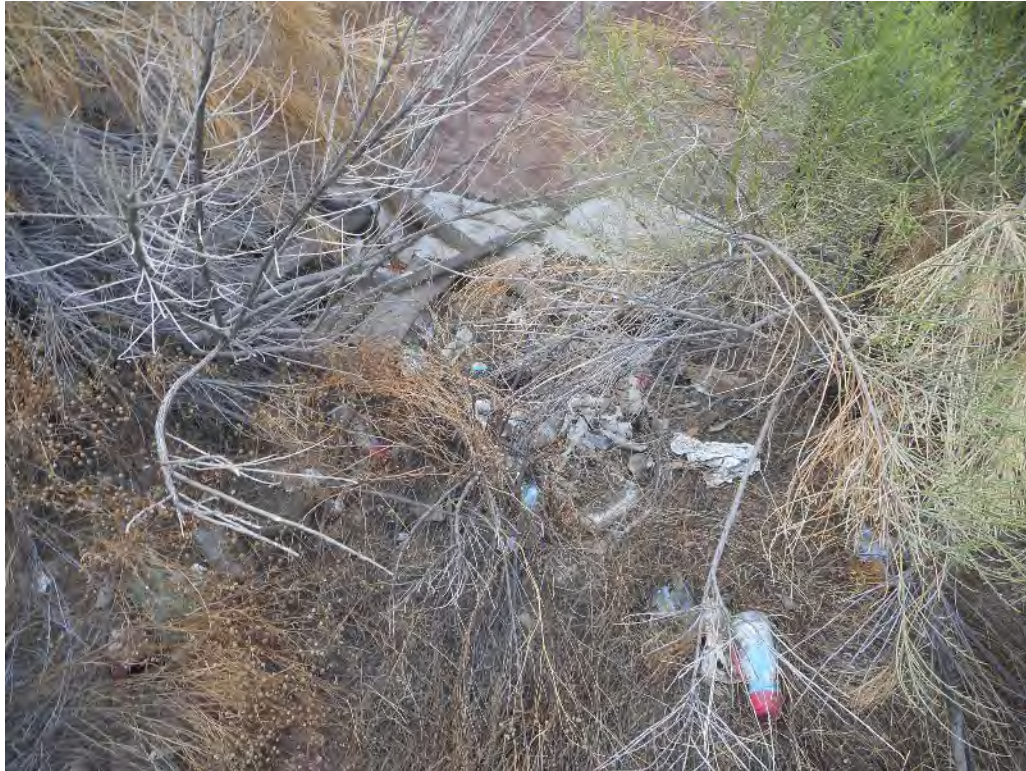
PHOTOGRAPH NO. 19

Trash observed in the northeast stormwater retention basin

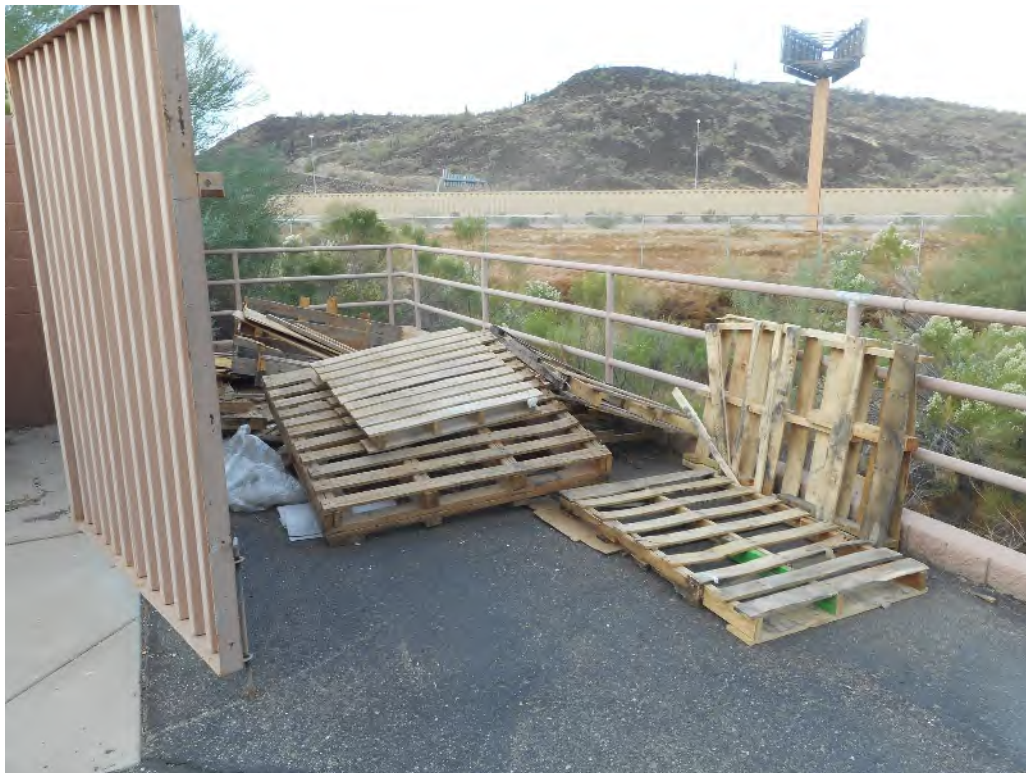
PHOTOGRAPH NO. 20

Trash located east of the northeast stormwater retention basin, near the middle eastern boundary of the Site.

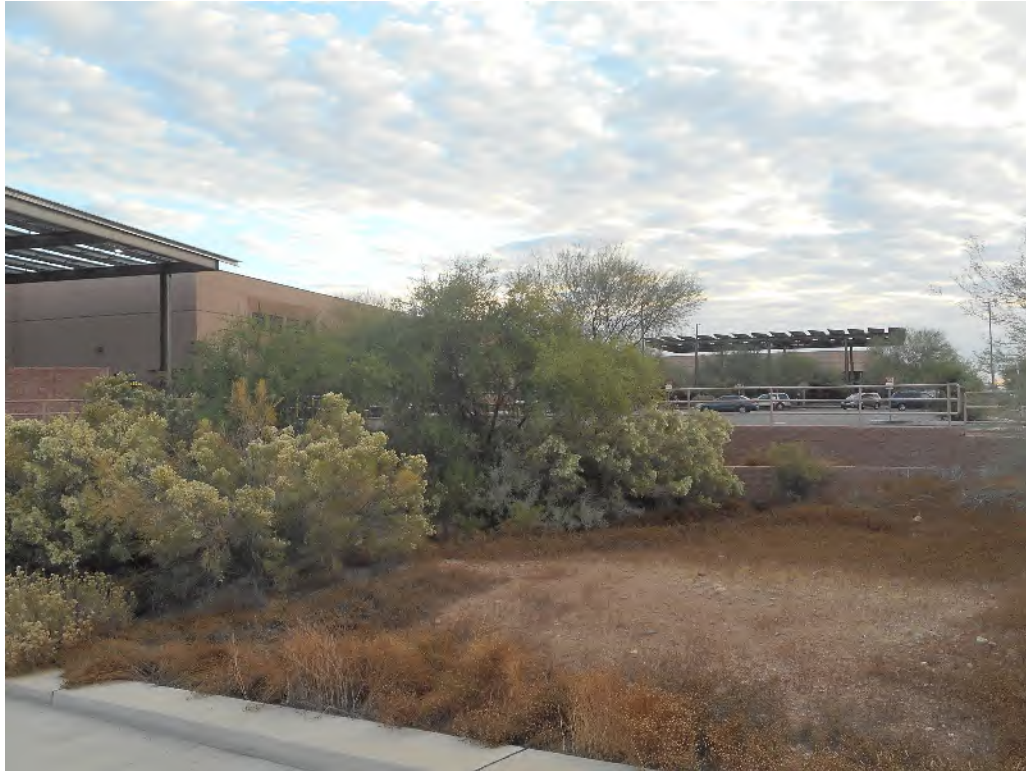
PHOTOGRAPH NO. 21

View from the southeastern portion of the Site, looking northeast, showing southeastern adjoining school

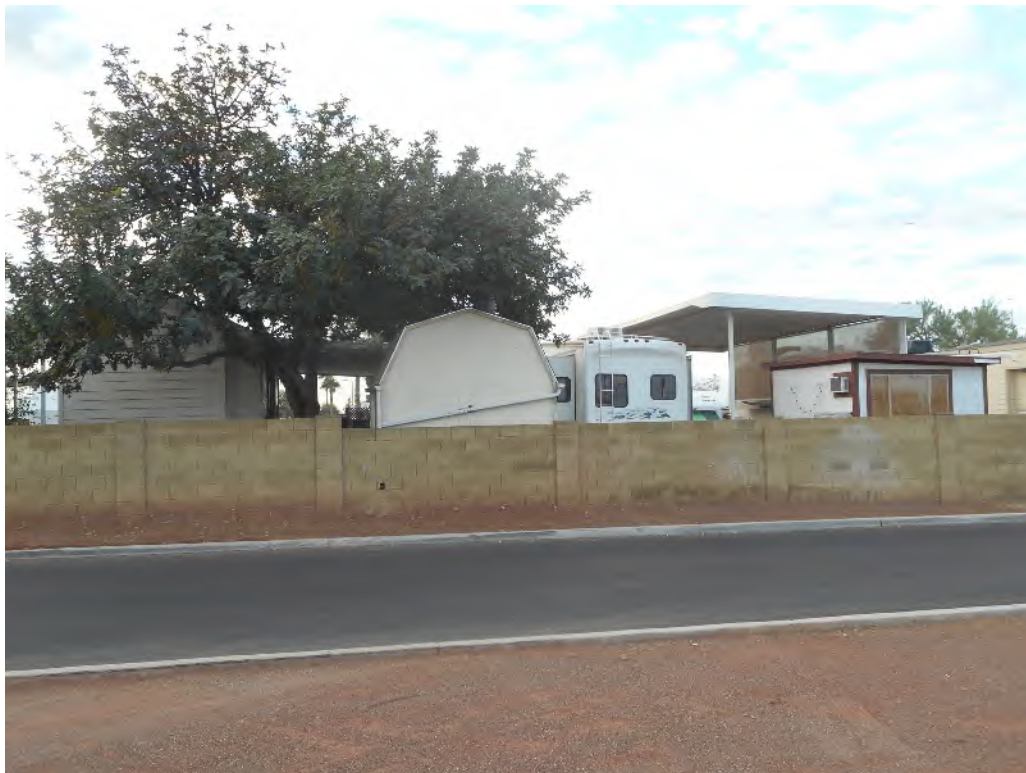
PHOTOGRAPH NO. 22

View from the middle southern boundary of the Site, looking south, showing the southern adjoining RV Park

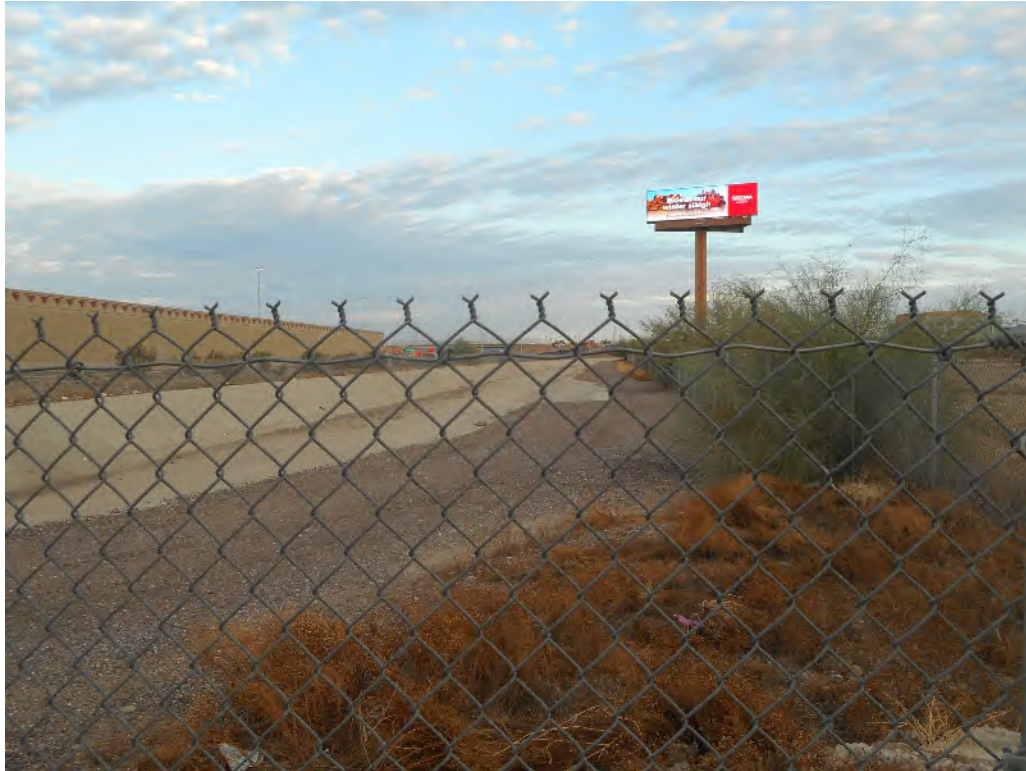
PHOTOGRAPH NO. 23

View from the southwestern portion of the Site, looking northwest, showing the western adjoining stormwater canal and I-17 Highway

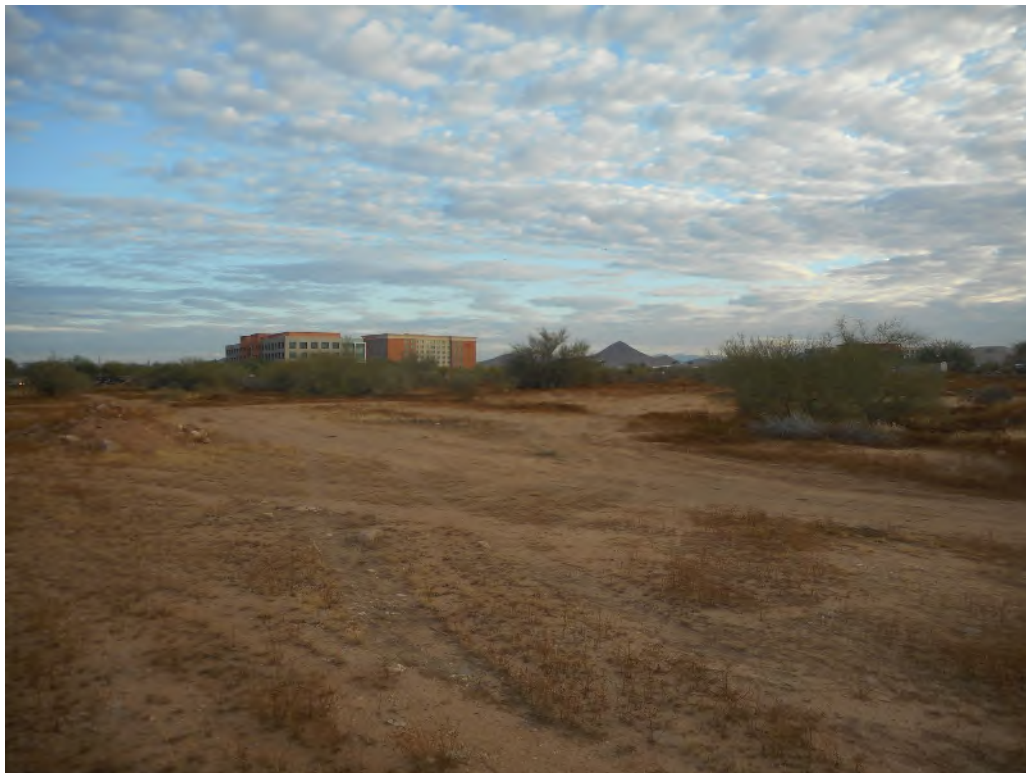
PHOTOGRAPH NO. 24

View from the northwestern portion of the Site, looking northeast, showing the northern adjoining vacant, undeveloped land followed by commercial buildings

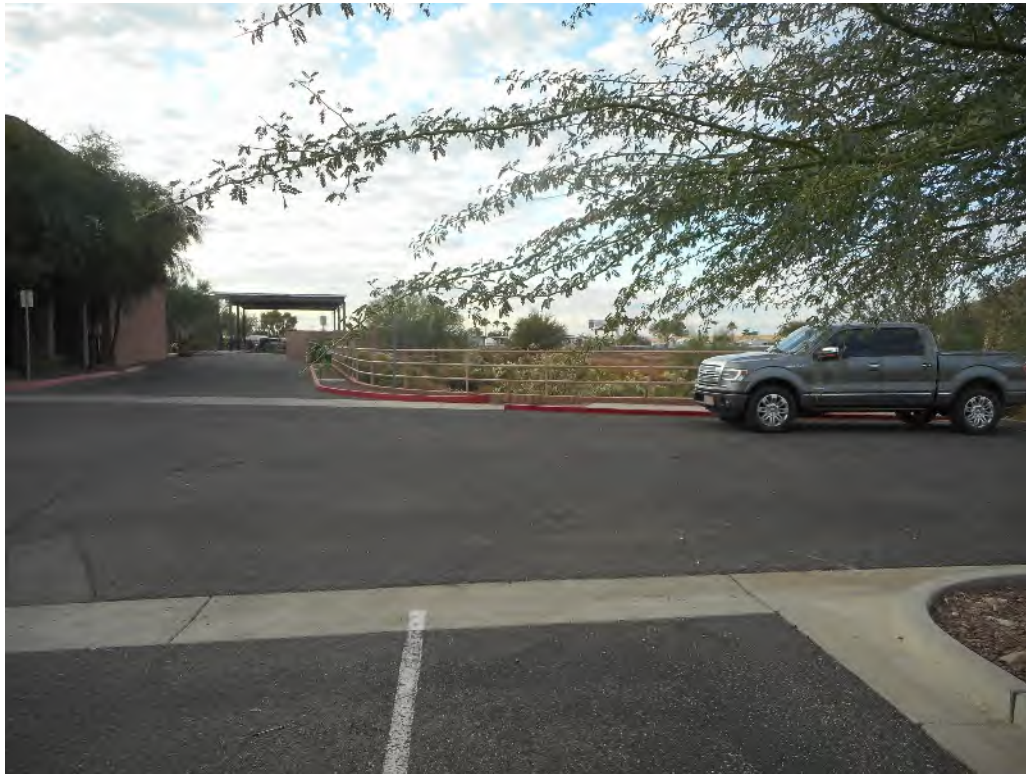
PHOTOGRAPH NO. 25
View from the northeastern portion of the Site looking southeast, showing the eastern adjoining parking lot
