J. SOLID WASTE MANAGEMENT UNITS

**PHASE I ENVIRONMENTAL
SITE ASSESSMENT
LOT 7 DEER VALLEY COMMERCE
CENTER
2453 WEST PARKSIDE LANE
PHOENIX, ARIZONA
GEO TEK PROJECT No.: 1929-PH**

PHASE I ENVIRONMENTAL SITE ASSESSMENT

LOT 7 DEER VALLEY COMMERCE CENTER
2453 WEST PARKSIDE LANE
PHOENIX, ARIZONA

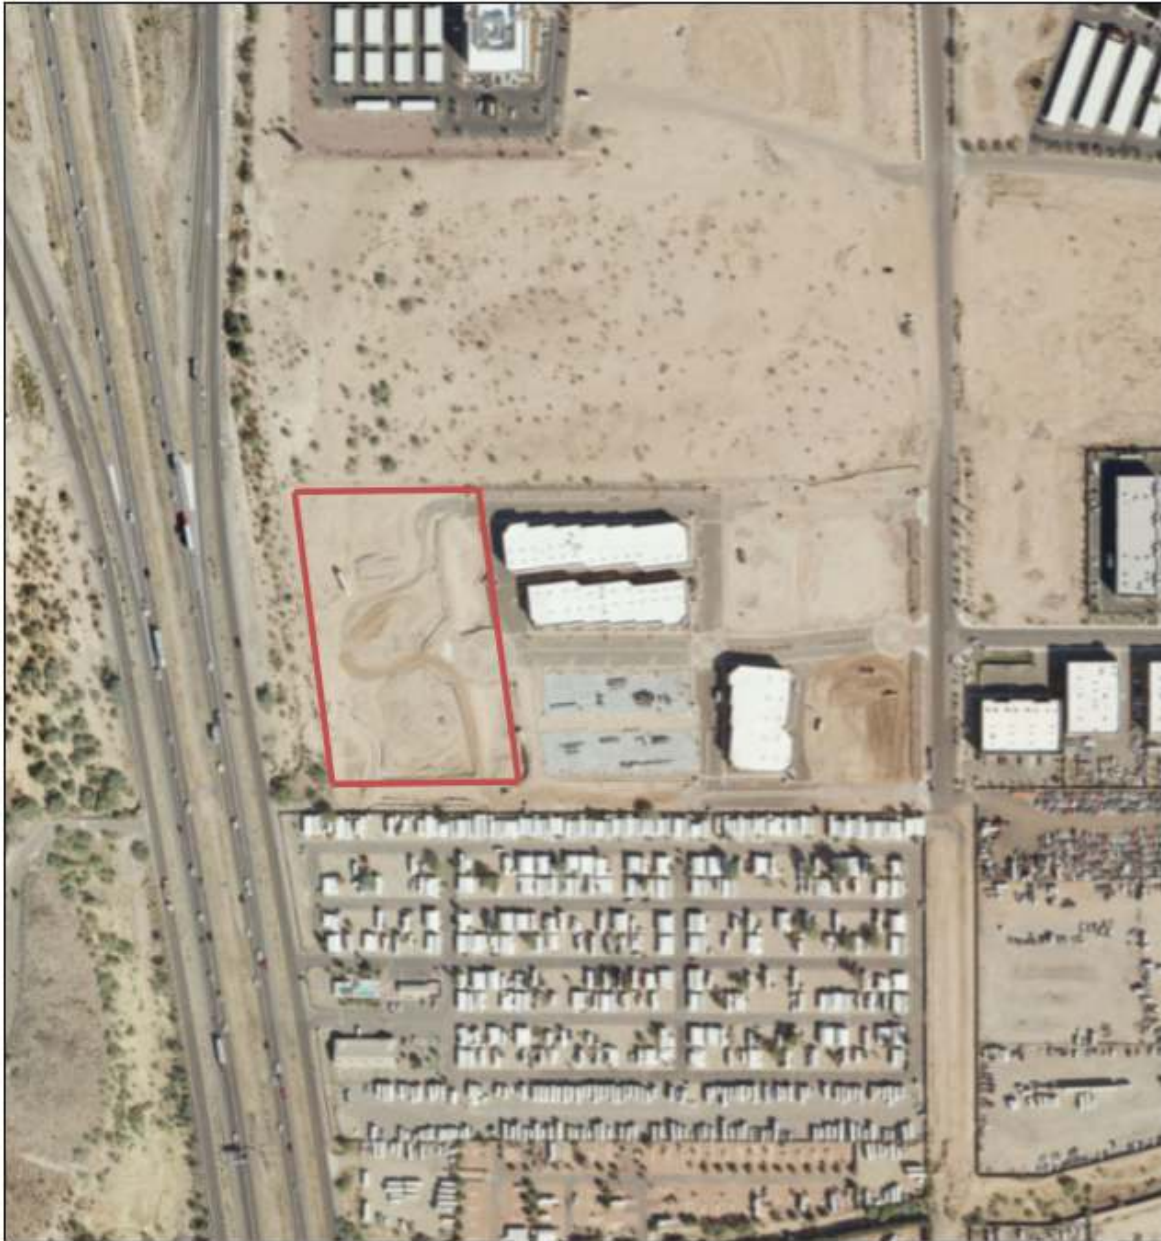
Historical Aerial Photography 2007

2007 Aerial Photograph- Maricopa County Historical Aerials
Site Features: Dirt roads appear to be graded for vehicle access. Gravel piles appear near the center of the Site.
Adjoining Property Features: North: Vacant, undeveloped land with native vegetation followed by a commercial building construction site. South: There were no apparent changes from the 1986 aerial photograph. East: Commercial buildings east of the Site are under construction. West: There were no apparent changes from the 2001 aerial photograph.
2008 and 2009 Aerial Photographs- Maricopa County Historical Aerials
Site Features: Vehicles and a trailer were located on the Site, probably associated with the construction of the adjoining concrete-lined stormwater canal. Concrete spillways are built on northeast, southeast, and southwest corner retention basins. Fencing appears around the corner retention basins.
Adjoining Property Features: North: There were no apparent changes from the 2007 aerial photograph. South: There were no apparent changes from the 1986 aerial photograph. East: The commercial building east of the north end of the Site appeared complete with construction continuing on the remaining commercial buildings east of the north and south ends of the Site. West: Concrete-lined stormwater canal east of the Black Canyon followed by I-17. The canal was completed by 2009.
