Air Quality Field Inspection Report

Company Name: Energy Fuels Resources (USA) Inc.	Inspection Report No.: 449060	
Place Name: Pinyon Plain Mine Place ID No.: 827	Inspector(s): Rob Verville, Len Drago, Lauren Hildebrand	
County: Coconino	Arrival Date and Time: 6/11/2024 7:40 AM	
Physical Location: Hwy 64 to FR 305, Tusayan, AZ 86023	Reason for Inspection: <input type="checkbox"/> Complaint Complaint No.: <input checked="" type="checkbox"/> Full Inspection <input type="checkbox"/> Partial Inspection <input type="checkbox"/> Follow-Up Original Inspection Report No.:	
Mailing Address: Lakewood, CO		
Coordinates (for new locations): Latitude: Longitude:		
Permit No.: 88788 Permit Expiration Date: 10/19/2026	Was Inspection Announced? <input checked="" type="checkbox"/> Yes <input type="checkbox"/> No	
Onsite Contact Person(s)/Title(s)/Number(s): Mathew Germansen, Assistant Mine Superintendent	Operational Status: In Development	
	Type of Source: Class II, Underground Uranium Mine

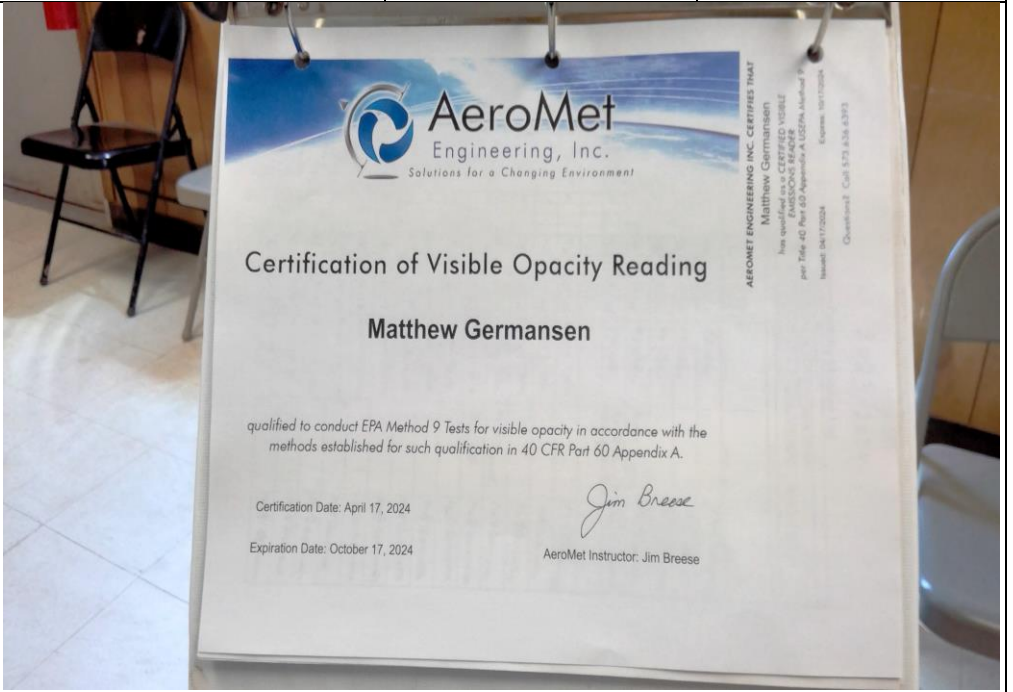
Photo No. 1	Date: 6/11/2024		
Direction Photo Taken: South			
Photo Description: Mathew Germansen Method 9 field certification. Expiration date: October 17, 2024.

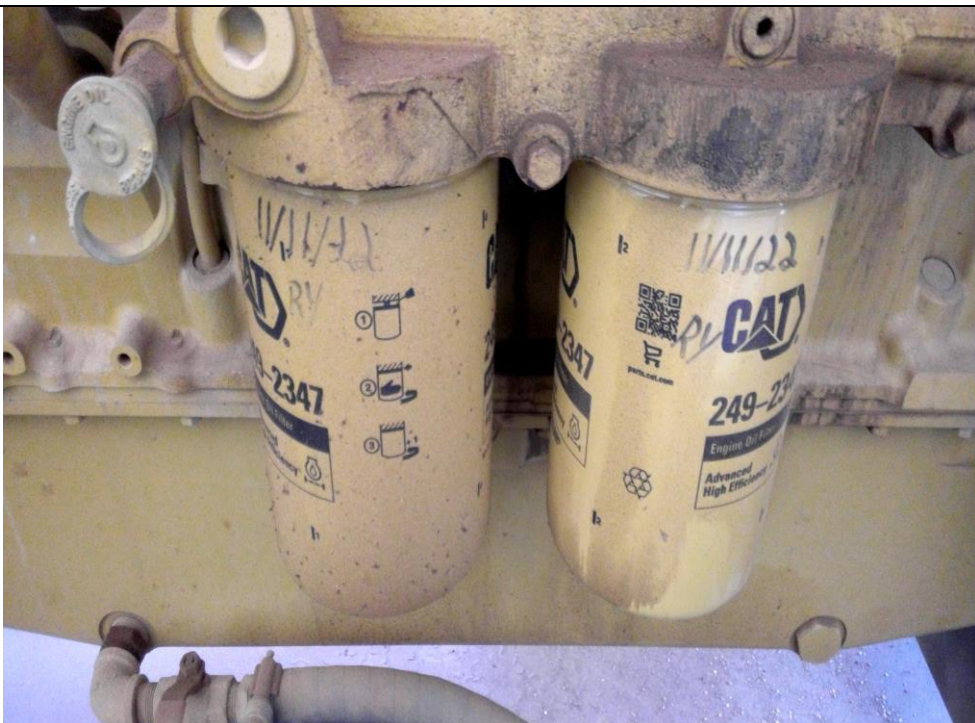
Photo No. 5	Date: 6/11/2024

Direction Photo Taken: North		
Photo Description: Oil filter change date on generator engine. Date: 11/16/22 The facility is using oil analysis to defer oil changes.

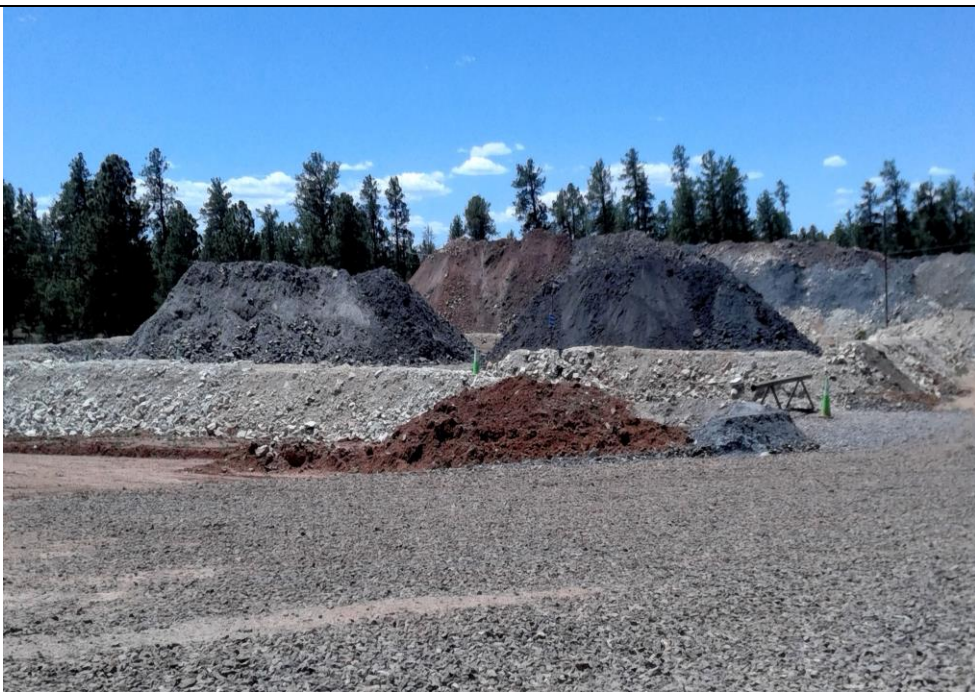
Photo No. 7	Date: 6/11/2024

Direction Photo Taken: South		
Photo Description: Black/gray material beyond gray berm is uranium ore. 3,750 tons currently on the Ore Pad. Pole on the right has five foot increments to measure pile height. Development and waste rock in background.

Mr. Germansen stated the Ore Storage Pad currently has approximately 3,750 tons of uranium ore on the pad from development operations and testing (photograph #7). Mr. Germansen stated they have not hauled any uranium ore off site. Mr. Germansen stated, the ore comes from the underground with approximately 15% moisture in the material. Mr. Germansen point out a pole with painted markings at 5-foot increments so they can gauge the height of the ore pile.

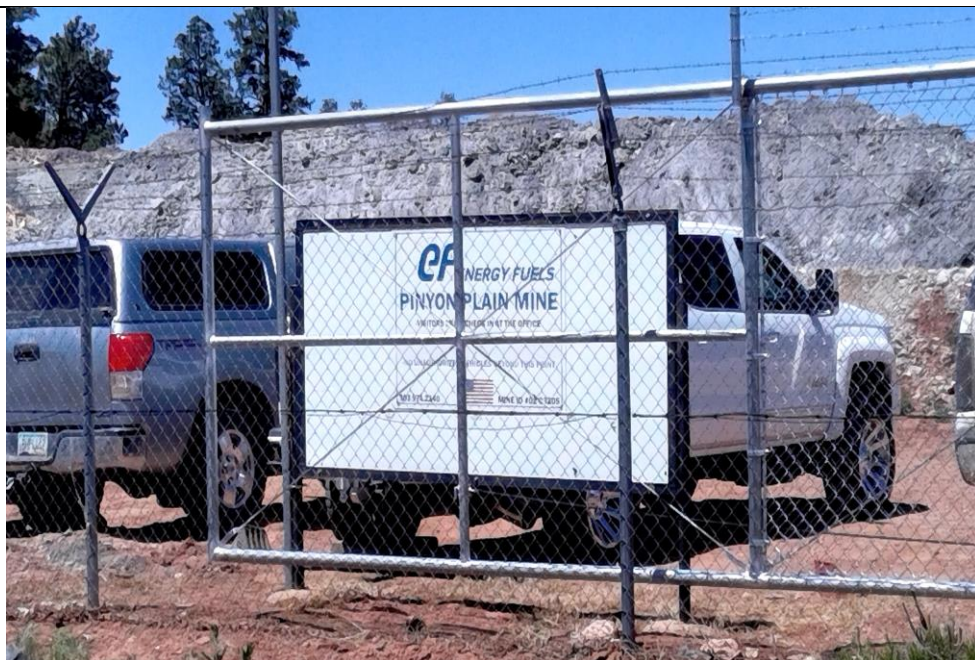
Photo No. 8	Date: 6/11/2024
Direction Photo Taken: Northwest	
Photo Description: Facility sign at entrance.

A photograph showing a white pickup truck parked behind a chain-link fence. The truck has a large white sign on its side that reads "CP ENERGY FUELS" in blue and black text, followed by "PINYON PLAIN MINE" in black. Below this, in smaller text, it says "WEIGH STATION" and "WEIGH HERE TO GET THE OFFICE". There is also a small American flag graphic and the text "MADE IN THE USA". To the left of the white truck, the rear of a silver SUV is visible. The scene is set in a dry, rocky area with a steep, light-colored rock face in the background under a clear blue sky. A metal fence with two horizontal rails runs across the foreground, and a single strand of barbed wire is visible at the top.

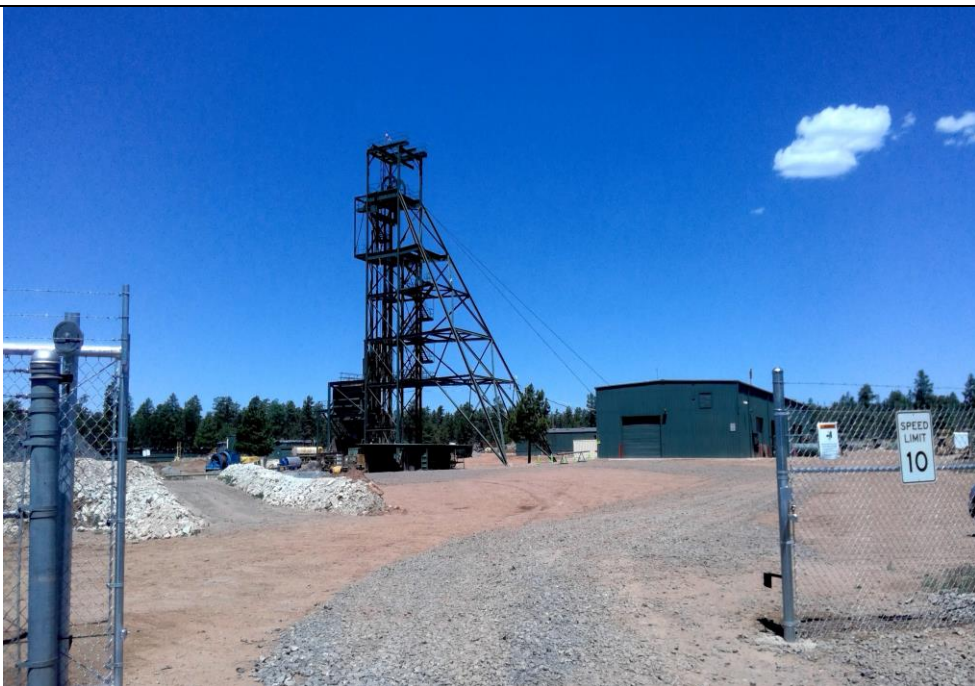
Photo No. 9	Date: 6/11/2024

Direction Photo Taken: North		
Photo Description: Headworks from entrance gate area. Crushed stone on internal roads through site.

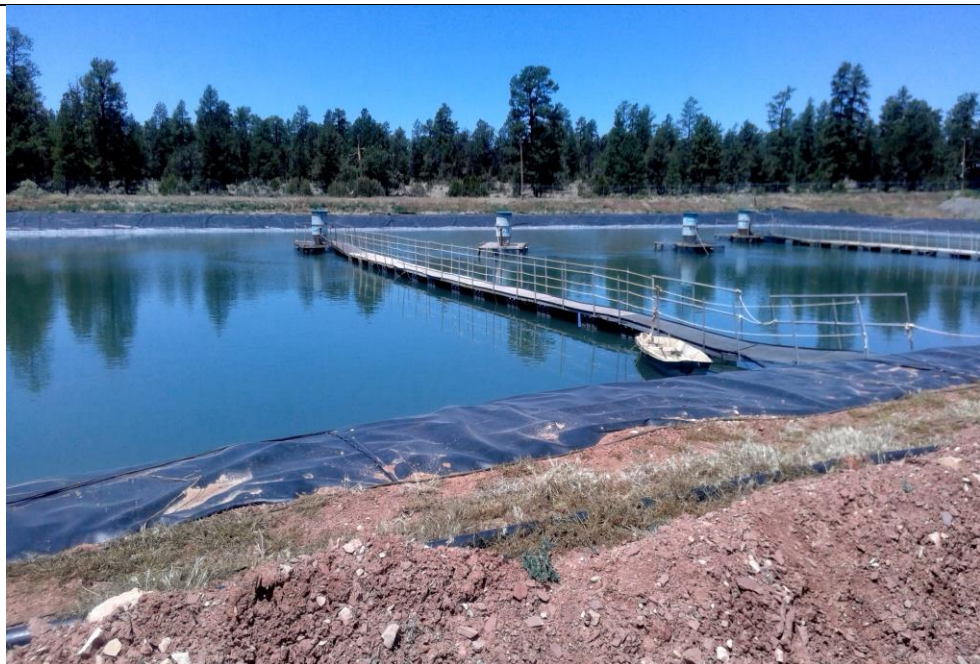
Photo No. 12	Date: 6/11/2024

Direction Photo Taken: Northwest		
Photo Description: Evaporation pond with four APEX down draft evaporators.

The mine continues to pump water from the underground mining area to the non-storm water evaporation pond. The evaporation pond has four APEX down firing evaporators to assist with evaporation. A water mist is visible around the APEX units (photographs #12, #15, #16). No mist was observed migrating outside the perimeter of the pond.

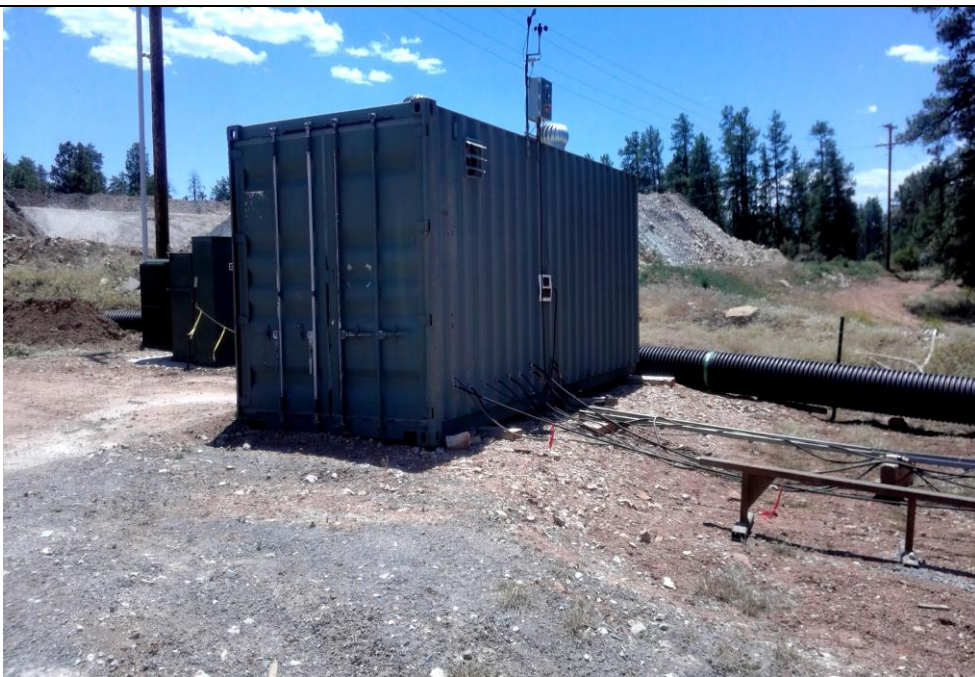
Photo No. 13	Date: 6/11/2024

Direction Photo Taken: South		
Photo Description: Shipping container with electric heaters for APEX evaporators.

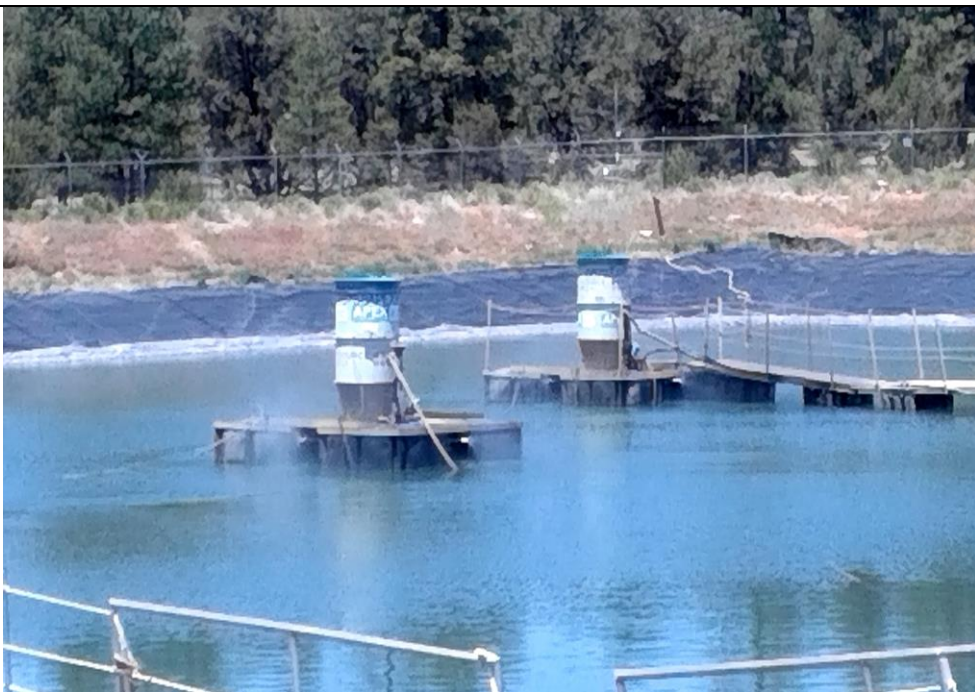
Photo No. 15	Date: 6/11/2024

Direction Photo Taken: Northwest		
Photo Description: The two north down firing evaporators while operating. Visible mist present around the units.

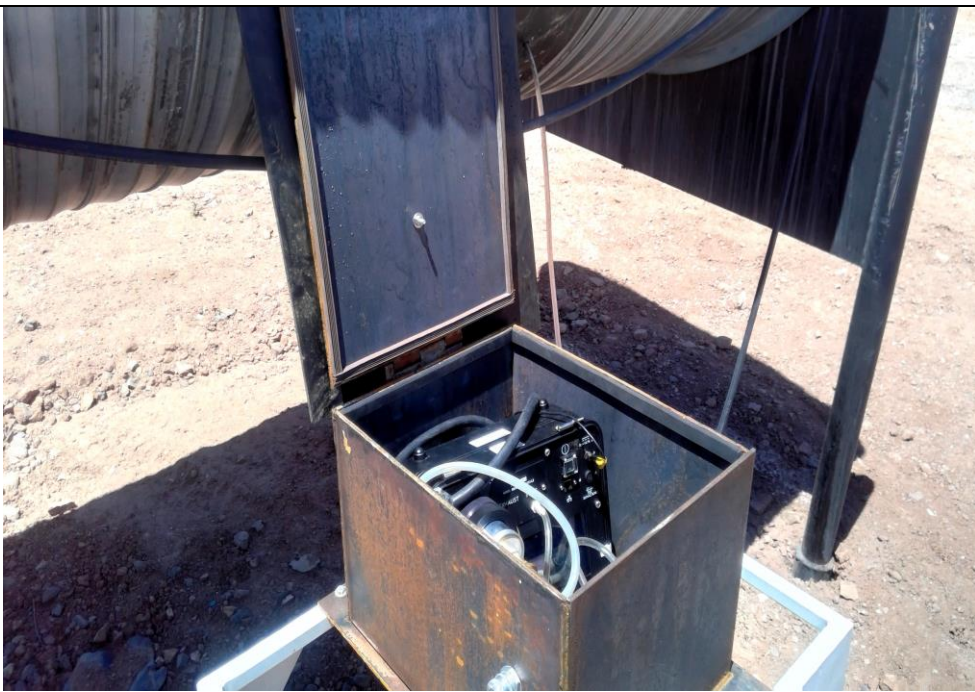
Photo No. 17	Date: 6/11/2024

Direction Photo Taken: Down		
Photo Description: Radon detector at mine vent shaft. Each vent has a unit.

The mine has an emergency escape shaft that also serve as the Mine Vents (photograph #11). Mr. Germansen showed the ADEQ inspectors the Mine Vent shaft radon monitors (photograph #17). Each Mine Vent has a monitor. Mr. Germansen stated they receive a realtime readout.

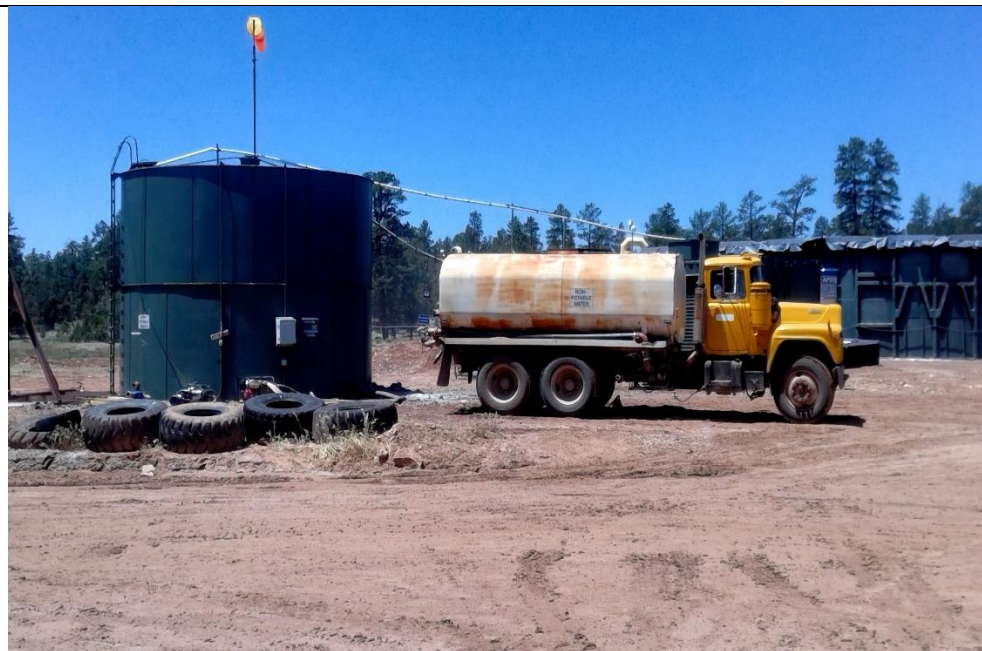
Photo No. 20	Date: 6/11/2024
Direction Photo Taken: West	
Photo Description: Water truck and water tank for dust control.

A photograph showing a yellow water truck with a white tank parked on a dirt surface next to a large green water tank. The truck's tank has "WATER" and "1000 GALLONS" written on it. The green tank has a yellow flag on top. Several old tires are stacked in the foreground. The background shows a line of trees under a clear blue sky.

The Coconino level water is managed separately and pumped to a water treatment system and to two open top holding tanks, one 400,000 gallons and one 1,000,000 gallons (photograph #14). Mr. Germansen stated, the treated water can be used for onsite dust control and area ranches can use the treated water. The site has a water tank and water truck for dust control (photograph #20).

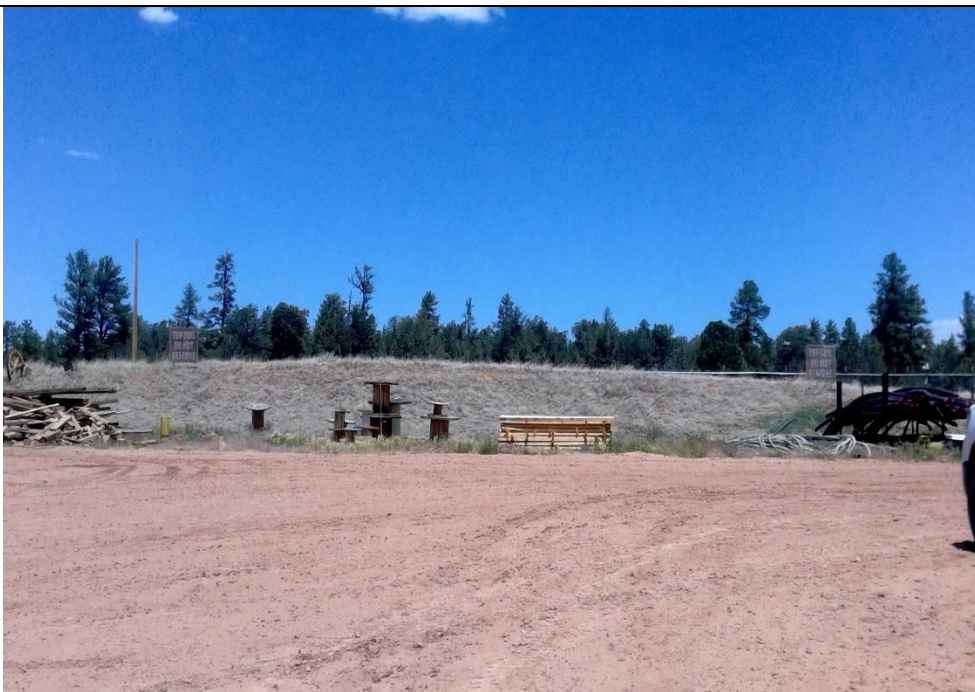
Photo No. 21	Date: 6/11/2024

Direction Photo Taken: North		
Photo Description: Top Soil storage area against north fence. Signs on top of the hill state: "Top Soil Do Not Remove"

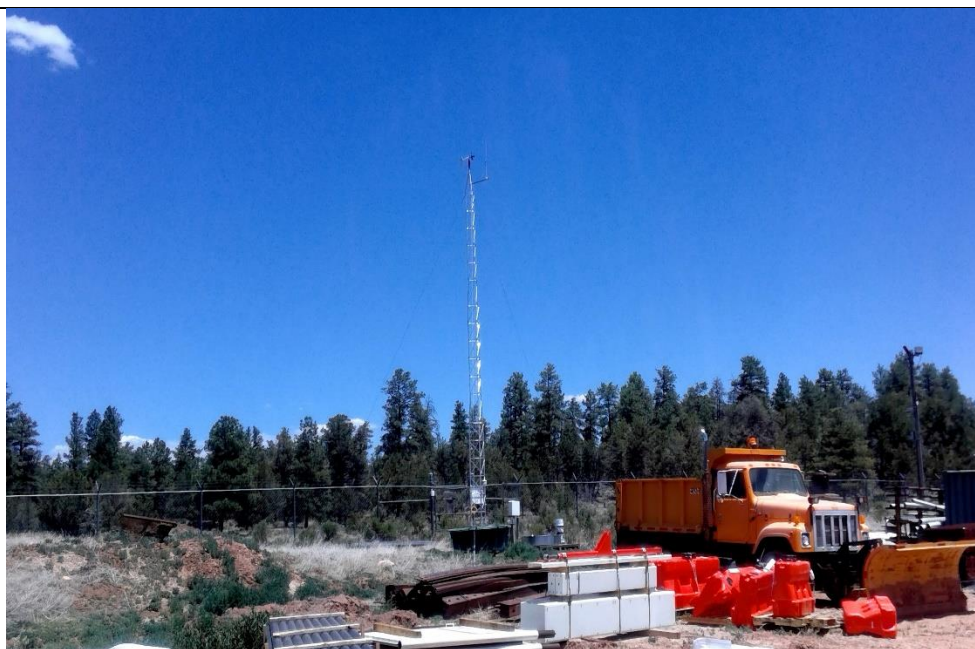
Photo No. 22	Date: 6/11/2024

Direction Photo Taken: Northeast		
Photo Description: Newly installed Met station.

The facility installed a Met station on February 19, 2024 (photograph #22). The facility provided the installation and calibration report for the Met station from the vendor. Mr. Germansen stated the system will notify the operators of a wind event and provide instructions on what actions are required.

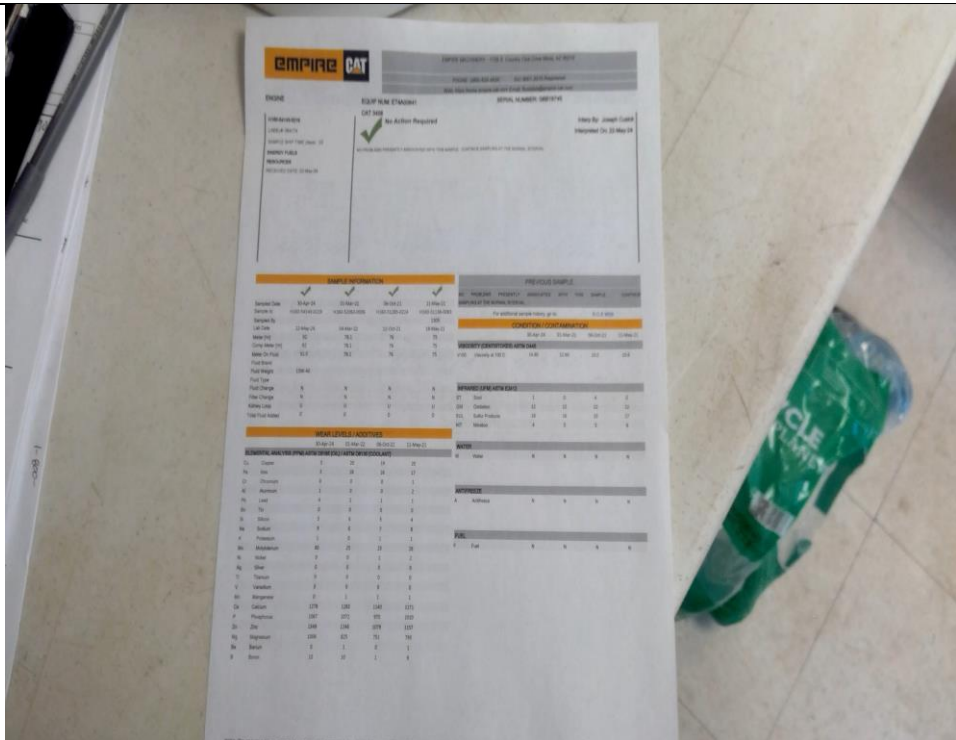
Direction Photo Taken:
Down

Photo Description:
Oil analysis for generator engine. Analysis conducted 22-May-24, 30-Apr-23, 01-Mar-22.
