Hermosa Project – Trench Camp Property

Aquifer Protection Permit SIGNIFICANT Amendment Application

P-512235

Santa Cruz County, Arizona

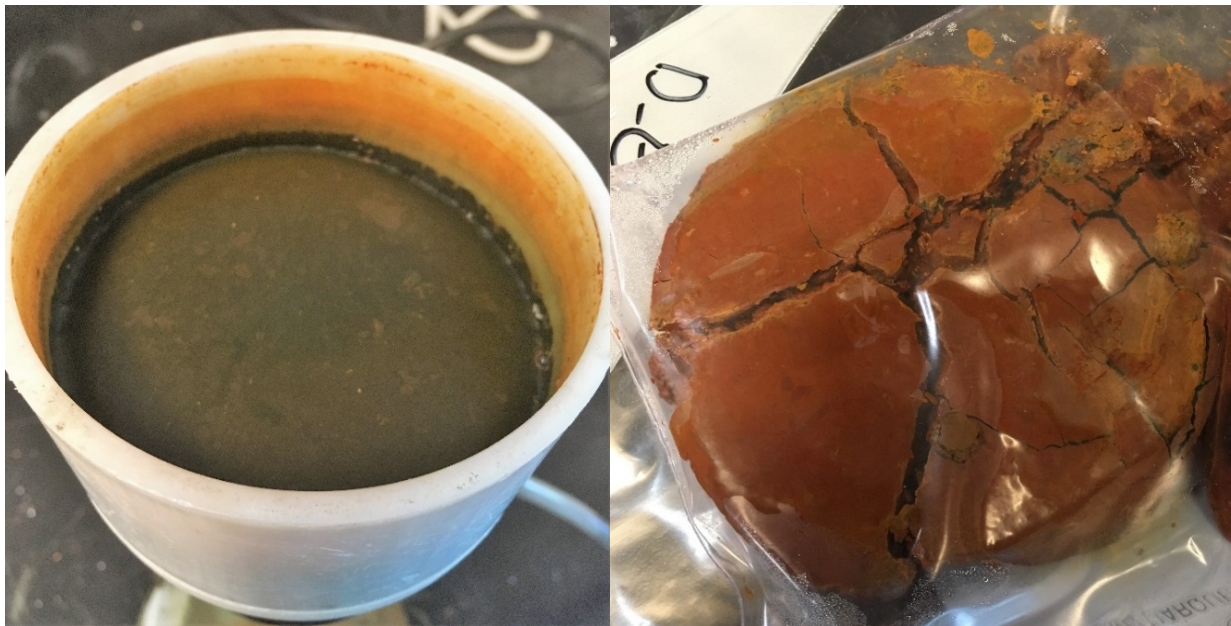
Figure 5-5 Thickened and filtered solid residue samples generated during the ERC tests.

Figure 5-5 shows two pictures of the treatment residue generated by the ERC treatment. The picture on the left shows the thickened solids slurry in the Buckner funnel for filtration after the supernatant solution was decanted. The picture on the right shows the filter cake produced after vacuum filtration of the thickened slurry. Approximately 15 g of wet treatment residue at ~ 70% moisture was generated by the direct ERC treatment for every liter of spent IX regenerant solution that was treated to meet the 0.01 mg/L treatment target. The filter cake generated in this way was sent to the analytical labs for elemental digestion and TCLP tests. Results of these tests are presented and discussed in this section.

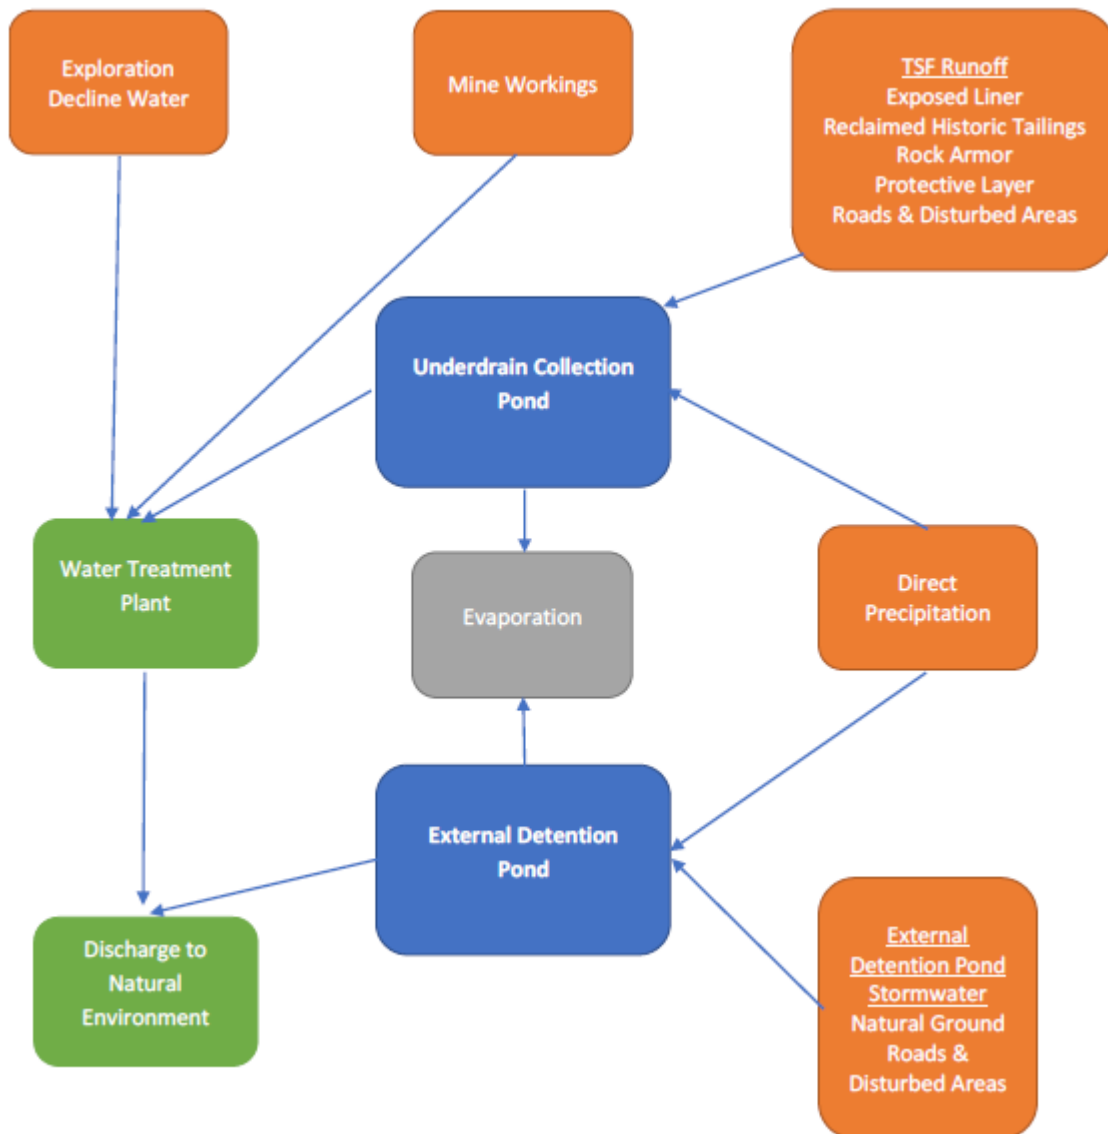
FIGURE 8.1 WATER BALANCE MODEL SCHEMATIC

ERC's analysis utilized historic site precipitation data (2008 – 2019) and the BADCT prescriptive design storm (100-yr/24-hr event) as shown in Appendix H. A flow diagram showing the inputs and outputs is presented in Figure 8.1.

The water balance incorporates water inputs into the TSF system based on the current interim VRP TSF geometry as well as the TSF Amended Design modifications. It is important to note that the TSF, Underdrain Collection Pond, External Detention Pond and upstream watershed areas remain unchanged throughout both scenarios. The only modifications are to the material specific properties within each watershed which occurs during stacking.

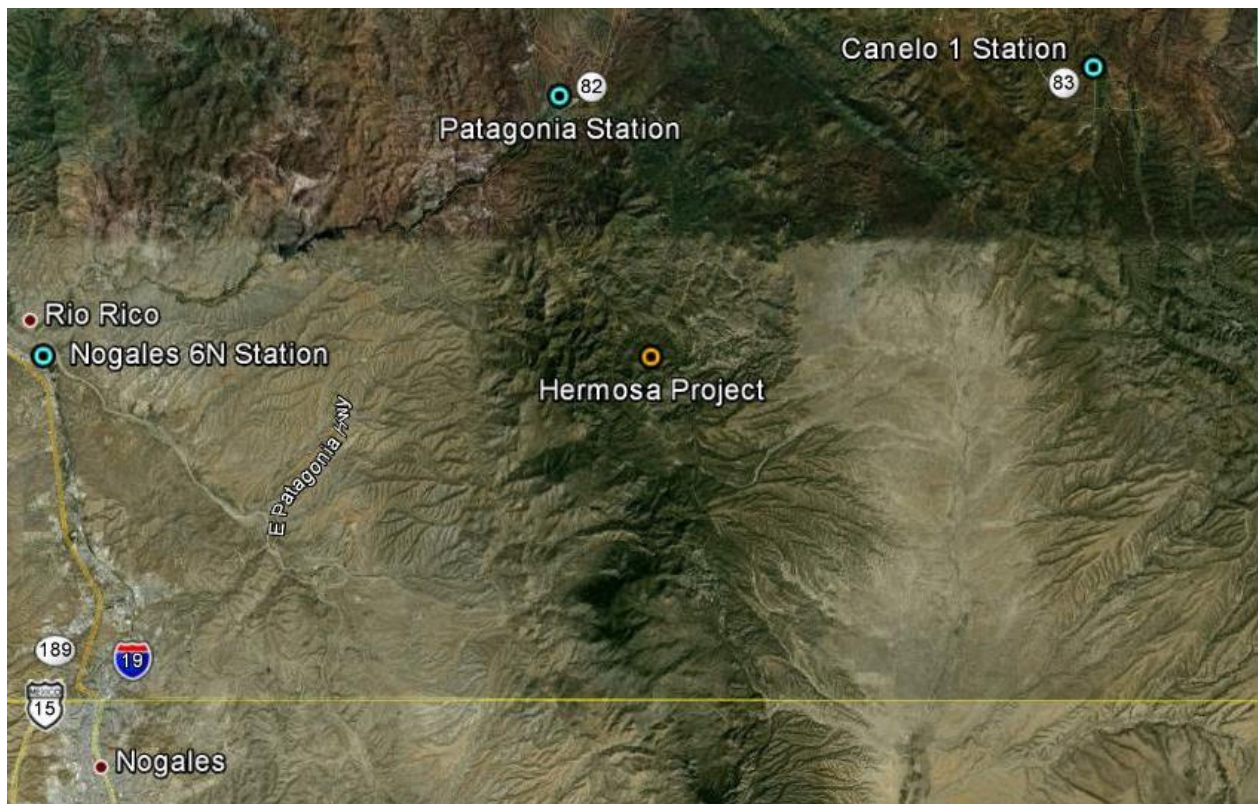
Figure 1 – Station Locations (from Google Earth)

Site	Distance from Mine	Station Elevation (ft)	Precipitation Data Available	Pan Evaporation Data Available
Nogales 6N (ID:25924)	15 miles (W)	3,460	October 1952 - December 2016	1952-2005
Patagonia (ID:26280)	7 miles (NW)	4,189	June 1922 – December 2016	NA
Canelo 1 (ID:21231)	13 miles (NE)	5,009	January 1910 - December 2012	NA
Site Station	NA	5,436	Oct 2007 – Dec 2016	2015

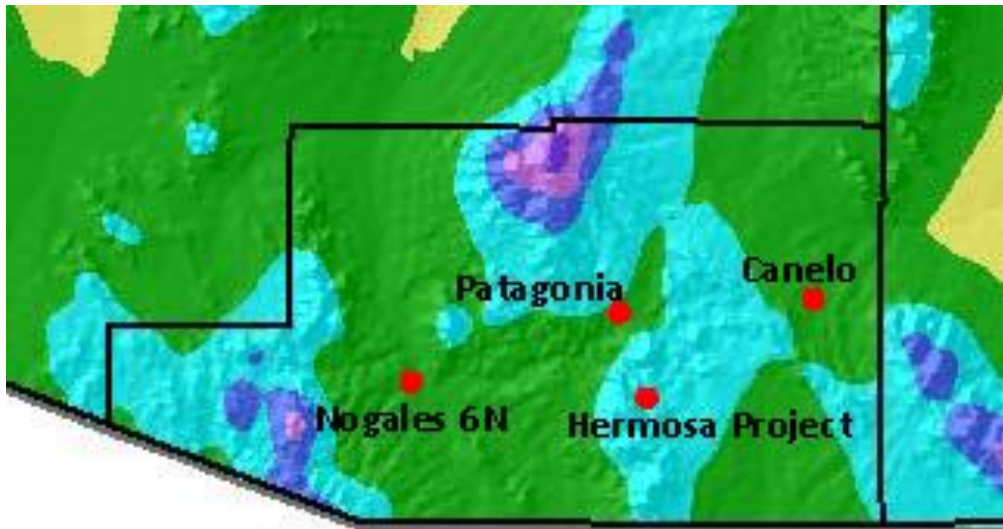
Figure 2 – Estimates of Annual Precipitation (from PRISM)
**Average Annual Precipitation, 1971-2000
Arizona**

The final step for verifying estimates of site precipitation data was the review of annual estimates from other sources. A precipitation map for Arizona based on average annual precipitation from a period of 1971-2000 was created using the Parameter-elevation Regressions on Independent Slope Model (PRISM) developed by Utah State University. PRISM utilizes observed precipitation values, elevation, orographic effects and aspect to estimate precipitation at unknown site. The PRISM model for Arizona was obtained and expanded in the region of the site to show computer model estimates of long-term average annual precipitation. **Figure 2** shows PRISM results for the State and the mine area including the regional precipitation sites used in our analysis. PRISM results generally confirm conclusions based on the raw data and show that the site is expected to receive more precipitation than any of the regional sites. Effects of elevation on precipitation can be clearly seen from this map. While not matching the exact values recorded at the different stations, PRISM results support the overall estimates above.

The PRISM map suggests that average annual precipitation at Nogales 6N is between 15" and 18" (ERC's estimate from data is about 17"), annual precipitation at Patagonia is between 18" and 19" (ERC's estimate from data is about 18") and precipitation at the site is between 20" and 25" (ERC's estimate is about 25"). The PRISM data generally fits with ERC's estimates, therefore ERC's estimate including a 15% increase over values recorded at site from late 2007 – 2016 appear to be reasonable. We suggest that the

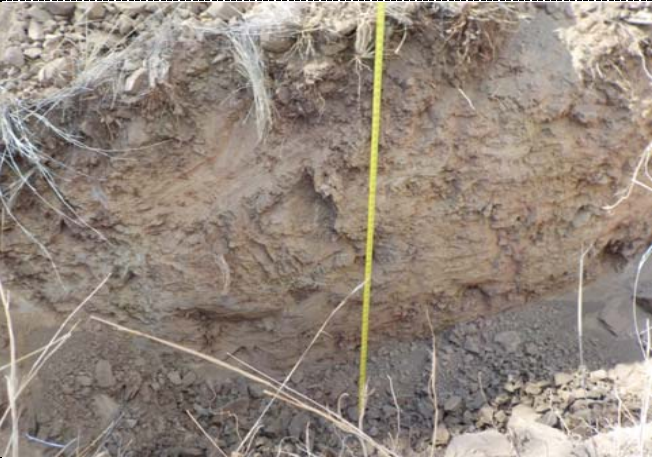
2.0 clayey SAND (SC) with gravel, fine to coarse grained, subangular, MPS=5in., medium plastic fines, dry, light brown.	Roots to 12in. %G=19, %S=62, %F=19 PL=19, LL=30, PI=11 ω%=6.4
5.0			6.0 Bedrock- Andesite, highly weathered, weak, highly fractured, MPS=12in., slight plasticity, light brown.	
7.5				
10.0				
12.5				
15.0				
17.5				
20.0

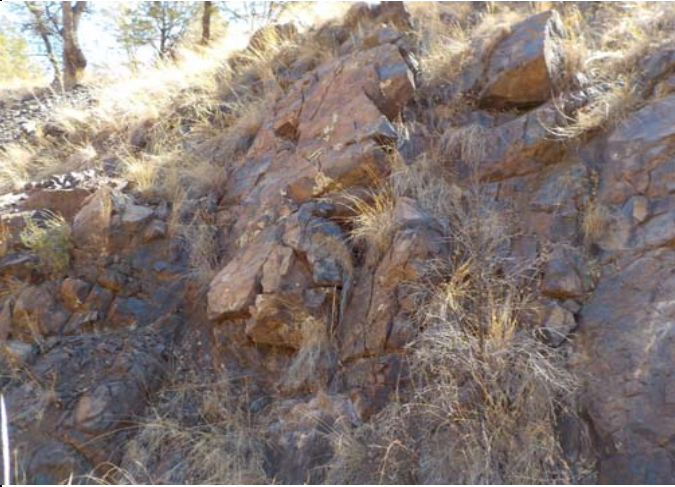
Bedrock- Andesite, slightly weathered, highly fractured, fracture spacing 2-12in., medium strong to strong, maroon to gray	Roots to 12in. LA Abrasion - 26% Loss
5.0				
7.5				
10.0				
12.5				
15.0				
17.5				
20.0

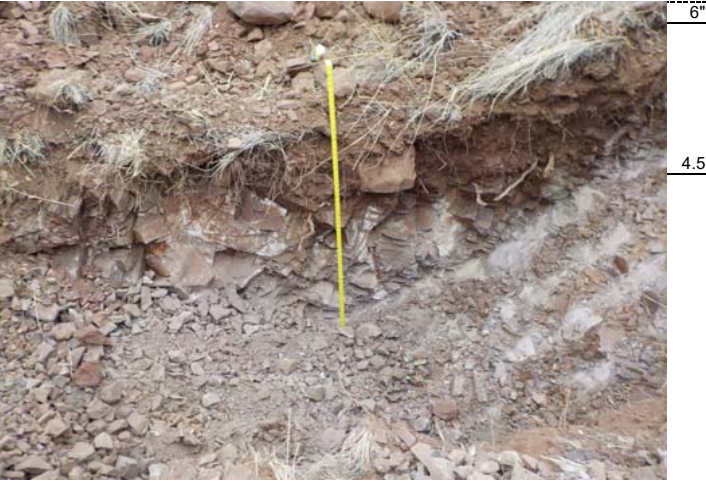
6" silty SAND with organics (topsoil)	Roots to 12in.
			Bedrock- Andesite, slightly weathered, strong, highly fractured, oxidized fracture surfaces, MPS=10in., maroon	
5.0			4.5	
7.5			TD = 4.5ft, refusal on bedrock Water table not encountered at time of excavation.	
10.0				
12.5				
15.0				
17.5				
20.0

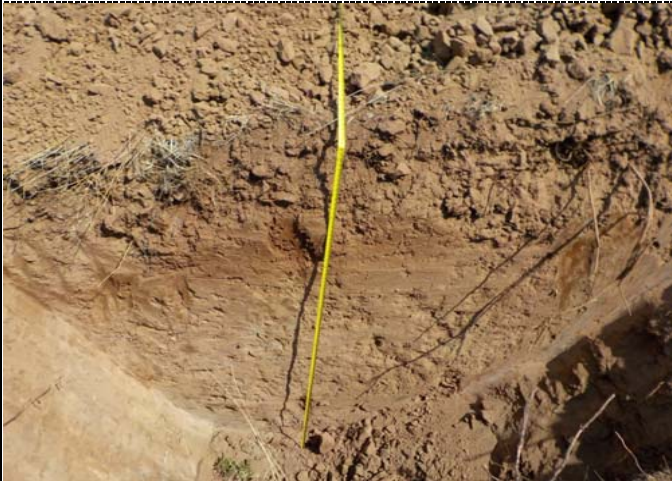
clayey SAND (SC) some gravel, MPS=5in., medium plasticity, dry, reddish brown	Roots at 12in.
5.0				%G=9, %S=48, %F=43 PL=21, LL=45, PI=24
7.5			Bedrock- Andesite, highly weathered, weak, highly fractured, MPS=6in., maroon	
10.0			8.3 TD = 8.3ft, refusal on bedrock Water table not encountered at time of excavation.	
12.5				
15.0				
17.5				
20.0

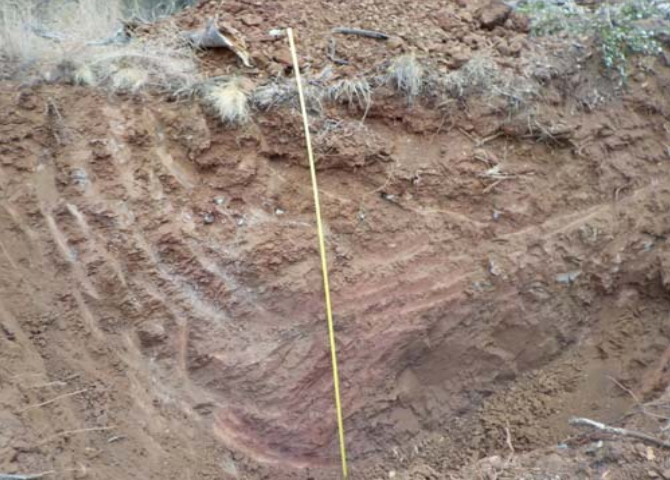
clayey GRAVEL (GC) with sand, occasional cobbles MPS=7in., low to medium plastic fines, weak friable clasts, slightly moist (Residual bedrock)	%G=46, %S=39, %F=15 PL=14, LL=39, PI=25
5.0				
6.5			Bedrock Andesite, highly weathered, weak, highly fractured, friable clasts, MPS=10in.	
7.5				
10.0			TD = 10.0ft, Refusal on bedrock Water table not encountered at time of excavation.	
10.0				
12.5				
15.0				
17.5				
20.0

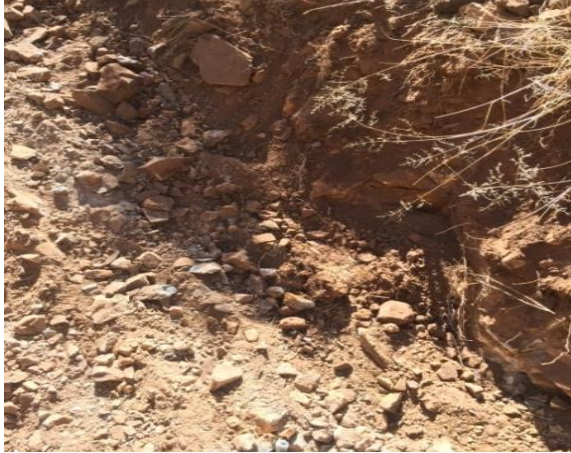
Pit ID: **TP-01**

Growth Media	
1.0				
2.0	LD 14-31in.		14"	Poorly graded GRAVEL with silt and sand (GP-GM), angular, NP, fine to coarse grained, brown, dry
3.0		31"	Water table not encountered at time of excavation. TD = 31". Refusal due to Bedrock.

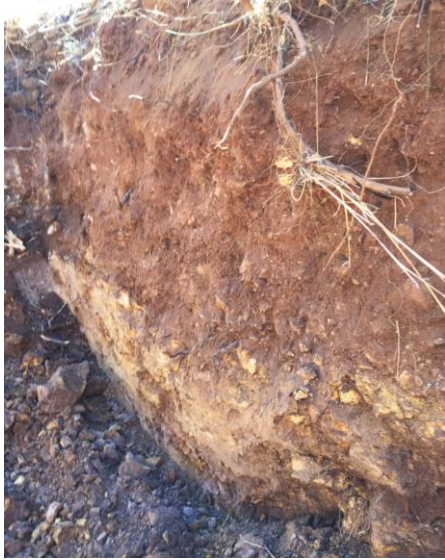
Growth Media		
1.0					
2.0					
3.0	LD @ 18-44in.		18"	Well graded GRAVEL with silt and sand (GW-GM), fine to coarse grained, angular, medium plastic, brown, dry	PL = 29 PI = 14
4.0		44"	Water table not encountered at time of excavation. TD = 44". Refusal due to Bedrock.

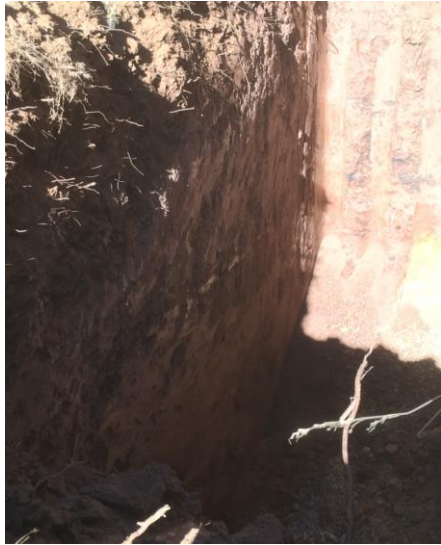
Growth Media	
2.0	LD @ 22-69 in.		Clayey SAND(SC) subangular to angular, medium plasticity, tan, dry	PL = 22 PI = 16
6.0			Clayey SAND with gravel (SC) subangular to angular, medium plasticity, yellowish-white, moist	PL = 22 PI = 15
8.0	SD @ 69-120 in.			
10.0			Water table not encountered at time of excavation. TD = 120". Limits of Excavator.

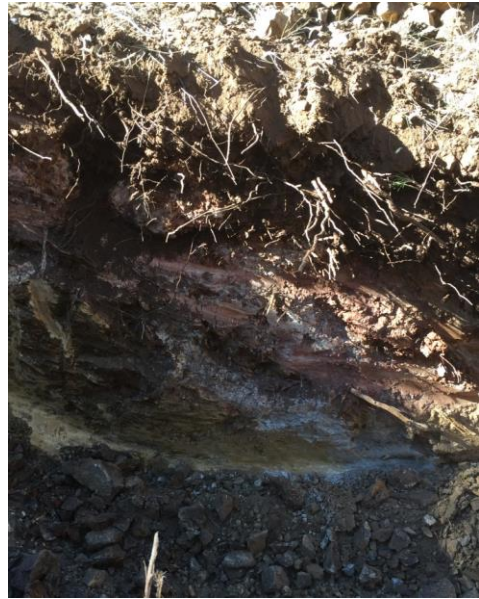
Project:	Arizona Minerals Inc.; Tailings and Potentially Acid Generating (PAG) Material Remediation, Placment and Storage; Infrastructure Pad		Pit ID:	TP-04
Project Location:	Santa Cruz, AZ		Project #:	475.0014.011
Equipment:	CAT 180G LC Excavator	Contractor:	Date:	1/29/2018
Lat/Long (N/E):	N:170,330; E:1,069,843	Elevation:	Logged by:	JRK
Shoring (if used):		Surface Conditions:	Total Pit Depth:	47"
			Backfilled:	Yes

Growth Media		
1.0					
2.0	SD @ 16-24 in.		16"	Clayey SAND (SC), subangular to angular, medium plasticity, reddish-brown, moist	PL = 20 PI = 13
3.0	LD @ 16-47 in.			Poorly graded GRAVEL with clay and sand (GP-GC), subangular to angular, high plasticity, brown, moist	PL = 25 PI = 20
4.0	SD @ 40-47 in.		47"	Silty SAND (SM), subrounded to subangular, medium plasticity, white, moist	PL = 28 PI = 17
5.0			Water table not encountered at time of excavation. TD = 47". Refusal due to Bedrock.

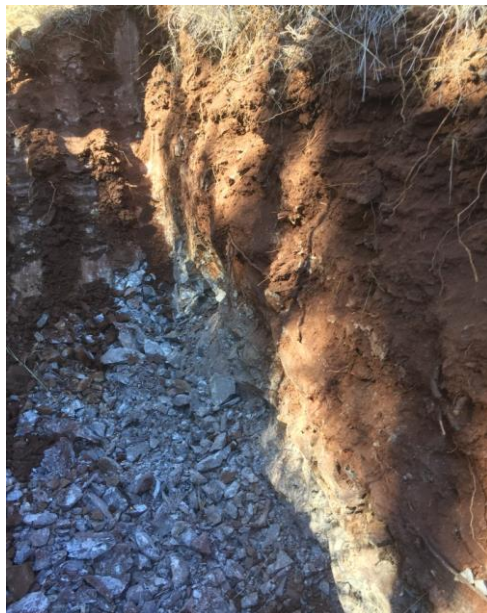
Project:	Arizona Minerals Inc.; Tailings and Potentially Acid Generating (PAG) Material Remediation, Placment and Storage; Infrastructure Pad	Project #:	Pit ID: TP-05
Project Location:	Santa Cruz, AZ	Date:	475.0014.011 1/29/2018
Equipment:	CAT 180G LC Excavator	Contractor:	DM Engineering & Excavating
Lat/Long (N/E):	N:170,265; E:1,069,758	Elevation:	5168'
Shoring (if used):		Surface Conditions:	Existing Ground
		Total Pit Depth:	49"
		Backfilled:	Yes

Growth Media		
1.0					
1.8			18"		
2.0	LD @ 18-36 in.		36"	Clayey GRAVEL with sand (GC), angular, high plasticity, brown, dry	PL = 23 PI = 23 Max. Dry Density = 128.0 pcf Optimum Moisture = 8.6% per ASTM D 1557 Method C
3.0			49"	Poorly graded GRAVEL with clay and sand (GP-GC), angular, high plasticity, brown, dry	PL = 22 PI = 19
4.0	LD @ 36-49 in.				
5.0			Water table not encountered at time of excavation. TD = 49". Refusal due to Bedrock.

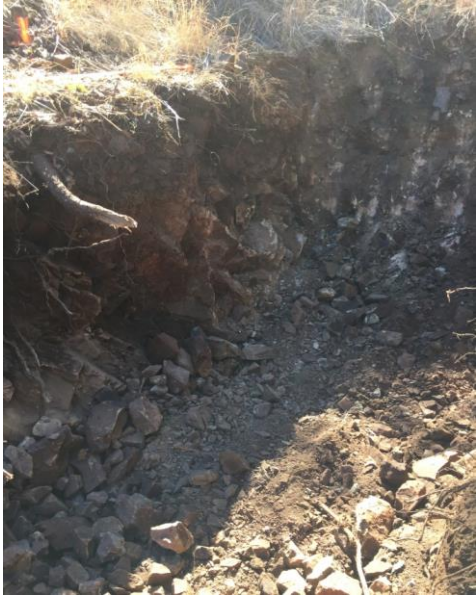
Project:	Arizona Minerals Inc., Tailings and Potentially Acid Generating (PAG) Material Remediation, Placment and Storage; Infrastructure Pad	Project #:	Pit ID: TP-06
Project Location:	Santa Cruz, AZ	Date:	475.0014.011 1/29/2018
Equipment:	CAT 180G LC Excavator	Contractor:	DM Engineering & Excavating
Lat/Long (N/E):	N:170,181; E:1,069,845	Elevation:	5165'
Shoring (if used):		Surface Conditions:	Existing Ground
		Total Pit Depth:	46"
		Backfilled:	Yes

Growth Media		
1.0					
2.0					
3.0	LD @ 15-46 in.			Clayey GRAVEL with sand (GC), subrounded-subangular, medium plasticity, brown, dry	PL = 23 PI = 15
4.0					
5.0					
			Water table not encountered at time of excavation. TD = 46". Refusal due to Bedrock.

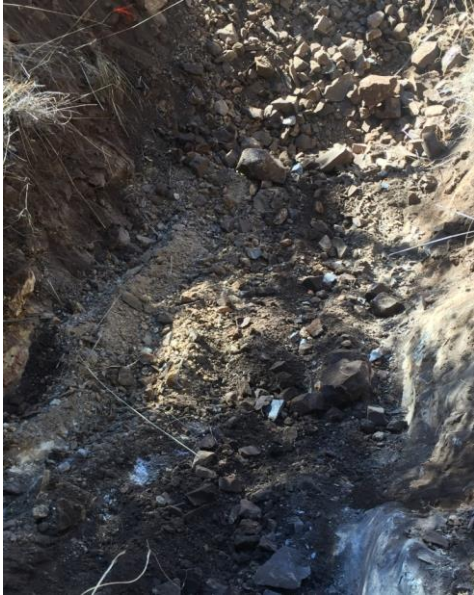
Project:	Arizona Minerals Inc., Tailings and Potentially Acid Generating (PAG) Material Remediation, Placment and Storage; Infrastructure Pad	Project #:	Pit ID: TP-07
Project Location:	Santa Cruz, AZ	Date:	475.0014.011 1/29/2018
Equipment:	CAT 180G LC Excavator	Contractor:	JRK
Lat/Long (N/E):	N:170,563; E:1,069,908	Elevation:	30"
Shoring (if used):		Surface Conditions:	Existing Ground
		Backfilled:	Yes

Growth Media		
1.0					
2.0			16"	Poorly graded GRAVEL with silt and sand (GP-GM), angular, NP, fine to coarse grained, brown, dry	
3.0			30"	Water table not encountered at time of excavation. TD = 30". Refusal due to Bedrock.	
4.0					
5.0

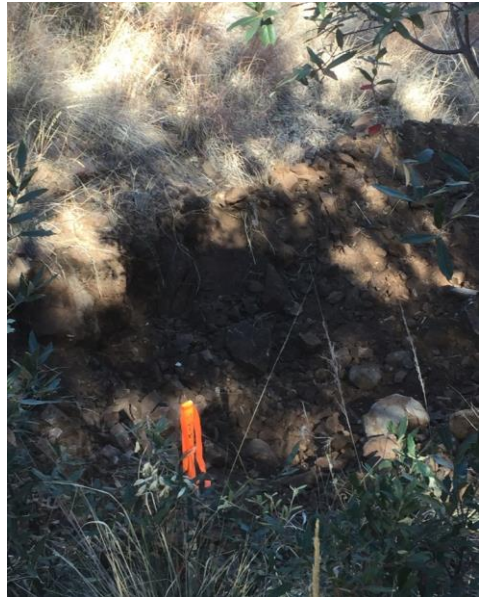
Project:	Arizona Minerals Inc.; Tailings and Potentially Acid Generating (PAG) Material Remediation, Placment and Storage; Infrastructure Pad	Project #:	Pit ID: TP-08
Project Location:	Santa Cruz, AZ	Date:	475.0014.011 1/29/2018
Equipment:	CAT 180G LC Excavator	Contractor:	DM Engineering & Excavating
Lat/Long (N/E):	N:170,505; E:1,069,649	Elevation:	5161'
Shoring (if used):		Surface Conditions:	Existing Ground
		Logged by:	JRK
		Total Pit Depth:	49"
		Backfilled:	Yes

Growth Media		
1.0					
2.0					
3.0	LD @ 16-49 in.			Clayey GRAVEL with sand (GC), subrounded to subangular, medium plasticity, brown, dry	PL = 24 PI = 17
4.0					
5.0			Water table not encountered at time of excavation. TD = 49". Refusal due to Bedrock.

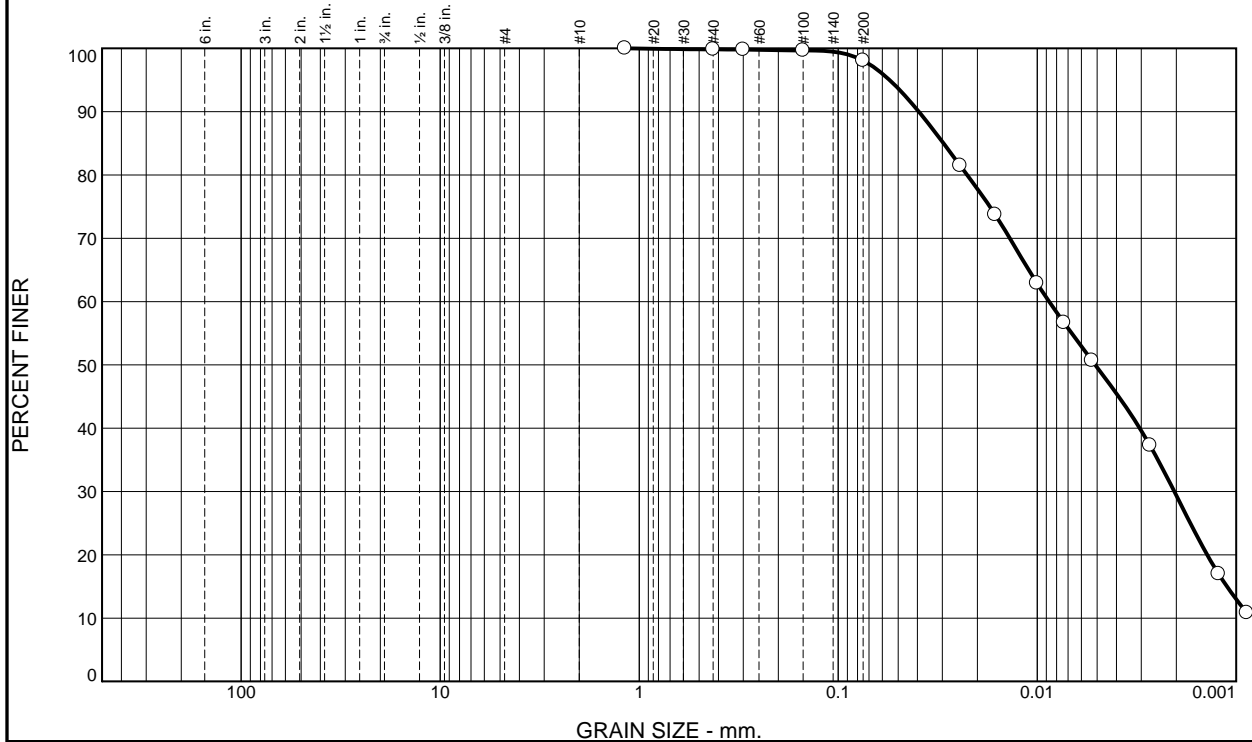
Particle Size Distribution Report

% +3"	% Gravel		% Sand			% Fines	
	Coarse	Fine	Coarse	Medium	Fine	Silt	Clay
0.0	0.0	0.0	0.0	0.2	1.7	68.7	29.4

SIEVE SIZE	PERCENT FINER	SPEC.* PERCENT	PASS? (X=NO)
#16	100.0		
#40	99.8		
#50	99.8		
#100	99.7		
#200	98.1

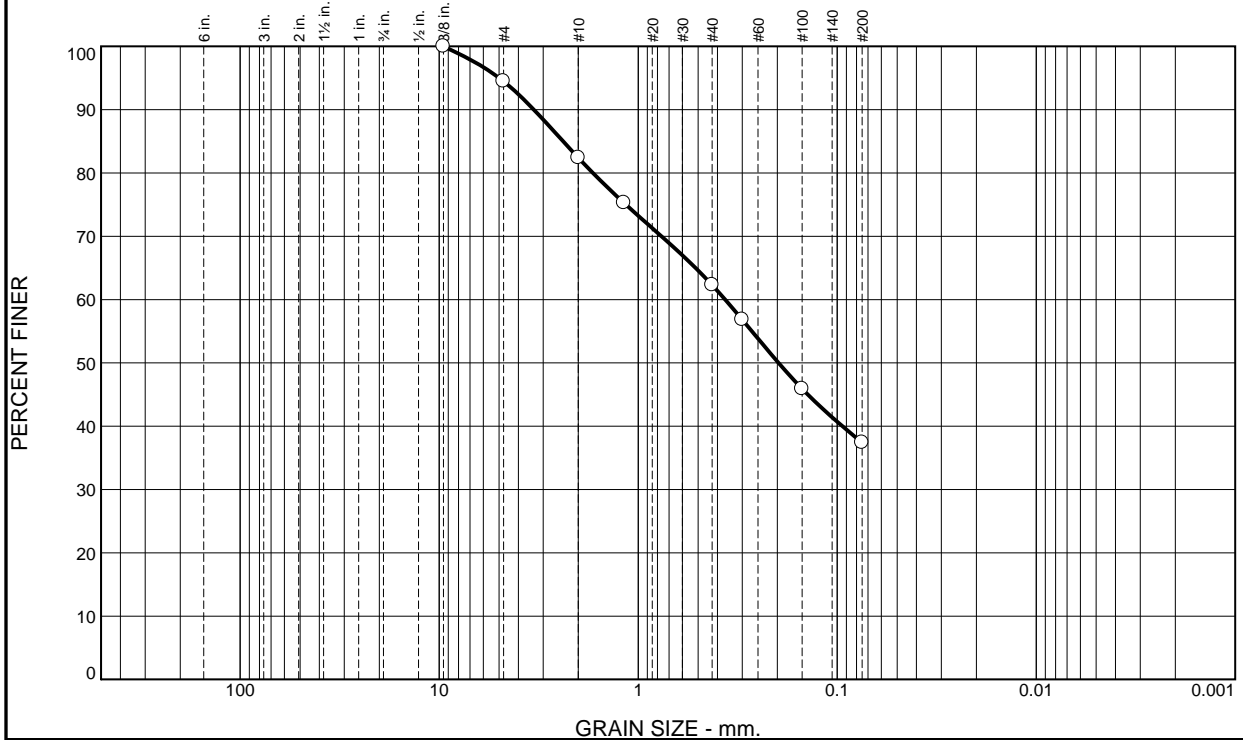
Particle Size Distribution Report

% +3"	% Gravel		% Sand			% Fines	
	Coarse	Fine	Coarse	Medium	Fine	Silt	Clay
0.0	0.0	5.5	12.1	20.1	24.9	37.4

SIEVE SIZE	PERCENT FINER	SPEC.* PERCENT	PASS? (X=NO)
.375"	100.0		
#4	94.5		
#10	82.4		
#16	75.3		
#40	62.3		
#50	56.8		
#100	45.9		
#200	37.4

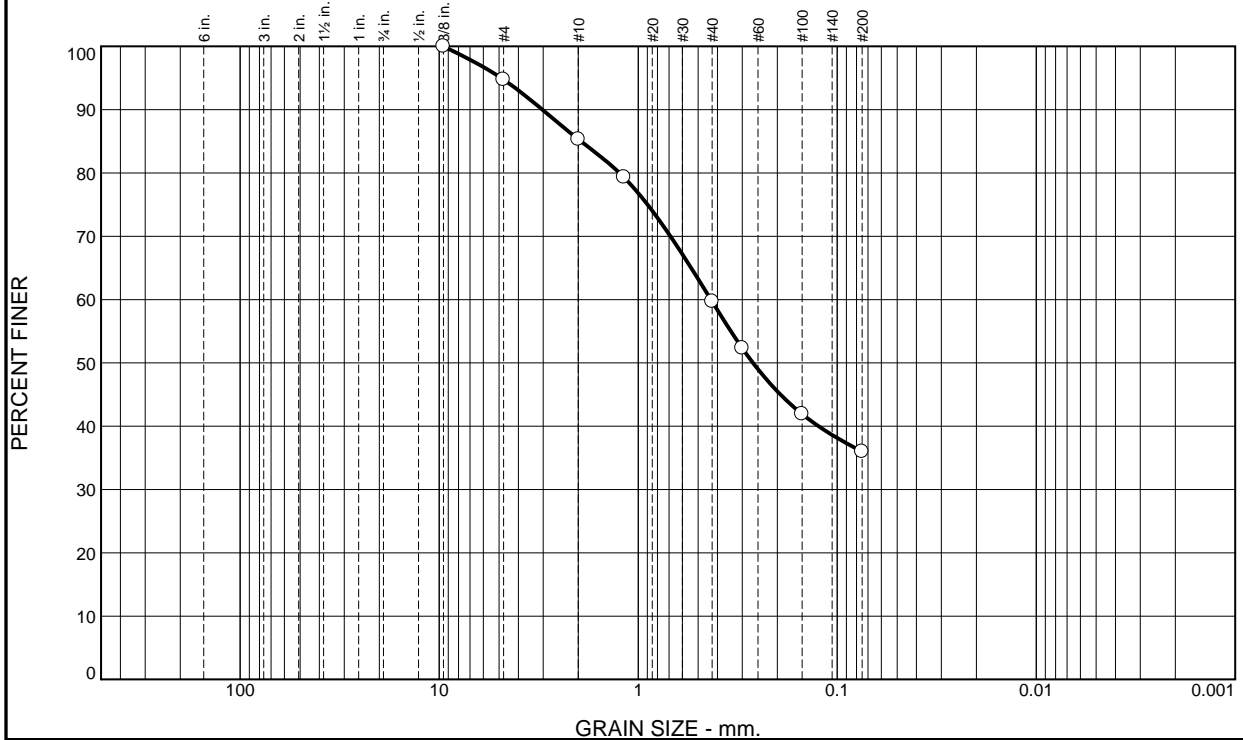
Particle Size Distribution Report

% +3"	% Gravel		% Sand			% Fines	
	Coarse	Fine	Coarse	Medium	Fine	Silt	Clay
0.0	0.0	5.2	9.5	25.6	23.7	36.0

SIEVE SIZE	PERCENT FINER	SPEC.* PERCENT	PASS? (X=NO)
.375"	100.0		
#4	94.8		
#10	85.3		
#16	79.3		
#40	59.7		
#50	52.3		
#100	41.9		
#200	36.0

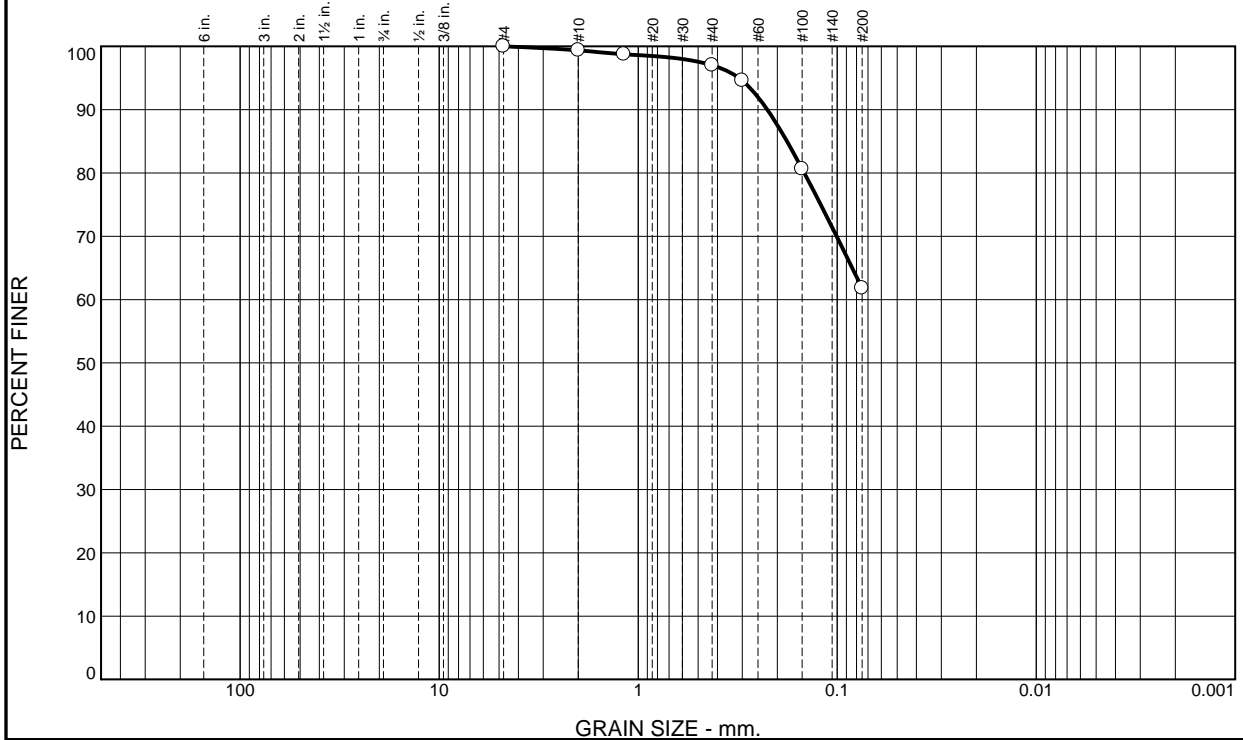
Particle Size Distribution Report

% +3"	% Gravel		% Sand			% Fines	
	Coarse	Fine	Coarse	Medium	Fine	Silt	Clay
0.0	0.0	0.0	0.6	2.4	35.2	61.8

SIEVE SIZE	PERCENT FINER	SPEC.* PERCENT	PASS? (X=NO)
#4	100.0		
#10	99.4		
#16	98.8		
#40	97.0		
#50	94.6		
#100	80.6		
#200	61.8

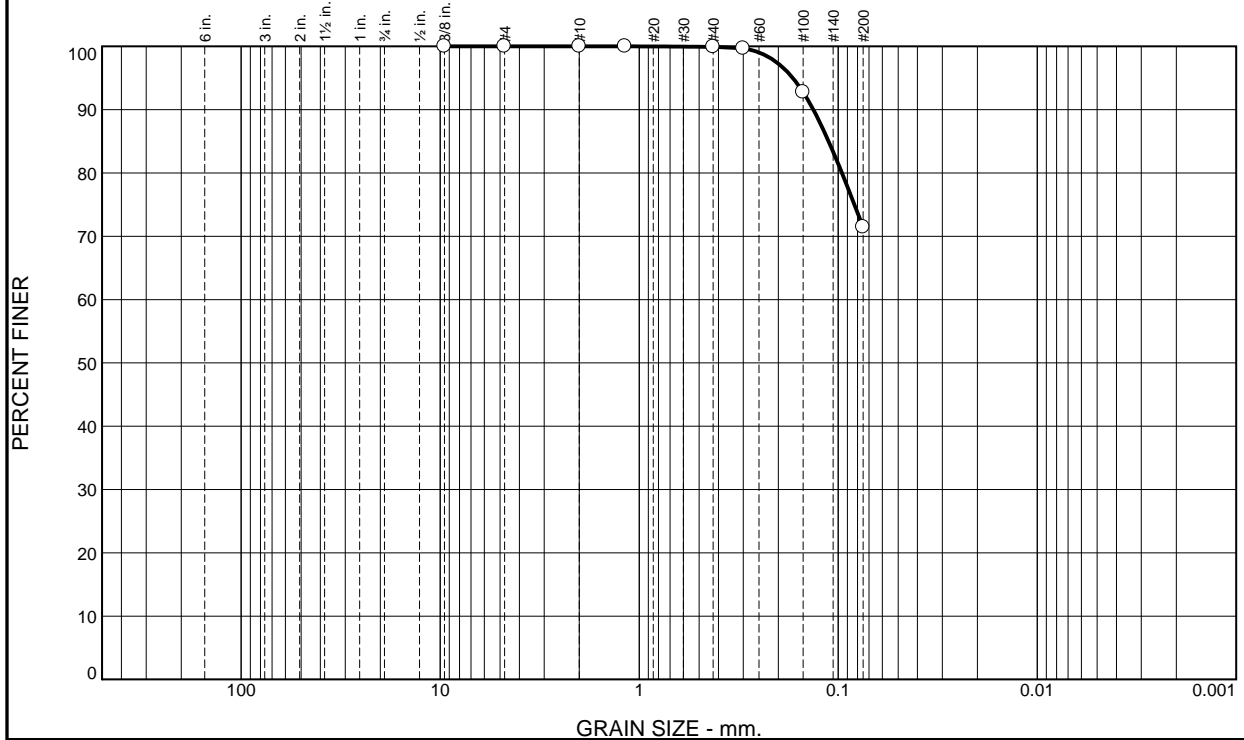
Particle Size Distribution Report

% +3"	% Gravel		% Sand			% Fines	
	Coarse	Fine	Coarse	Medium	Fine	Silt	Clay
0.0	0.0	0.0	0.0	0.1	28.4	71.5

SIEVE SIZE	PERCENT FINER	SPEC.* PERCENT	PASS? (X=NO)
.375"	100.0		
#4	100.0		
#10	100.0		
#16	100.0		
#40	99.9		
#50	99.7		
#100	92.8		
#200	71.5

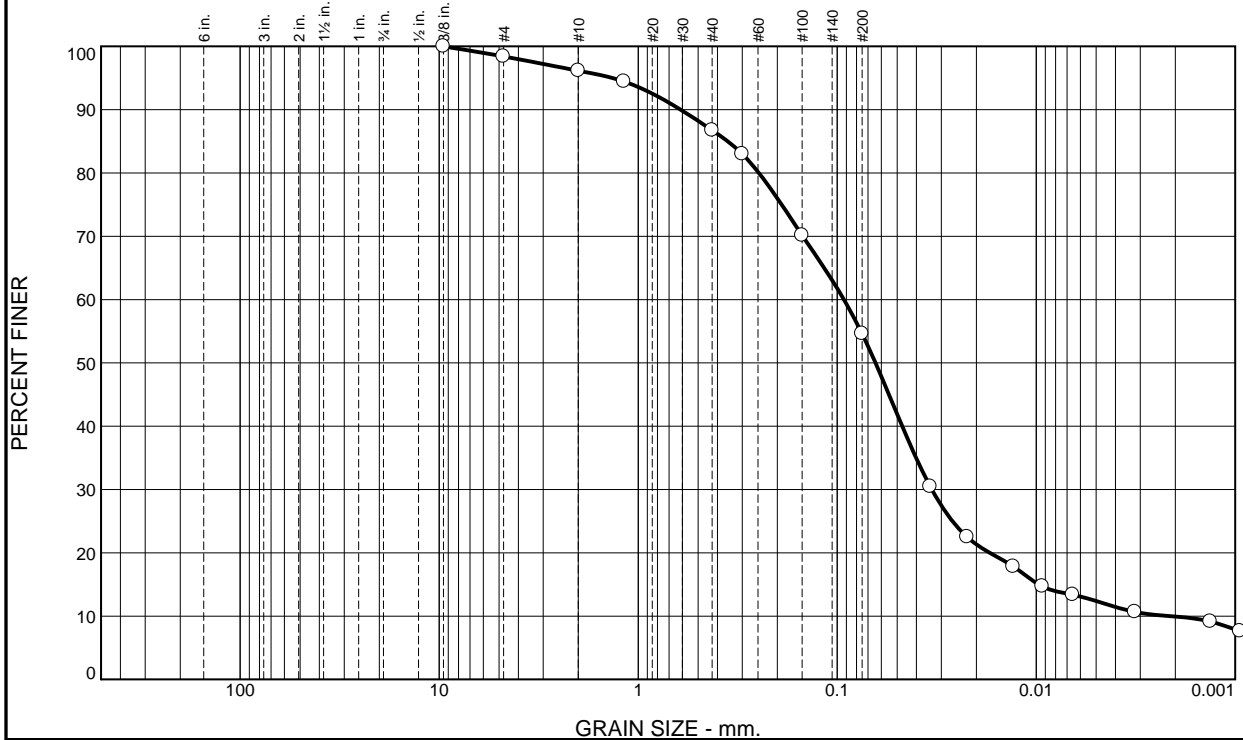
Particle Size Distribution Report

% +3"	% Gravel		% Sand			% Fines	
	Coarse	Fine	Coarse	Medium	Fine	Silt	Clay
0.0	0.0	1.6	2.2	9.5	32.1	44.7	9.9

SIEVE SIZE	PERCENT FINER	SPEC.* PERCENT	PASS? (X=NO)
.375"	100.0		
#4	98.4		
#10	96.2		
#16	94.5		
#40	86.7		
#50	83.0		
#100	70.2		
#200	54.6

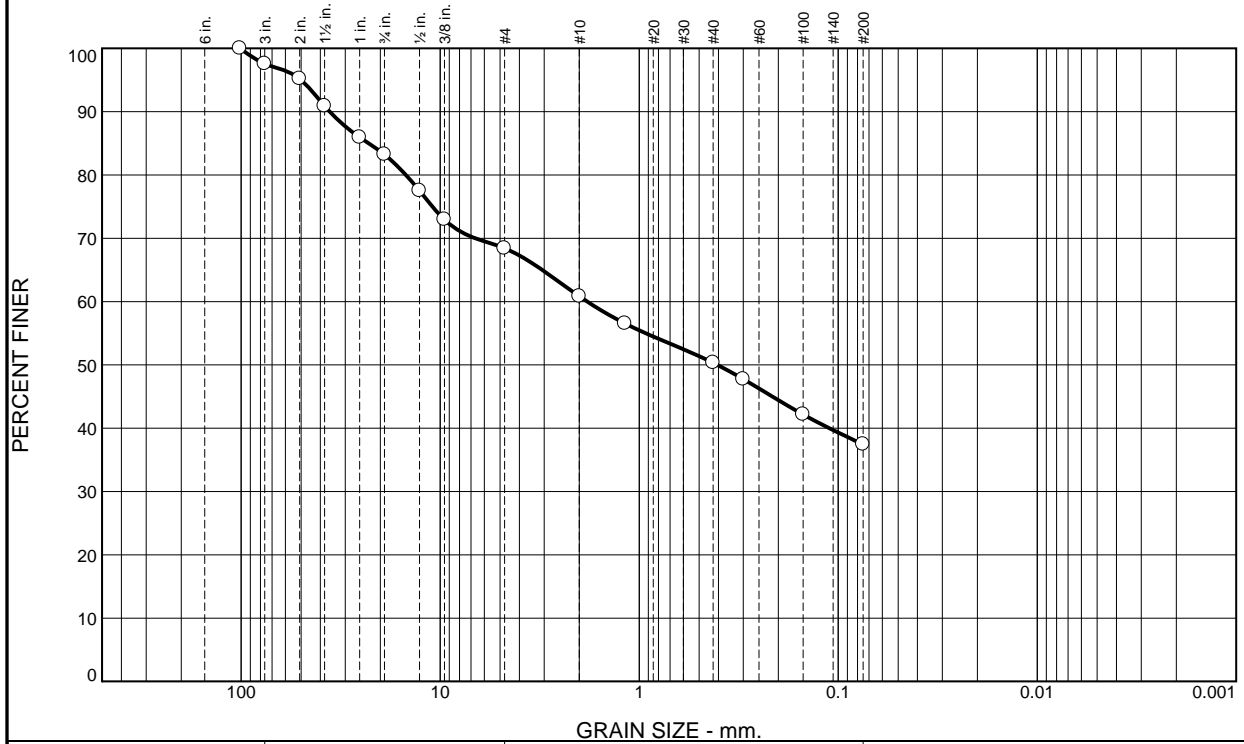
Particle Size Distribution Report

% +3"	% Gravel		% Sand			% Fines	
	Coarse	Fine	Coarse	Medium	Fine	Silt	Clay
2.4	14.4	14.8	7.6	10.5	12.9	37.4

SIEVE SIZE	PERCENT FINER	SPEC.* PERCENT	PASS? (X=NO)
4"	100.0		
3	97.6		
2	95.2		
1.5	90.9		
1	85.9		
.75	83.2		
.5	77.5		
.375	72.9		
#4	68.4		
#10	60.8		
#16	56.6		
#40	50.3		
#50	47.8		
#100	42.2		
#200	37.4

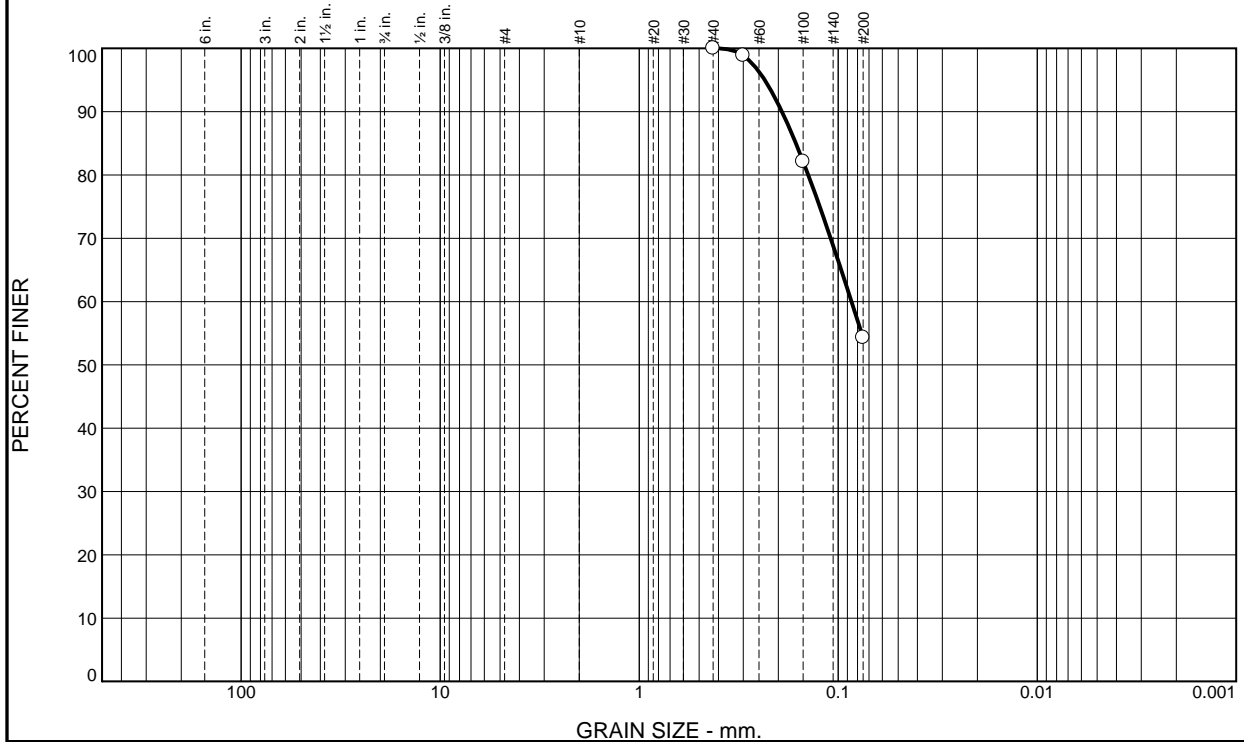
Particle Size Distribution Report

% +3"	% Gravel		% Sand			% Fines	
	Coarse	Fine	Coarse	Medium	Fine	Silt	Clay
0.0	0.0	0.0	0.0	0.0	45.7	54.3

SIEVE SIZE	PERCENT FINER	SPEC.* PERCENT	PASS? (X=NO)
#40	100.0		
#50	98.9		
#100	82.1		
#200	54.3

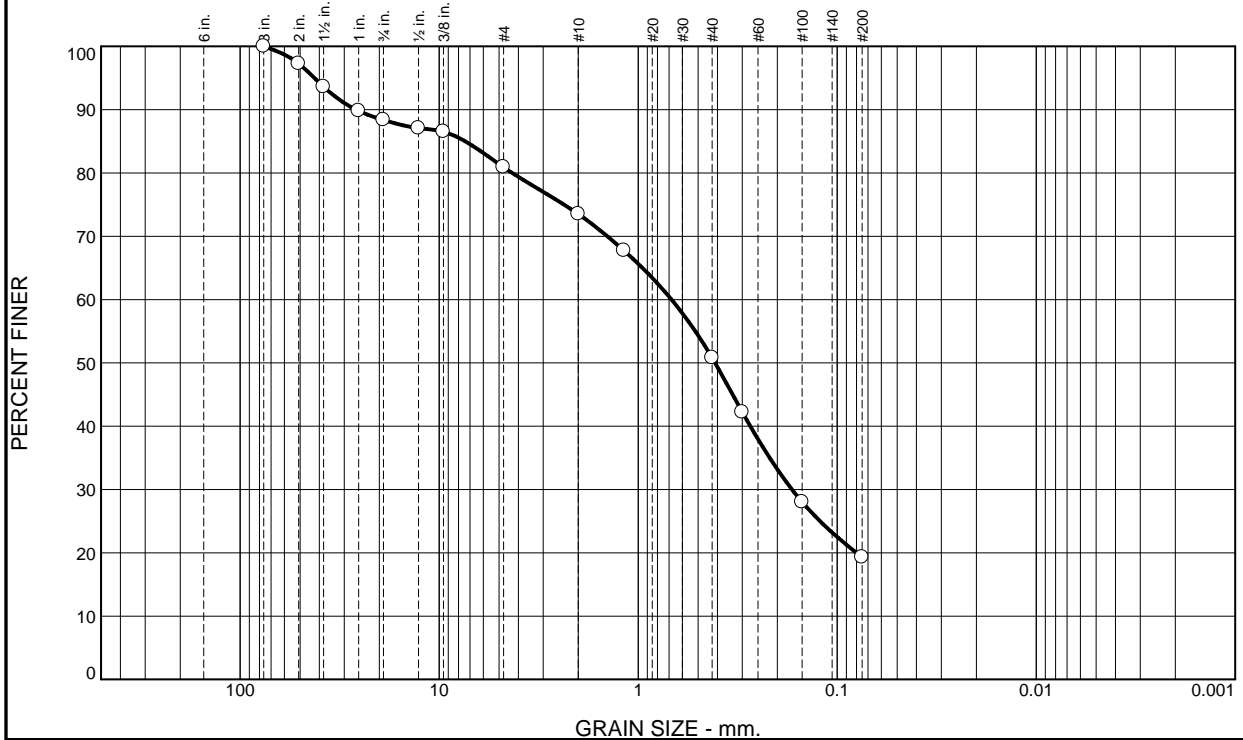
Particle Size Distribution Report

% +3"	% Gravel		% Sand			% Fines	
	Coarse	Fine	Coarse	Medium	Fine	Silt	Clay
0.0	11.6	7.5	7.4	22.7	31.5	19.3

SIEVE SIZE	PERCENT FINER	SPEC.* PERCENT	PASS? (X=NO)
3"	100.0		
2"	97.3		
1.5"	93.6		
1"	89.8		
.75"	88.4		
0.5"	87.1		
0.375"	86.5		
#4	80.9		
#10	73.5		
#16	67.7		
#40	50.8		
#50	42.2		
#100	28.0		
#200	19.3

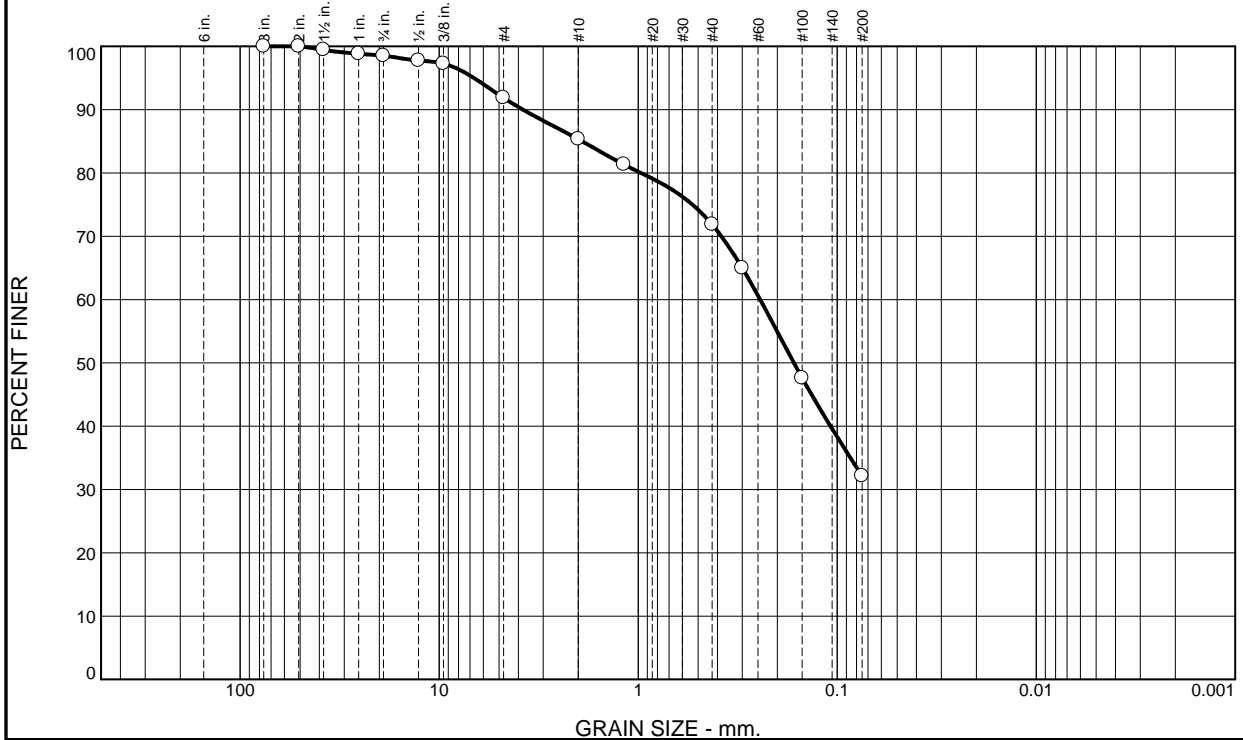
Particle Size Distribution Report

% +3"	% Gravel		% Sand			% Fines	
	Coarse	Fine	Coarse	Medium	Fine	Silt	Clay
0.0	1.5	6.6	6.6	13.4	39.8	32.1

SIEVE SIZE	PERCENT FINER	SPEC.* PERCENT	PASS? (X=NO)
3"	100.0		
2"	100.0		
1.5"	99.4		
1"	98.8		
0.75"	98.5		
0.5"	97.8		
0.375"	97.3		
#4	91.9		
#10	85.3		
#16	81.3		
#40	71.9		
#50	65.0		
#100	47.6		
#200	32.1

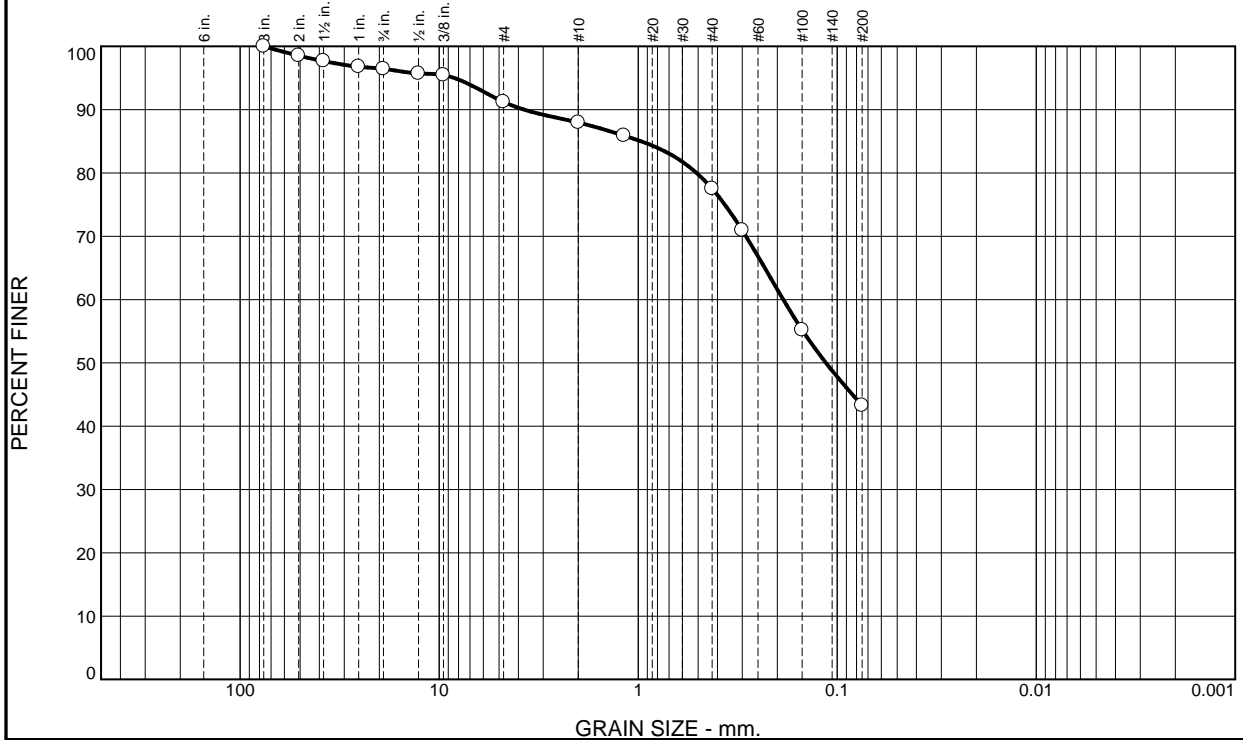
Particle Size Distribution Report

% +3"	% Gravel		% Sand			% Fines	
	Coarse	Fine	Coarse	Medium	Fine	Silt	Clay
0.0	3.6	5.2	3.2	10.5	34.2	43.3

SIEVE SIZE	PERCENT FINER	SPEC.* PERCENT	PASS? (X=NO)
3"	100.0		
2"	98.5		
1.5"	97.7		
1"	96.8		
0.75"	96.4		
0.5"	95.7		
0.375"	95.5		
#4	91.2		
#10	88.0		
#16	85.9		
#40	77.5		
#50	70.9		
#100	55.2		
#200	43.3

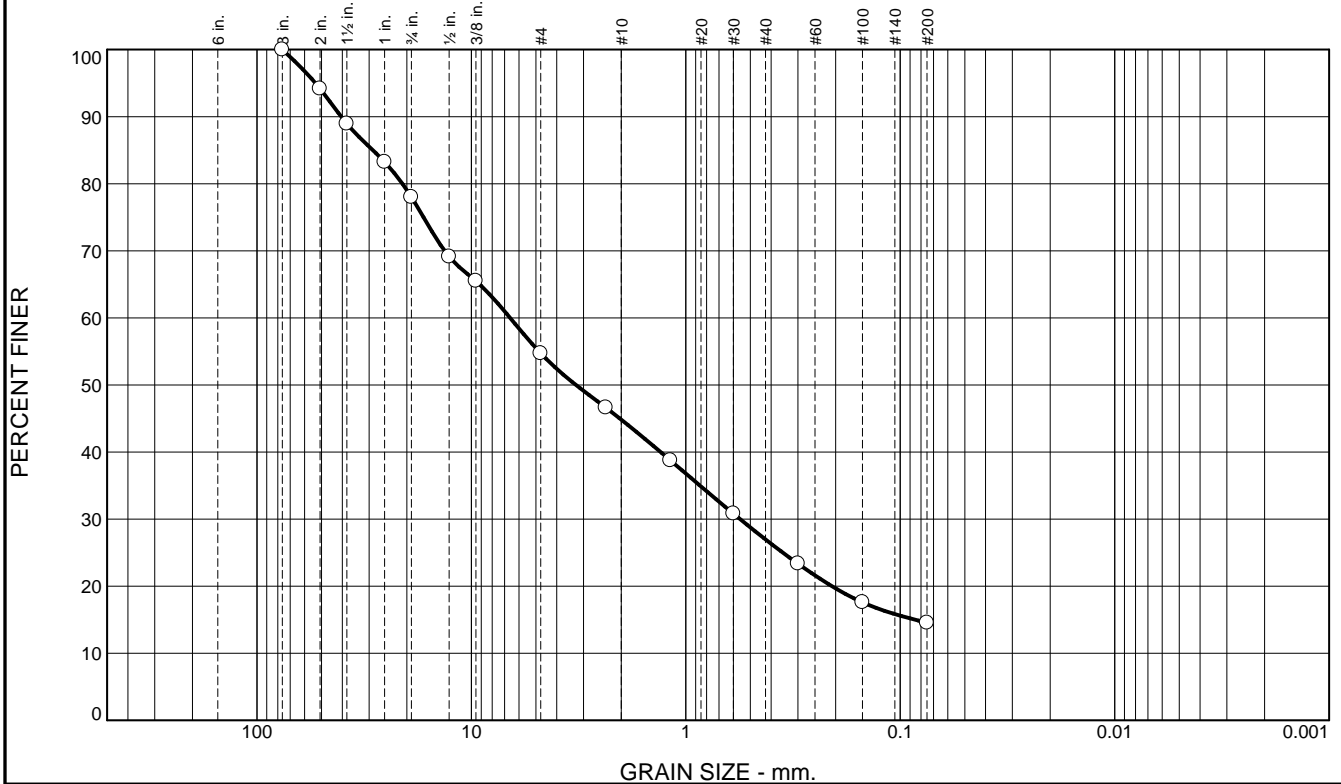
Particle Size Distribution Report

% +3"	% Gravel		% Sand			% Fines	
	Coarse	Fine	Coarse	Medium	Fine	Silt	Clay
0.0	22.0	23.3	9.9	17.8	12.5	14.5

SIEVE SIZE	PERCENT FINER	SPEC.* PERCENT	PASS? (X=NO)
3.0	100.0		
2.0	94.2		
1.5	89.0		
1.0	83.3		
0.75	78.0		
0.5	69.1		
0.375	65.5		
#4	54.7		
#8	46.6		
#16	38.8		
#30	30.8		
#50	23.4		
#100	17.6		
#200	14.5
