Hermosa Project – Trench Camp Property

Aquifer Protection Permit SIGNIFICANT Amendment Application

P-512235

Santa Cruz County, Arizona

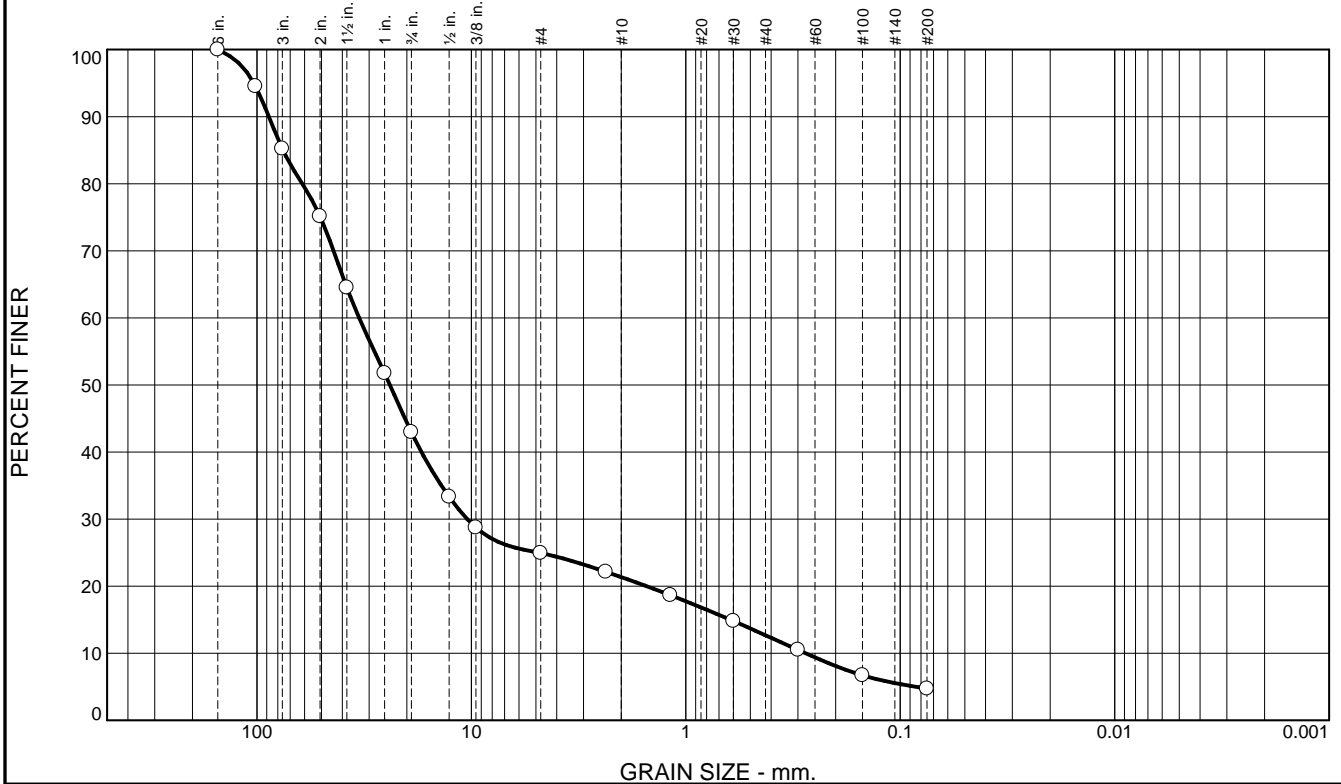
Particle Size Distribution Report

% +3"	% Gravel		% Sand			% Fines	
	Coarse	Fine	Coarse	Medium	Fine	Silt	Clay
14.8	42.2	18.1	3.6	8.6	8.0	4.7

SIEVE SIZE	PERCENT FINER	SPEC.* PERCENT	PASS? (X=NO)
6.0	100.0		
4.0	94.5		
3.0	85.2		
2.0	75.2		
1.5	64.5		
1.0	51.7		
0.75	43.0		
0.5	33.3		
0.375	28.7		
#4	24.9		
#8	22.1		
#16	18.7		
#30	14.8		
#50	10.5		
#100	6.7		
#200	4.7

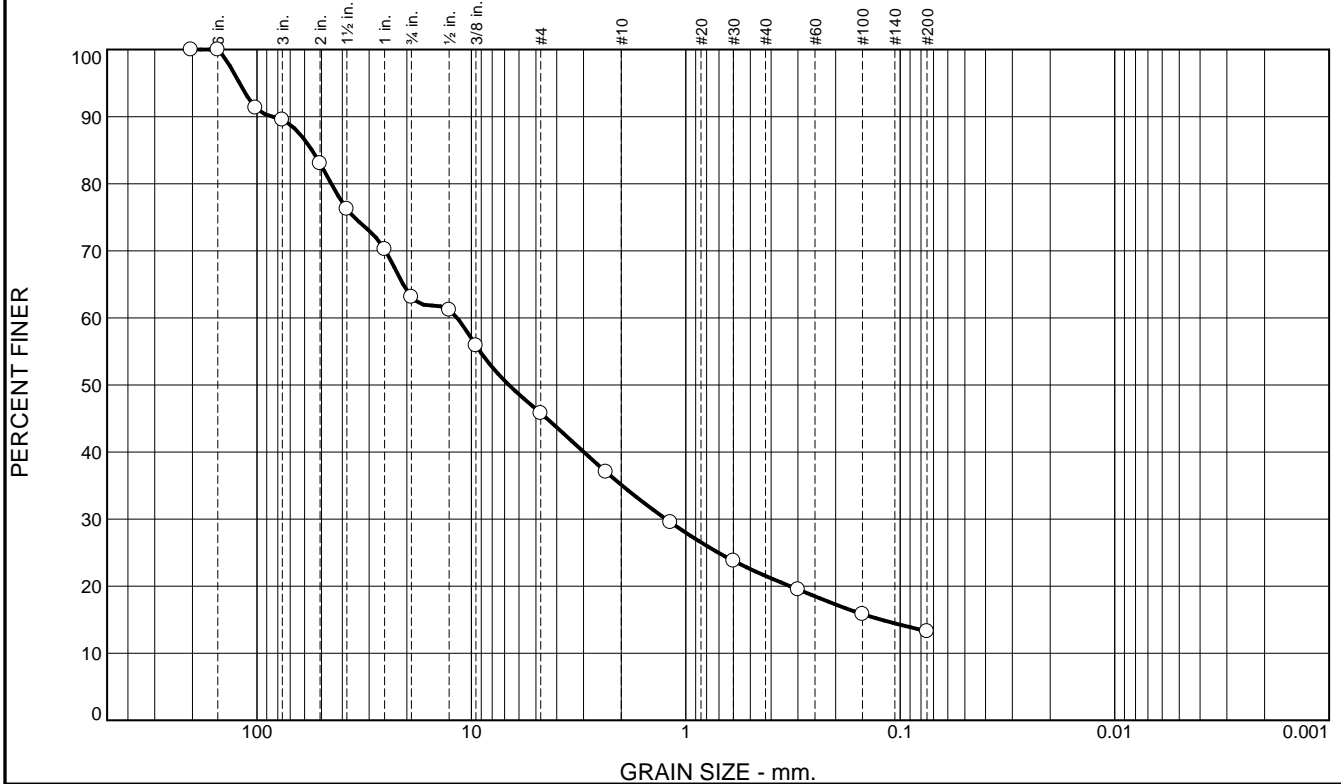
Particle Size Distribution Report

% +3"	% Gravel		% Sand			% Fines	
	Coarse	Fine	Coarse	Medium	Fine	Silt	Clay
10.5	26.4	17.3	10.7	13.6	8.2	13.3

SIEVE SIZE	PERCENT FINER	SPEC.* PERCENT	PASS? (X=NO)
8.0	100.0	100.0	
6.0	100.0		
4.0	91.3		
3.0	89.5		
2.0	83.0		
1.5	76.2		
1.0	70.2		
0.75	63.1		
0.5	61.2		
0.375	55.9		
#4	45.8		
#8	37.1		
#16	29.5		
#30	23.8		
#50	19.5		
#100	15.8		
#200	13.3	0.0 - 15.0

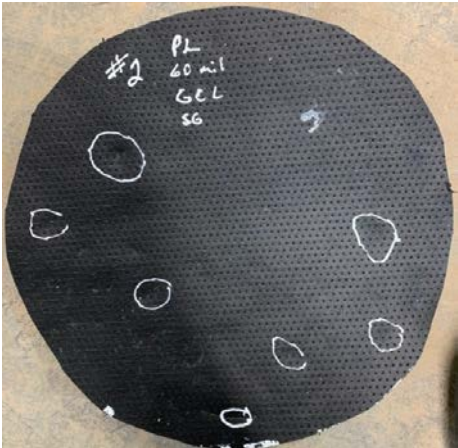
Test Parameters	
Geosynthetic:	60 Mil Textured Liner
Substrate:	GCL Subgrade
Superstrate:	PL
Normal Load (psf):	16,500

Test Data	
	Coupon
Start Date:	12/2/2019
Start Time:	2:00pm
End Date:	12/3/2019
End Time:	2:00pm
Duration (hrs):	24 hrs
No. of Dimples:	7
No. of Punctures:	0
No. of Tears:	0
(Pass/Fail)	PASS

General Test Notes: Small visible defects occurred during testing.

Loaded at 110' equivalent height for 24 hours.

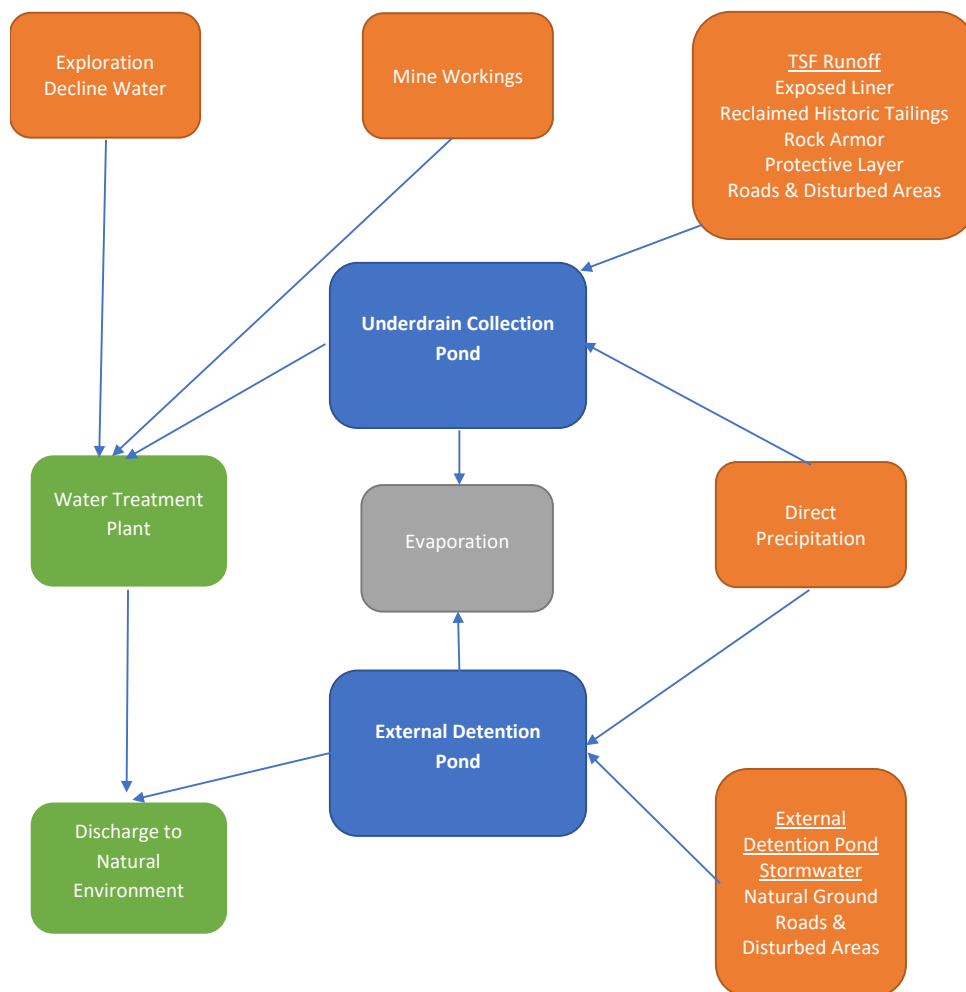
The water balance model was configured based on a daily time-step and tracks inflows to and losses from the system. The model calculates the daily storage in the UDCP and EDP and daily water treatment requirements. **Figure 3.1** shows a schematic of the overall water balance as it is configured in the model.

Figure 3.1. Water Balance Model Schematic

The water balance incorporates water inputs into the system based on the two different conditions: the Interim VRP TSF and the final TSF Amended Design. Inputs that contribute water to the UDCP include direct rainfall on the pond and runoff from the TSF. Runoff from the TSF is subdivided into runoff based on the various up-gradient land types and include the exposed geomembrane, reclaimed historic tailings surface, a rock armor layer, a protective layer placed over geomembrane liner and disturbed lands and roads. The area of each of these parameters differs from the Interim VRP TSF to the TSF Amended Design conditions. All water that enters the TSF/UDCP is considered contract water which requires treatment before it can be released. The existing water treatment plant has a treatment capacity is 120 gallons per minute (gpm) which was used in the model. In addition to treatment, water from the UDCP is eliminated from the system through evaporation.

The water balance model was developed using an analytical spreadsheet model developed in Microsoft Excel. The water balance calculated the daily storage volume in the UDCP and EDP as the difference between inflows and outflows (as shown in **Figure 3.1** above). Different models were generated to evaluate the current interim VRP TSF and TSF Amended Design phases. Twelve separate years of precipitation data were modeled to capture annual variability within each model. The peak pumping rate from the UDCP to the WTP was set at 120 gpm while the peak pumping rate from the EDP was set at 170 gpm. Results obtained from the model runs are presented below.

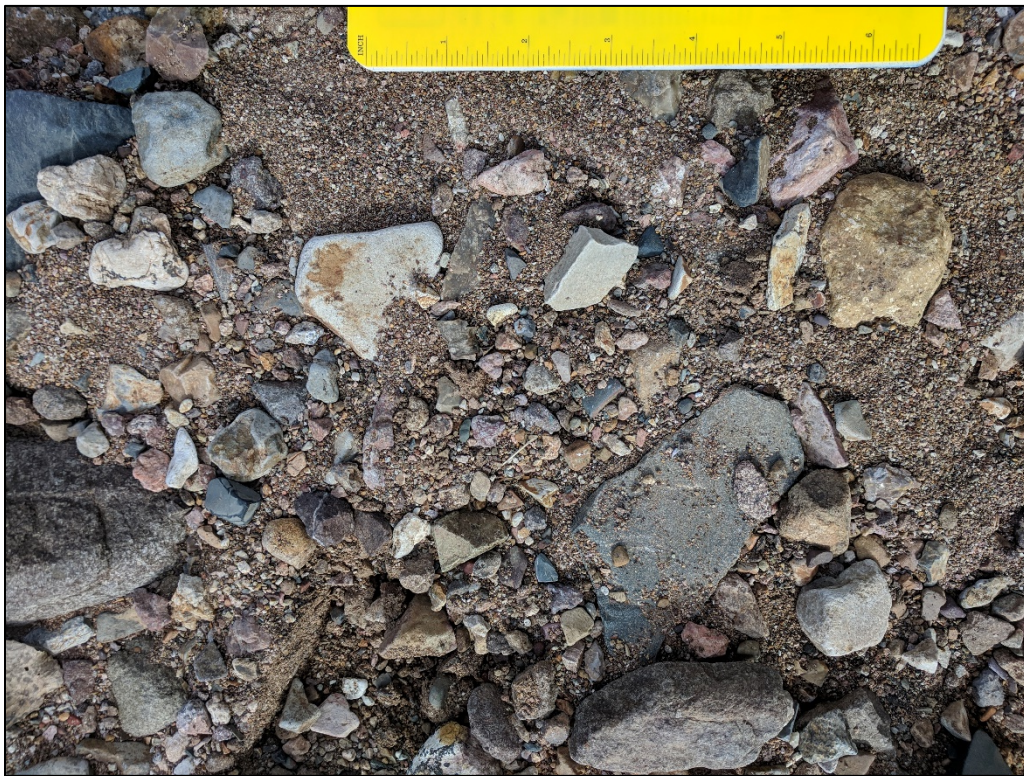
Figure 2 – Sample Input Photograph to Determine Sediment Gradation using FHWA’s Hydraulic Toolbox (Site 2 pictured)

are provided in **Appendix A**. ERC obtained between 4 and 6 photos at each infiltration site and used them to quantify a cumulative gradation. **Table 2** and **Figure 3** show the calculated gradations in tabular and graphical form, respectively.

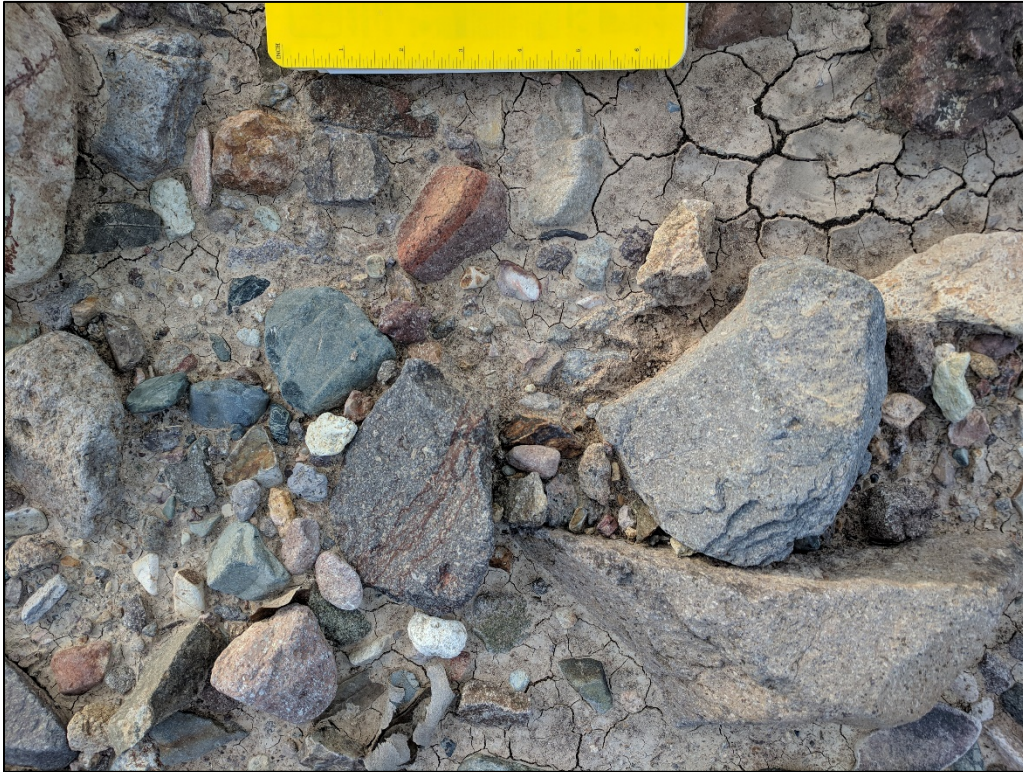
Figure 4 – Sample Bed Material at East Branch of Site 3

Figure 4 shows that the gradation for Site 3 appears to be an outlier in that its bed gradation is coarser than that from the other four sites. This site is located at the downstream end of a small braided section of Harshaw Creek, with samples collected from the east branch, the west branch, and immediately downstream of the junction of the two branches. On the east branch of the braid, ERC observed much less sandy material than the other sites visited throughout the creek noting mostly large gravel and cobble material along with patches of dried-out mud. **Figure 4** depicts a sample photograph of the bed material along the east branch just before the braided creek returns to one channel. This was the only site visited by ERC where this material distribution was observed, and ERC does not believe it representative of the Harshaw Creek main channel (refer to **Appendix A** for photos from all sites). If this location was excluded from the Hydraulic Toolbox analysis and only the sample sites on the west branch of the stream and downstream of the junction of the two braids considered, the application produces a D_{50} of the Site 3 bed material of 0.64 inches, which is consistent with the median particle sizes of the other sites listed above in **Table 2**.

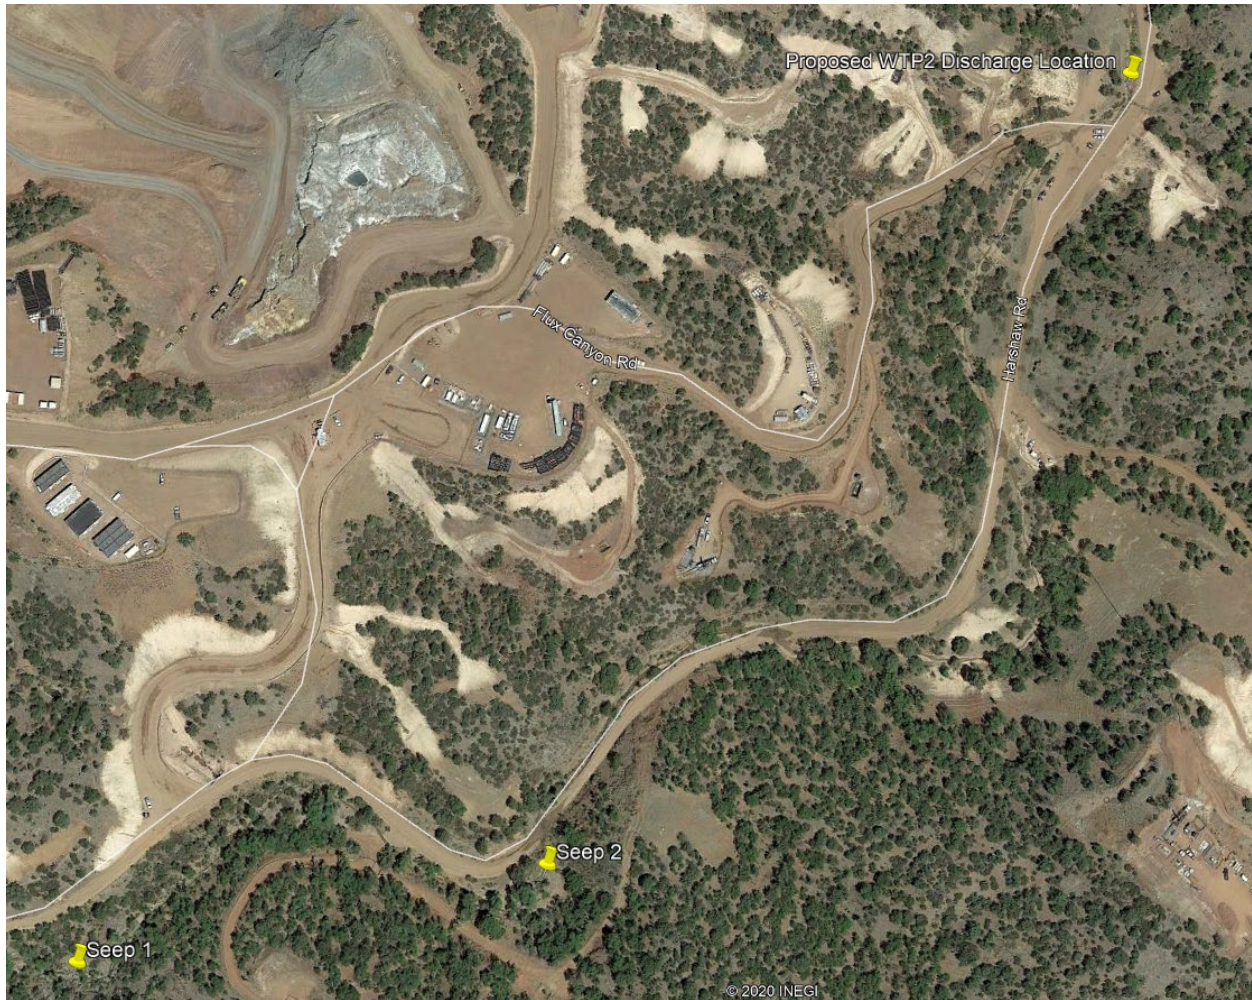
Figure 5 – Seep 1 and 2 Locations

ERC investigated two locations along Harshaw Creek where surface water was present at the time of the October 2018 site visit. The first location (Seep 1) is approximately 0.6 miles upstream of the WTP2 discharge location at the outfall of an old masonry dam, and the second location (Seep 2) is approximately 0.4 miles upstream of the discharge location. These locations are shown in **Figure 5**. ERC estimated the infiltration rates of Harshaw Creek downstream of the seeps by measuring the current flow rate at the upstream end of each seep and then dividing the flow rate by the approximate surface area of the wetted area at each location.

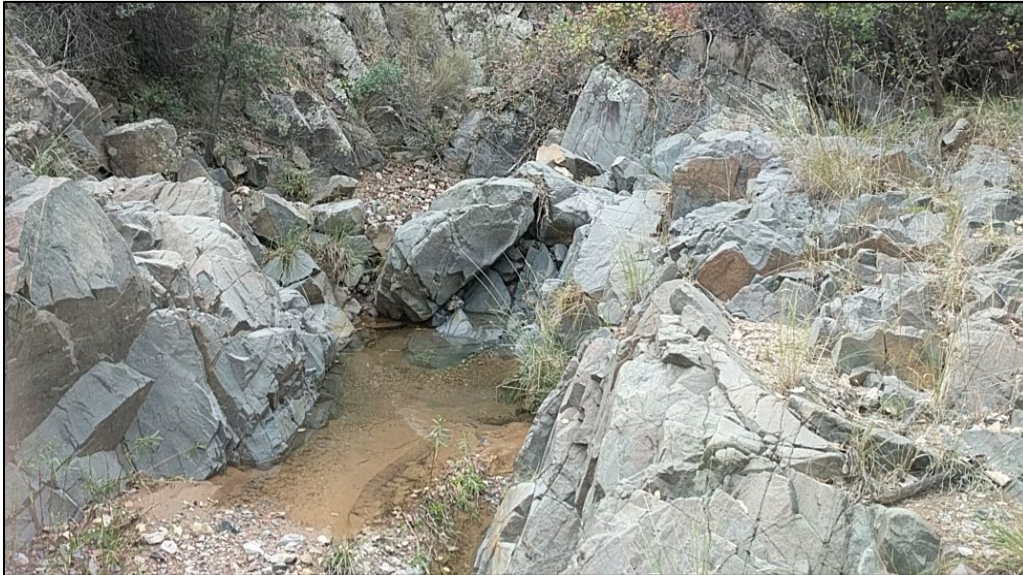
Figure 6 – Typical Seep 1 Bedform, Looking Upstream

The channel through which Seep 1 was flowing at the time of the site visit consisted primarily of exposed bedrock with shallow patches of sand and finer material present in pools between the bedrock. **Figure 6** displays a typical pool within the wetted area of the seep. Flow was passing through a small pipe in the masonry dam at the upstream end of the seep during the site visit (**Figure 7**). ERC measured the flow rate out of the pipe by placing a bucket under the pipe outlet and measuring the volume of water filling the bucket over a 30-second period. This was conducted three times and flow rates of 0.011, 0.010, and 0.012 cfs were calculated, for an average rate of 0.011 cfs. ERC measured from the upstream to downstream end of the seep to get a wetted channel bed length of approximately 285 feet and measured the width at roughly 20-foot intervals to obtain an average wetted width of about 2.9 feet, resulting in a total wetted area of approximately 827 ft². Dividing the average measured flow rate by this wetted area produces an average infiltration rate of 0.57 inches per hour (in/hr), or 1.14 feet per day (ft/d).

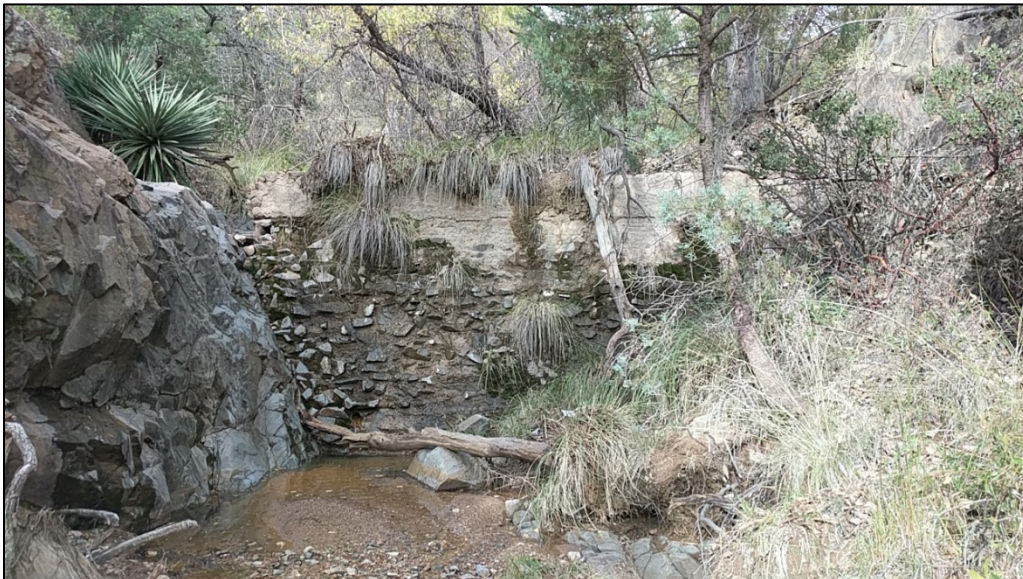
Figure 7 – Mason Dam at the Upstream End of Seep 1

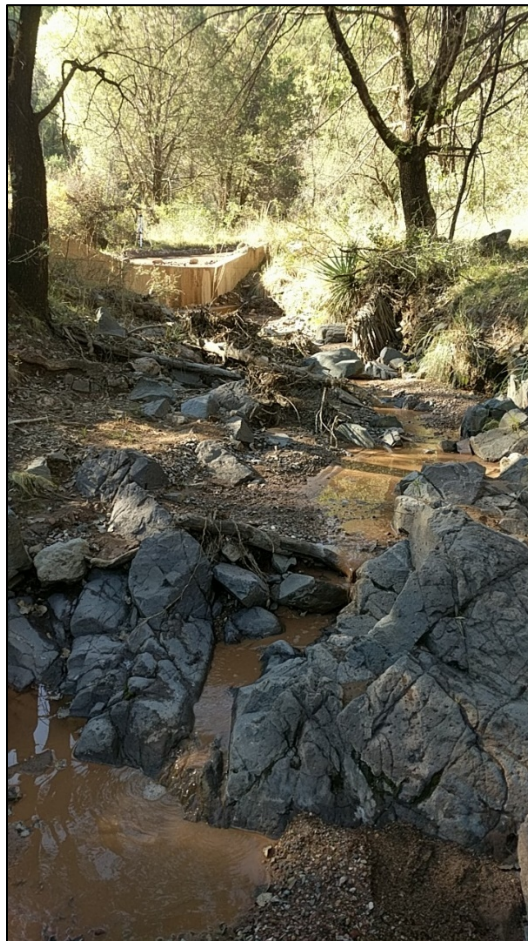
Figure 8 – Typical Seep 2 Bedform, Looking Upstream

Seep 2 consisted of significant quantities of exposed bedrock with gravel, sand, and finer material dispersed throughout, although ERC observed less bedrock in the channel surface downstream of Seep 2 than was noted below Seep 1 (**Figure 8**). ERC measured from the upstream end to the downstream end of the wetted area in Seep 2 to get a length of approximately 400 feet and measured the average width to be 2.0 feet, for a total wetted area of approximately 811 ft². Because there was no single point source from Seep 2, ERC estimated the flow rate by using field methods to approximate velocity at multiple locations and then multiplying each velocity by the width and depth of the flow at those locations. ERC calculated an average flow rate in this seep of 0.041 cfs. This results in a calculated infiltration rate of 2.21

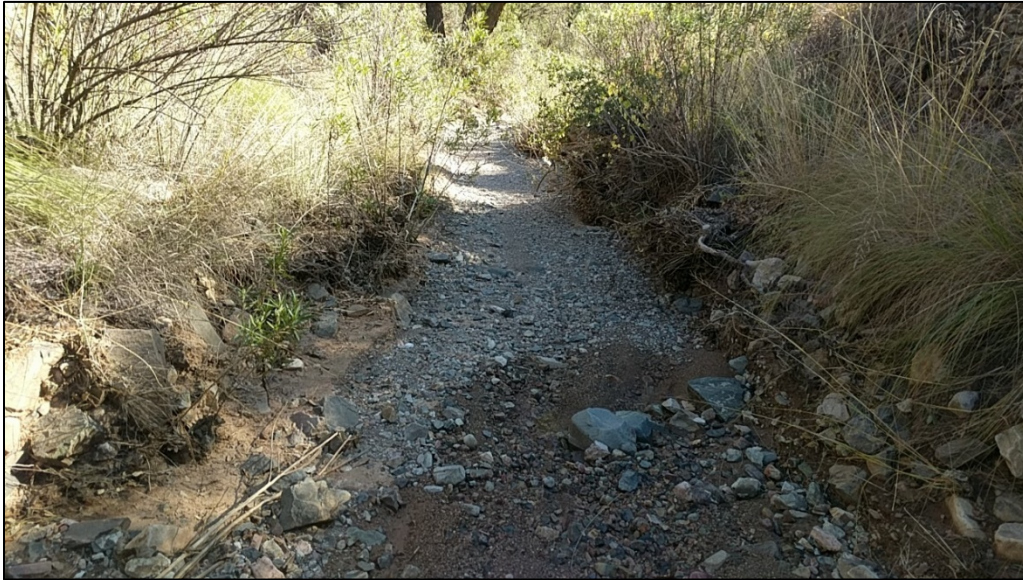
Figure 9 – Downstream End of Seep 2

The infiltration rate at the two upstream seeps is expected to be less than the overall average infiltration rate of the creek due to the significant exposed bedrock present at both seep locations. Areas in Harshaw Creek downstream of the proposed discharge have little to no exposed bedrock. Calculated infiltration rates below Seep 1 were less than below Seep 2 likely due to greater prevalence of bedrock (**Table 4**). Infiltration rates increase in areas without bedrock control, as observed below Seep 2 where the seep water infiltrated almost immediately at the transition from exposed bedrock to coarse grained channel bed materials (**Figure 9**).

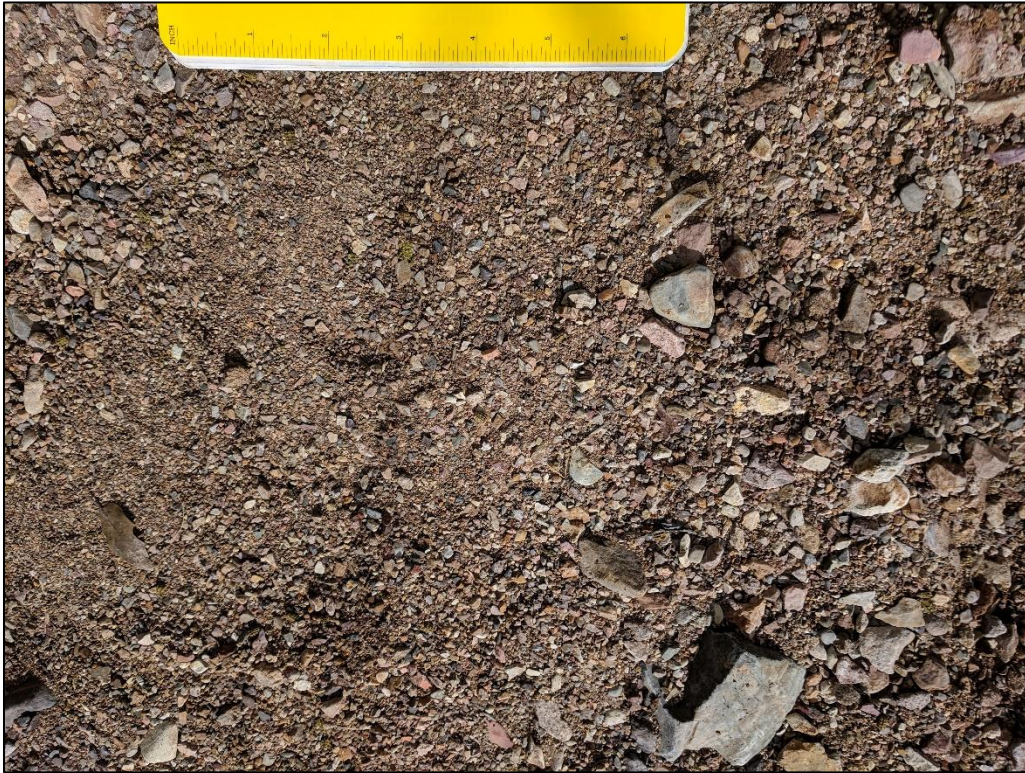
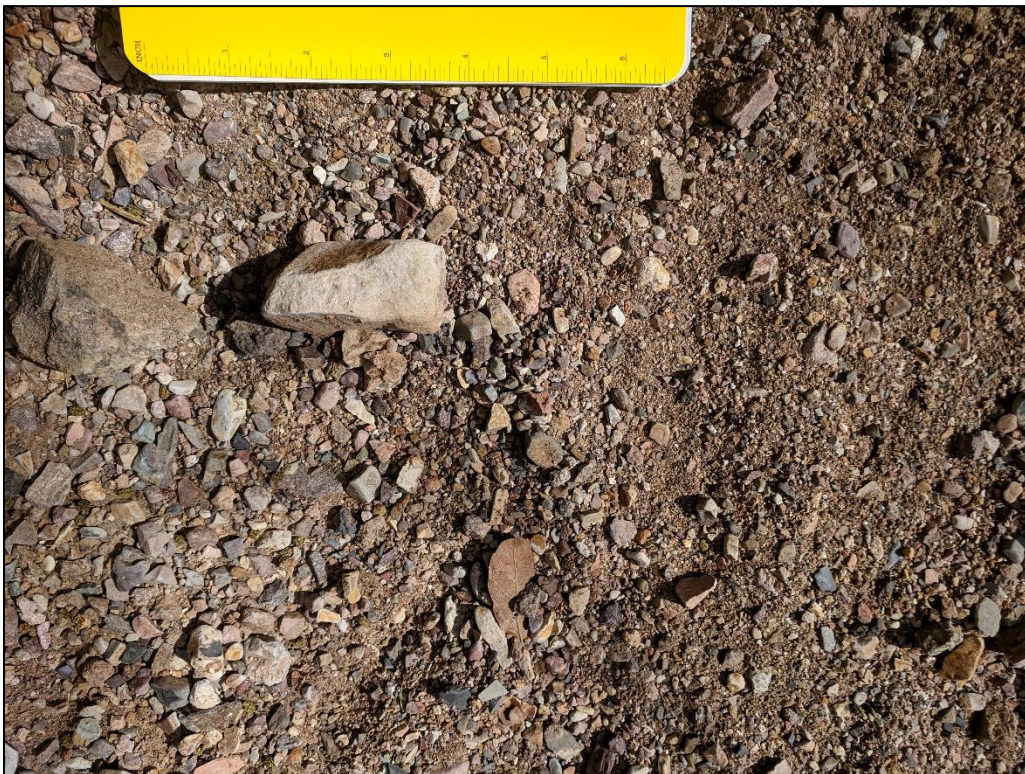
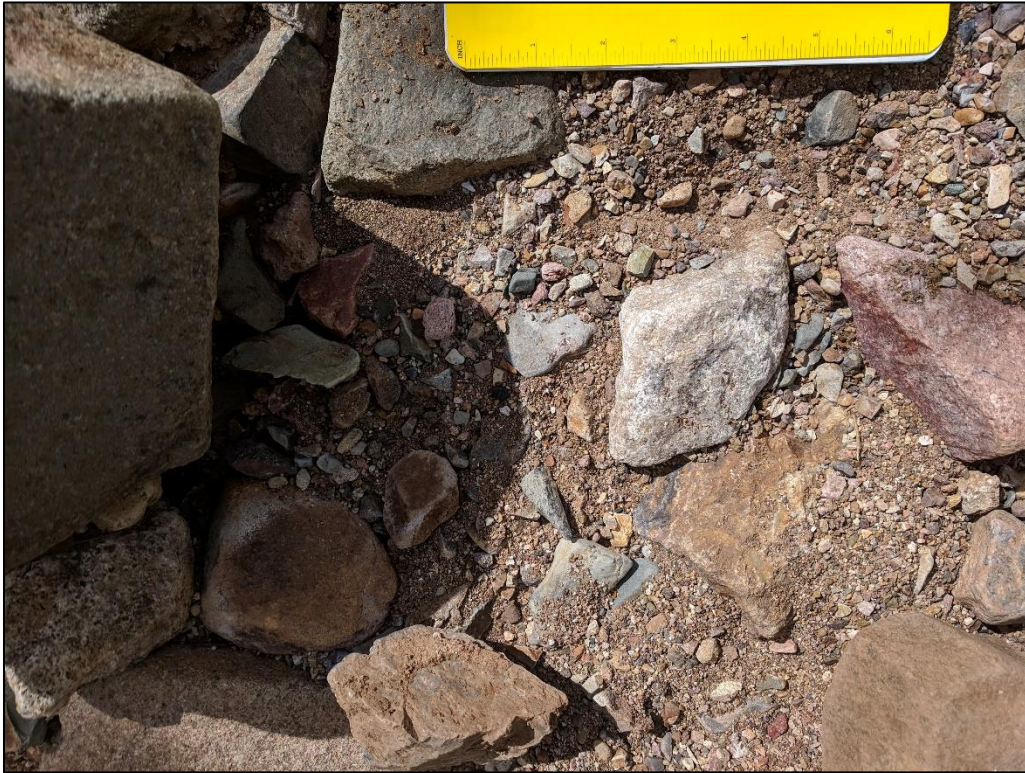
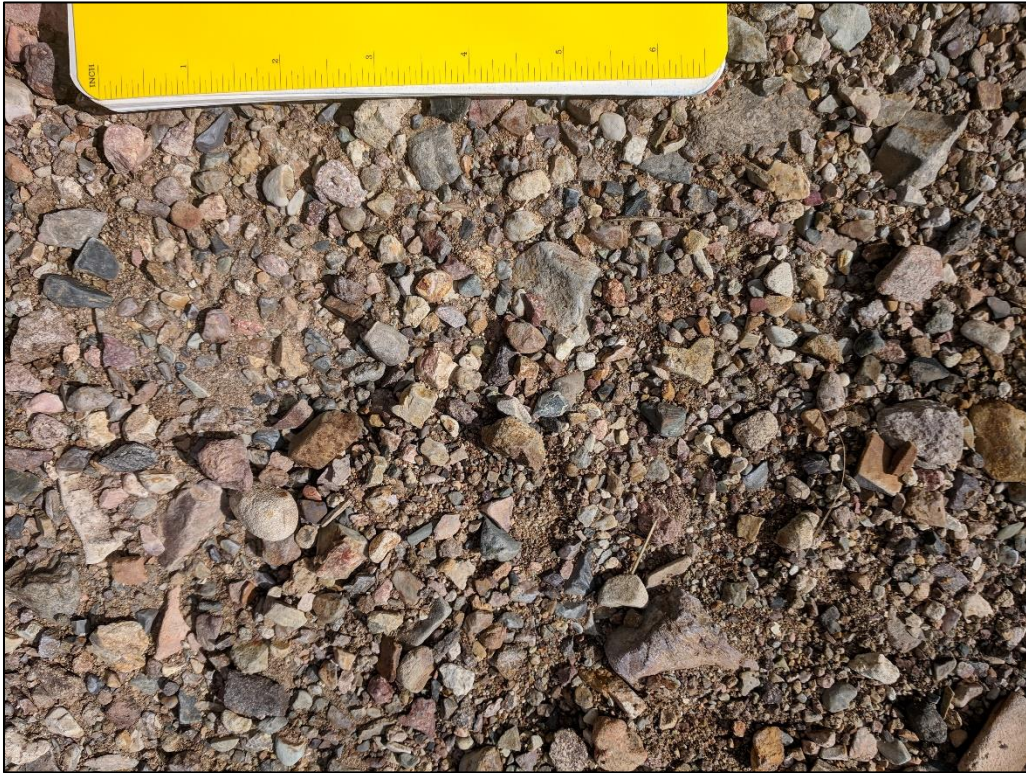
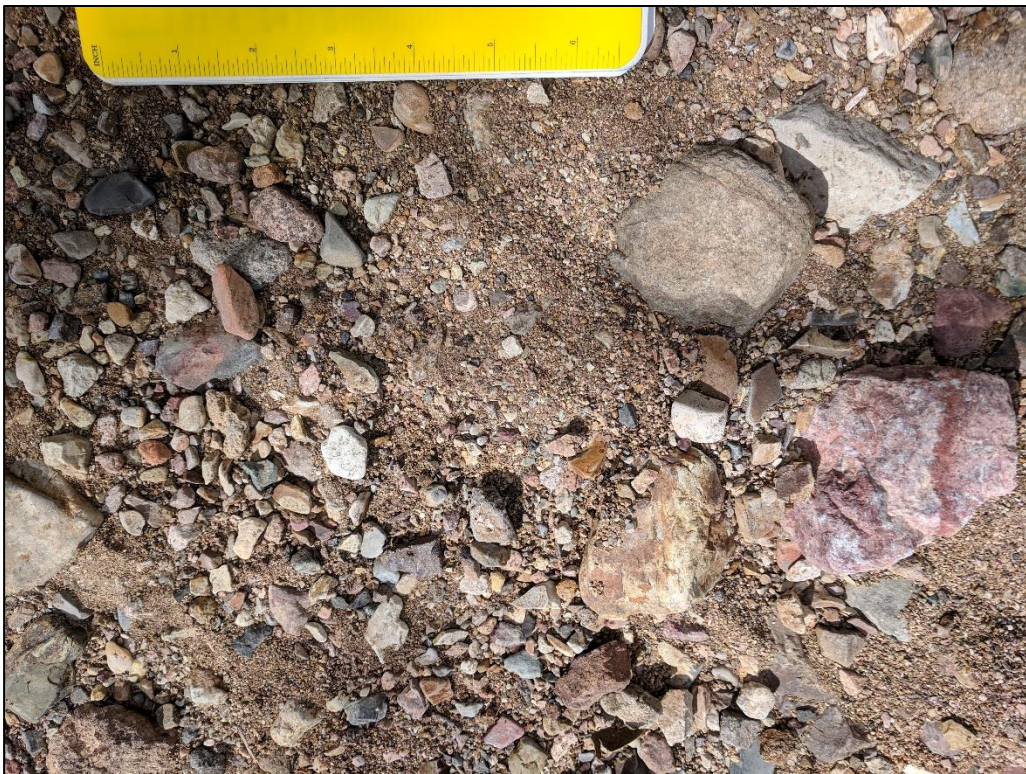
Figure A1 – Site 1 Channel Bed Surface Material

Figure A2 – Site 1 Channel Bed Surface Material

Figure A3 – Site 1 Channel Bed Surface Material

Figure A5 – Site 1 Channel Bed Surface Material

Figure A6 – Site 1 Channel Bed Surface Material

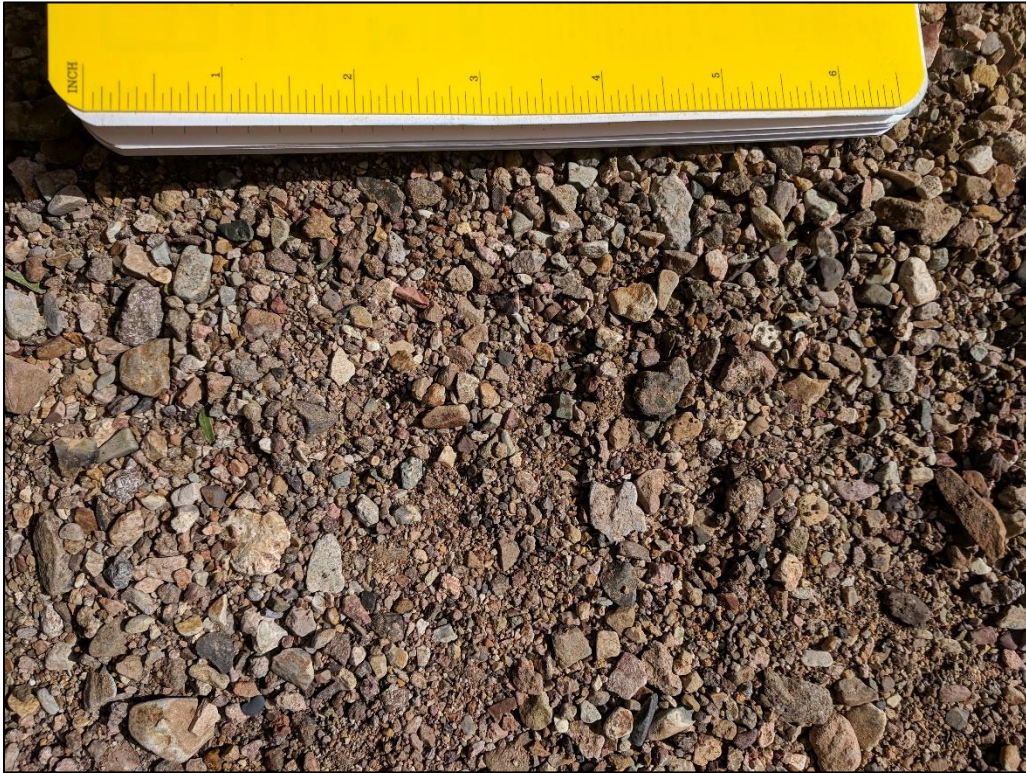
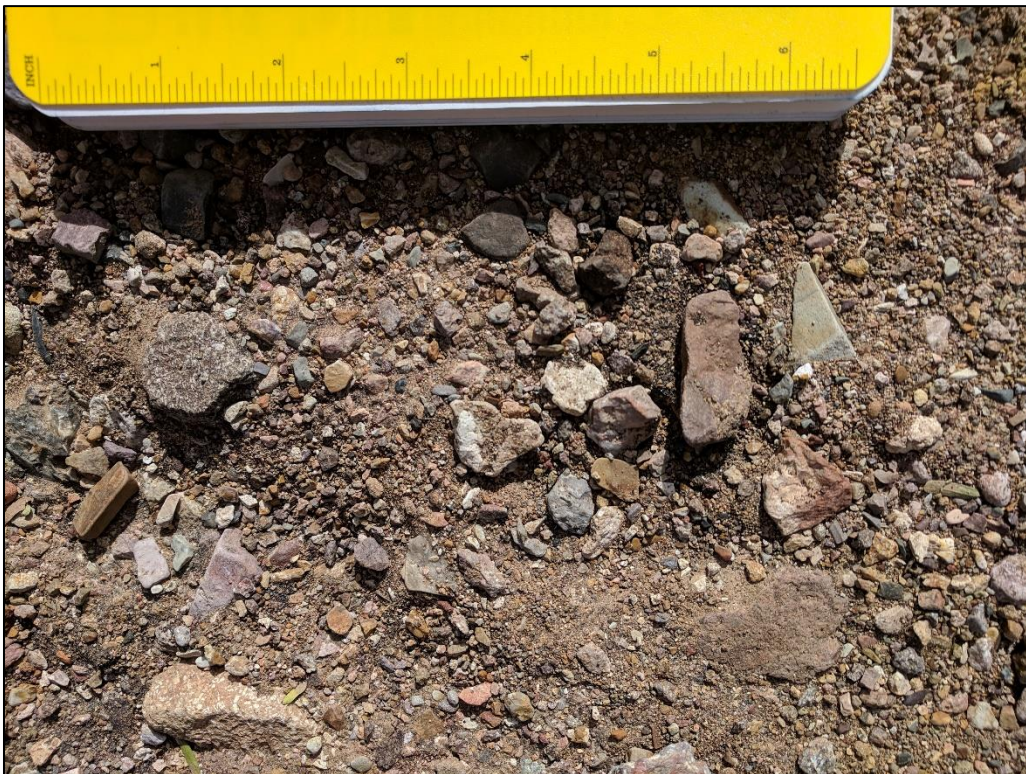
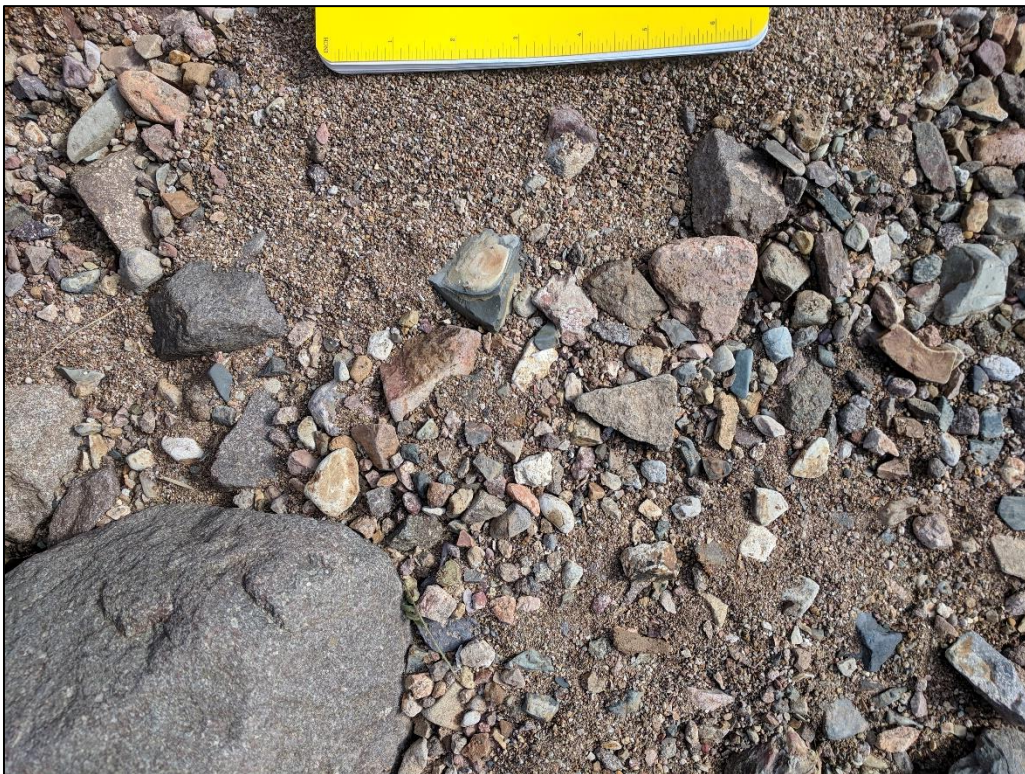
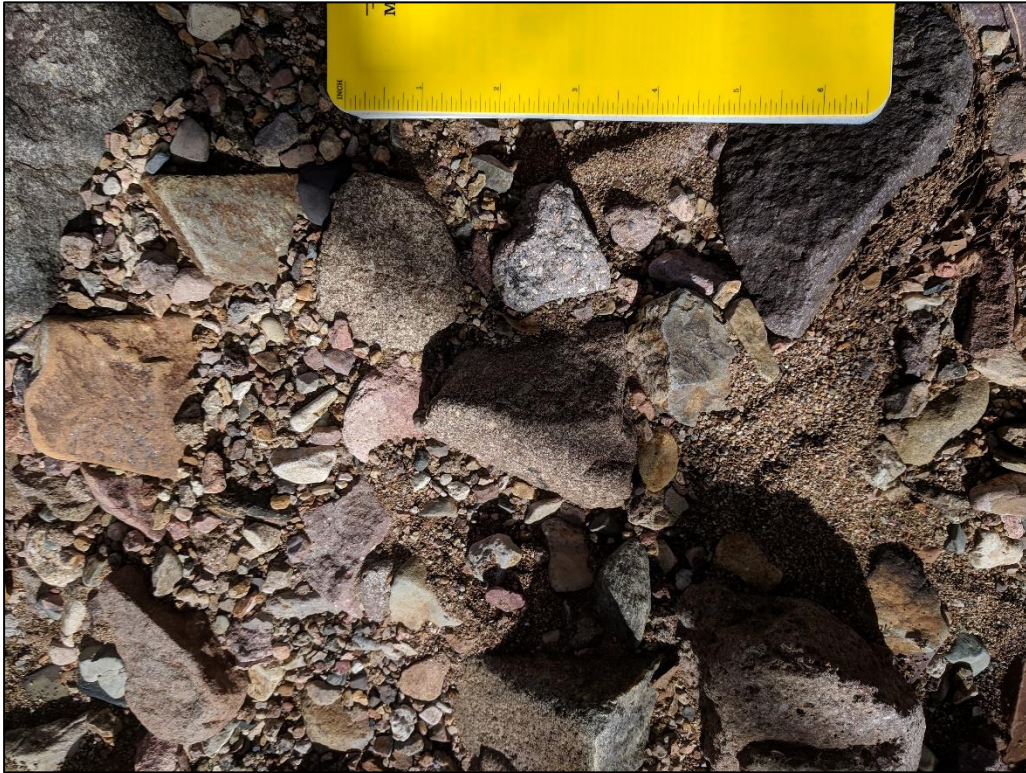
Figure A7 – Site 2 Channel Bed Surface Material

Figure A8 – Site 2 Channel Bed Surface Material

Figure A10 – Site 2 Channel Bed Surface Material

Figure A11 – Site 2 Channel Bed Surface Material

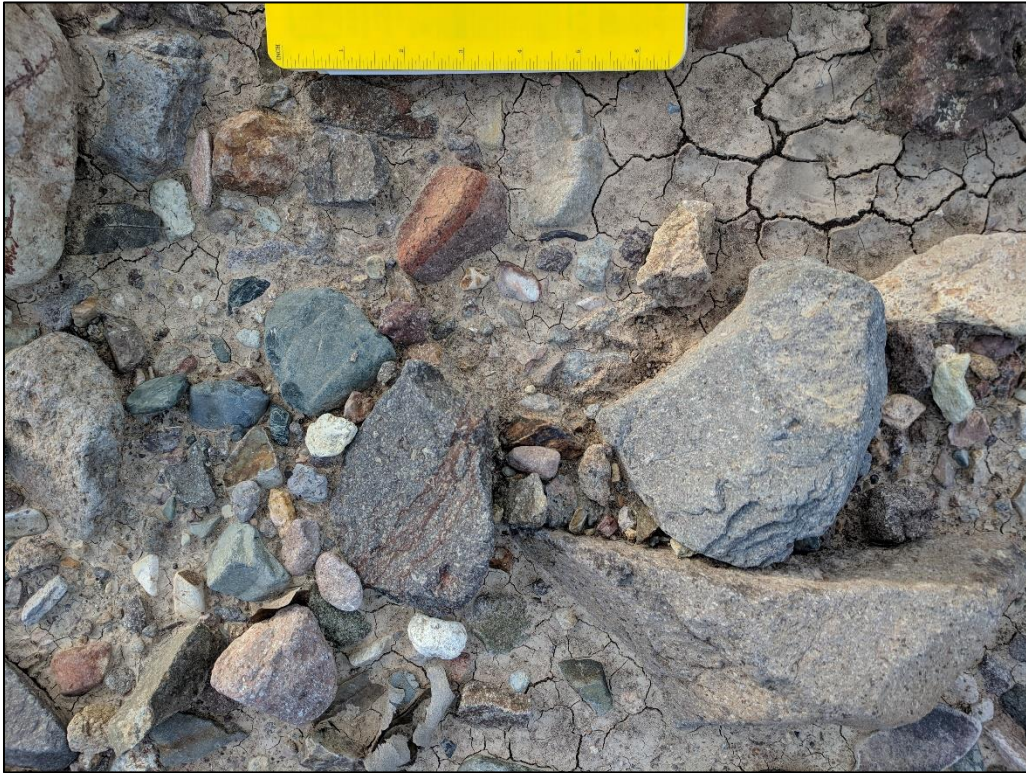
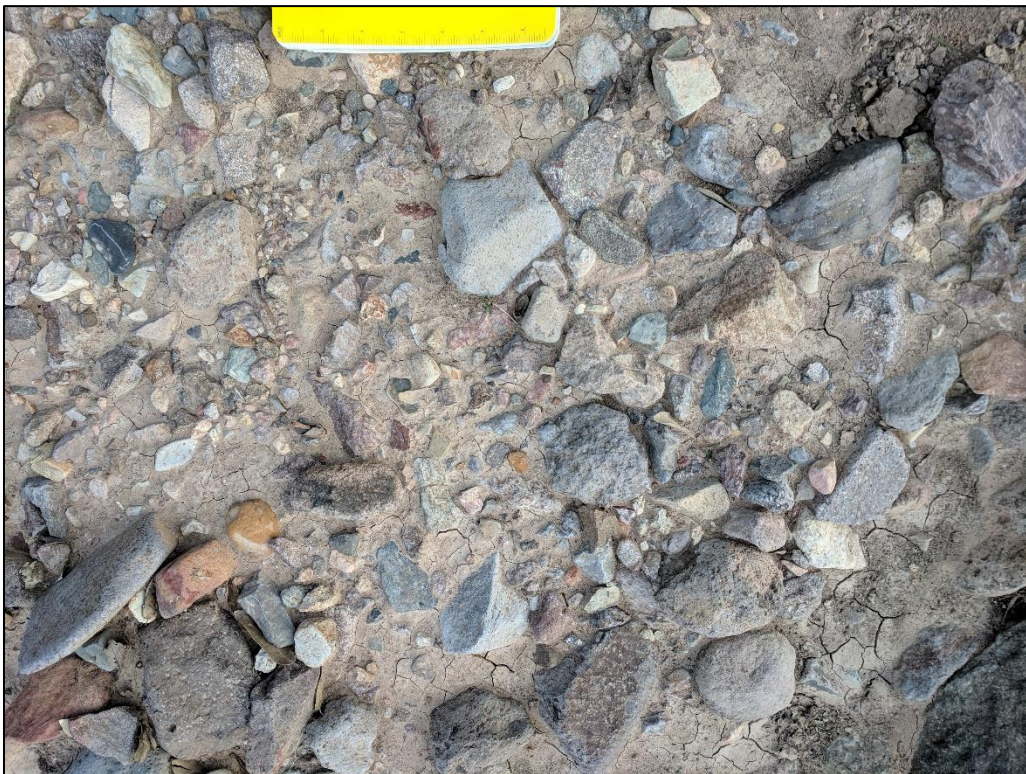
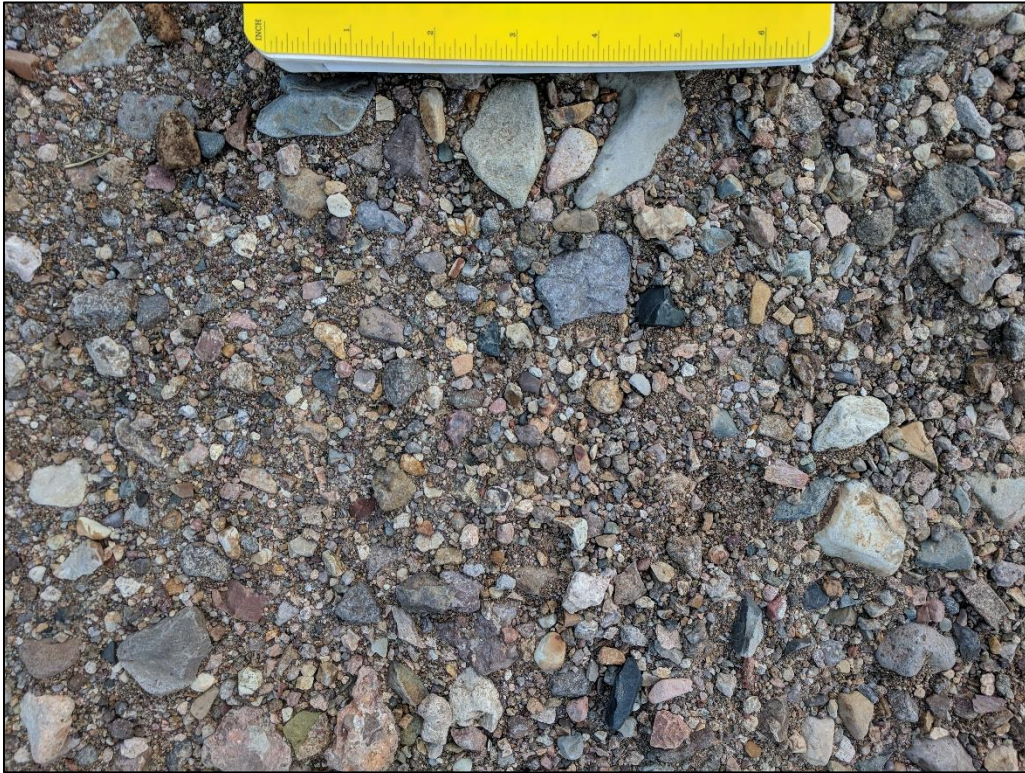
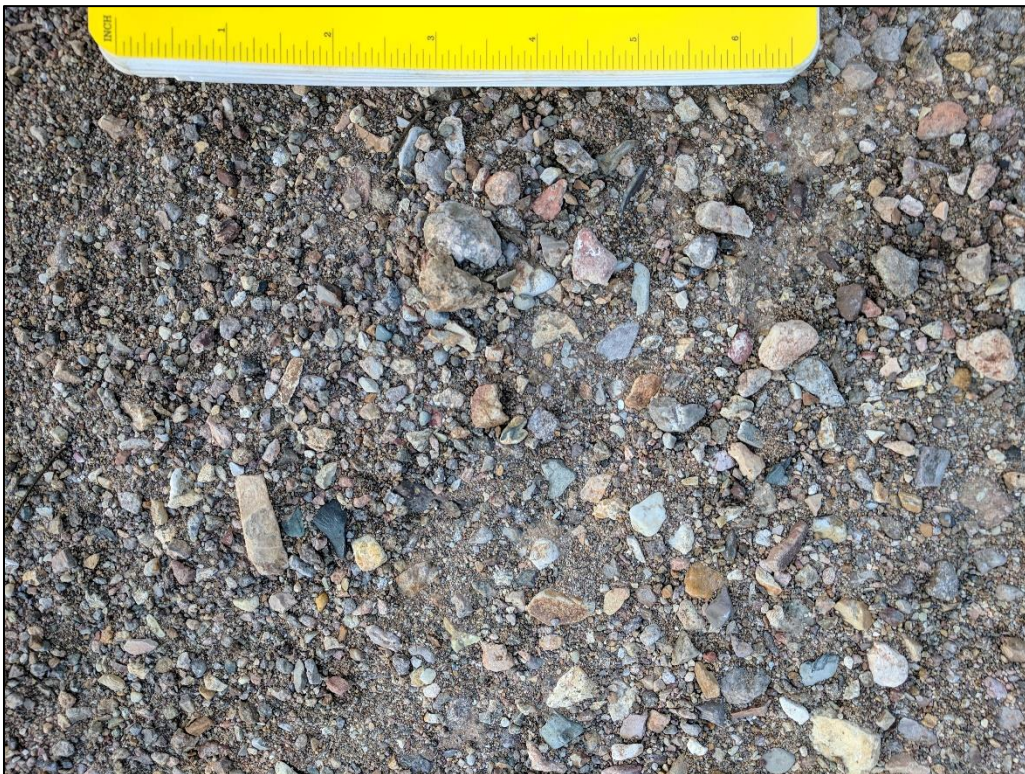
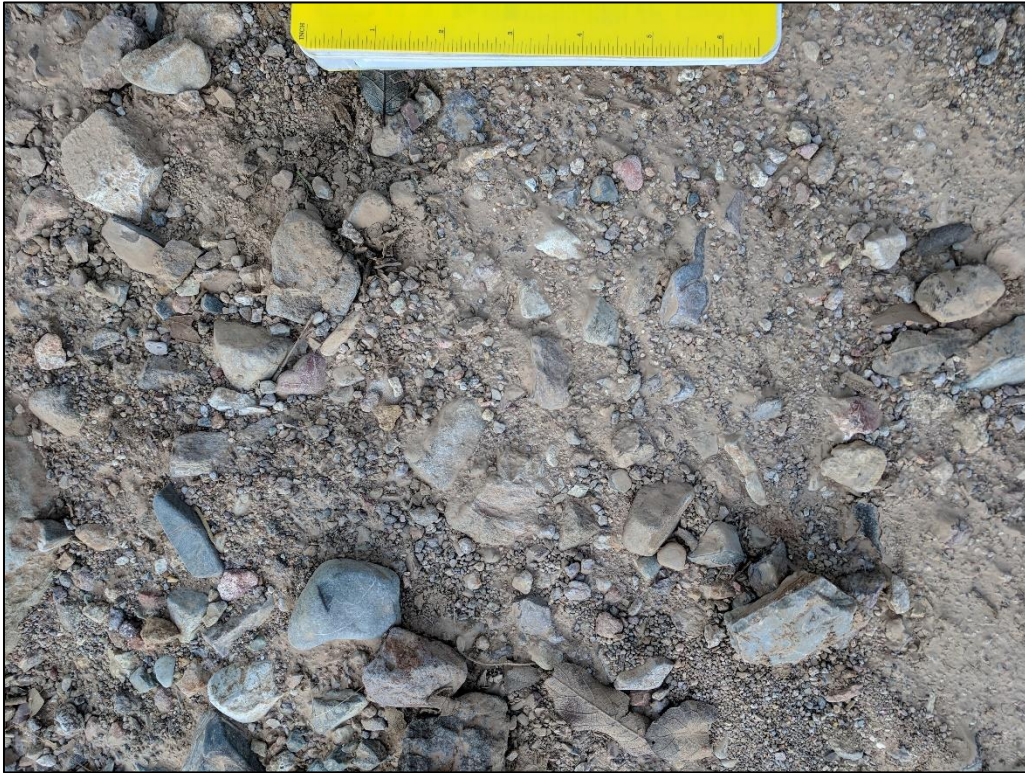
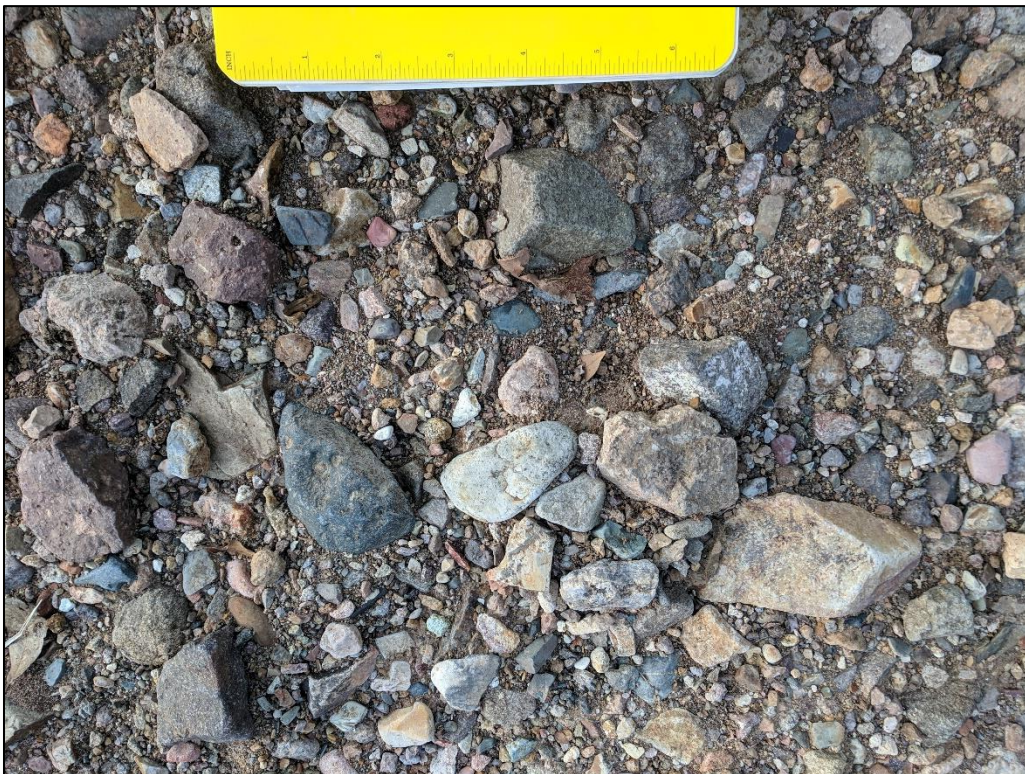
Figure A13 – Site 3 Channel Bed Surface Material (East Branch)

Figure A14 – Site 3 Channel Bed Surface Material (East Branch)

Figure A15 – Site 3 Channel Bed Surface Material (West Branch)

Figure A16 – Site 3 Channel Bed Surface Material (West Branch)

Figure A17 – Site 3 Channel Bed Surface Material (Downstream of Junction)

Figure A18 – Site 3 Channel Bed Surface Material (Downstream of Junction)
