Hermosa Project – Trench Camp Property

Aquifer Protection Permit SIGNIFICANT Amendment Application

P-512235

Santa Cruz County, Arizona

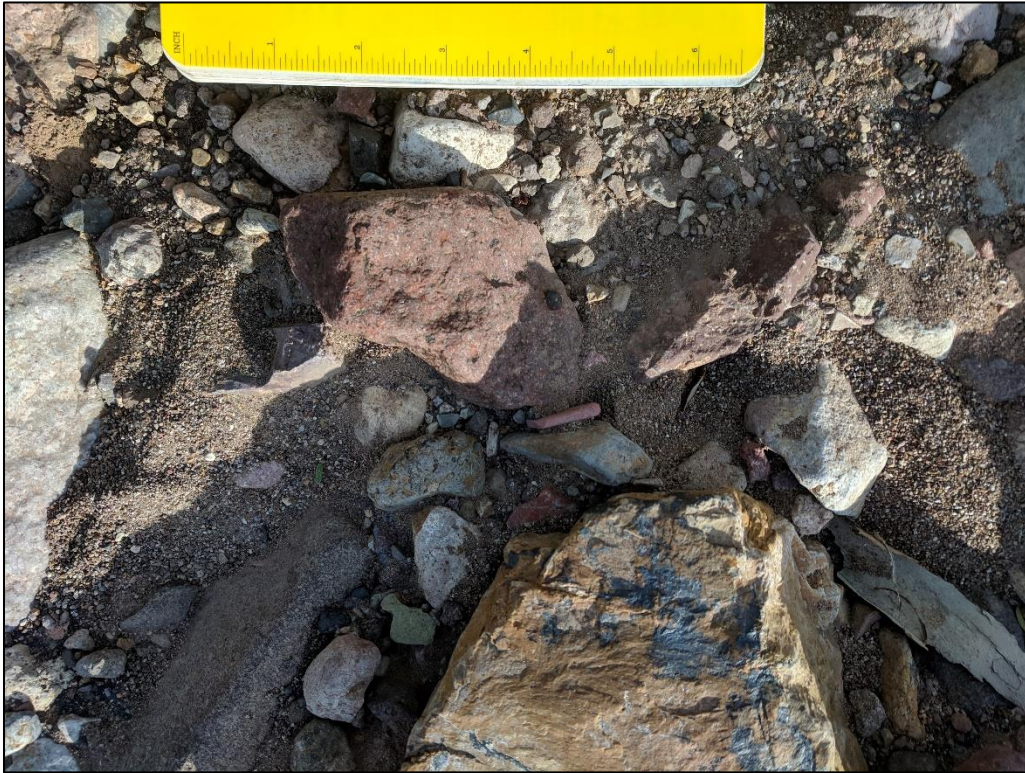
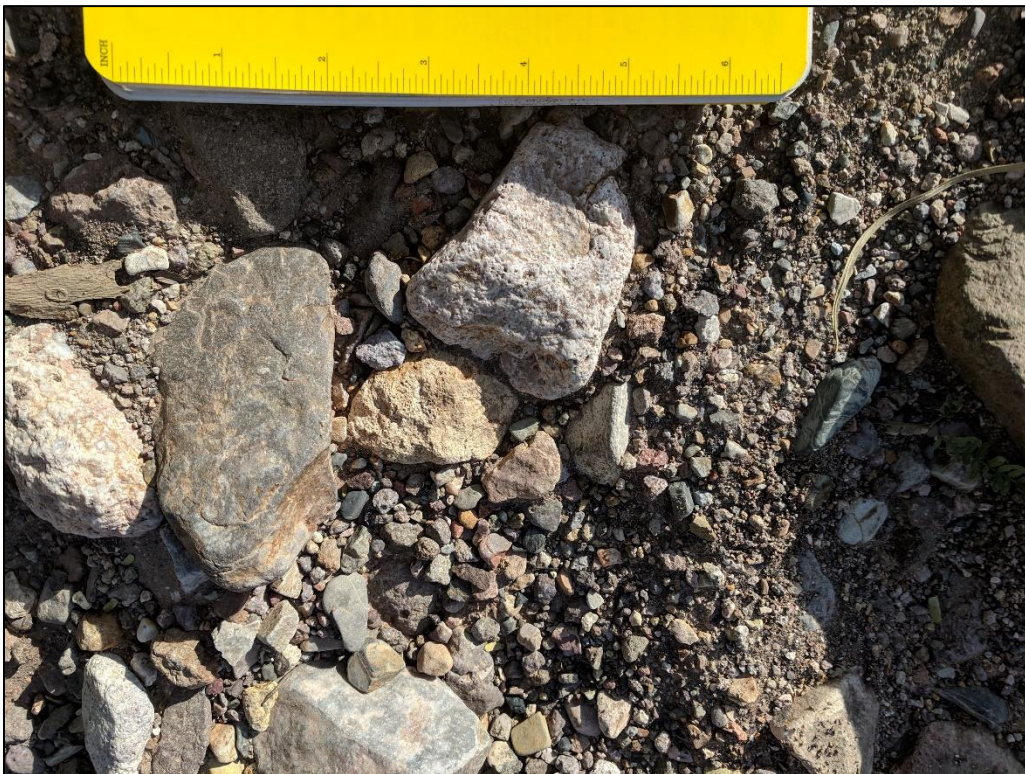
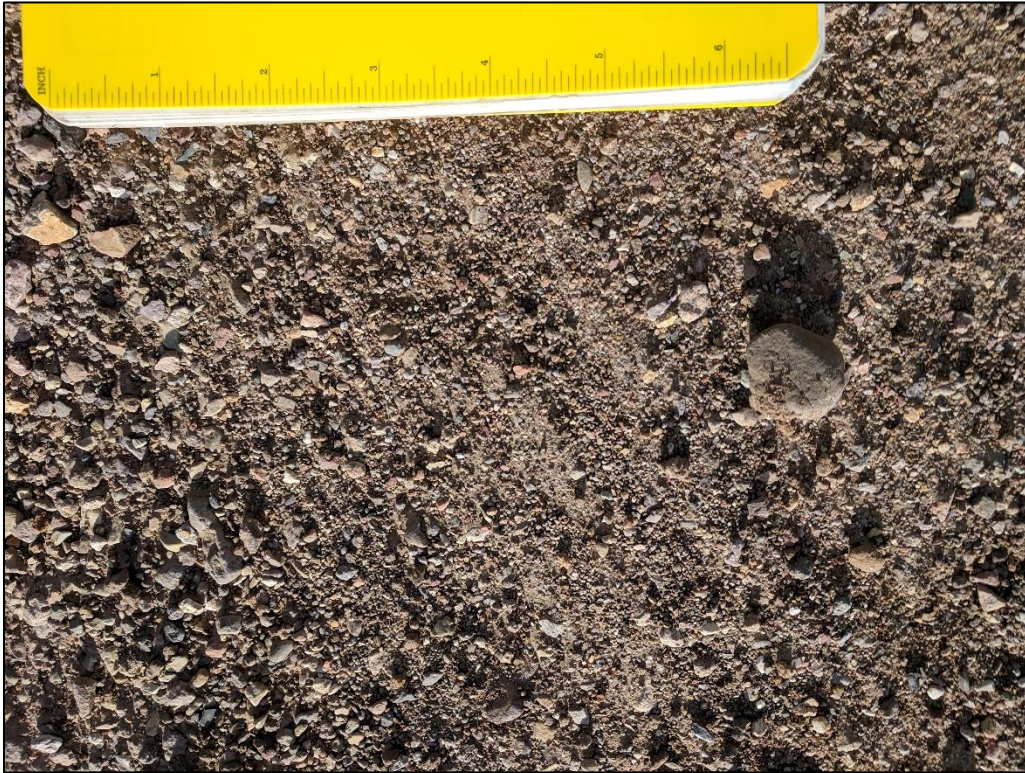
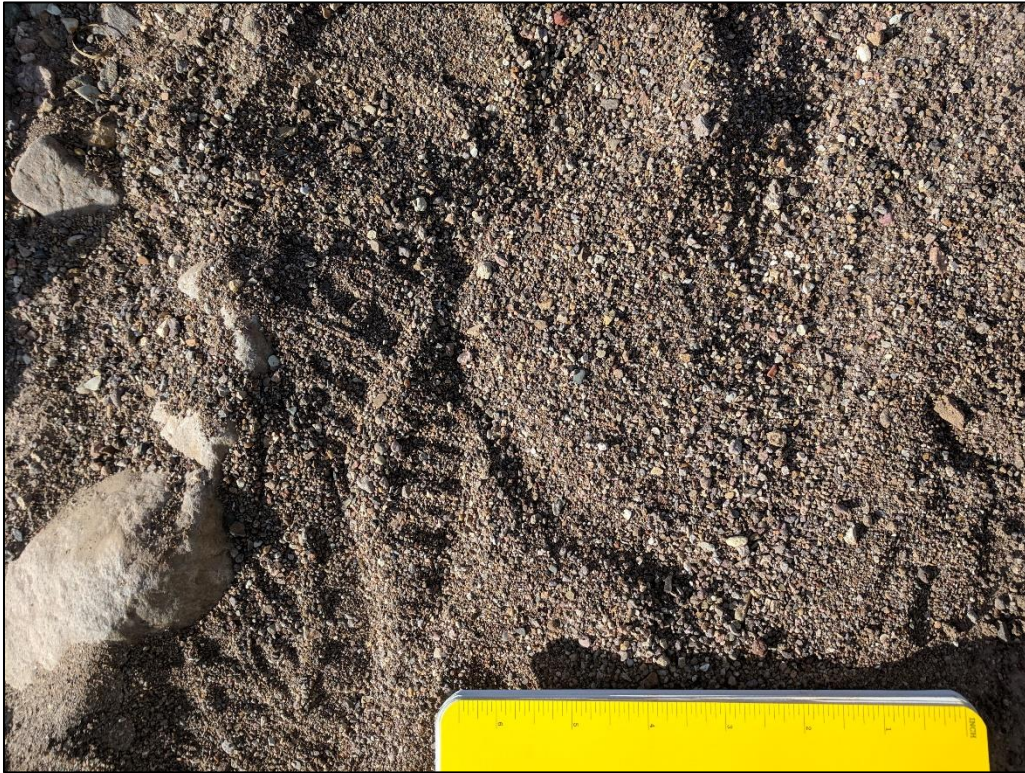
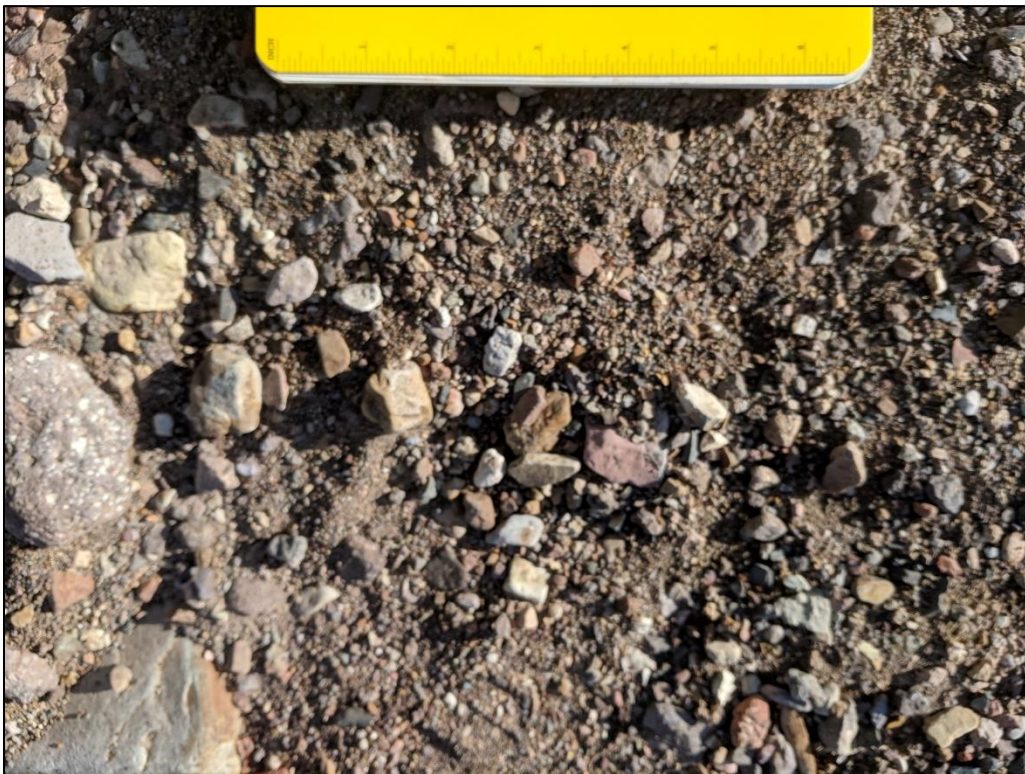
Figure A19 – Site 4 Channel Bed Surface Material

Figure A20 – Site 4 Channel Bed Surface Material

Figure A21 – Site 4 Channel Bed Surface Material

Figure A23 – Site 4 Channel Bed Surface Material

Figure A24 – Site 4 Channel Bed Surface Material

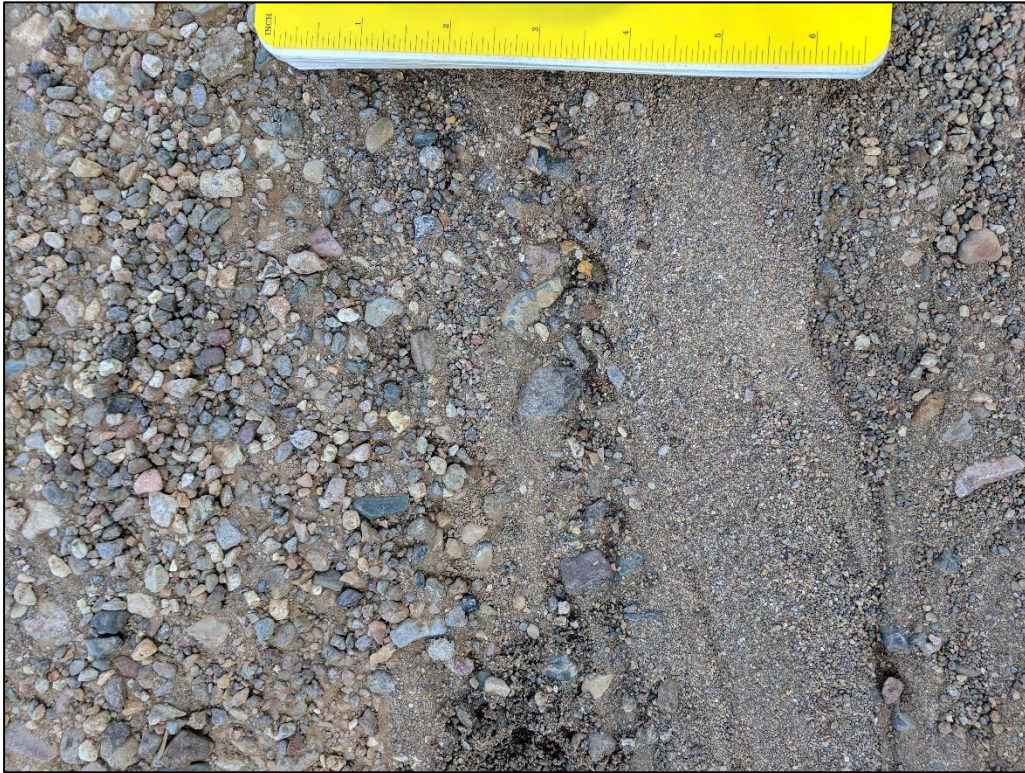
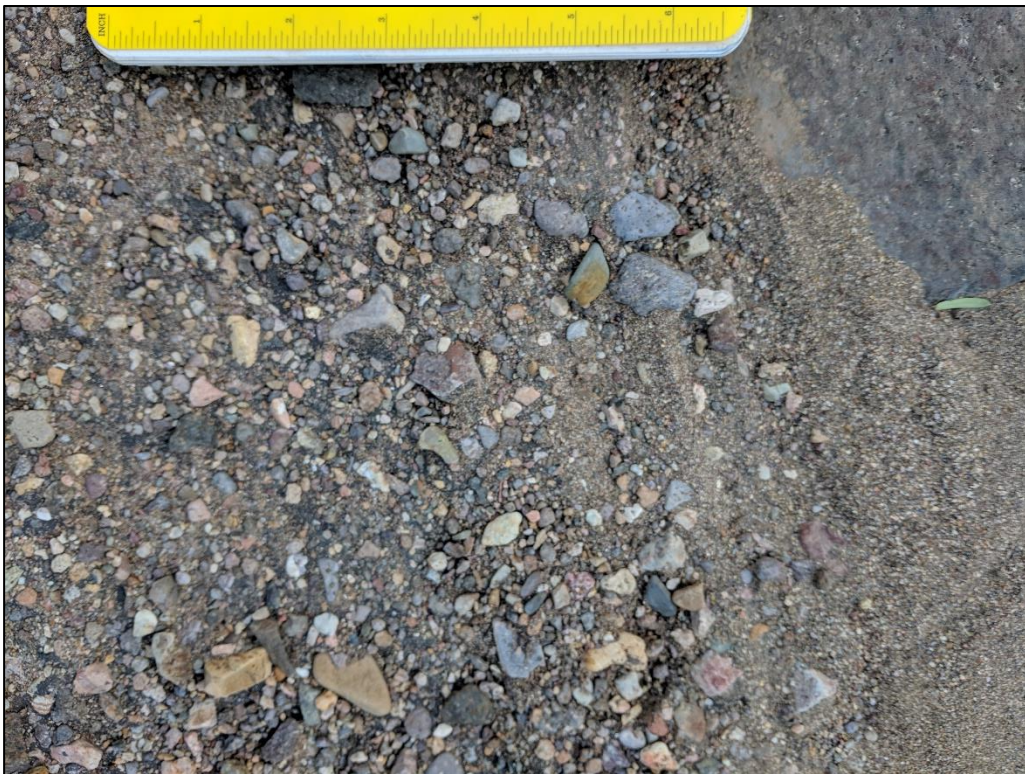
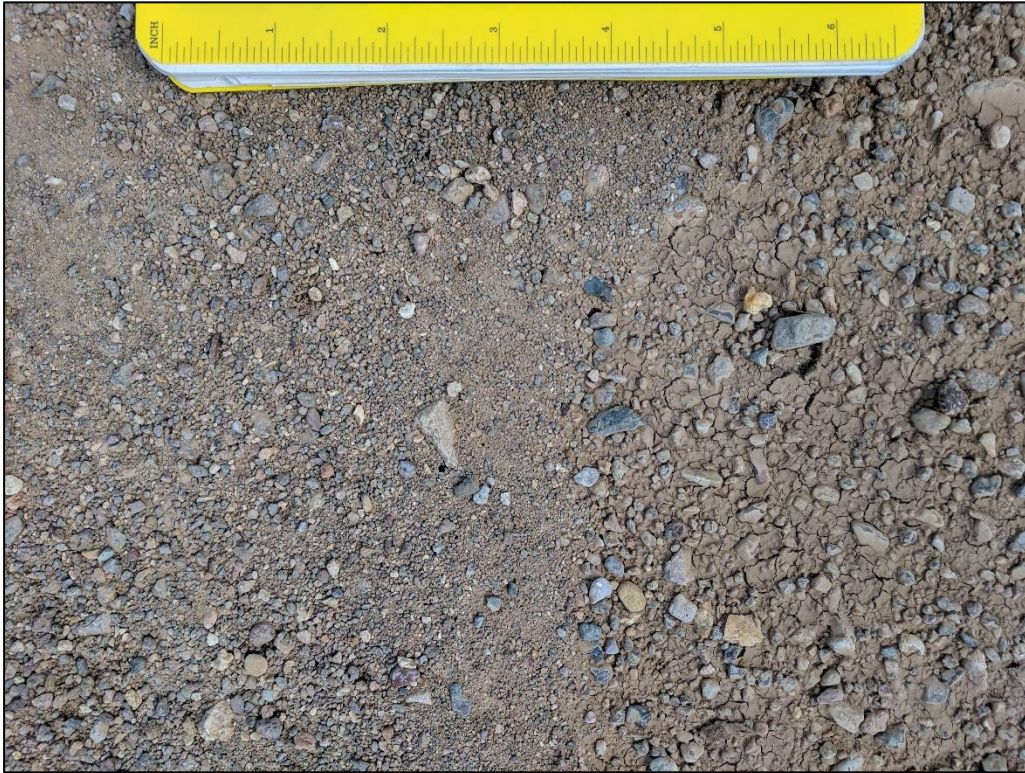
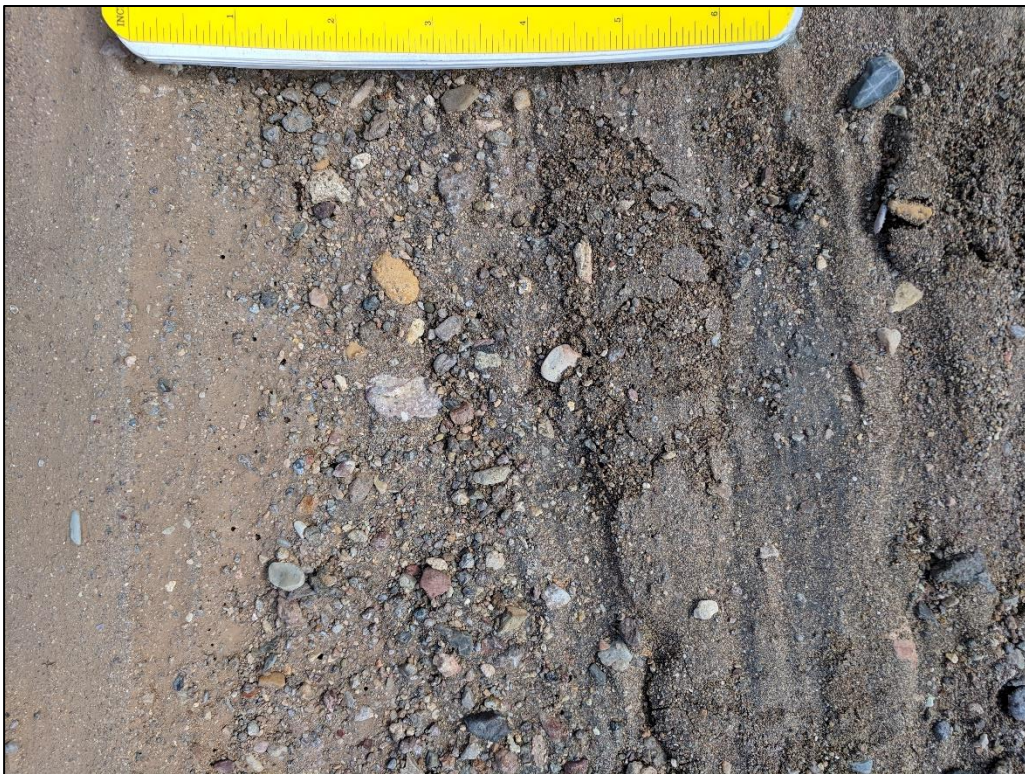
Figure A25 – Site 5 Channel Bed Surface Material

Figure A26 – Site 5 Channel Bed Surface Material

Figure A27 – Site 5 Channel Bed Surface Material

Figure A28 – Site 5 Channel Bed Surface Material
