SURFACE WATER PROTECTION (SWP) - INSPECTION REPORT

Facility Name (PLACE): January Adit (Norton Mine) Facility Type: Mine or Mill Site Permit Number (LTF): 85604 Alternative Permit ID: AZ0026387 County: Santa Cruz	Inspection ID: 430750 Type of Inspection: <input checked="" type="checkbox"/> Announced Compliance Inspection <input type="checkbox"/> Unannounced Compliance Inspection <input type="checkbox"/> Complaint Inspection - Complaint ID: <input type="checkbox"/> Follow-Up Inspection:
Physical Location: 749 Harshaw Rd. City, State, Zip: Patagonia, AZ, 85624 Mailing Address: 1860 E River Rd Ste 200 City, State, Zip: Tucson, AZ, 85718	Lead Inspector (Author): Steven Saeed Inspector Email: Saeed.steven@azdeq.gov Inspector Phone: (520) 419-7322 Additional Inspectors: None
Permittee (CUSTOMER): South32 Hermosa Inc. Address: 1860 E River Rd Ste 200 Phone: (803) 235-5563 Email: Jpappas@arizonamining.com	Inspection Date: September 27, 2023 Weather: Sunny Start Time: 0925 End Time: 1530

Introduction This inspection was a routine inspection of the January Mine Hermosa Project for compliance with the Arizona Pollutant Discharge Elimination System (AZPDES) Individual Permit (Permit No. AZ00

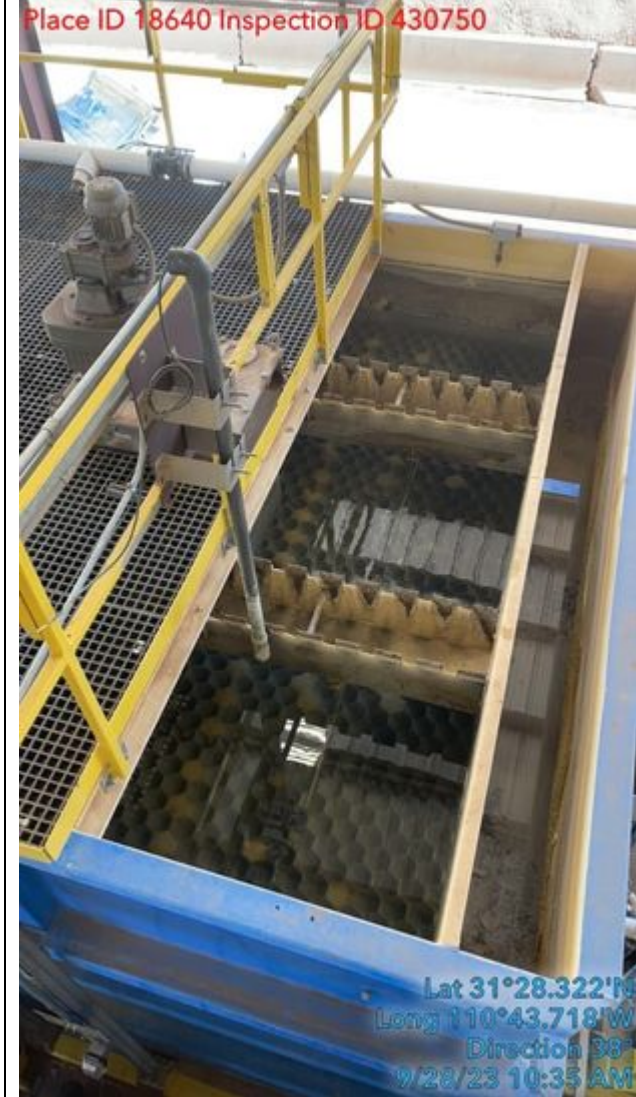
Photo #: 3	Direction: East	Description: Clarifier. Lime is added to drop metals out of solution. pH is increased to approximately 10.5.
------------	-----------------	--

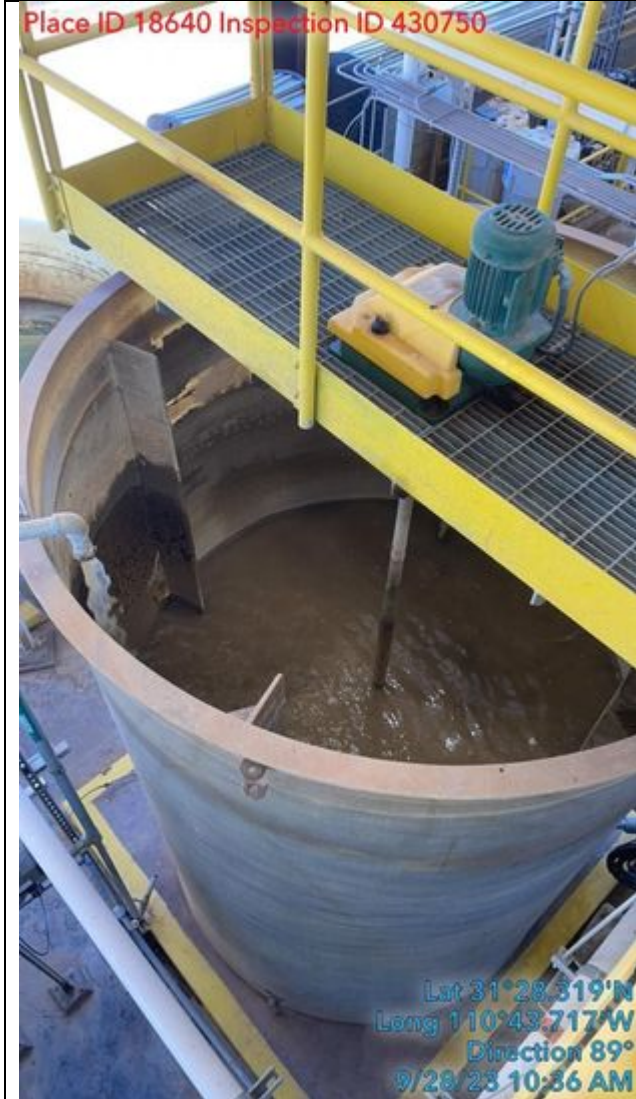
Photo #: 4	Direction: East	Description: Sludge tank. The solids that are collected on the bottom of the clarifier then flow with some water into this tank, the "sludge tank". Mixing occurs within this tank. The sludge will then flow to the filter press.
------------	-----------------	--

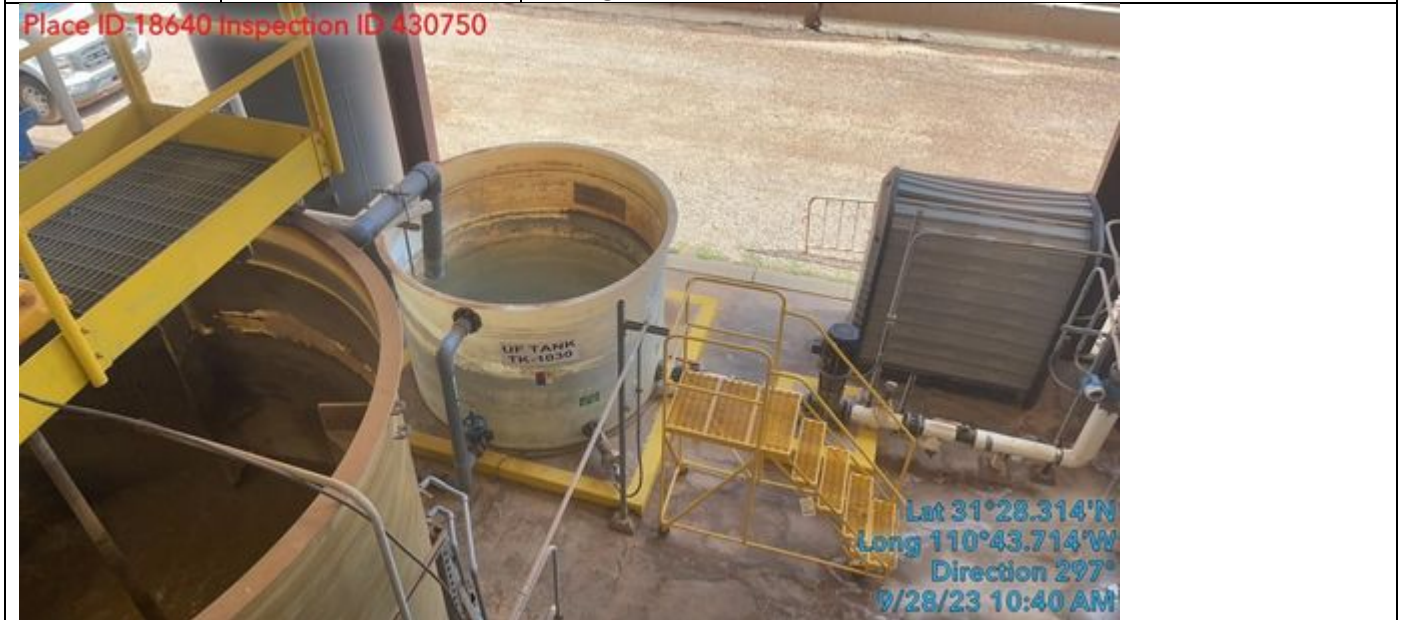
Photo #: 5	Direction: East	Description: The clarified water from the clarifier then goes to the "UF Tank", or "Ultra Filtration Tank". This clarified water then gets pumped through the Ultra Filtration media.
------------	-----------------	---

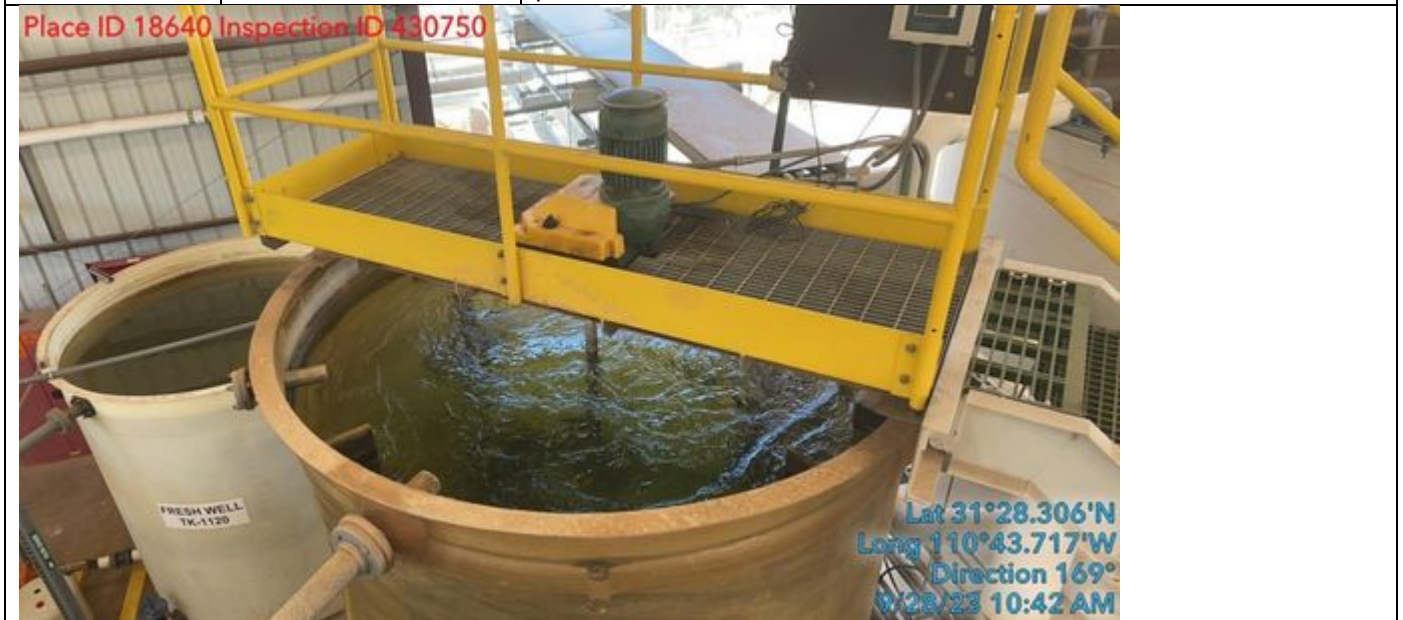
Photo #: 6	Direction:	Description: "pH Adjust Tank". After the ultra filtration, the water then flows into this pH adjust tank, where sulfuric acid is added to bring the pH back down to about 9.
------------	------------	--

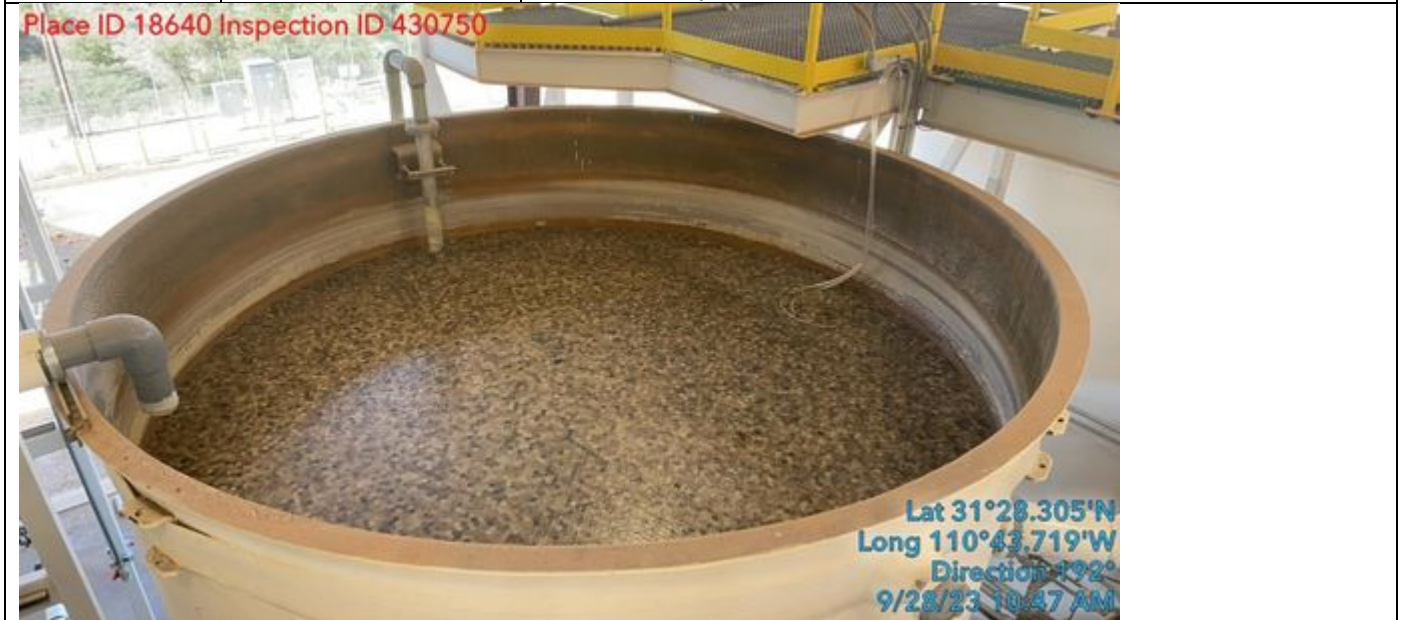
Photo #: 7	Direction: West	Description: MBBR. Moving bed bio reactor. The water then gravity flows into the MBBR. Which was designed for treating ammonia. However, they site has not needed to treat for ammonia.
------------	-----------------	---

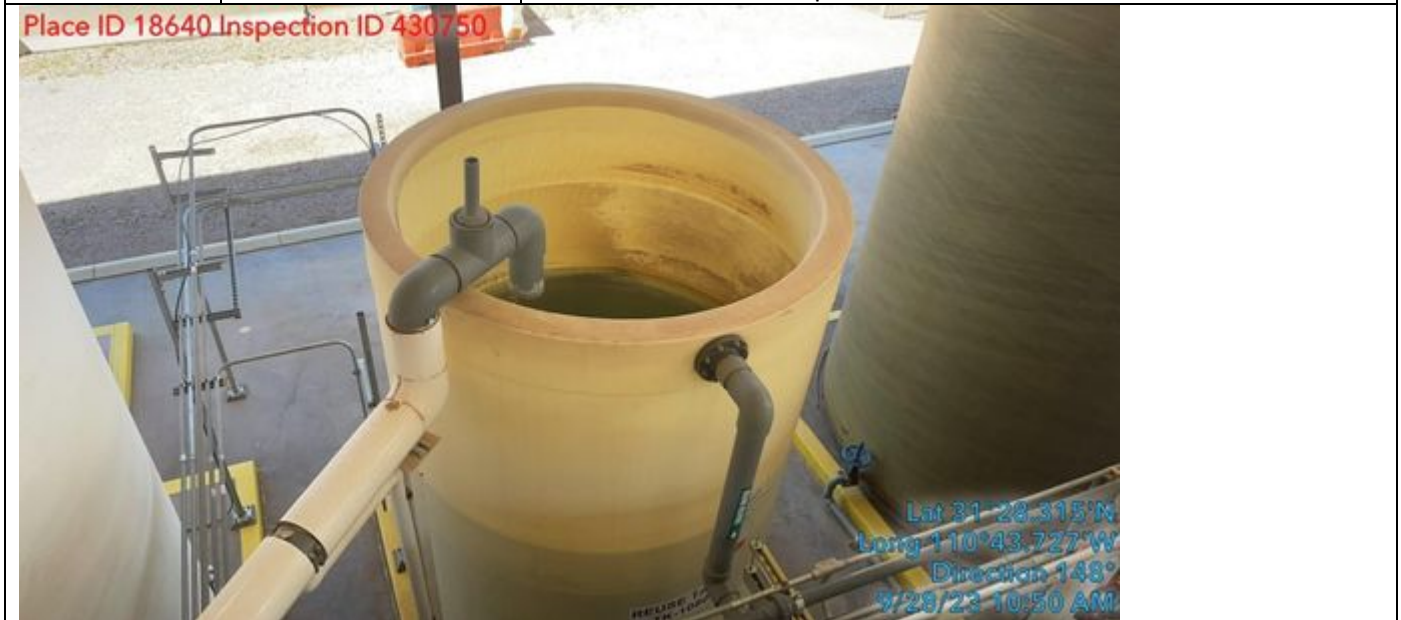
Photo #: 8	Direction:	Description: Resuse tank. After the water the flows through the MBBR, the treated water then is stored in this reuse tank. Once the water reaches a certain level, the treated water is automatically pumped to the construction water pond.
------------	------------	--

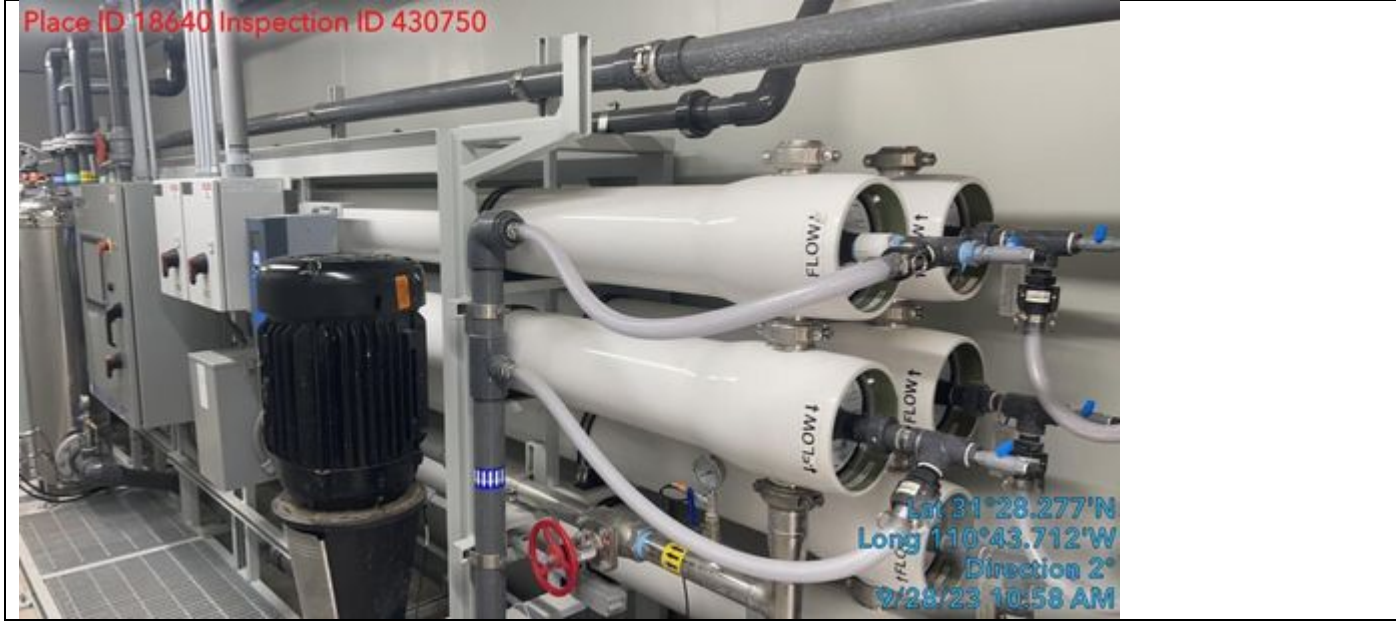
Photo #: 9	Direction: n/a	Description: Nano filtration for sulfates. Anti scalant is added so the filters don't get clogged
------------	----------------	---

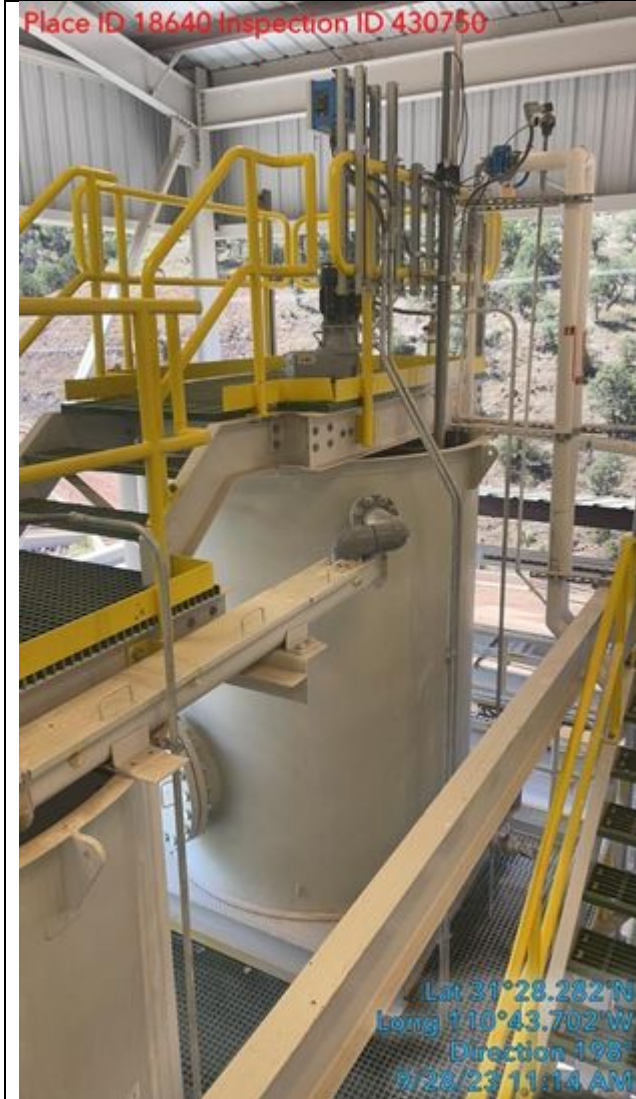
Photo #: 10	Direction: West	Description: Reactor 1. Concentrate from the nano filters then flows to Reactor 1. Desaturation occurs with ferric chloride. Mixing is occurring so the solids don't settle out. Lime is added to increase the pH to approximately 10.9. Calcium sulfate is also added
-------------	-----------------	--

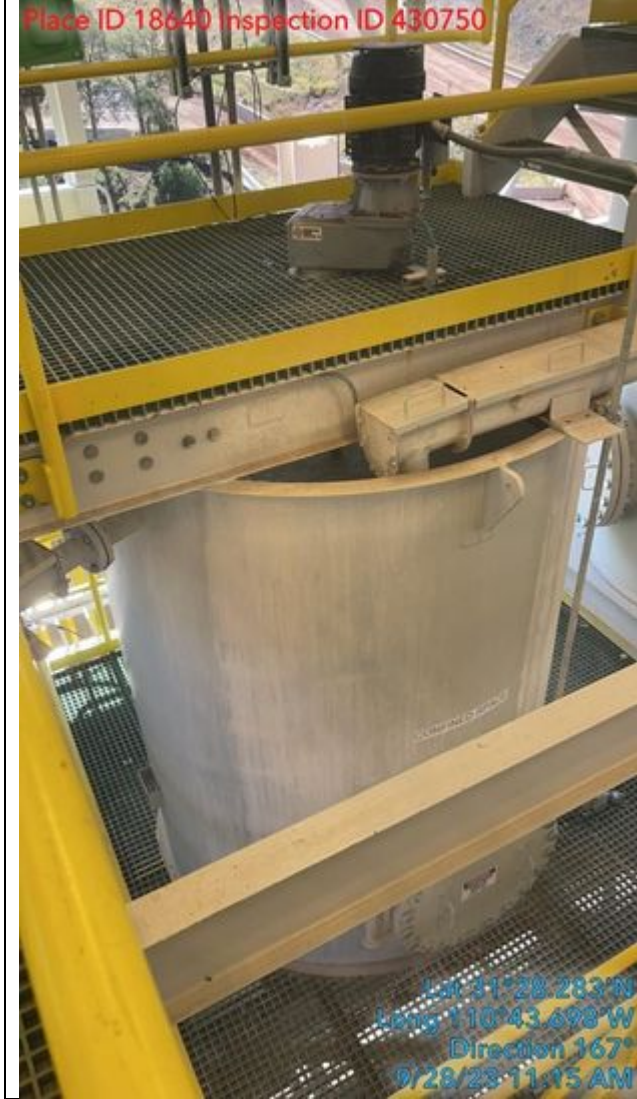
Photo #: 11	Direction: Southwest	Description: Reactor 2. More contact time with ferric chloride and lime.
-------------	----------------------	--

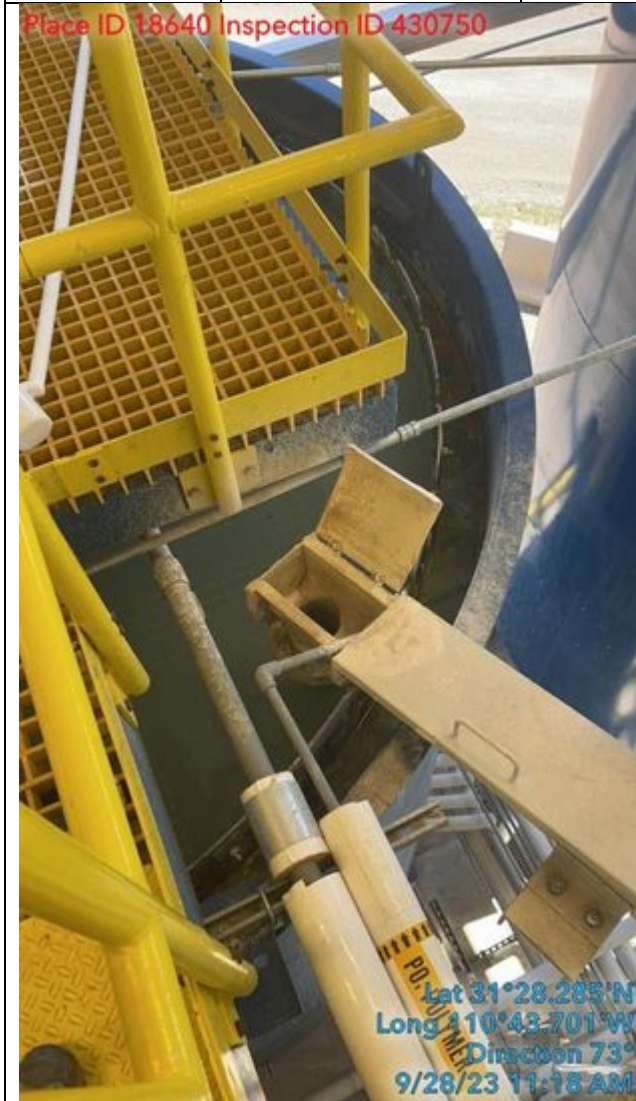
Photo #: 12	Direction: n/a	Description: Water flows from reactor 2 into the desaturation clarifier. Polymer is added to drop solids, including calcium sulfate, out of solution. Once the density in the clarifier becomes 25% solids, they'll send some solids to the filter press.
-------------	----------------	---

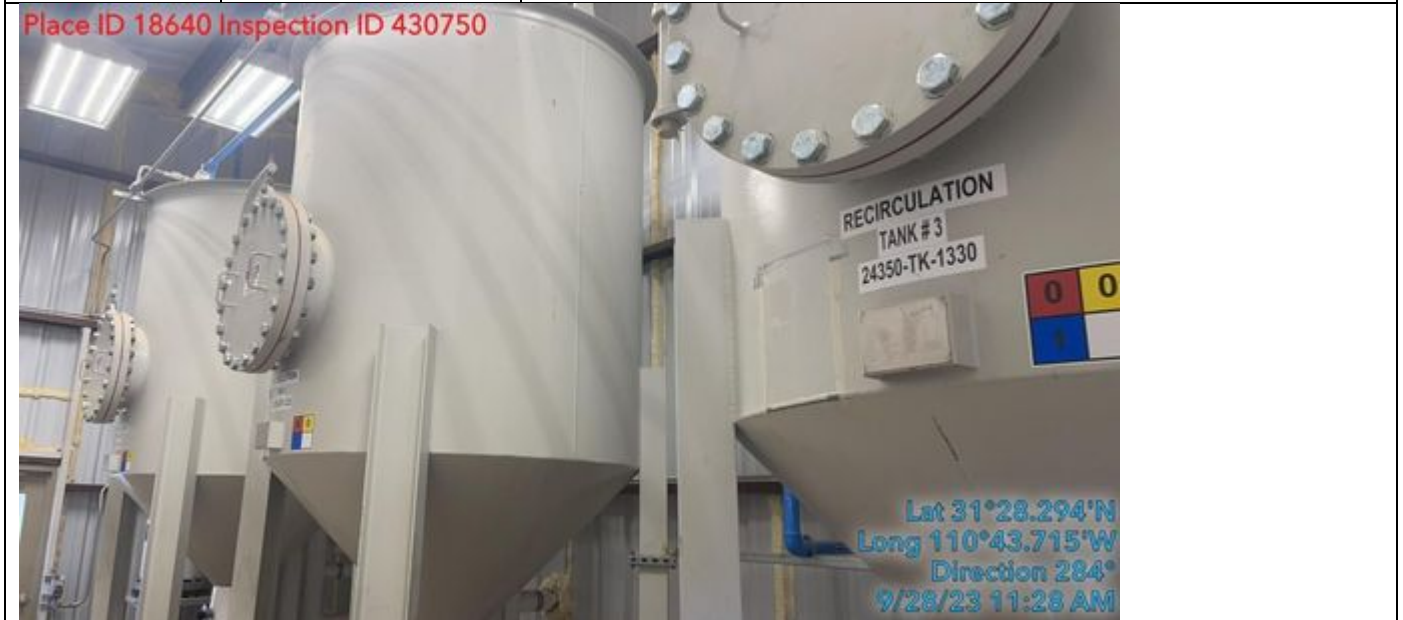
Photo #: 13	Direction: n/a	Description: From the desaturation clarifier, the water then flows to an ERC feed tank, which then pumps the water into one of three circulation tanks. The circulation tanks circulates the water through one of three ERC units.
-------------	----------------	--

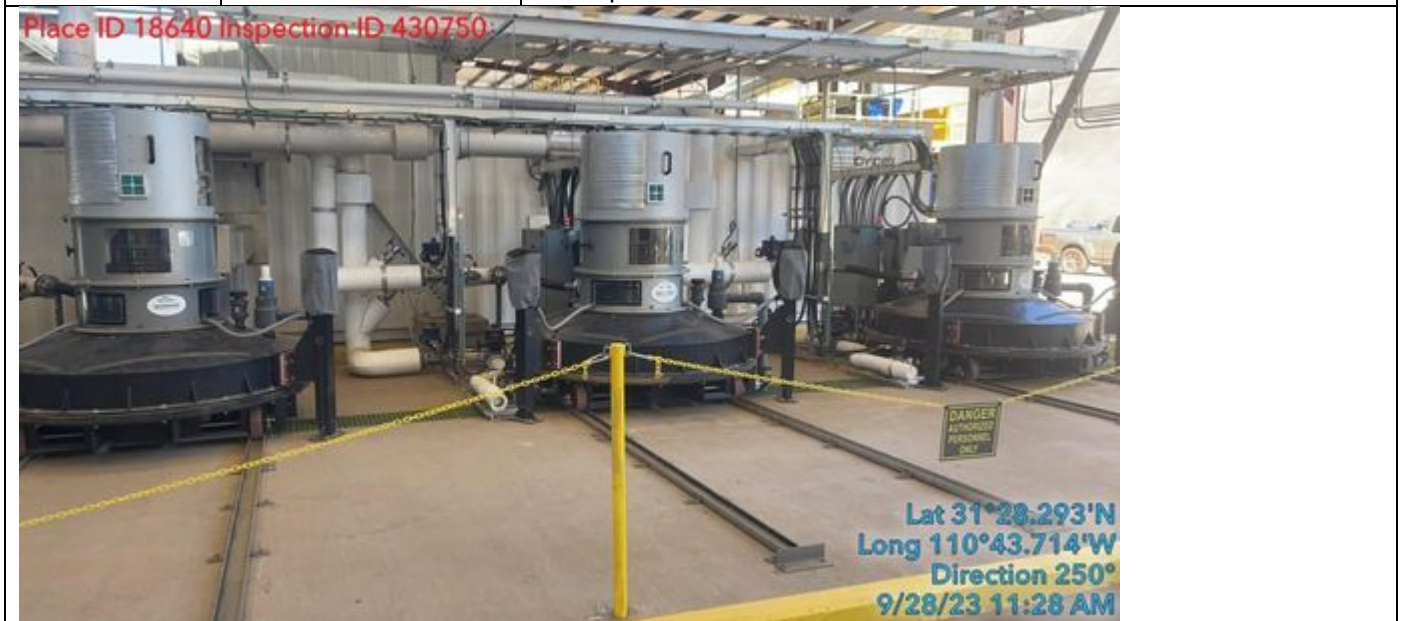
Photo #: 14	Direction: North	Description: Three ERC Units.
-------------	------------------	-------------------------------

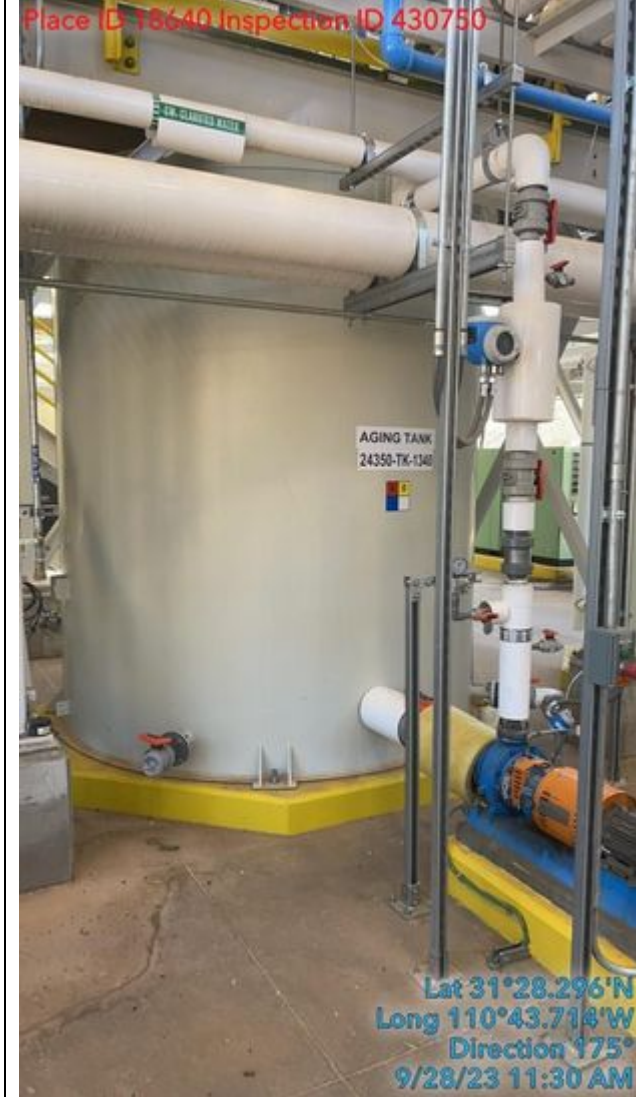
Photo #: 15	Direction:	Description: After the water is circulated through an ERC, the water is then maintained in this aging tank to give more contact time.
-------------	------------	---

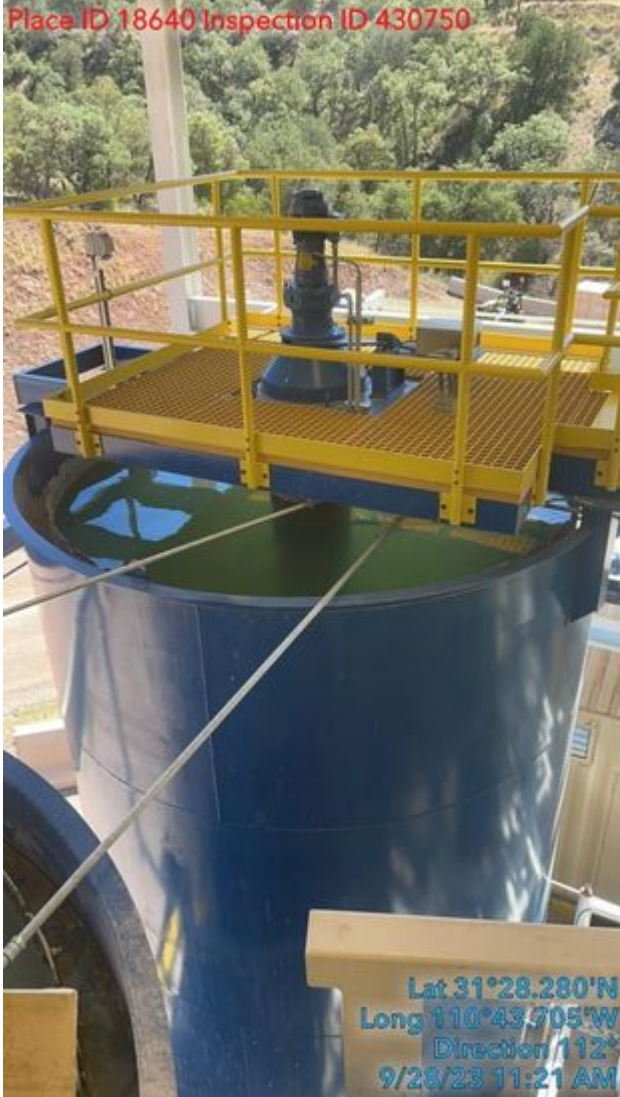
Photo #: 16	Direction:	Description: From the aging tank, the water is then transferred to the ERC clarifier where a different type of polymer is added.
-------------	------------	--

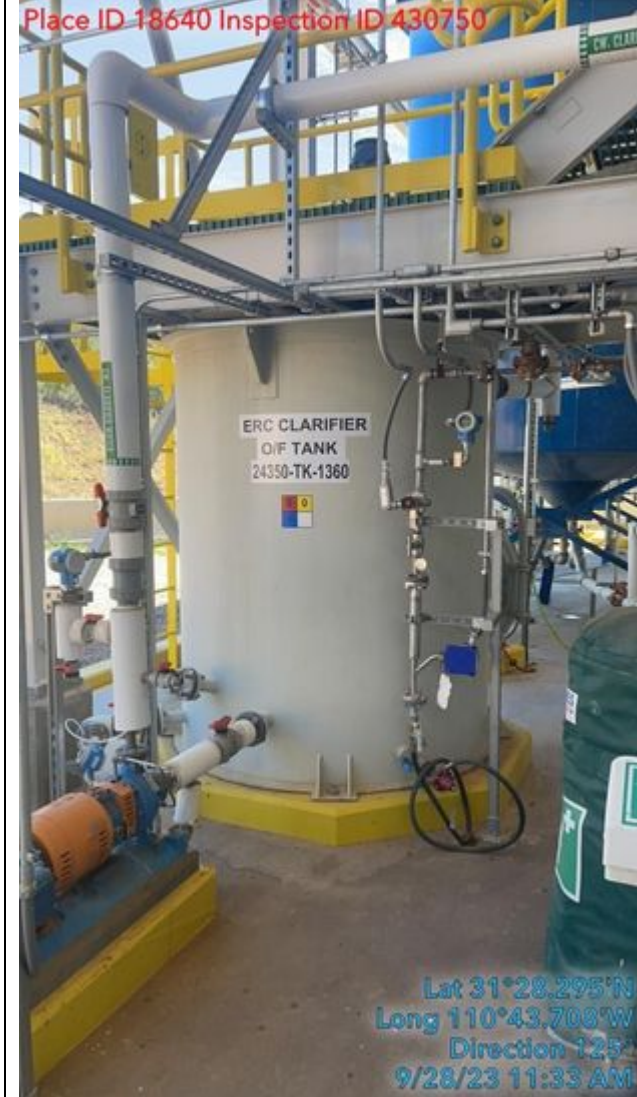
Photo #: 17	Direction:	Description: From the ERC clarifier, the water flows into this ERC clarifier Overflow Tank.
-------------	------------	---

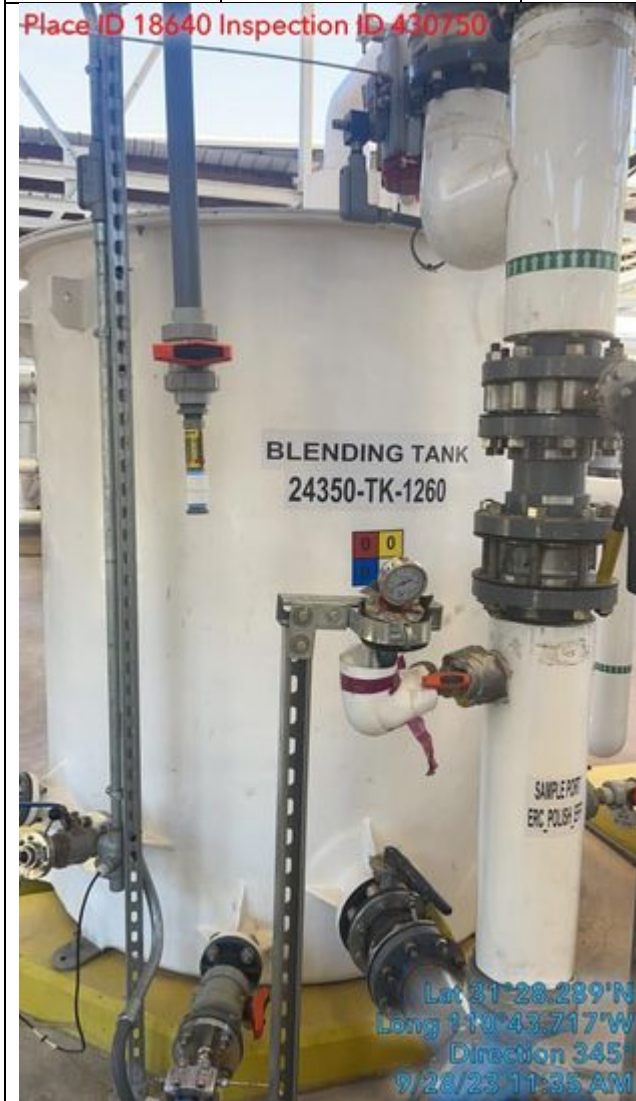
Photo #: 18	Direction:	Description: From the ERC Clarifier Over Flow tank, the water then flows to a his blending tank which includes a baffle. Sodium bicarbonate is added to reduce the pH to about 8. From here the water flows to the MBBR and subsequently the reuse tank.
-------------	------------	--

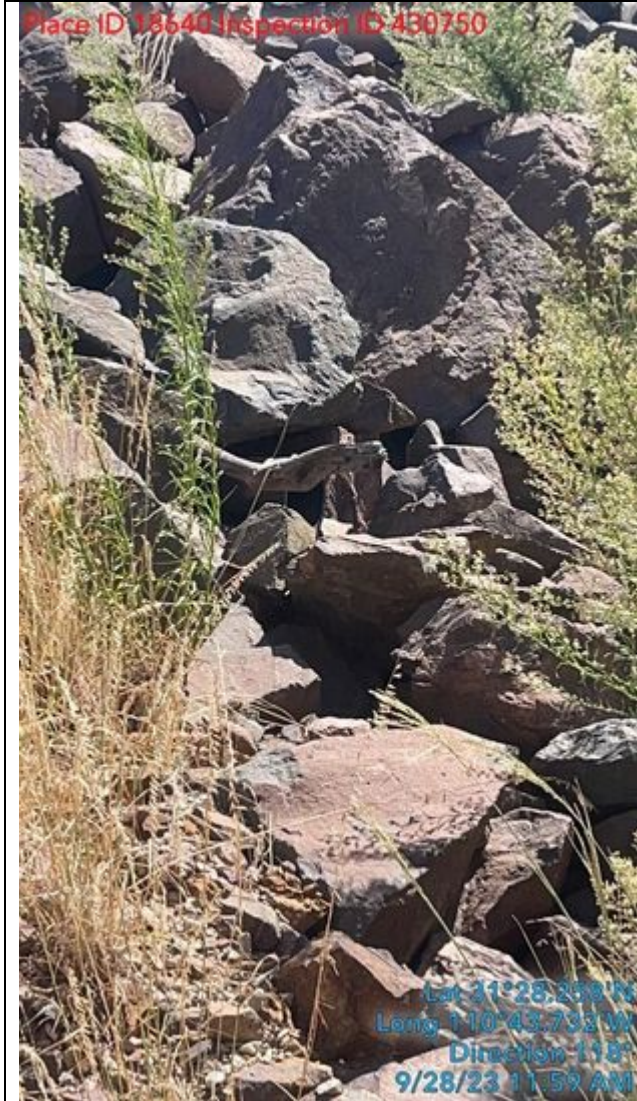
Photo #: 19	Direction: Northeast	Description: Outfall 001
-------------	----------------------	--------------------------

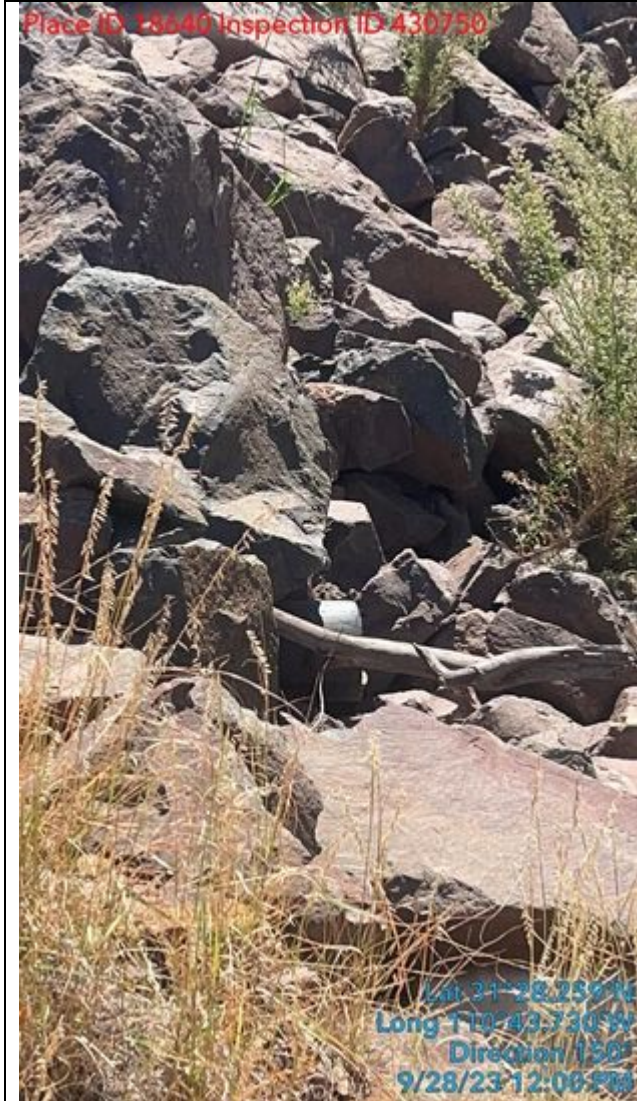
Photo #: 20	Direction: Southeast	Description: Outfall 001
-------------	----------------------	--------------------------

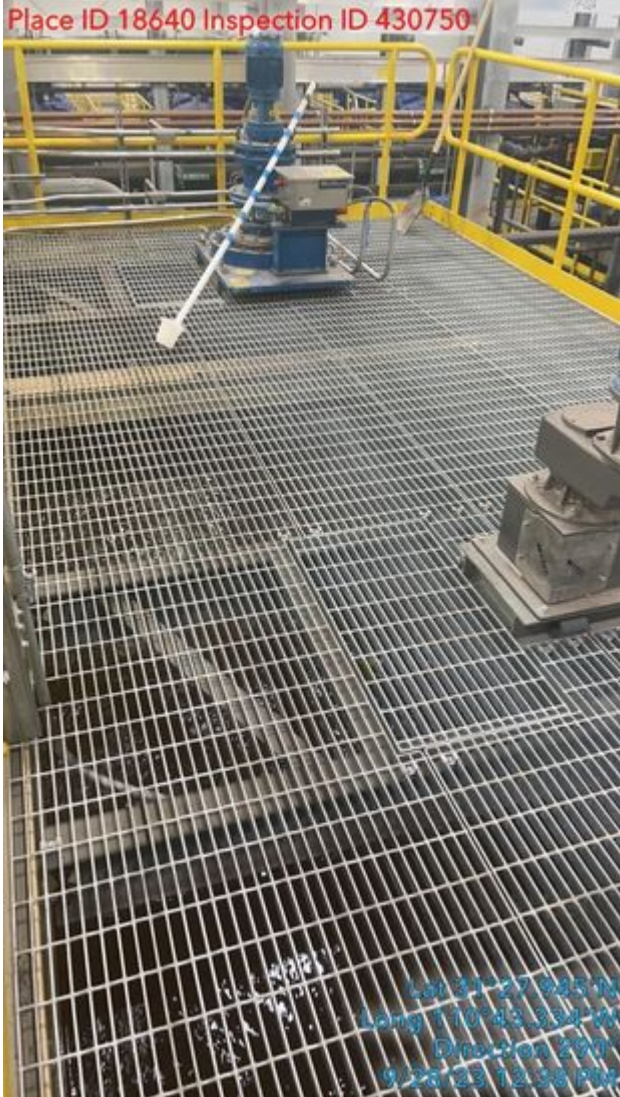
Description: Sand ballasted clarifier

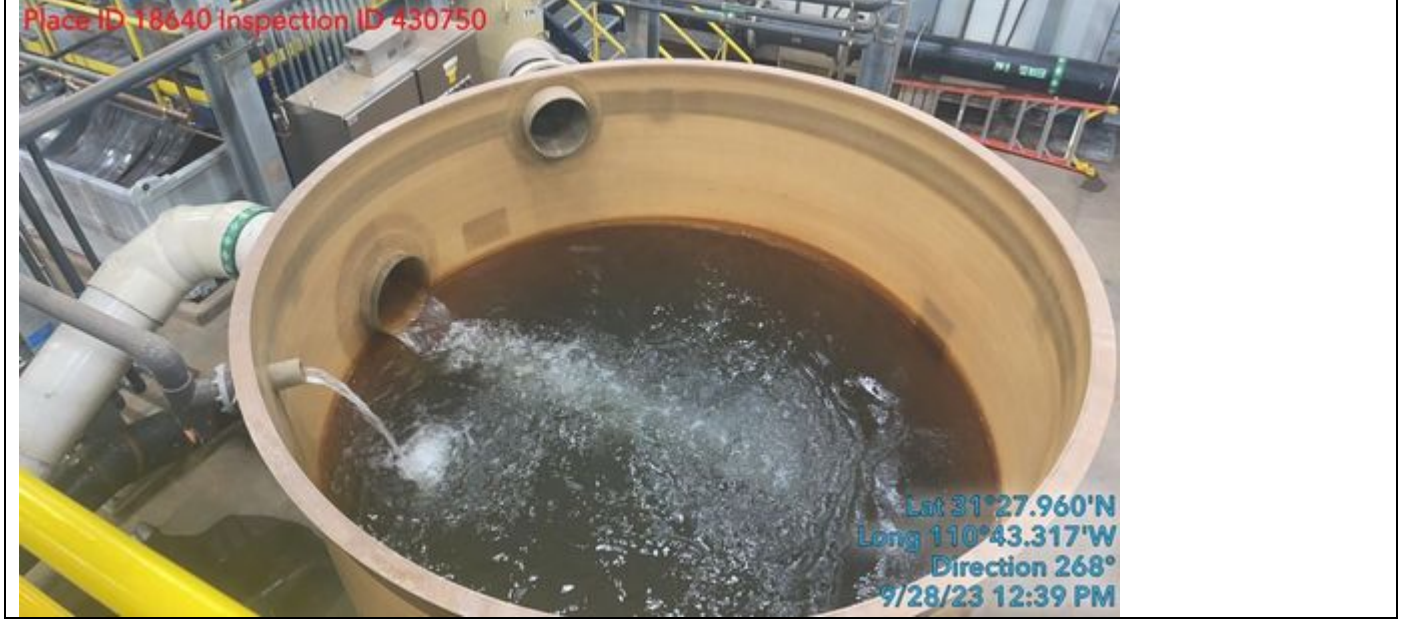
Photo #: 24	Direction: n/a	Description: Filter feed tank. Water from the sand ballasted clarifier is fed to here.
-------------	----------------	--

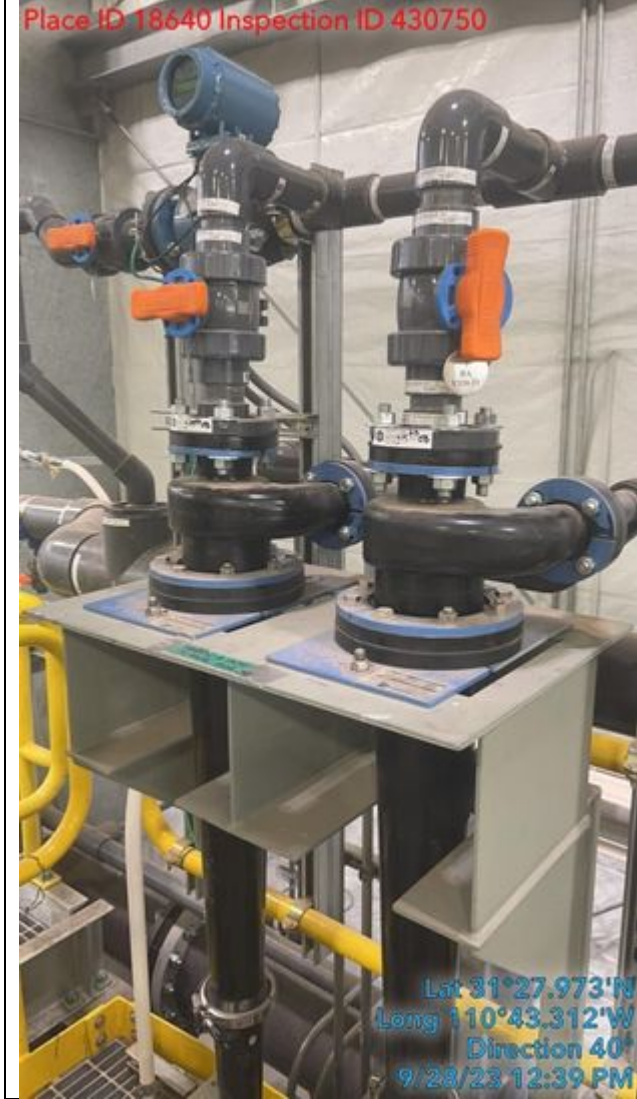
Photo #: 25	Direction: n/a	Description: The solids collected in the sand ballasted clarifier are collected using a hydro cyclone. The solids slurry is gravity fed
-------------	----------------	---

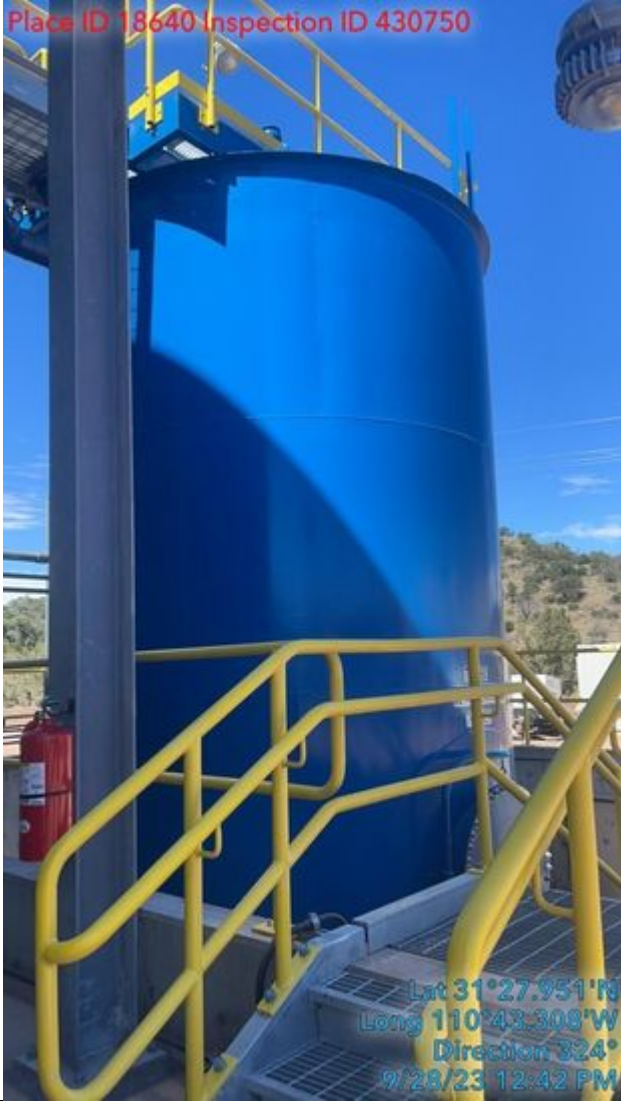
Photo #: 26	Direction: Northwest	Description: Metals remover thickener tank. Clarifier
-------------	----------------------	---

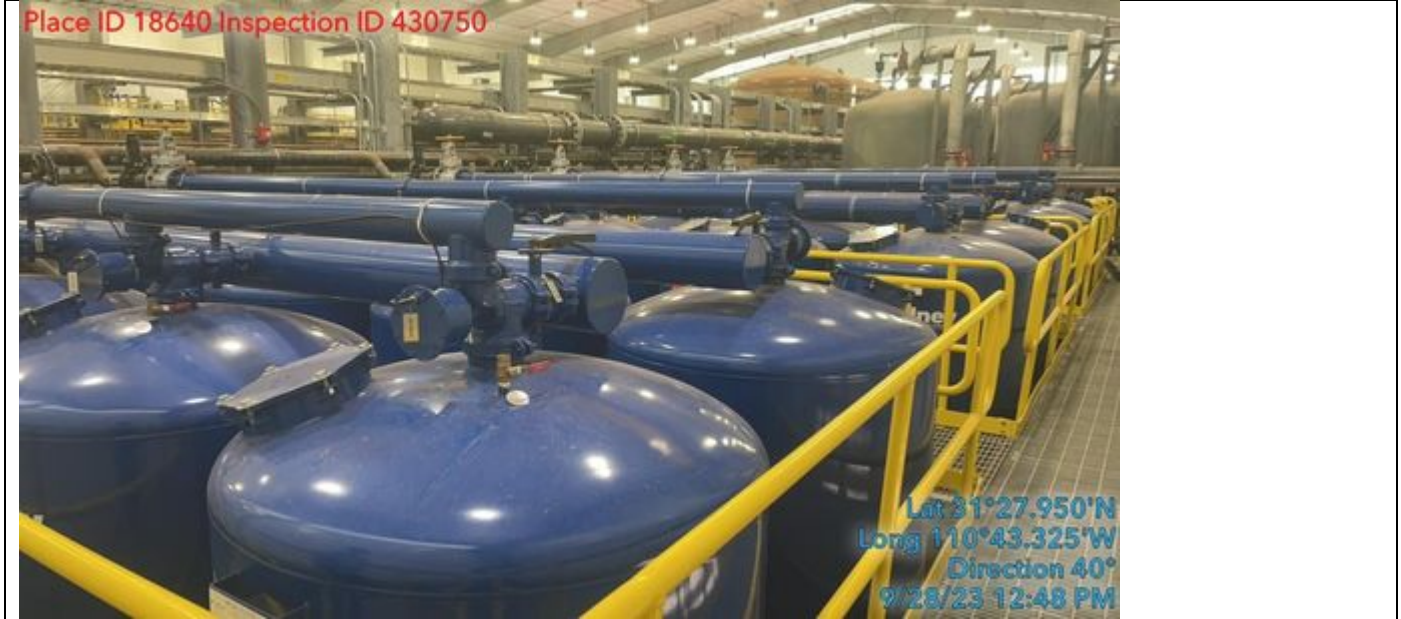
Photo #: 27	Direction: n/a	Description: Multi media filters. The water comes through these filters after the filter feed tank.
-------------	----------------	---

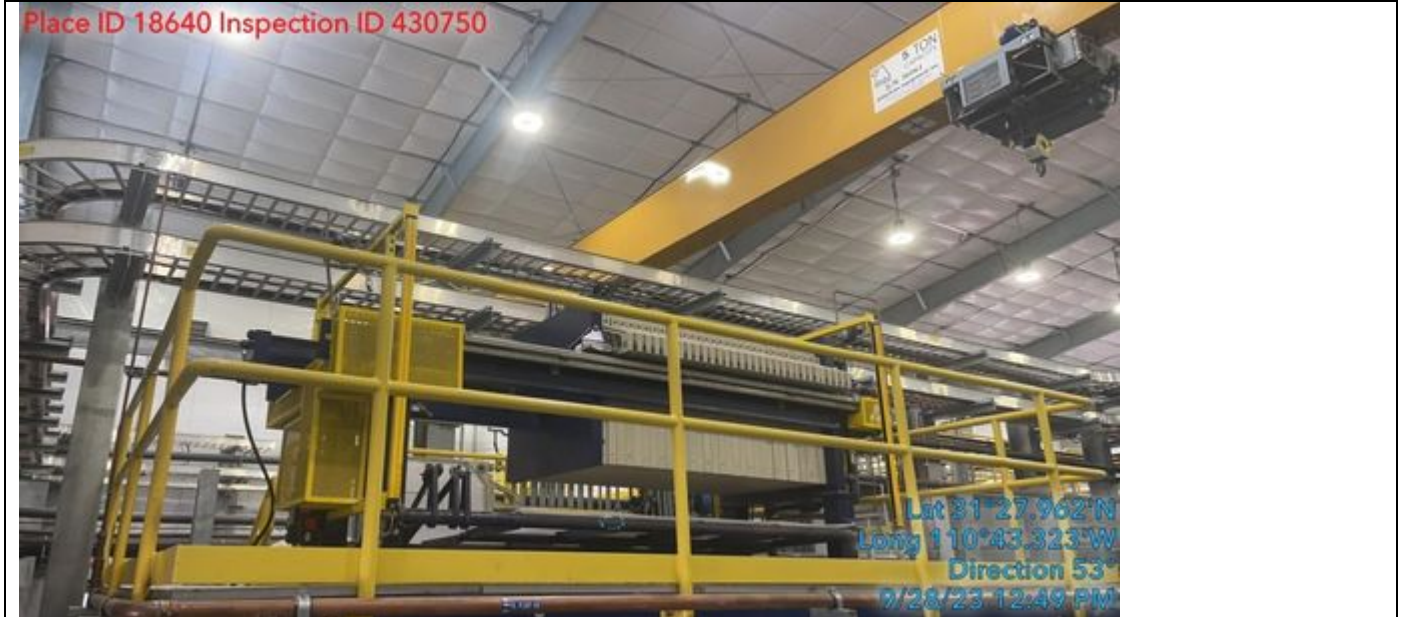
Photo #: 28	Direction: n/a	Description: Filter press for solids
-------------	----------------	--------------------------------------

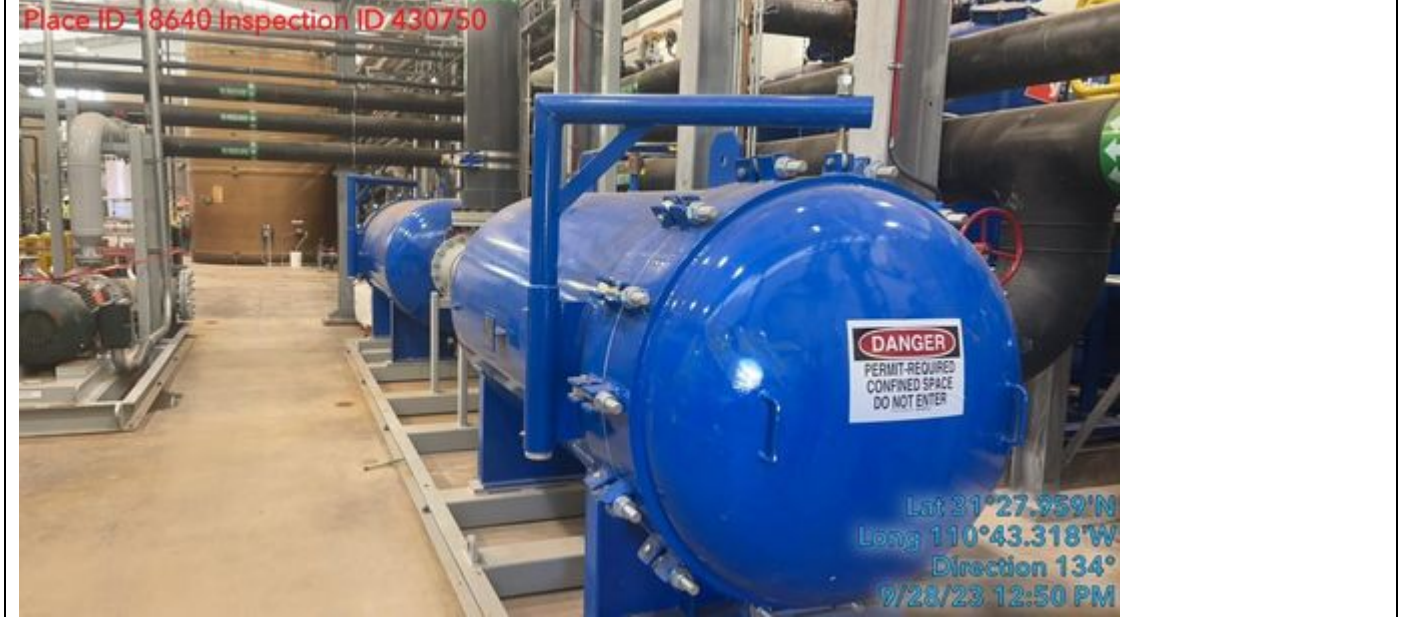
Photo #: 29	Direction: n/a	Description: Cartridge filters. After the multimedia filters, the water flows through cartridge filters.
-------------	----------------	--

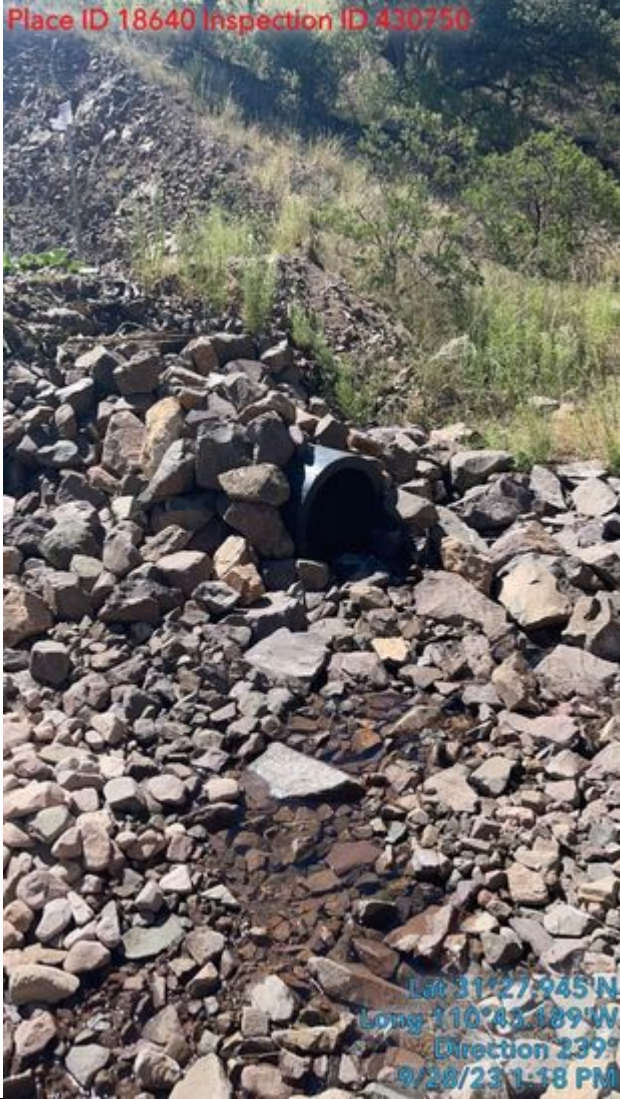
Photo #: 31	Direction: Northwest	Description: Treated effluent from WTP2. This is where the treated effluent from WTP2 daylights.
-------------	----------------------	--

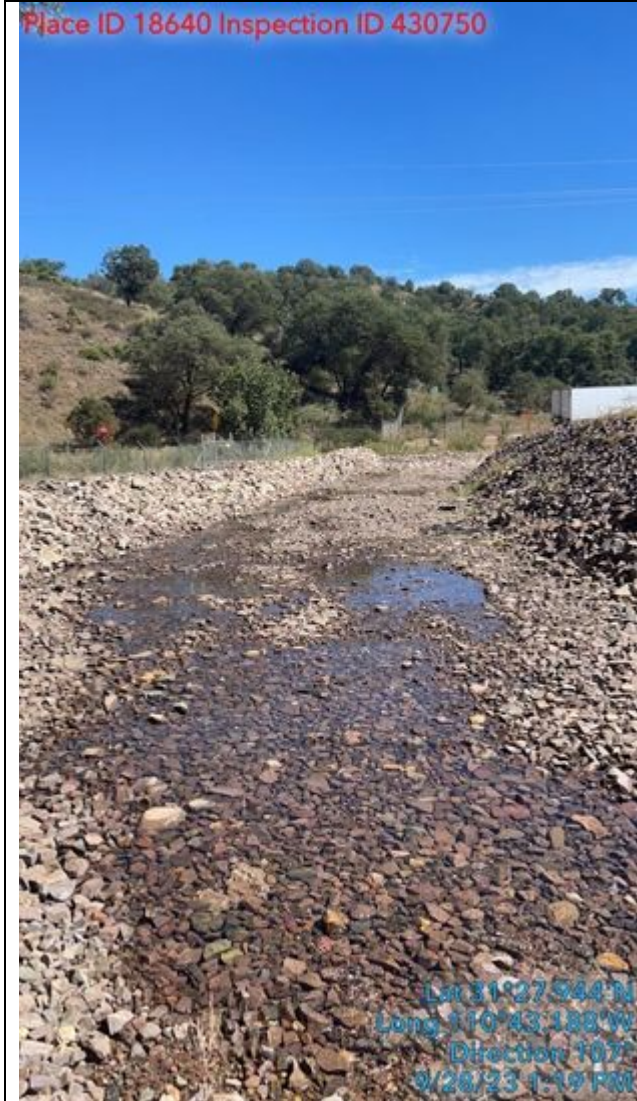
Photo #: 32 Direction: Southeast Description: Treated effluent flows down this rip rap lined channel

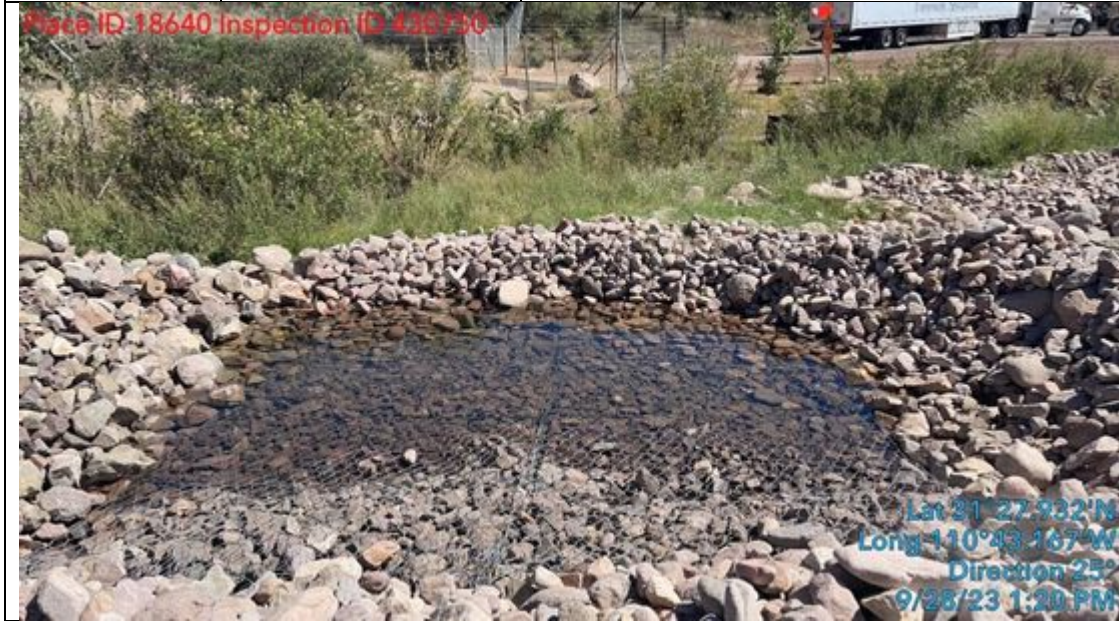
Photo #: 33 Direction: Southeast Description: Reno mattress
