## WQARF Meeting

Aug. 15, 2024

Clean Air, Safe Water, Healthy Land for Everyone

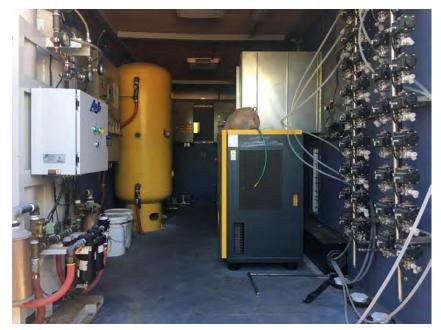
Ozone System at 24th & Grand Canal WQARF Site

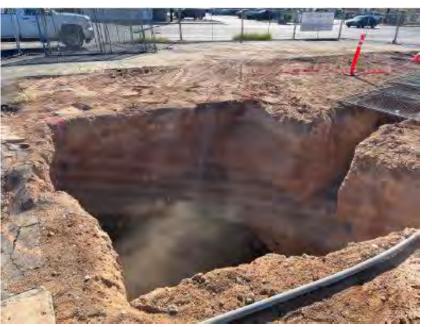
Source Removal at 32nd & Indian School WQARF Site

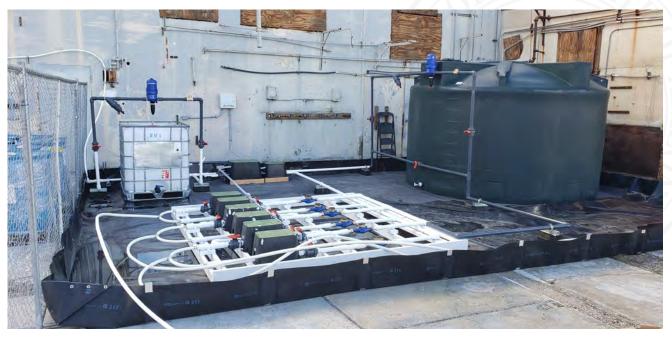
In-Situ Injection System at Lake Havasu & Holly WQARF Site

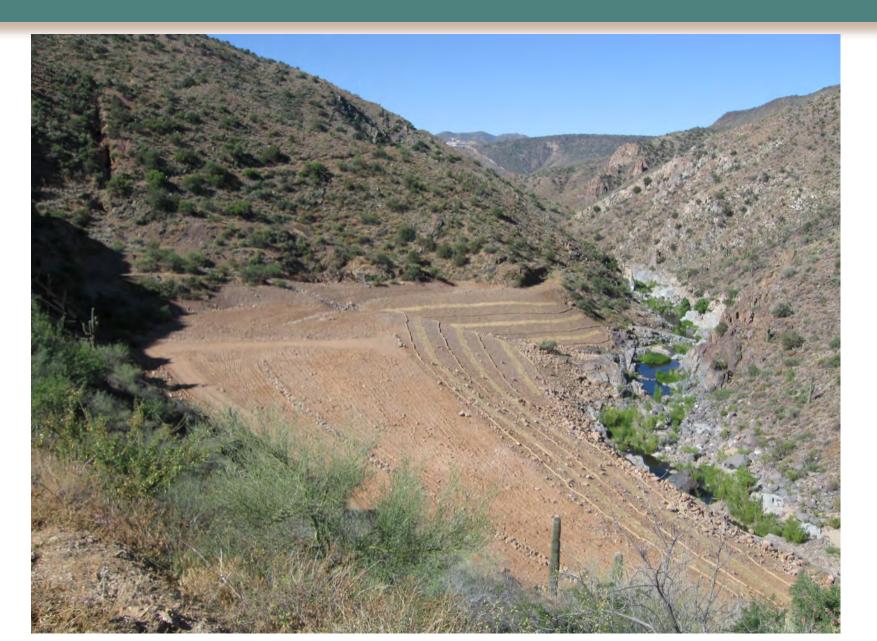
Installation of 2 engineered concrete plugs in the draining adit

Re-contoured about 5 acres of tailings

Covered tailings with an engineered soil cap

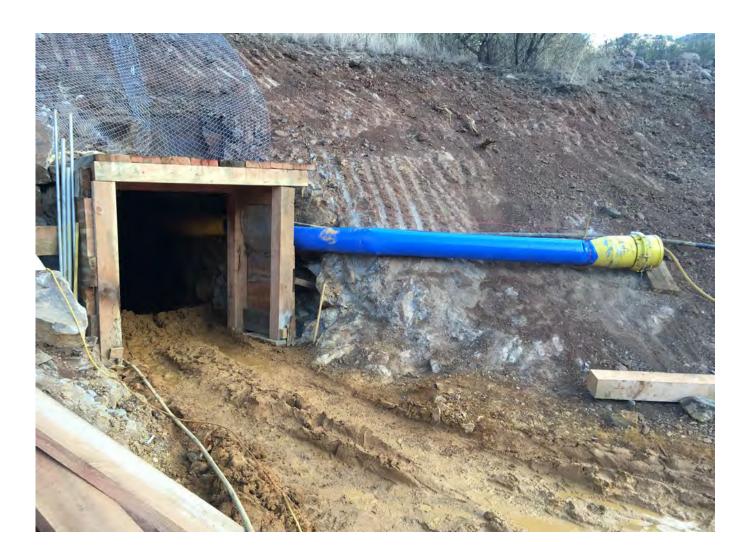
#### What An Engineered Adit Plug Should Look Like

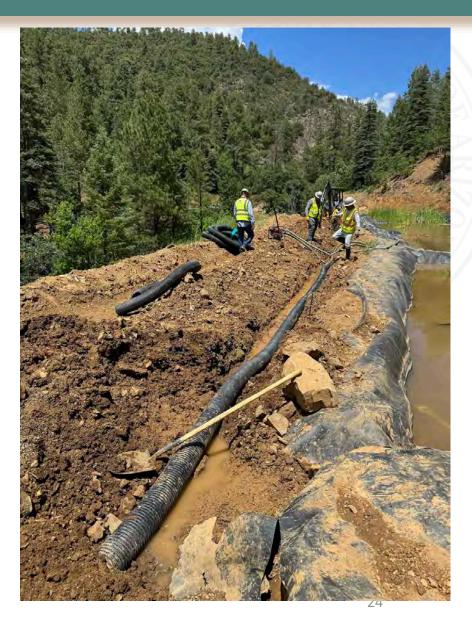
Constructing French drains to capture and redirect adit discharge away from top of the tailings and waste rock piles

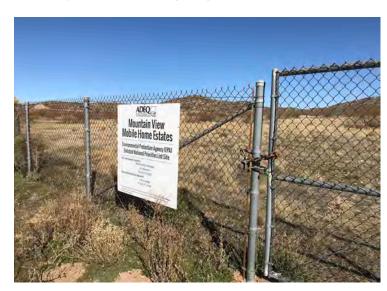
Mountain View Mobile Home Estates, Globe Cap Maintenance Cost Since 2013 = \$325K

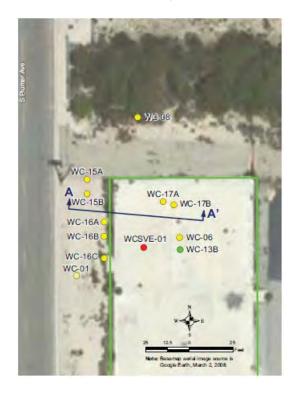
Former West Cap, Tucson Cap Maintenance Cost?

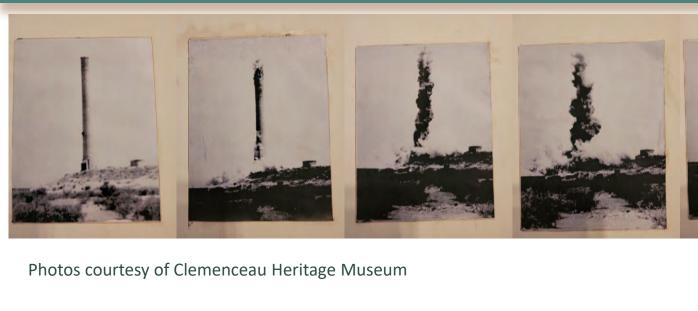
Stack demolished 1948

ADEQ field photo March 2024

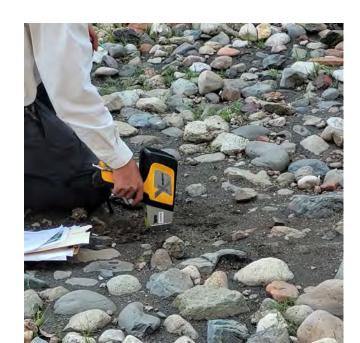
- Over 750 locations sampled by X-Ray Fluorescence (XRF) field instrument
- ~10% confirmatory samples sent to the lab

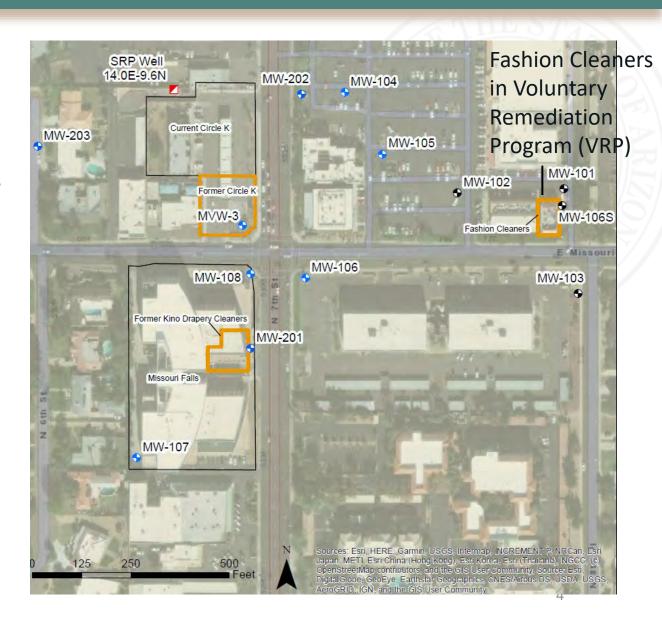
## 7<sup>th</sup> St and Missouri – Groundwater

- Historical flow direction to north, then north-northwest
  - Current northwest
- TCE only near former LUST release
  - BTEX compounds now below Aquifer Water Quality Standards after WQARF site remediation
- Cis-1,2-DCE now below Aquifer Water Quality Standards

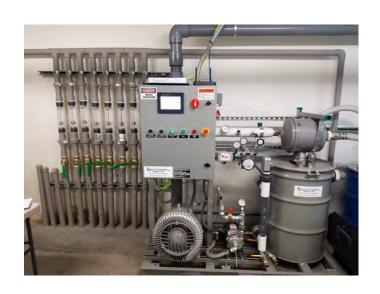
## 7<sup>th</sup> St and Missouri Ave – Remediation

#### SVE – soils remedy

Over 1000 lbs PCE removed

| | FY20 | FY21 | FY22 | FY23 | FY24* | Totals |
|---|--|---|---|--|--|---|
| Mass Removed (SVE) | 245 lbs | 88 lbs | 36 lbs | 80 lbs | 13 lbs | 1,015 lbs (total operation) |

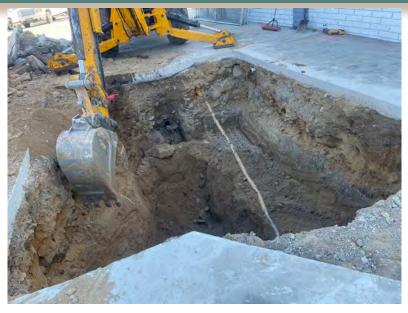
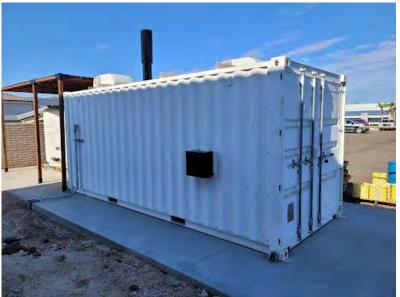
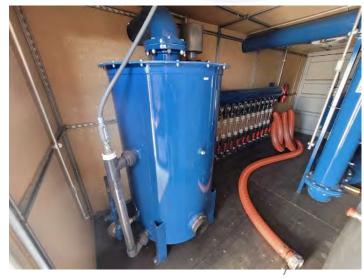
- 2019 2021: Preliminary Investigation (PI)
- 2021 Present: Remedial Investigation (RI)
- Early Response Actions (ERAs)
  - 2023 Former oil clarifier and over 50 tons of PCE contaminated soils removed
  - 2024 Soil Vapor
     Extraction (SVE) system
     design, install (~2.7 lbs
     TCE removed in pilot test)

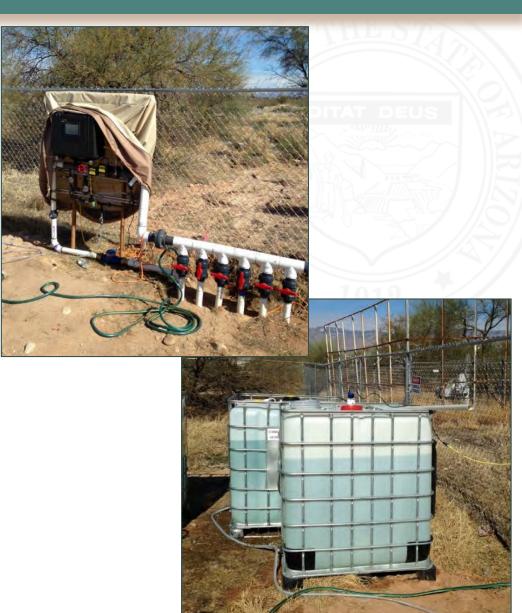
# Broadway Pantano - ISCO System Remediation

- The ISCO system was installed for BNL source area control in an area with the highest COC concentrations
- The system operated from January 2019 to July 2023
- Since operation began:
  - PCE maximum decreased 85%
  - TCE maximum decreased 87%
- Third party technical review confirmed the ISCO system provided:
  - Further containment of downgradient migration of PCE and TCE from the BNL
  - Reduced PCE and TCE mass within the hot spot area

## ISCO System Conceptual Site Model:

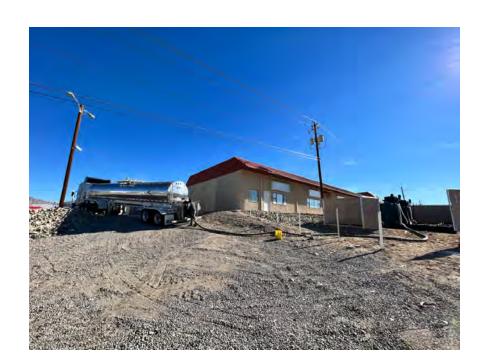
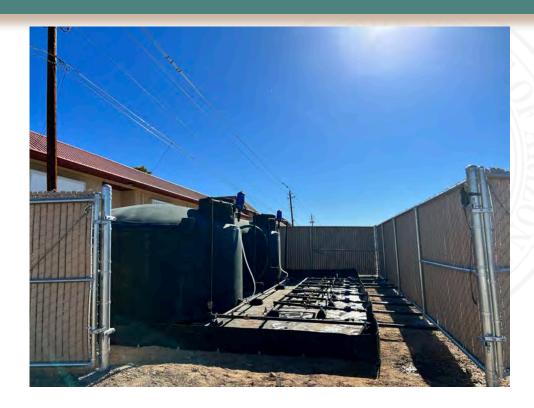
### In-situ bioremediation injections

- Pilot test FY 21
- Downgradient system installed FY22
  - Concentration reduction in chromium and nitrates

Source area system installed FY23

Plume extent shrunk by approximately 75%

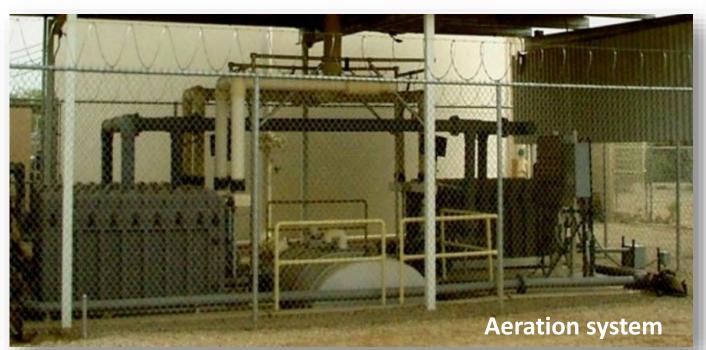
- Well head treatment system at S. Shannon well
  - Provides drinking water to community
  - Provides control and capture of Site plume
  - Aeration system installed in 1997
  - Upgraded to carbon in 2006

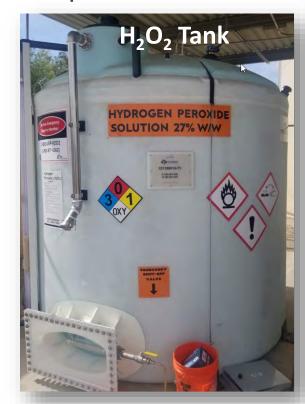
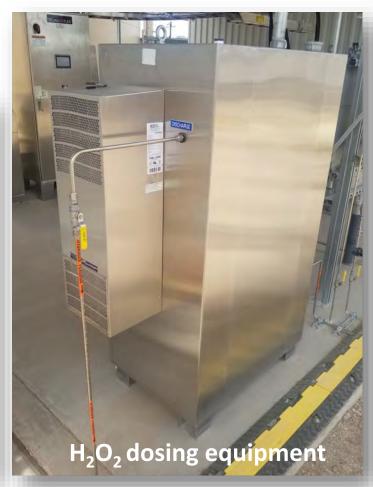
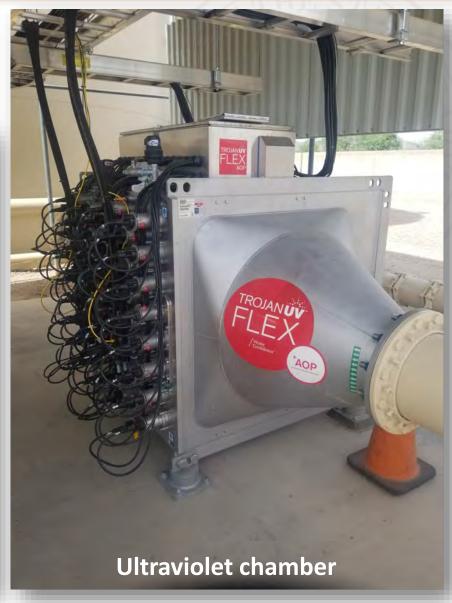
- Well head treatment system AOP upgrade
  - 10% of Metro Water's total production
  - 1,700 homes; 6,000 people
  - Plume capture and control

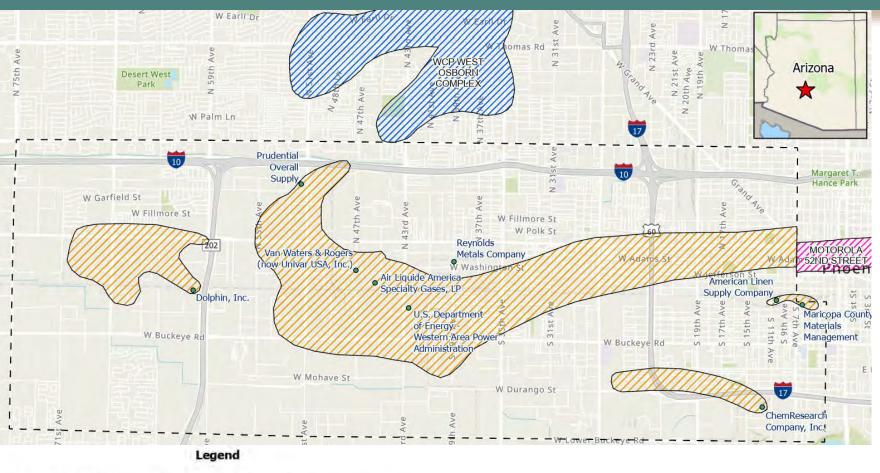
### West Van Buren—Site Location

- > Location: West Phoenix
- Impacted Media: Groundwater; Soil and Soil Vapor at potential responsible party (PRP) locations
- > Contaminants of Concern:
  - ➤ Tetrachloroethene (PCE)
  - ➤ Trichloroethene (TCE)
  - > VOC degradation products
  - > Total Chromium
- Sources: downgradient of Motorola 52<sup>nd</sup> St. Superfund Site; in an industrial area; many responsible parties
- Receptors: Production wells— Roosevelt Irrigation District (RID) wells and industrial wells; possibly some domestic wells

- Potential Responsible Party
- West Van Buren VOC (TCE/PCE)
  Plume 2023
- Motorola 52nd Street Superfund Site VOC (TCE) Plume
- West Osborn Complex WQARF Site VOC (TCE) Plume 2023
- \_ I Approx\_WVB\_WQARF\_Area

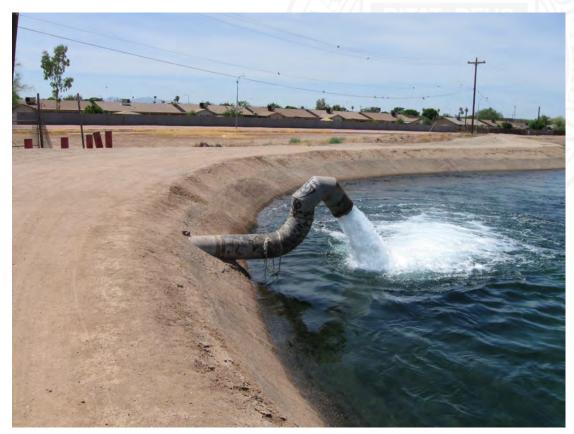
Production well RID-86

6/7/2010

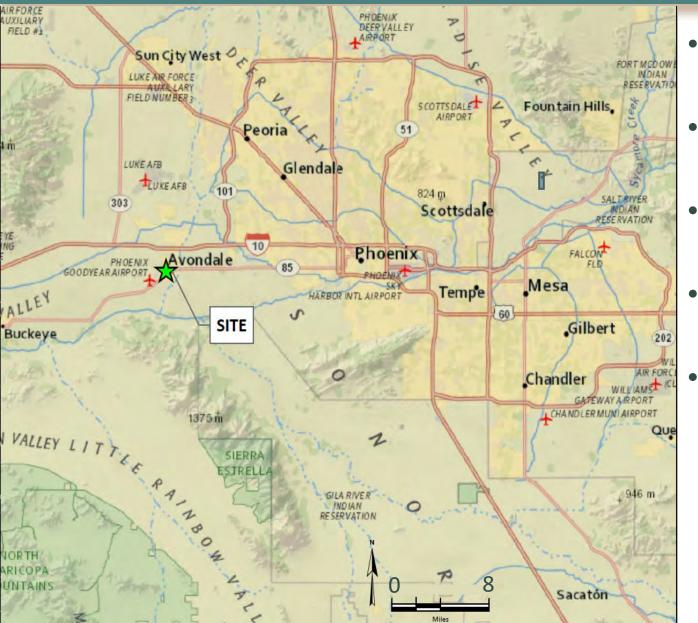
### Western Ave - Site Location

- Location:
  - Border of Avondale and Goodyear
- Impacted Media:
  - Groundwater
- Contaminants of Concern:
  - Tetrachloroethene (PCE)
- Source:
  - Unknown
- Receptors:
  - COG-1 production well, run as back up supply, poor condition, leaky casing, never above standard

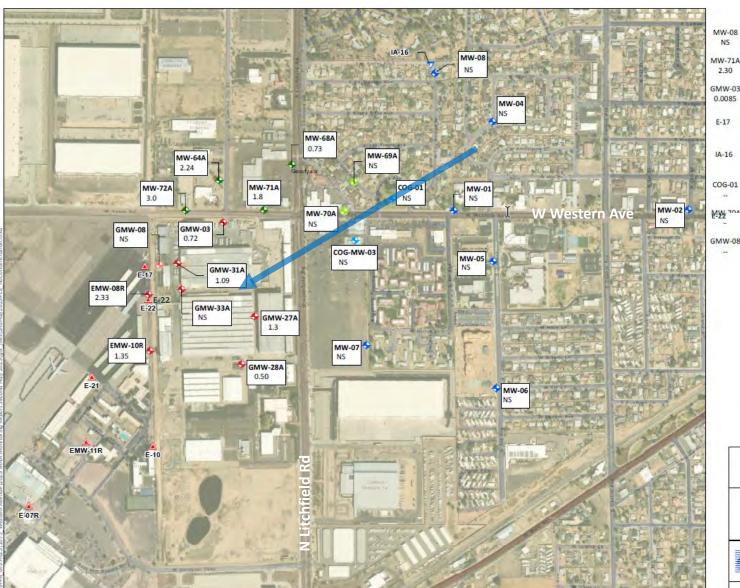
## Western Ave - Site Map

- Western Avenue Subunit A Monitor Well, Not Sampled During Fiscal Year 2024
- Phoenix-Goodyear Airport North Site Subunit A Monitor Well, PCE Concentration in ug/l
- GMW-03
