7<sup>th</sup> Avenue and Bethany Home Road Water Quality Assurance Revolving Fund (WQARF) Registry Site

Community Advisory Board (CAB)

Presentation

October 11, 2023

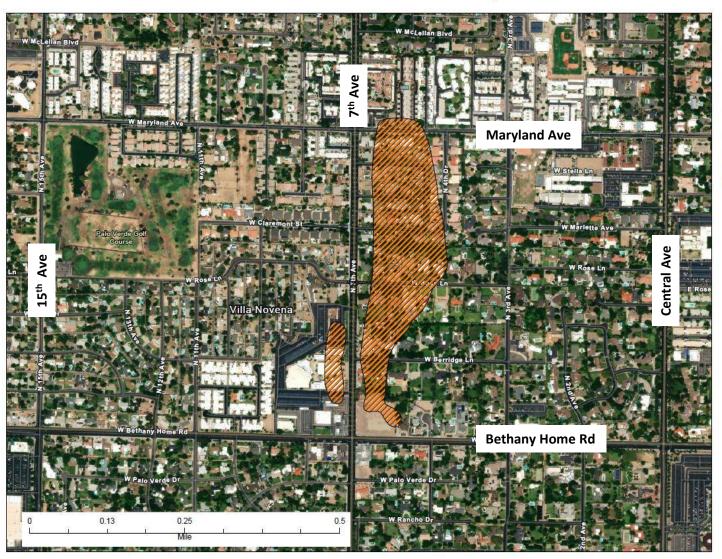
#### 7th Ave and Bethany Home Road

Estimated WQARF Plume
Counties

Plume boundaries depicted on the site map represent ADEGs interpretation of data available at the time the map was constructed. The map is intended to provide the public with basic information as to the estimated geographic extent of known contamination as of the date of map production. The actual extent of contamination may be different. Therefore, the plume for this site may change in the future as new information becomes available.

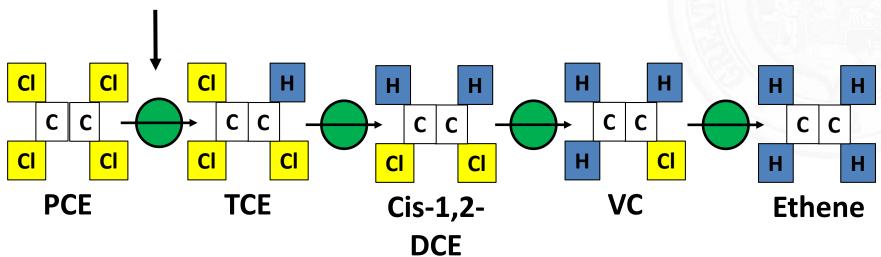
#### **Electron Donor & Bacteria**

#### **Enhanced Reductive Dechlorination**

- Biostimulation: Injection of Carbon Substrate (Food & Hydrogen) to Create the Right Conditions
- Bioaugmentation: Injection of Specialized Bacteria (Dehalococcoides [DHC]) to Facilitate Degradation of Chlorinated Compounds
- Performance Monitoring: Assess Conditions (Total Organic Carbon [food] and volatile organic compounds [VOCs])

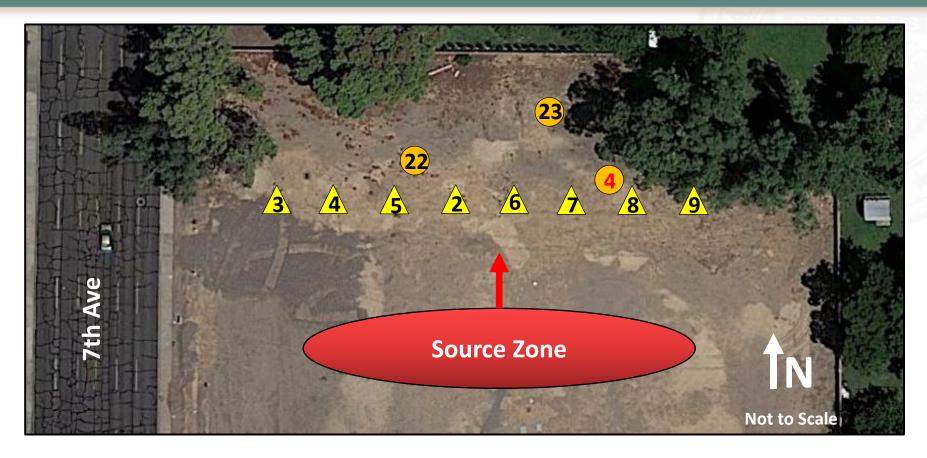
# **Bayless Property Detail Map**

Injection Well

Monitoring Well

<sup>\*</sup>Red numbered wells discussed on next slides

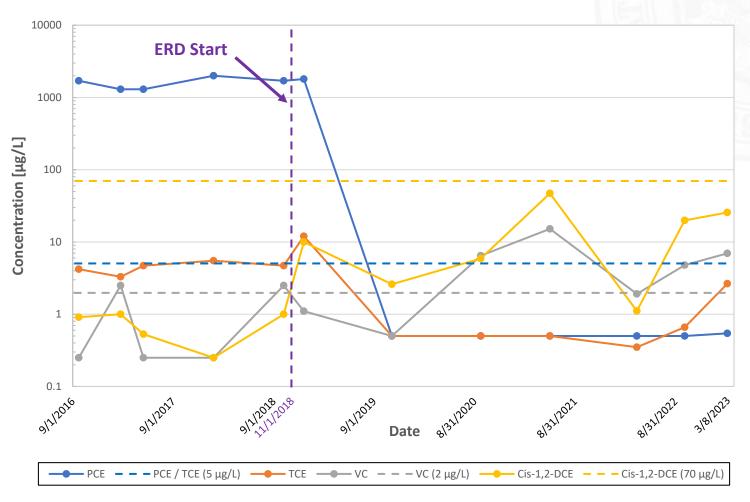
### Groundwater Concentrations Trend – Bayless Property

µg/L – micrograms per liter
Dashed Horizontal Line – Aquifer Water Quality Standard (AWQS) for respective constituent

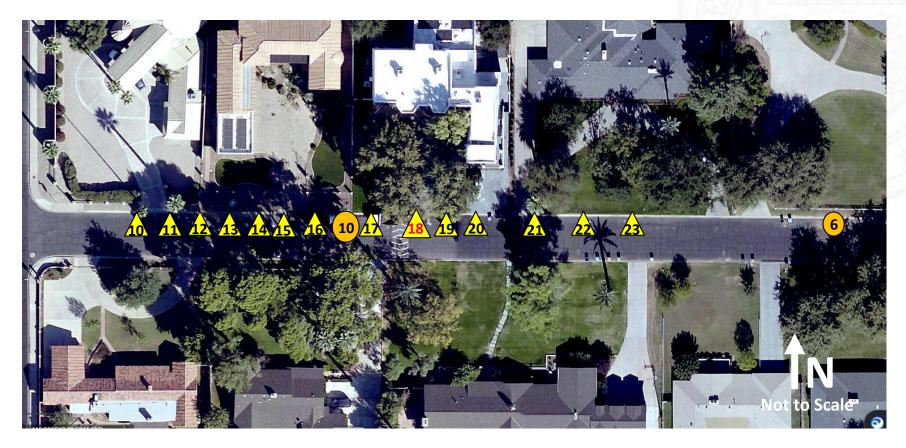
# Berridge Lane Detail Map

**Injection Well**

**Monitoring Well**

<sup>\*</sup>Red numbered wells discussed on next slides

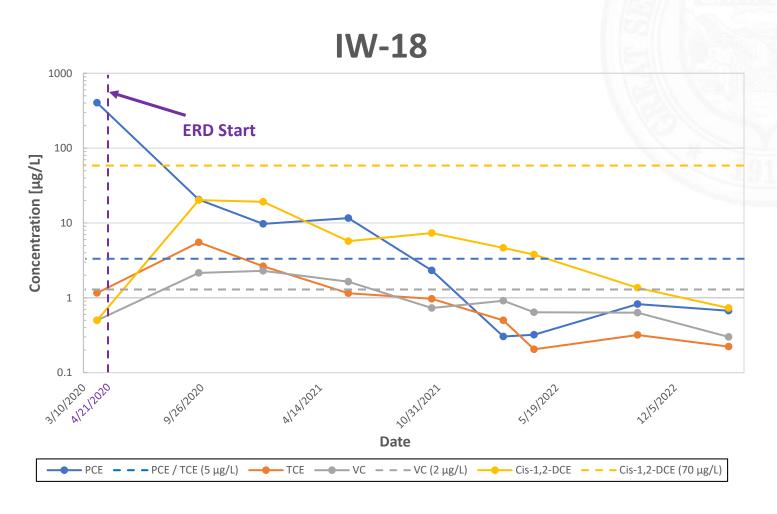
### Groundwater Concentrations Trend – Berridge Lane

μg/L – micrograms per liter
Dashed Horizontal Line – Aquifer Water Quality Standard (AWQS) for respective constituent

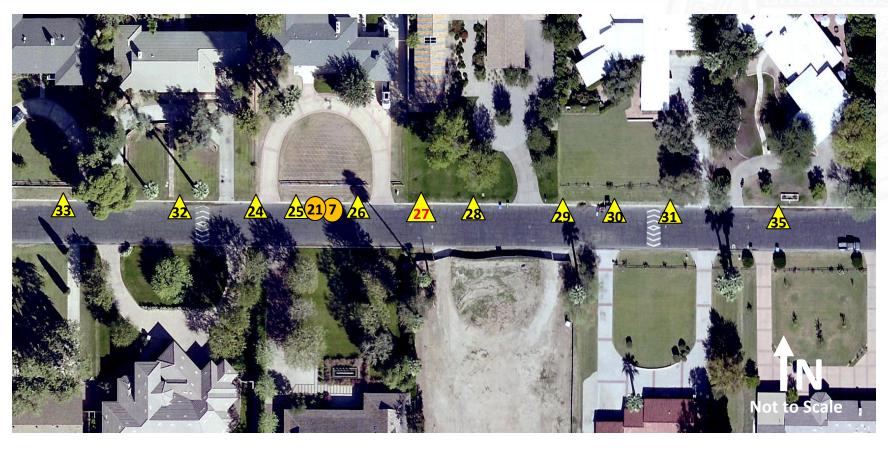
## Rose Lane Detail Map

**Injection Well**

**Monitoring Well**

<sup>\*</sup>Red numbered wells discussed on next slides

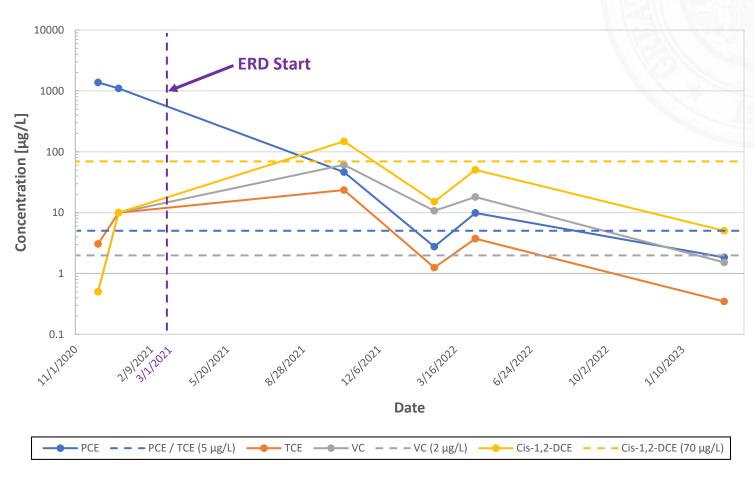
#### Groundwater Concentrations Trend – Rose Lane

µg/L – micrograms per liter
Dashed Horizontal Line – Aquifer Water Quality Standard (AWQS) for respective constituent
