Stone Avenue and Grant Road
Water Quality Assurance Revolving Fund (WQARF) Site
Record of Decision (ROD) and Remedy Implementation,
Updates, and Next Steps

9/2/2020

Community Advisory Board (CAB) Meeting

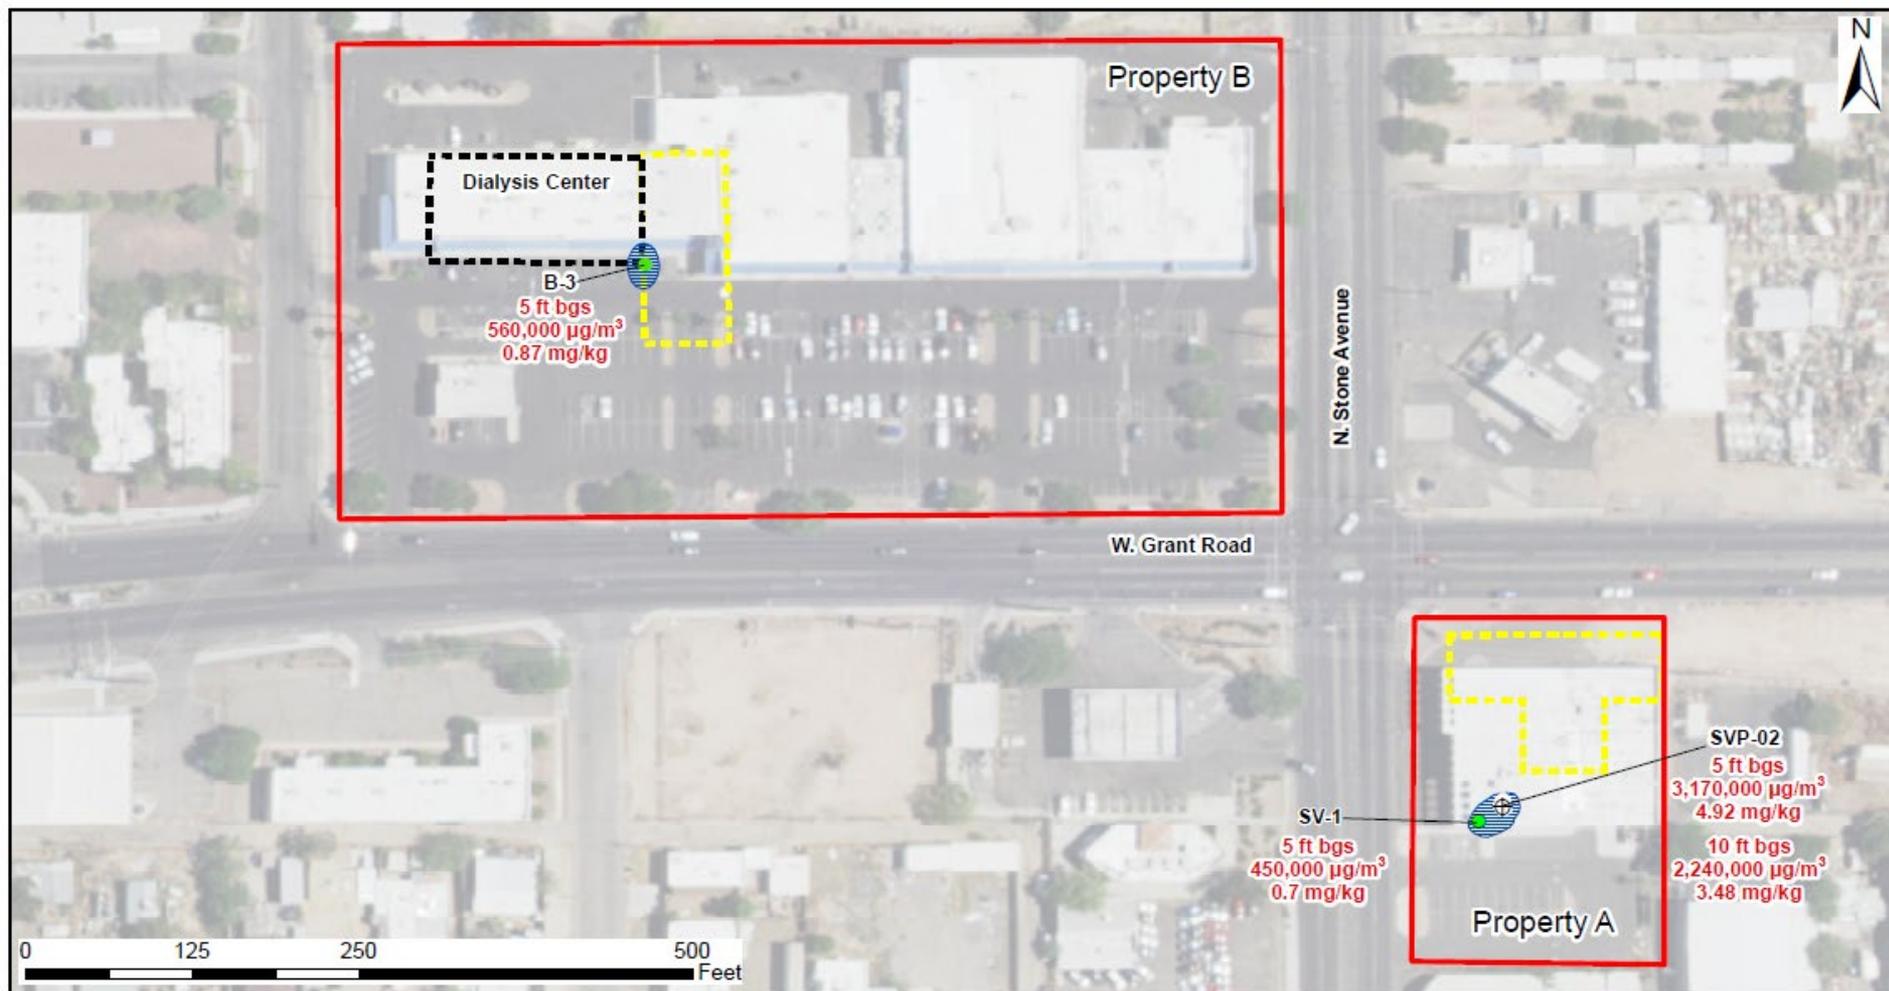
Figure 2
Site Remediation Areas
Stone Avenue and Grant Road WQARF Site
Tucson, Arizona

Remediation Areas

- Property Boundary
- Residential SRL Exceedance (Soil Equivalents) for PCE
- Sensitive Population
- Historic Dry Cleaner Locations
- Temporary Soil-Gas Sampling Location
- ⊕ Dedicated Soil-Gas Monitor

- **Contaminant of Concern: tetrachloroethene (PCE)**
 - Trichloroethene (TCE) was also investigated and determined to be present as a degradation product of PCE
- **Impacted Media:**
 - Soil up to 10 ft bgs, Soil Vapor up to 100 ft bgs
 - Regional Groundwater (GW) is not impacted
- **Exposure Pathway:**
 - Vapor intrusion to indoor air is the primary concern for exposure to PCE vapors via inhalation from source areas

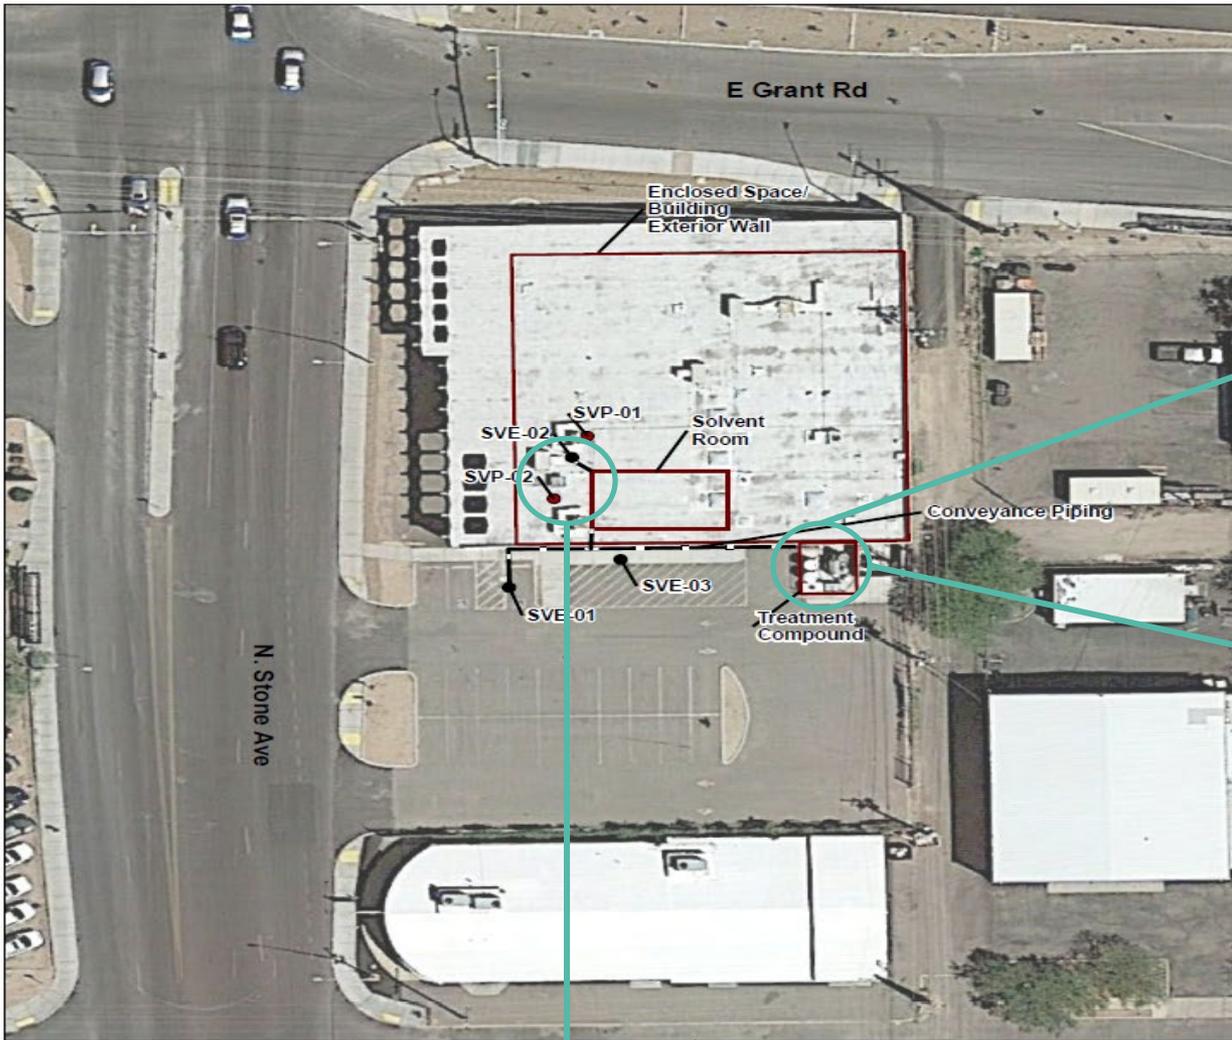
Property A, SVE Layout

Property A – Soil Vapor Extraction

- Legend**
- Soil Vapor Extraction Well
 - Soil Vapor Probe
 - Piping
 - ▭ Exterior Wall

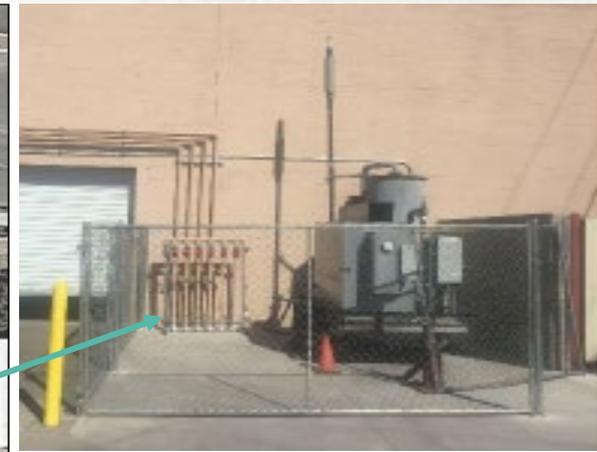
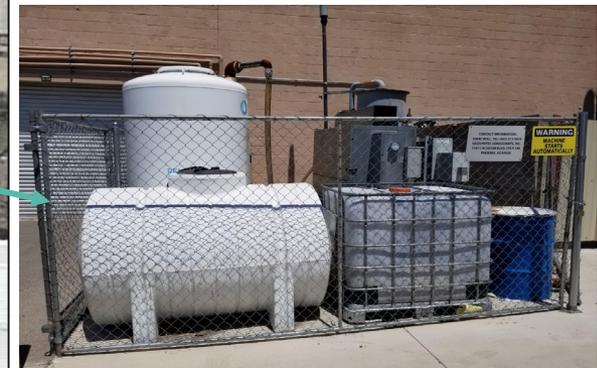
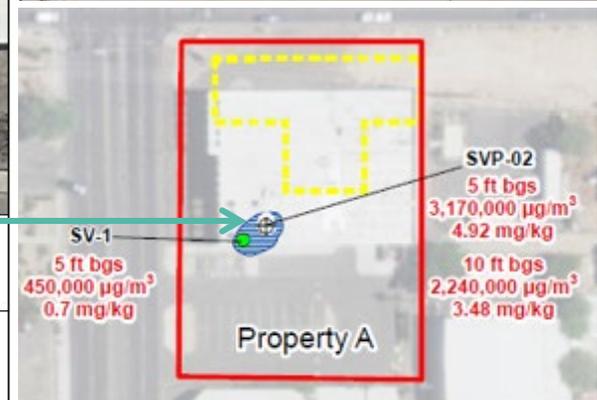
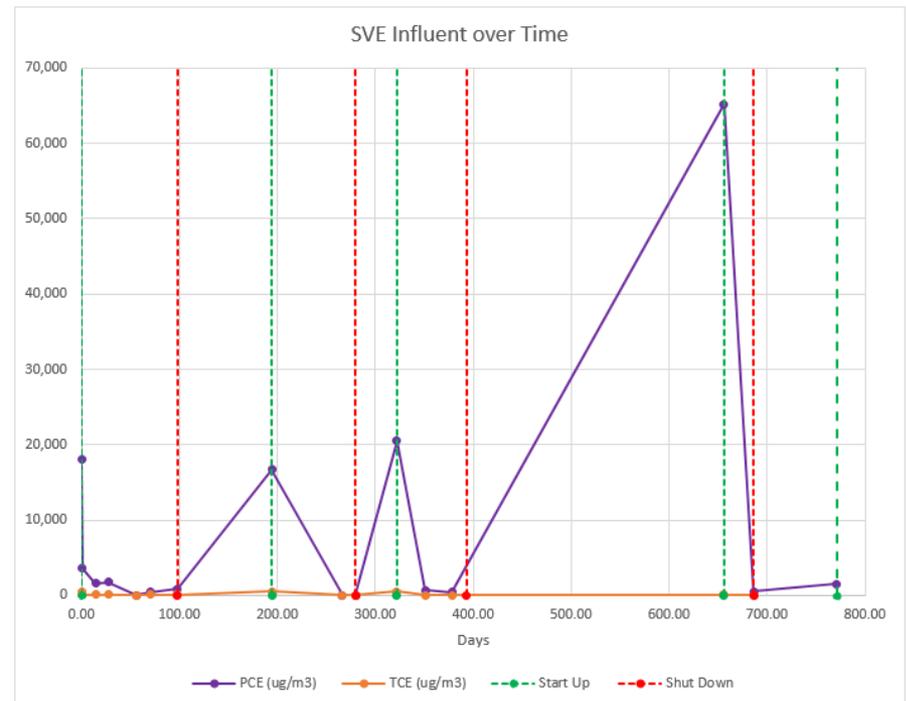
- Total Estimated Mass removed is 28.3 pounds of PCE as of March 2020
 - Best performance was after >200 days rebound
- System shut down: 3/24/2020
- Rebound Sampling: September 2020
- System Restart: October 2020

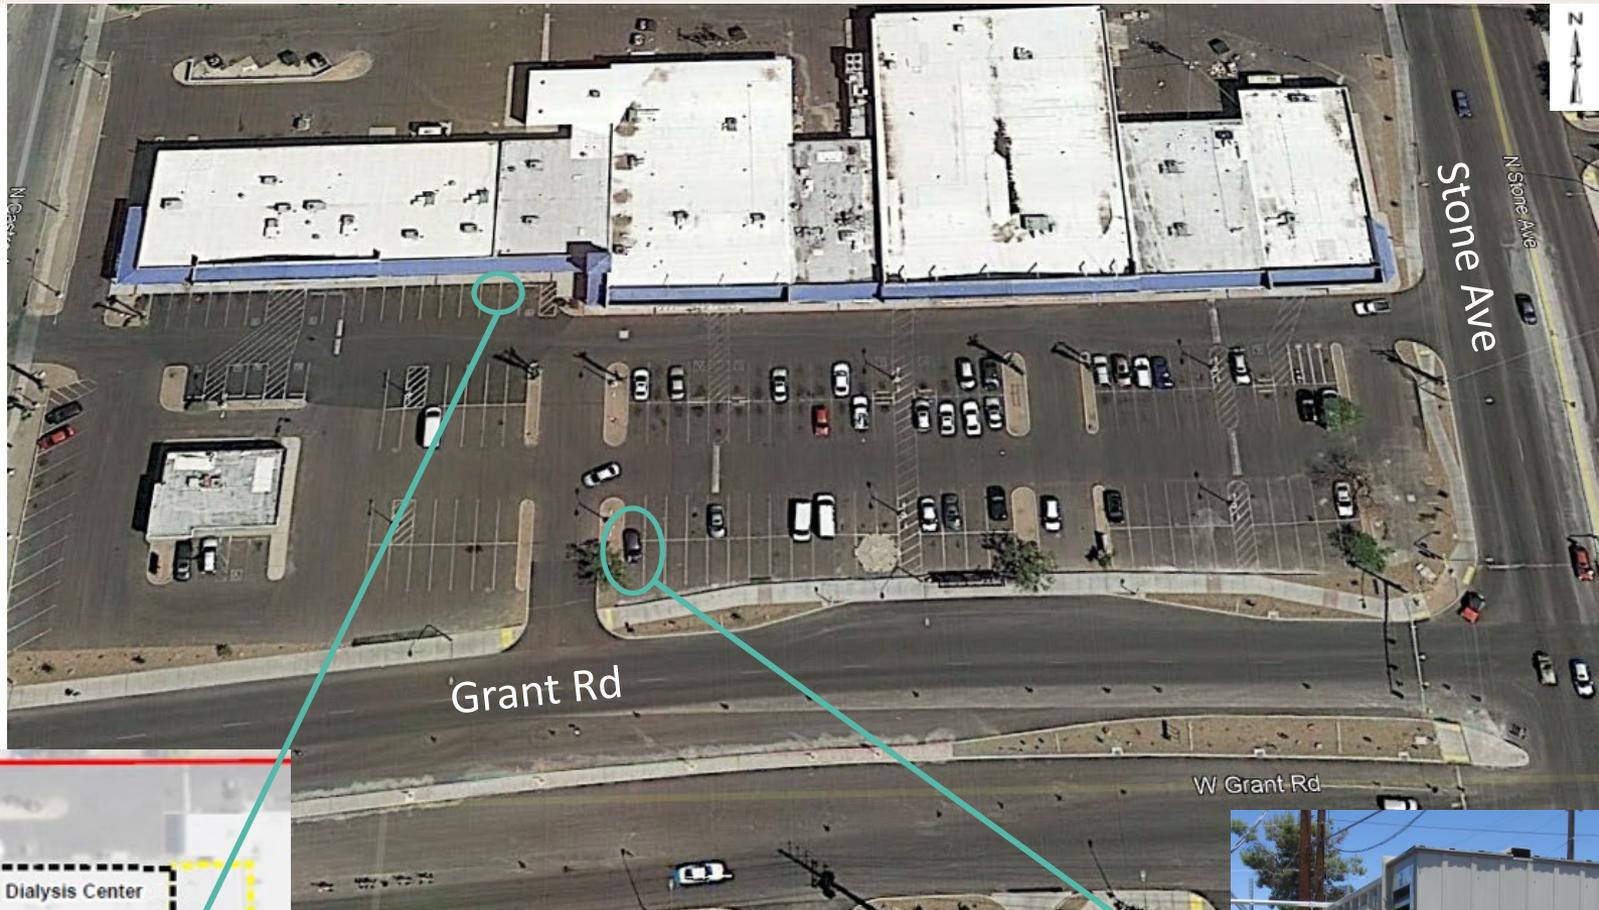
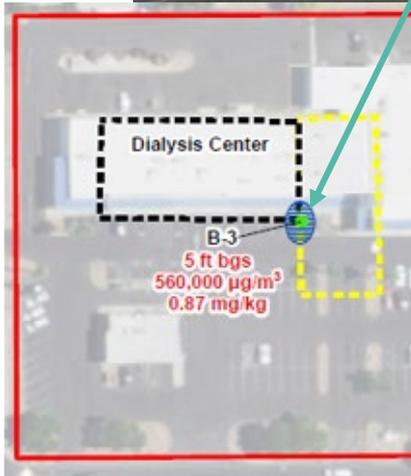
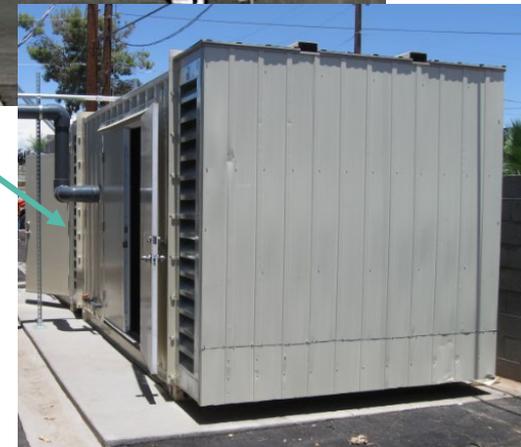
Property B – Soil Vapor Extraction

- October 2019: Pilot Test estimated COC mass removal of 0.54 pounds.
- July - August 2020: Working with TEP to get a power source for onsite SVE System
- September – December 2020: Install SVE wells onsite and Possible tie-in of existing wells / conversion to SVE wells

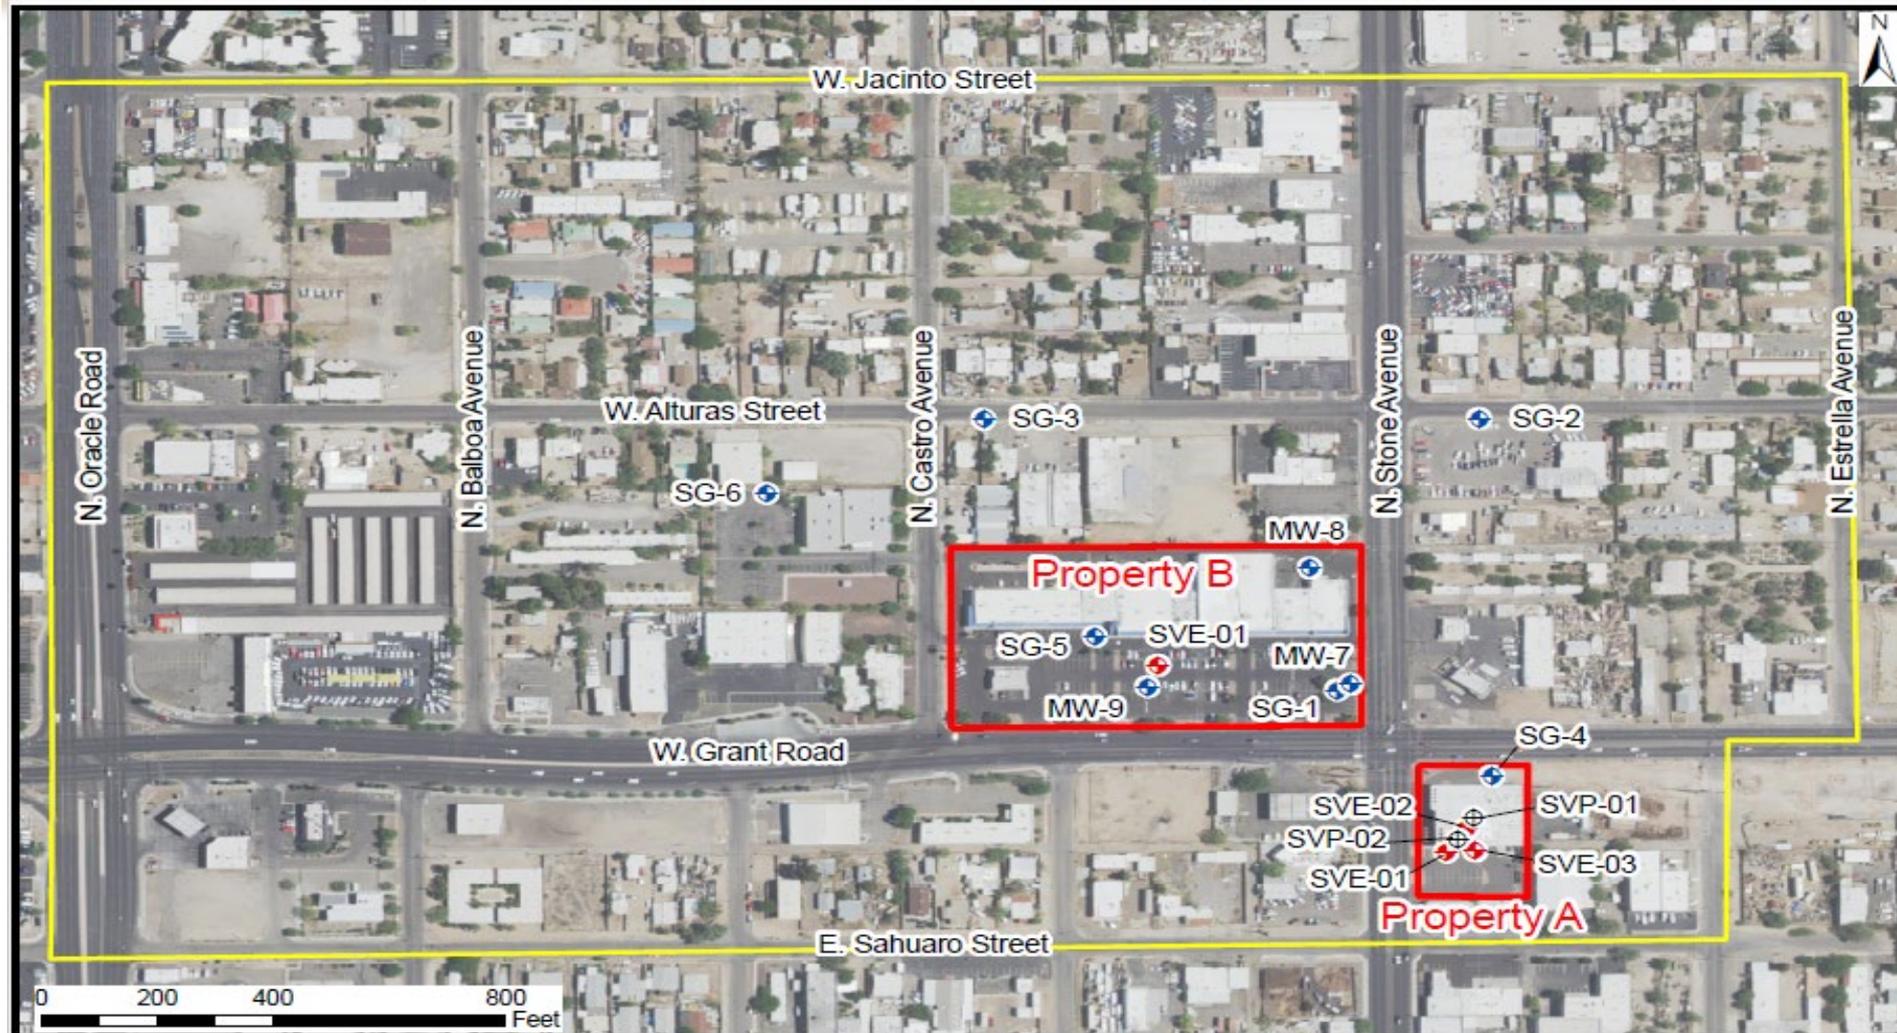
Figure 4
Monitoring Locations
Stone Avenue and Grant Road WQARF Site
Tucson, Arizona

Monitoring Locations

- Site Investigation Area
- Property Boundary
- Dedicated Soil-Gas Monitor
- SVE Well
- Groundwater Monitoring Wells (Shallow and Dual Nested)

- **Groundwater Monitoring**
 - Ensure no impacts to regional groundwater
- **Soil Vapor Monitoring**
 - Monitor contamination in subsurface off property
 - Monitor trends
- **Indoor Air Sampling**
 - Contingency; would be conducted after initial run of SVE at Property B, likely in 2021
