**MIRACLE MILE WATER QUALITY
ASSURANCE REVOLVING FUND (WQARF)
FEASIBILITY STUDY**

TUCSON, ARIZONA

October 15, 2019

HARGIS + ASSOCIATES, INC.
HYDROGEOLOGY • ENGINEERING

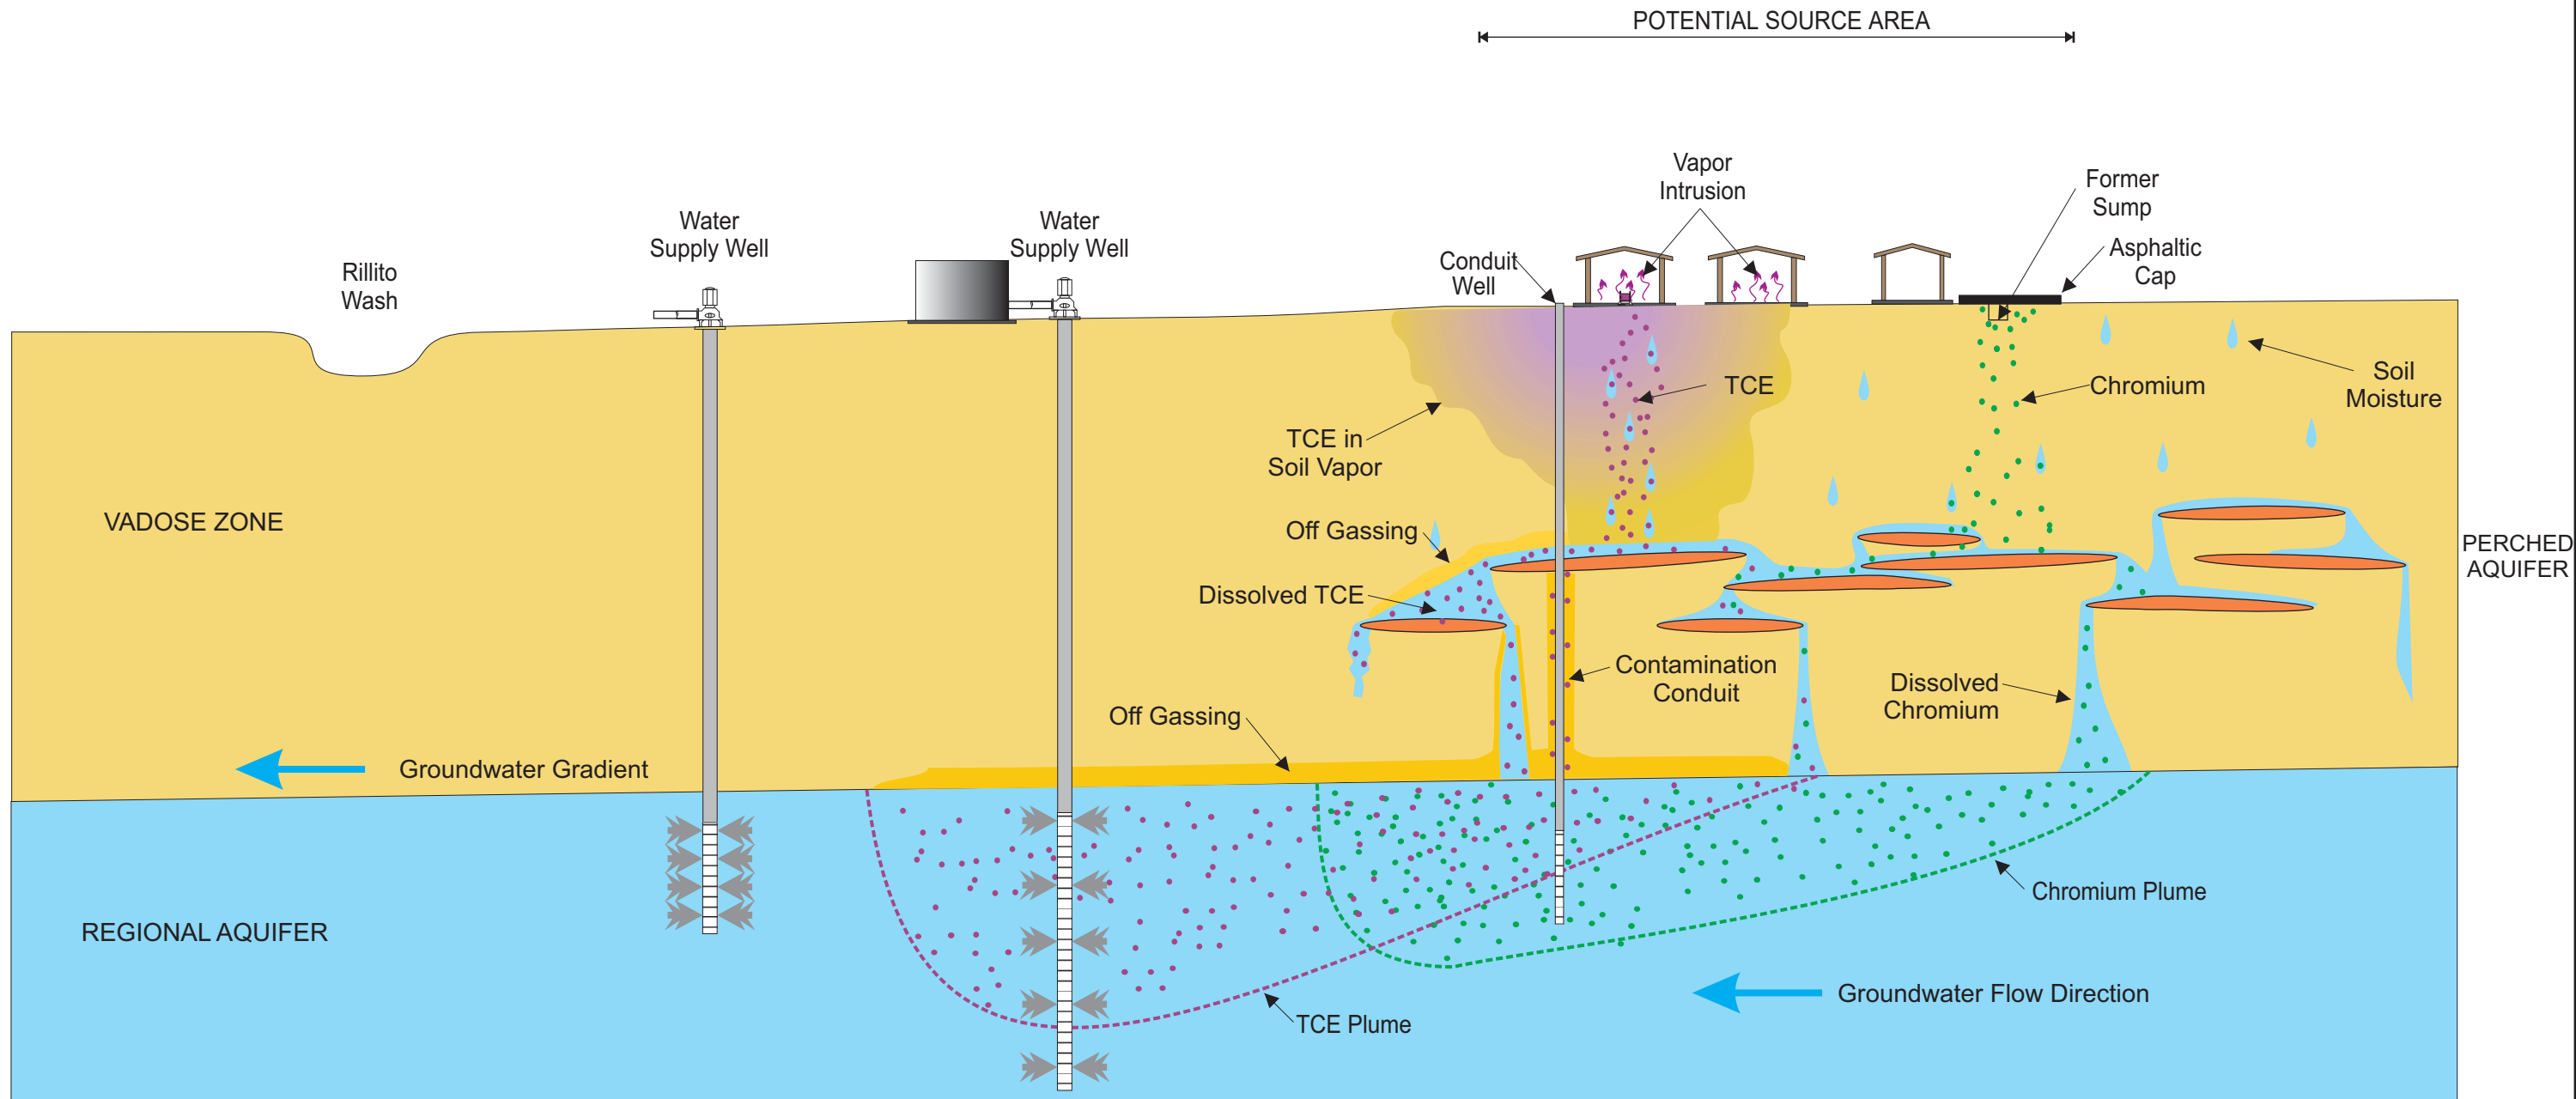
FIGURE 3: CONCEPTUAL SITE MODEL
Feasibility Study, Miracle Mile WQARF Site, Tucson, Arizona

MIGRATION: TCE released in the subsurface adheres to soil particles, volatilizes into air voids and/or dissolves in soil moisture. As soil moisture migrates downward, dissolved TCE moves with it, eventually reaching groundwater. TCE has been detected at elevated concentrations from near surface to the perched aquifer. Volatilized TCE in soil vapor tends to disperse from areas of high concentrations and/or high relative pressure to areas of lower concentrations and/or lower relative pressure. This results in high soil vapor concentrations near release locations with a dispersion halo around the release location (Figure 4). In the arid southwest, it has also been found that TCE vapor can travel down through the vadose zone and impact groundwater (Walter et. al, 2004).

Dissolved TCE and chromium can migrate with soil moisture deeper into the vadose zone, eventually coming into contact with groundwater. Some of the contaminated perched groundwater likely continued to flow vertically down reaching the regional aquifer. The Fairfax Well potentially acted as a conduit for vertical movement of contamination to the regional aquifer (Figure 3). Once within the regional aquifer, TCE and chromium move downgradient with the groundwater, generally to the north/northwest. TCE can volatilize from contaminated groundwater, therefore, a soil vapor halo of TCE is possible above contaminated groundwater.

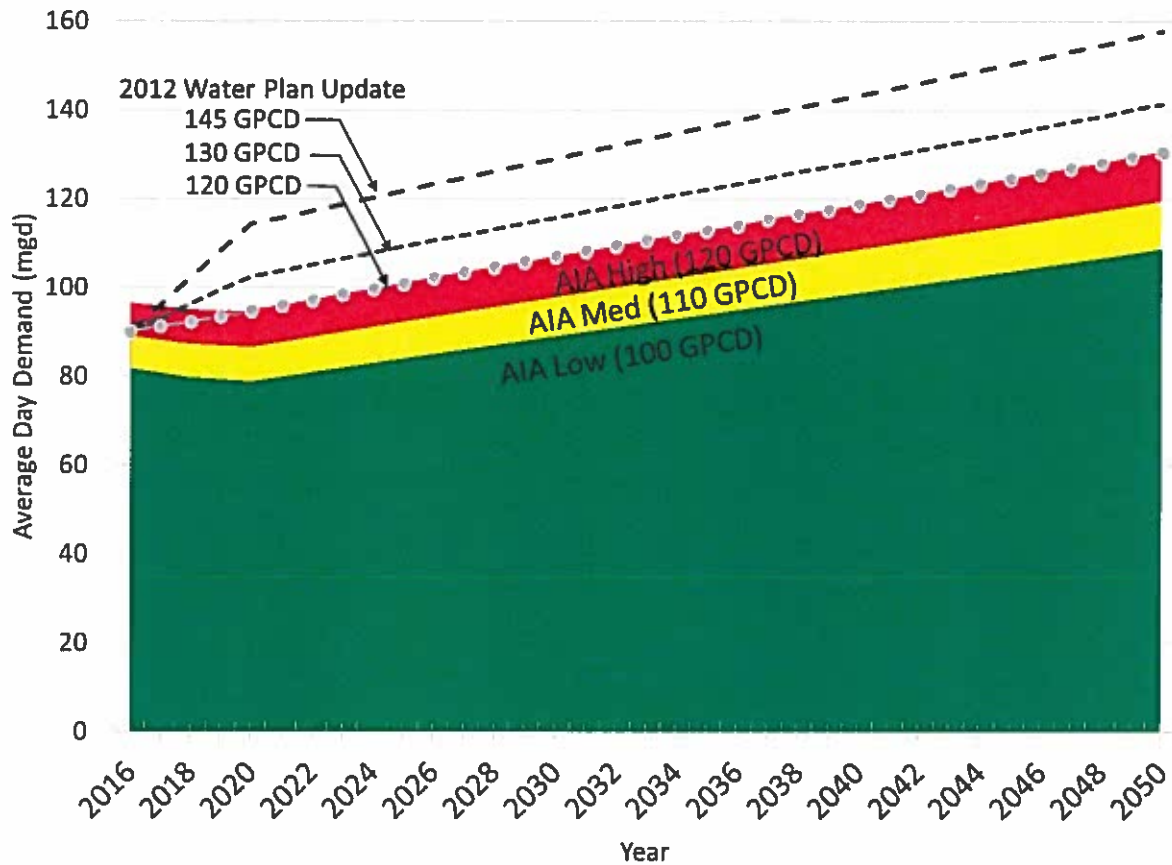
Figure ES-1. Potable Water Demand Projections – Average Day

One of the significant findings from the AIA study was that potable water demand forecasts for TW's service area were found to be substantially lower than prior projections. In determining the appropriate demand projections to utilize for the AIA study, per capita consumption (GPCD) rates for TW were applied to population projections obtained from the Arizona Department of Administration (ADOA) 2012 Report. A review of TW's *2012 Update - Water Plan: 2000-2050* (2012 Update) indicated that GPCD rates have decreased significantly from previous rates to about 130 GPCD. Upon further investigation and review of TW's draft annual pumpage and storage report for the year 2014, TW has been

experiencing a trend of decreasing per capita use below 130 GPCD. For the purposes of this study, projected GPCD rates for TW's service area were reduced until they reach a projected minimum range of 100 GPCD (low) and 120 GPCD (high) in the year 2020 – see Figure ES-1.

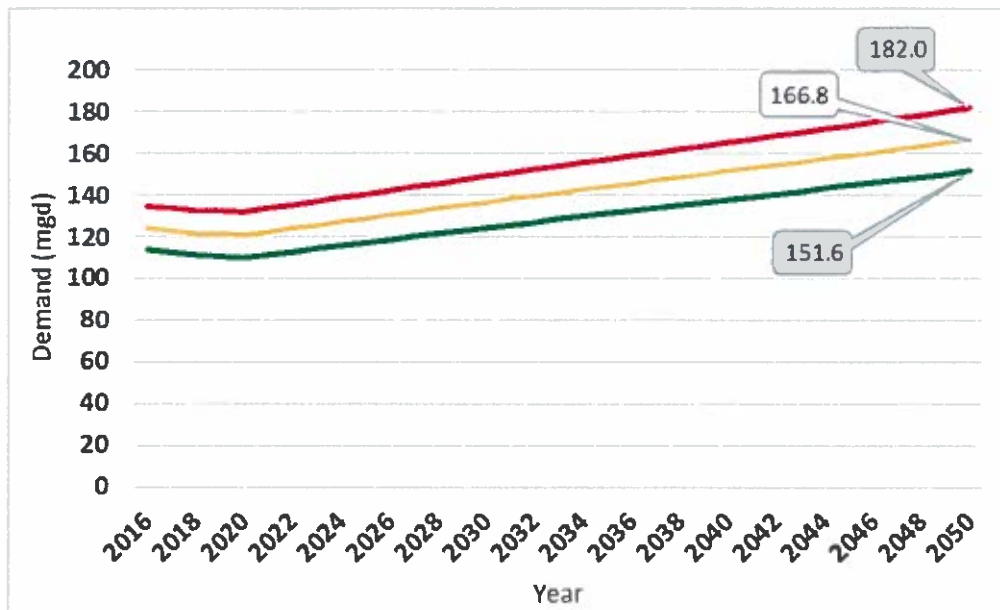
Figure ES-2. Potable Water Demand Projections – Peak Day

CH2M then applied a peaking factor of 1.4 (actual peaking factor for 2014, per TW) to the estimated average day demands to establish peak day demand projections for TW's water system. The resulting high-, most likely-, and low-demand projections for the peak day are shown in Figure ES-2.

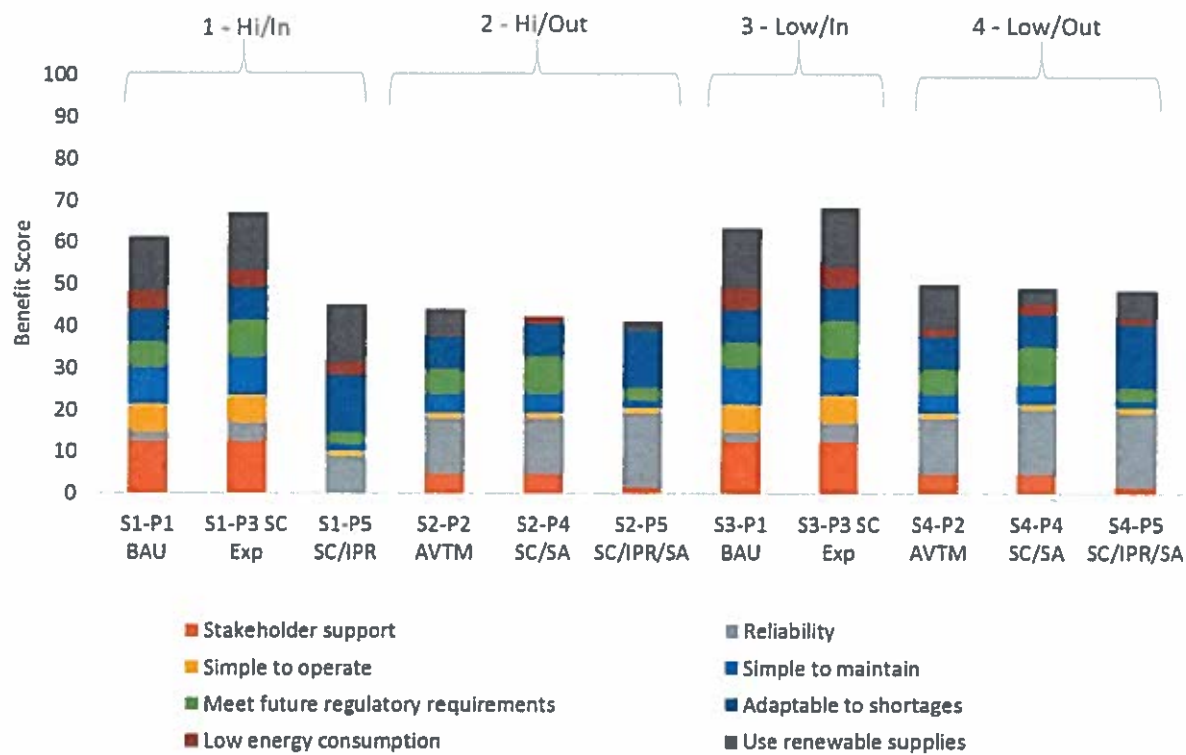
Figure ES-3. MODA Results (non-monetary)

- Multi-objective decision analysis (MODA) results suggest that Portfolio 3 (SC) is preferred when risk of failure is low (Scenarios 1 and 3). When the risk of failure is high (Scenarios 2 and 4) there is relatively little difference among the feasible portfolios with Portfolio 2 (AVTM 66) preferred slightly in both scenarios.

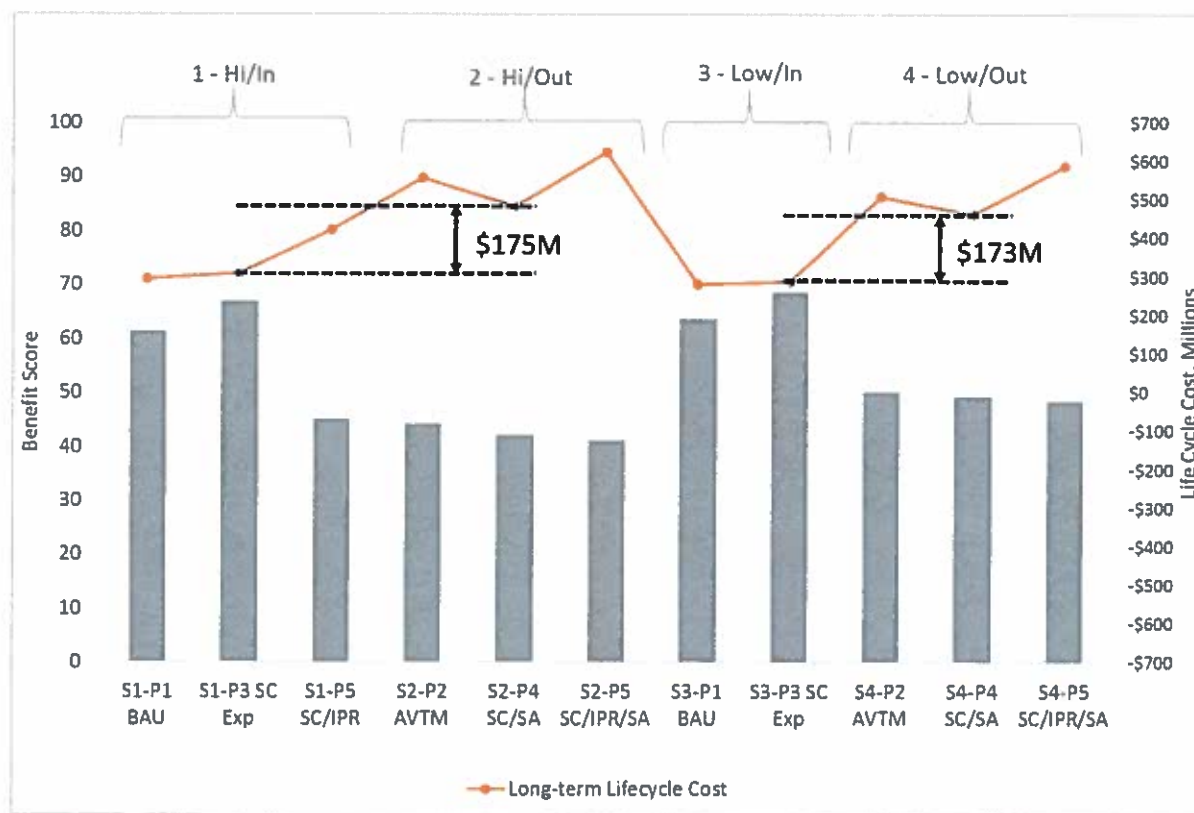
Figure ES-4. Value to Cost Comparison of Portfolios within Each Scenario

- The difference in total life-cycle cost (including risk cost) between Portfolios 3 (SC) and 4 (SC/AVTM 48) is more than \$170 million, and Portfolio 3 has a much higher MODA score. This implies that if TW can identify risk mitigation actions that would provide a similar level of risk to building the AVTM for less than \$170 million, those actions would be preferred (see Figure ES-4).
