PAYSON PCE

2012 PERIODIC SITE REVIEW WATER QUALITY ASSURANCE REVOLVING FUND PAYSON, ARIZONA

**2012 PERIODIC SITE REVIEW
PAYSON PCE WATER QUALITY ASSURANCE
REVOLVING FUND SITE
PAYSON, ARIZONA**

Prepared by
Arizona Department of Environmental Quality
1110 West Washington Street
Phoenix, Arizona 85007

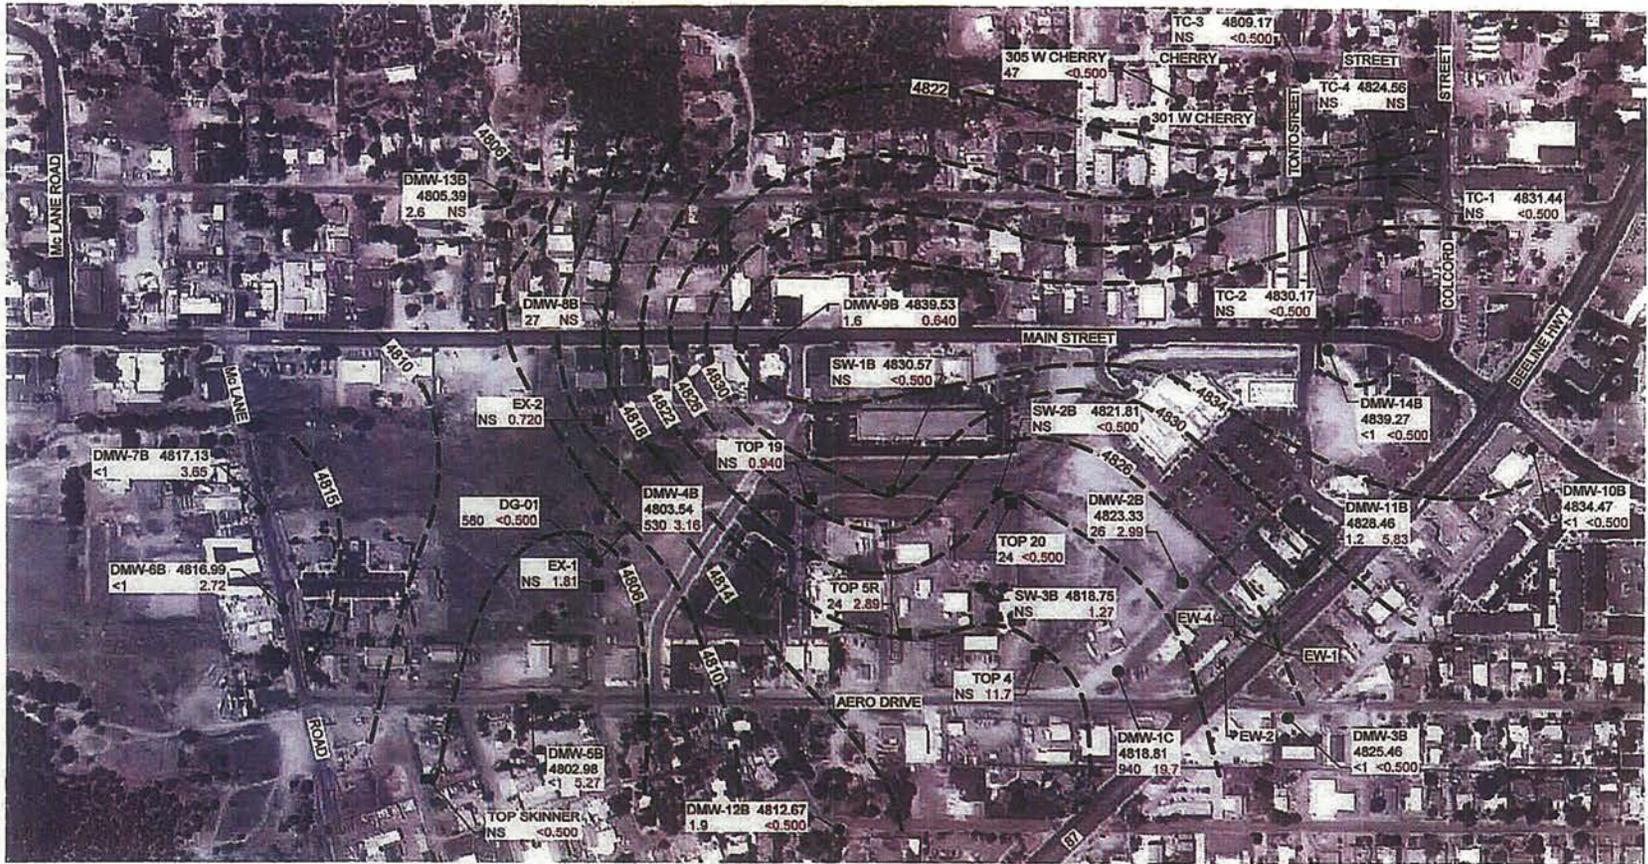
**FIGURE 4. GROUNDWATER CONTOUR MAP
SEPTEMBER 2011 - DG/FG UNIT
ADEQ Payson PCE and Tonto & Cherry
WQARF Study Areas
Payson, Arizona**

- Groundwater well locations and well head elevations are based on survey information provided by ADEQ. Locations of DMW-11 and DMW-13 are estimated.
- Groundwater elevation information is calculated based on WT depth to water level measurements collected between 13:11 September 19, 2011 and 14:49 September 20, 2011.
- Groundwater elevation information is presented based on WT's review and modification of contour maps created on Golden Software's Surfer Version 8.0 program.
- All concentrations are in micrograms per liter ($\mu\text{g/l}$).
- Includes data obtained by WT from the Payson PCE and Tonto & Cherry WQARF Study Areas.
- DMW-1C was identified as representative of the DG/FG Unit during the initial stages of the remedial characterization.

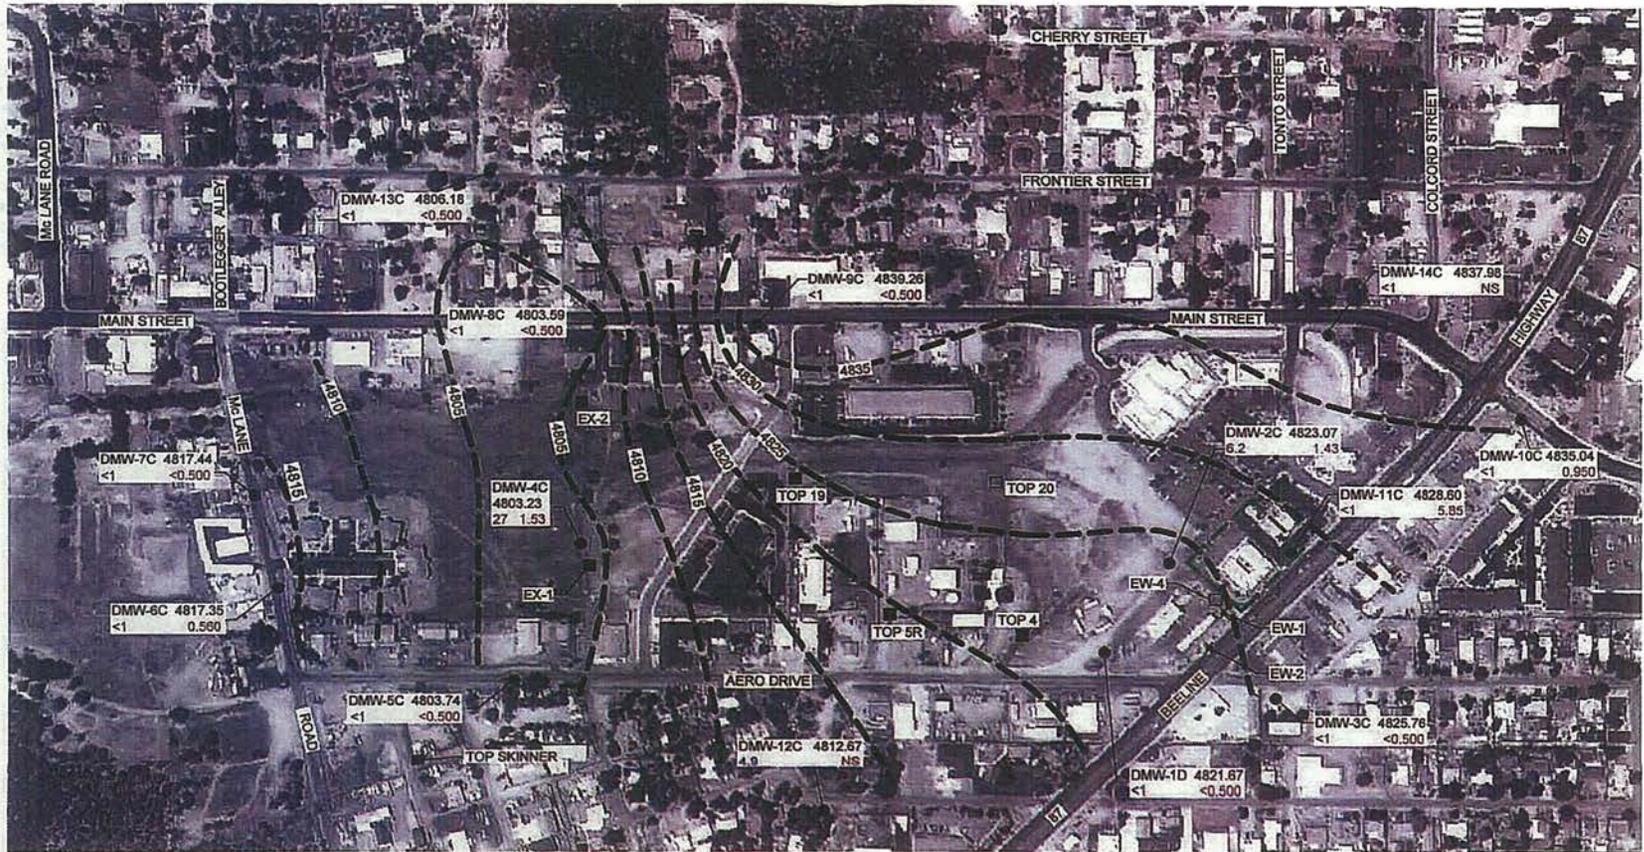
FIGURE 5. GROUNDWATER CONTOUR MAP SEPTEMBER 2011 - FG/CG UNIT ADEQ Payson PCE and Tonto & Cherry WQARF Study Areas Payson, Arizona

- Groundwater well locations and well head elevations are based on survey information provided by ADEQ. Locations of DMW-11 and DMW-13 are estimated.
- Groundwater elevation information is calculated based on WT depth to water level measurements collected between 13:11 September 19, 2011 and 14:49 September 20, 2011.
- Groundwater elevation information is presented based on WT's review and modification of contour maps created on Golden Software's Surfer Version 8.0 program.
- All concentrations are micrograms per liter ($\mu\text{g/l}$).
- Laboratory Detection Limit for PCE has varied through time.
- DMW-1D was identified as representative of the FG/CG Unit during the initial stages of the remedial characterization.

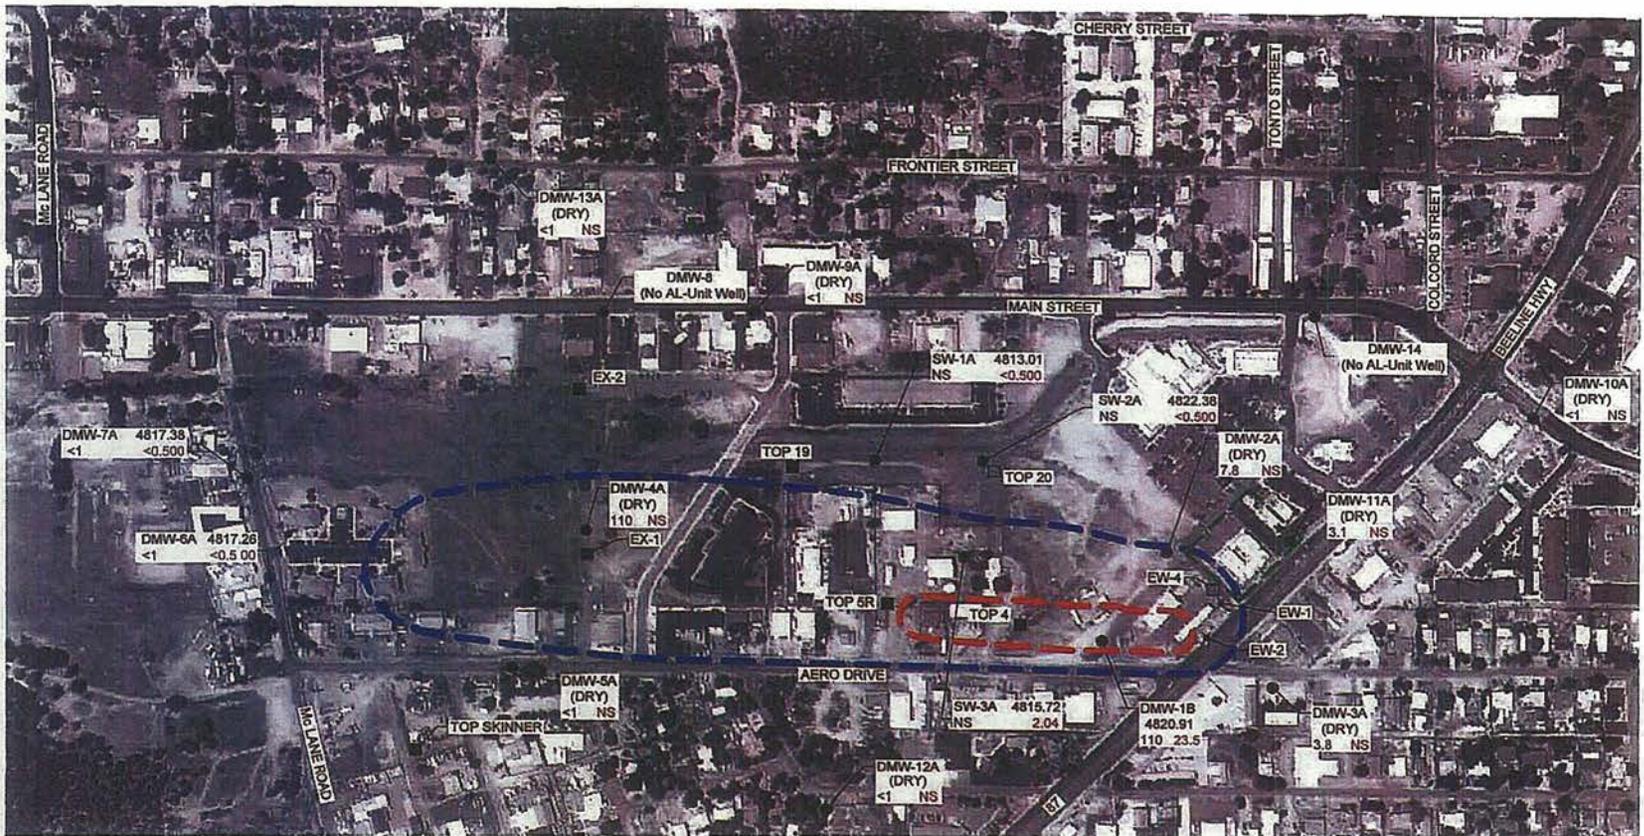
FIGURE 6. PCE CONCENTRATION MAP SEPTEMBER 2011 - AL UNIT
ADEQ Payson PCE and Tonto & Cherry WQARF Study Areas
Payson, Arizona

- Groundwater well locations and well head elevations are based on survey information provided by ADEQ. Locations of DMW-11 and DMW-13 are estimated.
- Groundwater elevation information is calculated based on WT depth to water level measurements collected between 13:11 September 19, 2011 and 14:49 September 20, 2011.
- All concentrations are micrograms per liter ($\mu\text{g/l}$).
- Laboratory Detection Limit for PCE in ND wells is 0.5 $\mu\text{g/l}$.
- (DRY) Indicates well was dry.
- DMW-1B has been used as a substitute AL Unit monitoring well since DMW-1A went dry in 2000-2001.

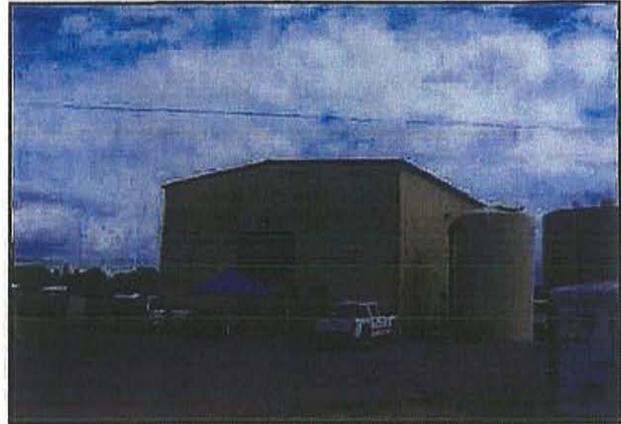
Picture 2 - View to the northeast of EGTS Structure. Distribution and Isolation water tanks are visible to right of photograph.

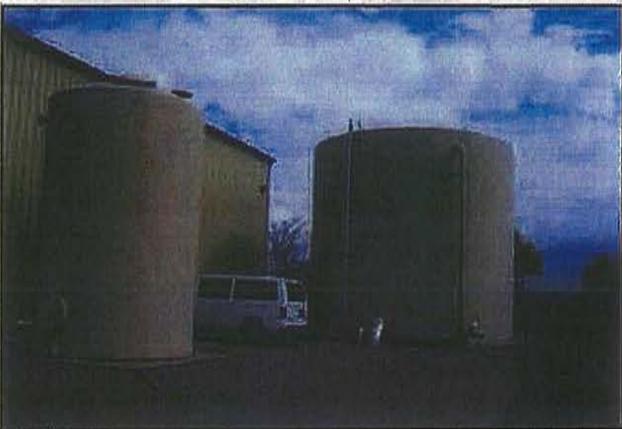
Picture 3 – View northeast of Storage-1 a contact chlorination/distribution water tank (on right) and Storage-2 an isolation water tank (on left).

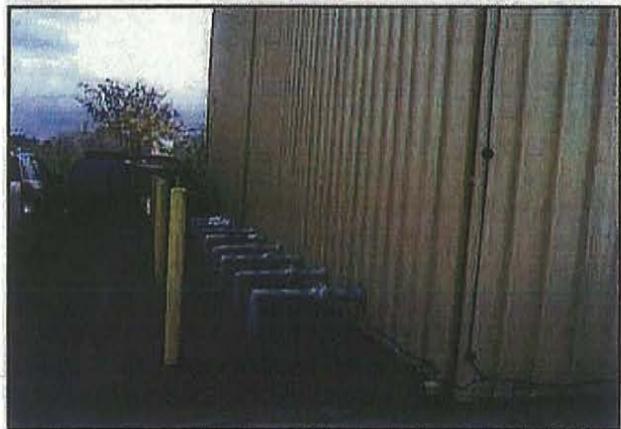
Picture 4 - View to the east along north side of EGTS structure, of entry point stub-ups from each extraction well.

Underground piping from each well exits the ground surface and enters the north wall of the EGTS. The aboveground portions of these exterior pipes were thermal wrapped for freeze protection. The thermal wrapping showed signs of wear but appeared to be in serviceable condition. Inside the building, the incoming pipelines joined a manifold along the north wall which led first to the bag pre-filters, then to and between the carbon vessels, and then from the carbon vessels to the Town of Payson distribution connection point. An adjustable manifold constructed of valves and flanged piping connections (the "decon piping system") served to support backflow, vessel isolation, and flow re-direction maintenance activities. The manifold, valves, and piping was painted and appeared in good condition. Staining and corrosion were not observed on the exterior of the piping or the underlying floor. Cracks and leaks were not evident. The piping was functioning at the time of the site inspection. Based on this review, the piping was in good condition.

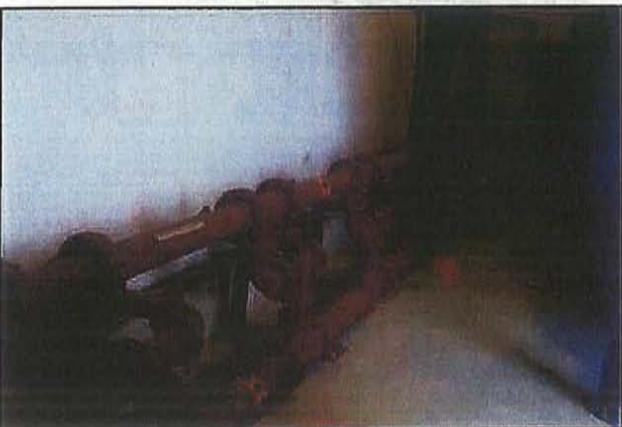
Picture 5 - View of EGTS entry point manifold inside north wall of the EGTS structure.

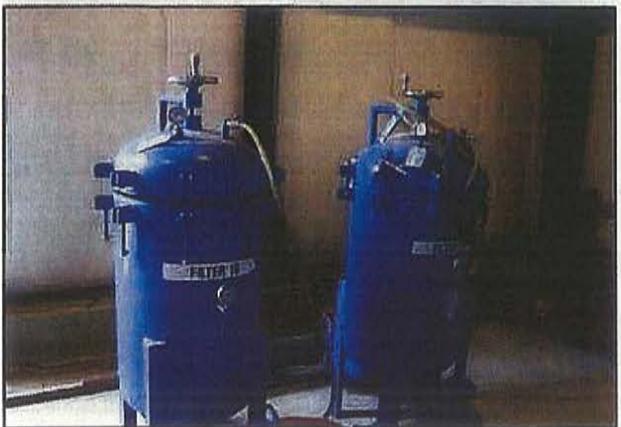
Picture 6 - View of EGTS bag-type pre-filters.

Two bag-style pre-filters were located in-line between the entry manifold and the carbon vessels. The pre-filters appeared in good condition. Staining and corrosion were not observed on the exterior of the filters housings or the underlying floor. Cracks and leaks were not evident. The piping was functioning at the time of the site inspection. Based on this review, the pre-filters were in good condition. On June 6, 2010, the Town of Payson reported discovery of bio-fouling originating from TOP-5R. The discovery was made because the Town of Payson Water Department Staff noticed an increase in the plugging rates of the bag filters media in the pre-filters. The Water Department staff, isolated the problem/affected components. TOP-5R was taken off-line and disinfected along with its distribution piping, manifold, and the bag filter units. The Town of Payson suspected nitrates as a contributing factor. The Town identified that slime bacteria were the suspected source of the issues and the treatment involved utilized frequent bag filter changes, periodic pH/chlorination treatment of the impacted wells and upgrading of the piping manifold at the EGTS.

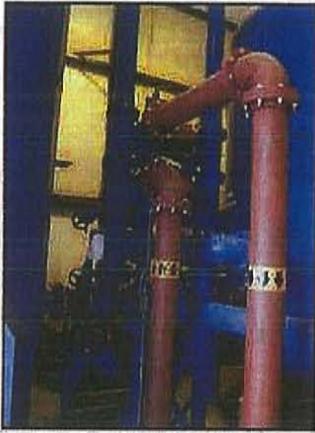
Picture 7 - View of EGTS carbon filtration manifold.

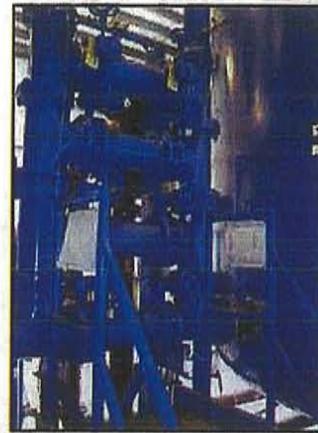
Picture 8 - View EGTS carbon filtration manifold.

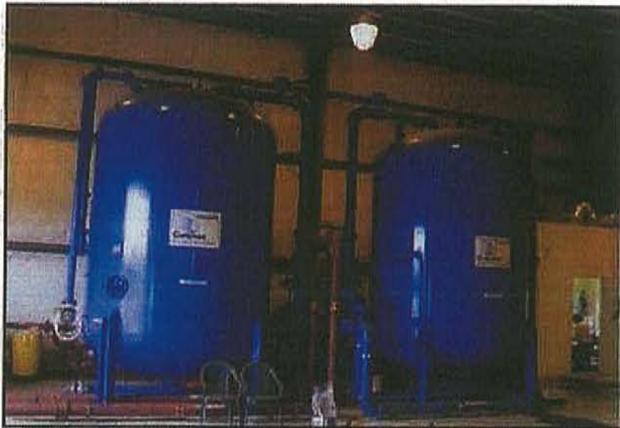
6. Damage to the EGTS Carbon Vessel 1A's liner was identified during the last carbon change out. A repair was not performed at that time due to a lack of funding and the need to return the system to operation. The carbon vessel lining should be repaired as soon as possible.

Picture 9 – View granular activated carbon vessels of the EGTS.

Two 500-gallon per minute (physical capacity) carbon vessels formed the functional core of the EGTS treatment system and were located in the north-central portion of the EGTS building. The EGTS was functioning at the time of the inspection and only the exterior of the carbon vessels were observed. The vessels appeared in good condition. Staining and corrosion were not observed on the exterior of the piping or the underlying floor. Cracks and leaks were not evident.

During a previous carbon change out event, the Town of Payson identified deterioration of the protective interior lining of the carbon vessels. Corrective action was taken by re-application of the lining to the vessels during the subsequent clean out event.

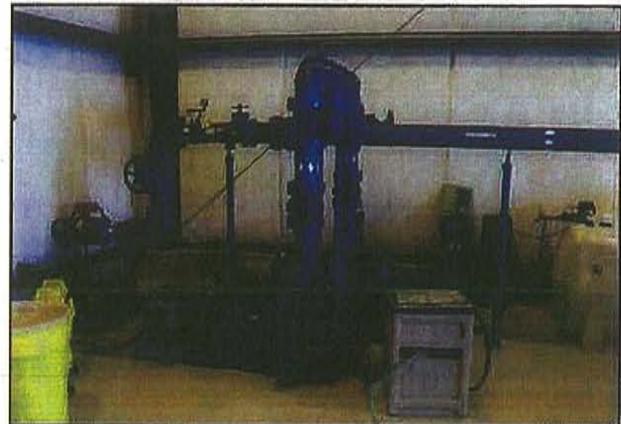
Picture 10 – View of alternate source (sources not requiring EGTS treatment) entry point, booster pumps, and isolation manifold.

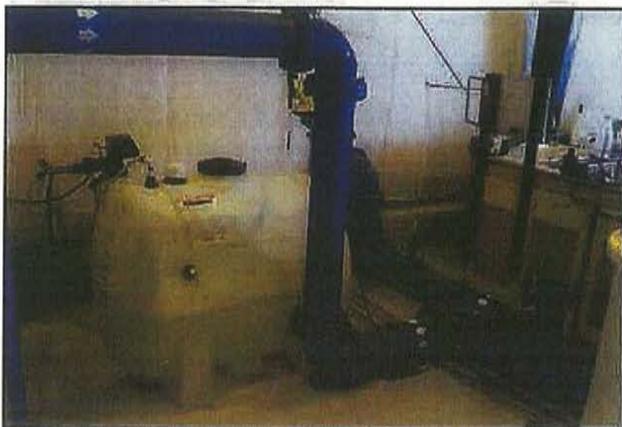
Picture 11 – View of EGTS discharge line, TOP alternate source connection, and chlorination station.

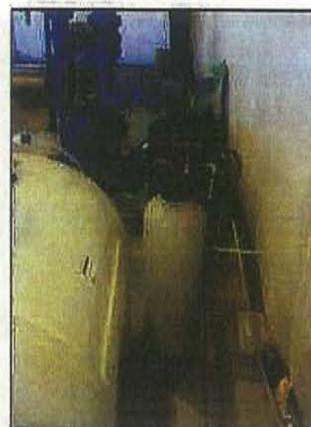
Picture 12 –View of chlorination metering device.

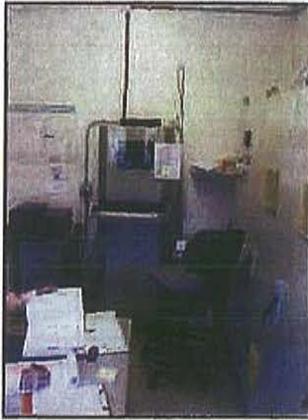
Picture 13 – View Control Center interface station in EGTS Control Room.

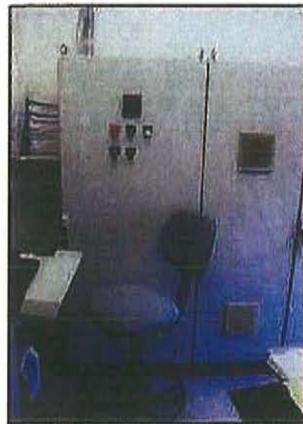
Picture 14 - View to the power control panel and emergency shut-off in EGTS Control Room.

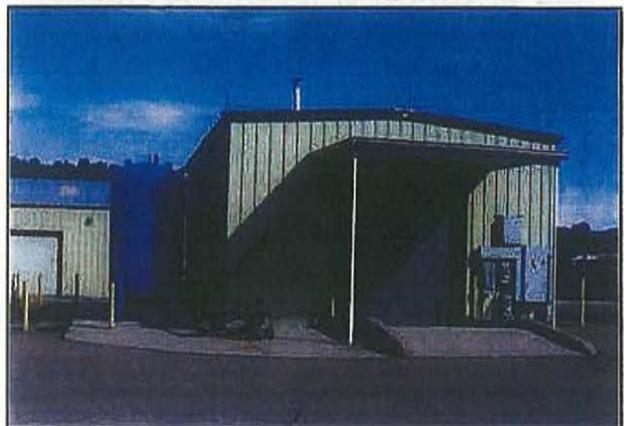
Picture 18 - View of inactive Interim Groundwater Treatment System (IGTS) Structure.
