# **RCRA FACILITY ASSESSMENT REPORT**

**A.A. SYDCOL WASTE TRANSFER FACILITY**

**A.A. SYDCOL, LLC**

Arizona Department of Environmental Quality  
Waste Programs Division  
Solid /Hazardous Waste Section  
Hazardous Waste Permits and Support

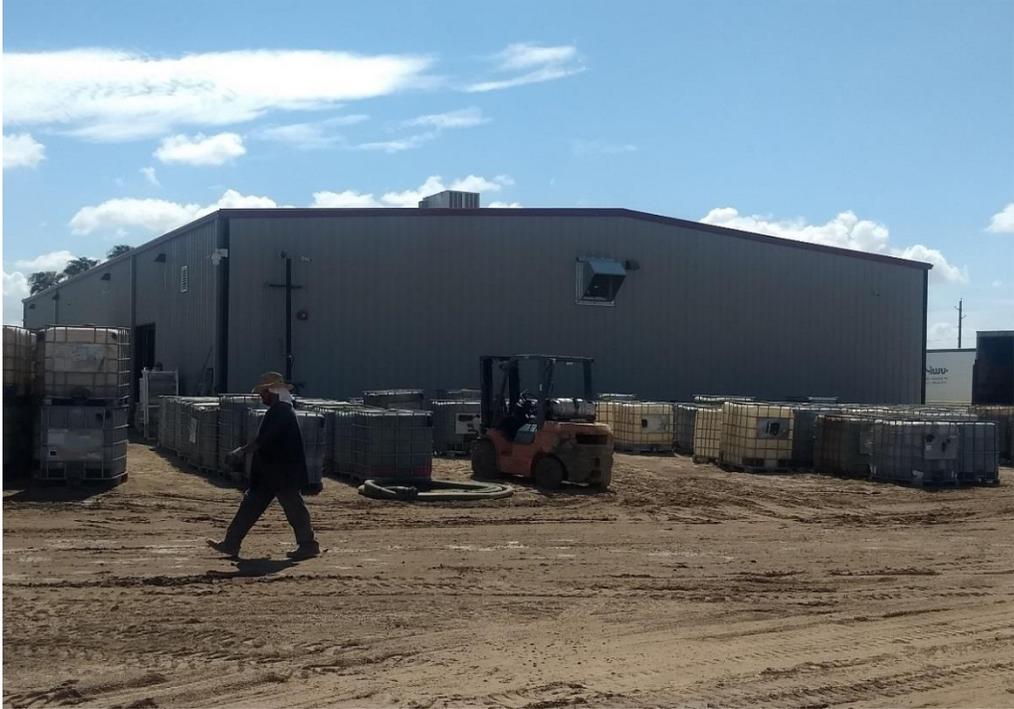
*Figure 6 - West Side of Central Building*

Figures 6 through 15 show the exterior and interior of the building. The interior of the building has a concrete base with epoxy coating, but due to mechanical wear, the epoxy coating was noted to have suffered significant wear (Figure 16). Section 2.2 describes the operations occurring within SWMU1.

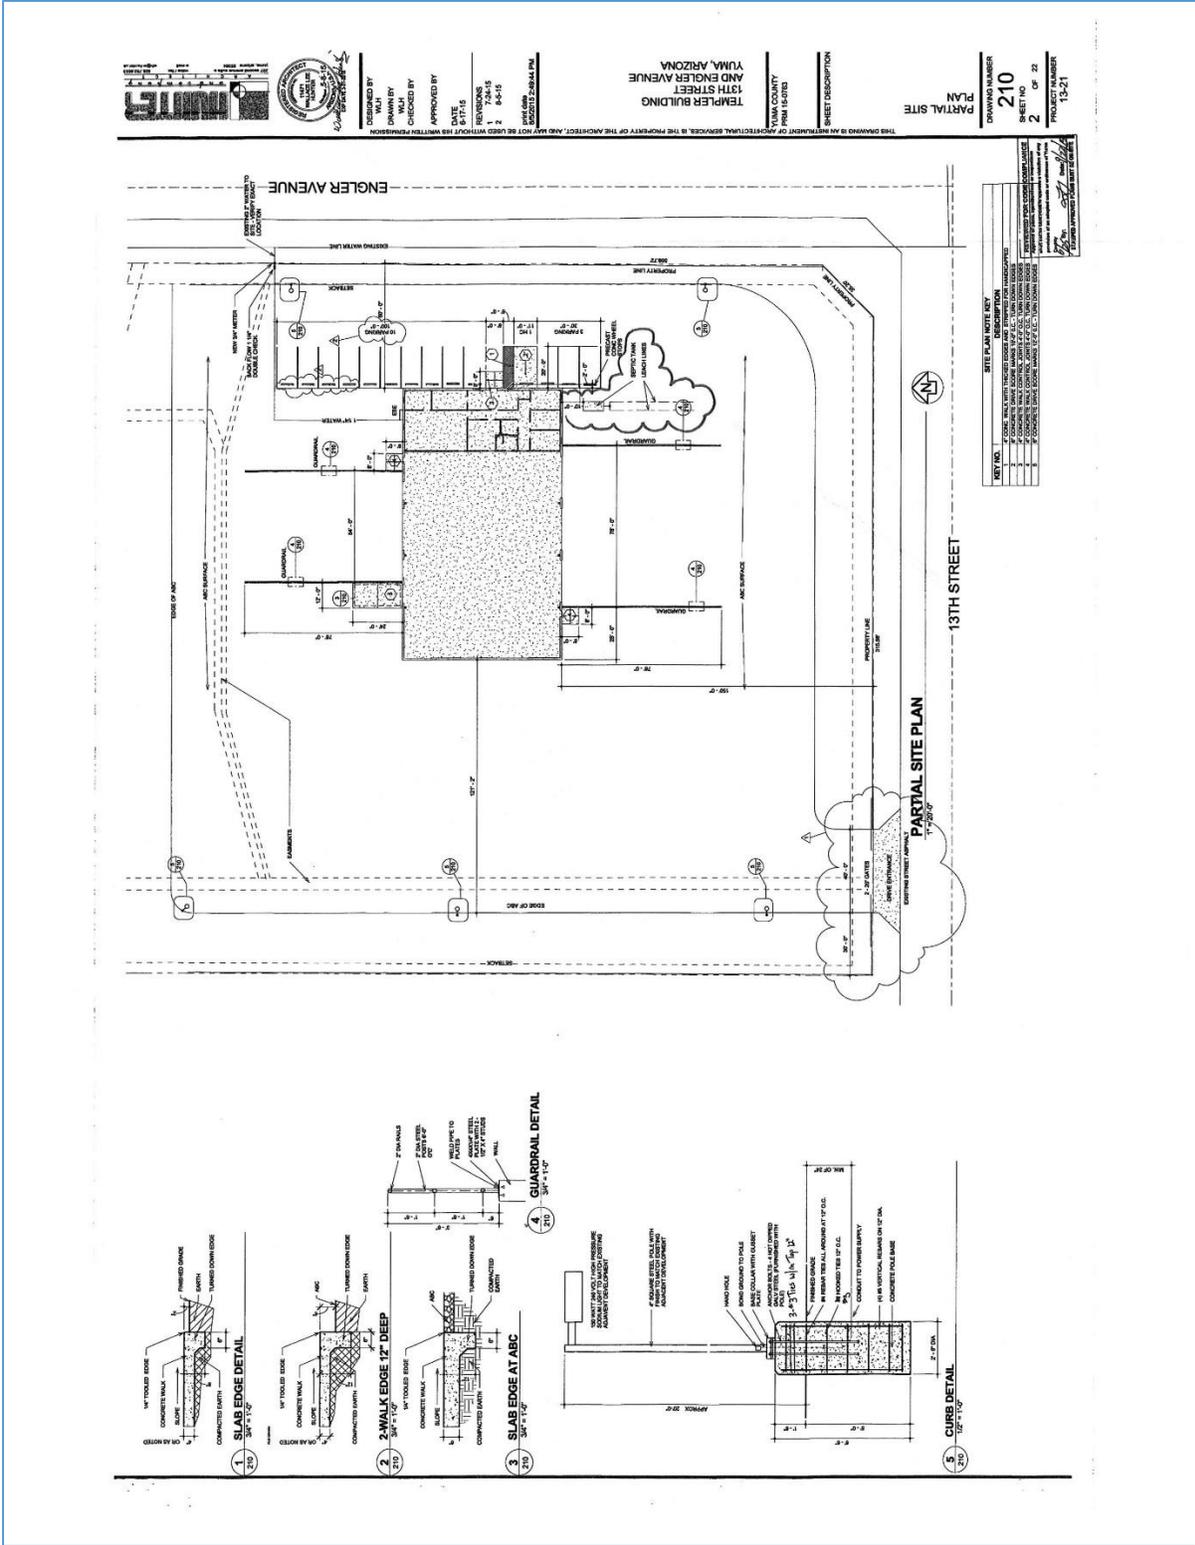
Figure 31 - Partial Site Plan Showing Septic System

Waste from the bathroom and the laboratory sink go to a septic system located to the southwest of the central building. No laboratory-generated solid wastes are directed to the septic system. Its location is shown on Figure 31.
