**THIRD FIVE-YEAR REVIEW REPORT FOR
INDIAN BEND WASH SUPERFUND SITE
MARICOPA COUNTY, ARIZONA**

U.S. Army Corps of Engineers

U.S. Environmental Protection Agency

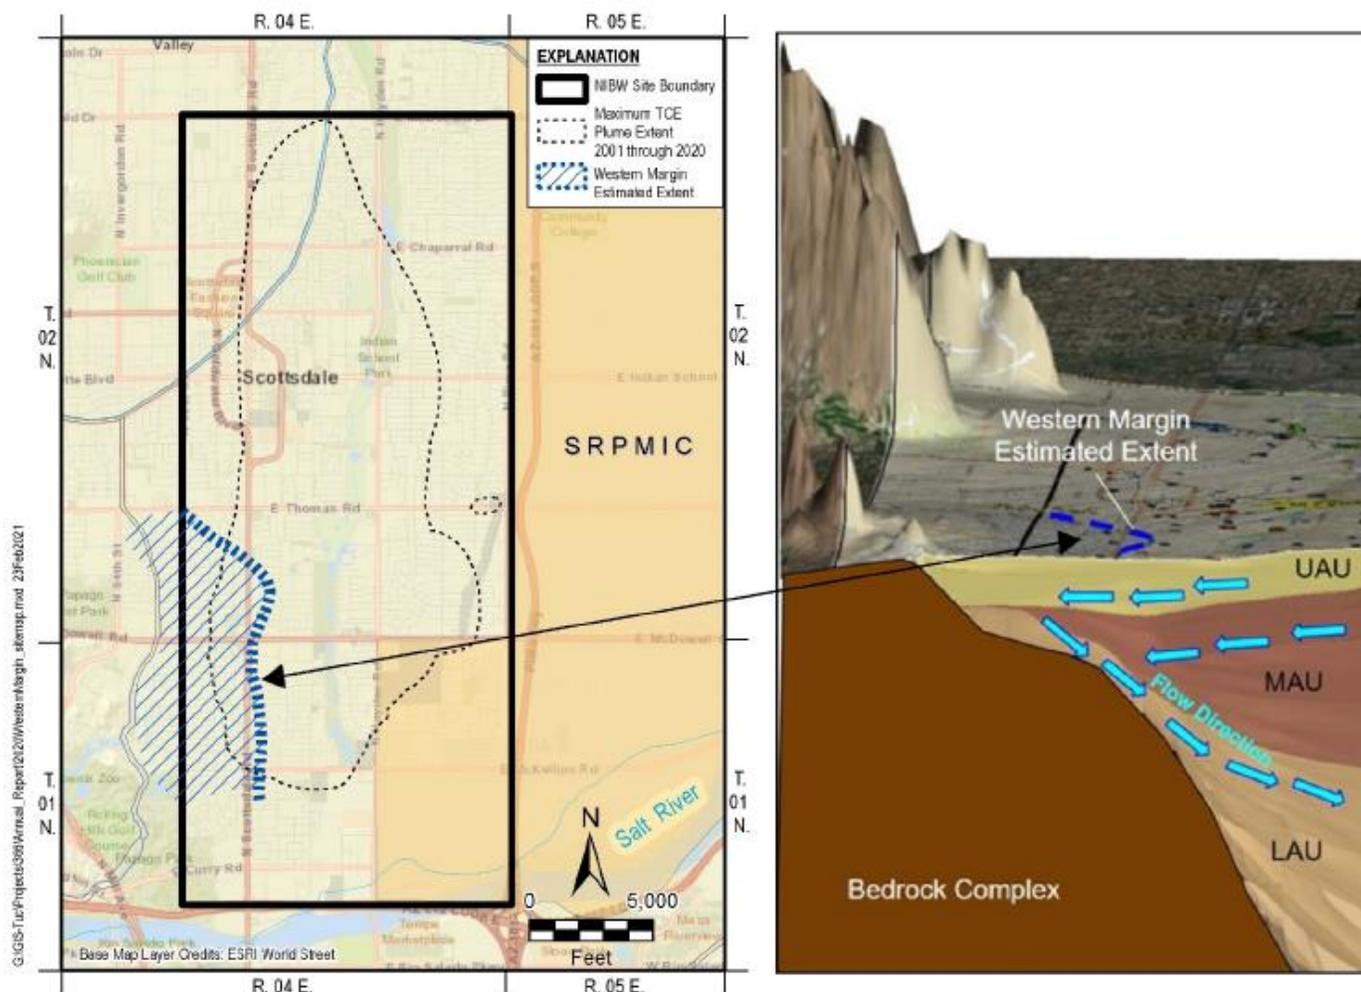
Figure 4. North Indian Bend Wash Plume extent and Western Margin

The North Indian Bend Wash Site is situated in the Basin and Range geologic province, with the groundwater basin consisting primarily sedimentary deposits derived from erosion and uplift of the surrounding mountain blocks. Principal geologic characteristics of the sedimentary alluvial deposits in the vicinity of the North Indian Bend Wash Site are present in three distinct groundwater units: the upper alluvial unit (UAU), middle alluvial unit (MAU), and lower alluvial unit (LAU) (Figure 4).

The upper alluvial unit consists primarily of sand, coarse gravel, cobbles, and boulders. The depth to the water table in the upper alluvial unit ranges from approximately 65 feet to 104 feet below ground surface (bgs), with 40 to 100 feet of saturated thickness. In the North Indian Bend Wash, the direction of groundwater movement in the upper alluvial unit is from east to west in the area south of McDowell Road, and (slightly changes directions from the northern part of the area) northeast to southwest in the vicinity of Thomas Road. The upper alluvial unit groundwater flows toward the southwest margin of the North Indian Bend Wash where bedrock is encountered, and there, groundwater moves vertically into the underlying alluvial units (Figure 4). The upper alluvial unit is not used for potable supply.

Large production wellfields located north of the North Indian Bend Wash groundwater plume draw groundwater primarily from the lower alluvial unit and to a lesser extent from the middle alluvial unit. At the western margin of the basin, the groundwater in the upper alluvial unit and middle alluvial unit flows into the lower alluvial unit due to the lower hydraulic head of the lower unit compared to the two upper units. Groundwater flow in the North Indian Bend Wash plume is complex; there is some uncertainty in the conceptual site model with regards to groundwater flow with respect to vertical and lateral gradients and contaminant transport.

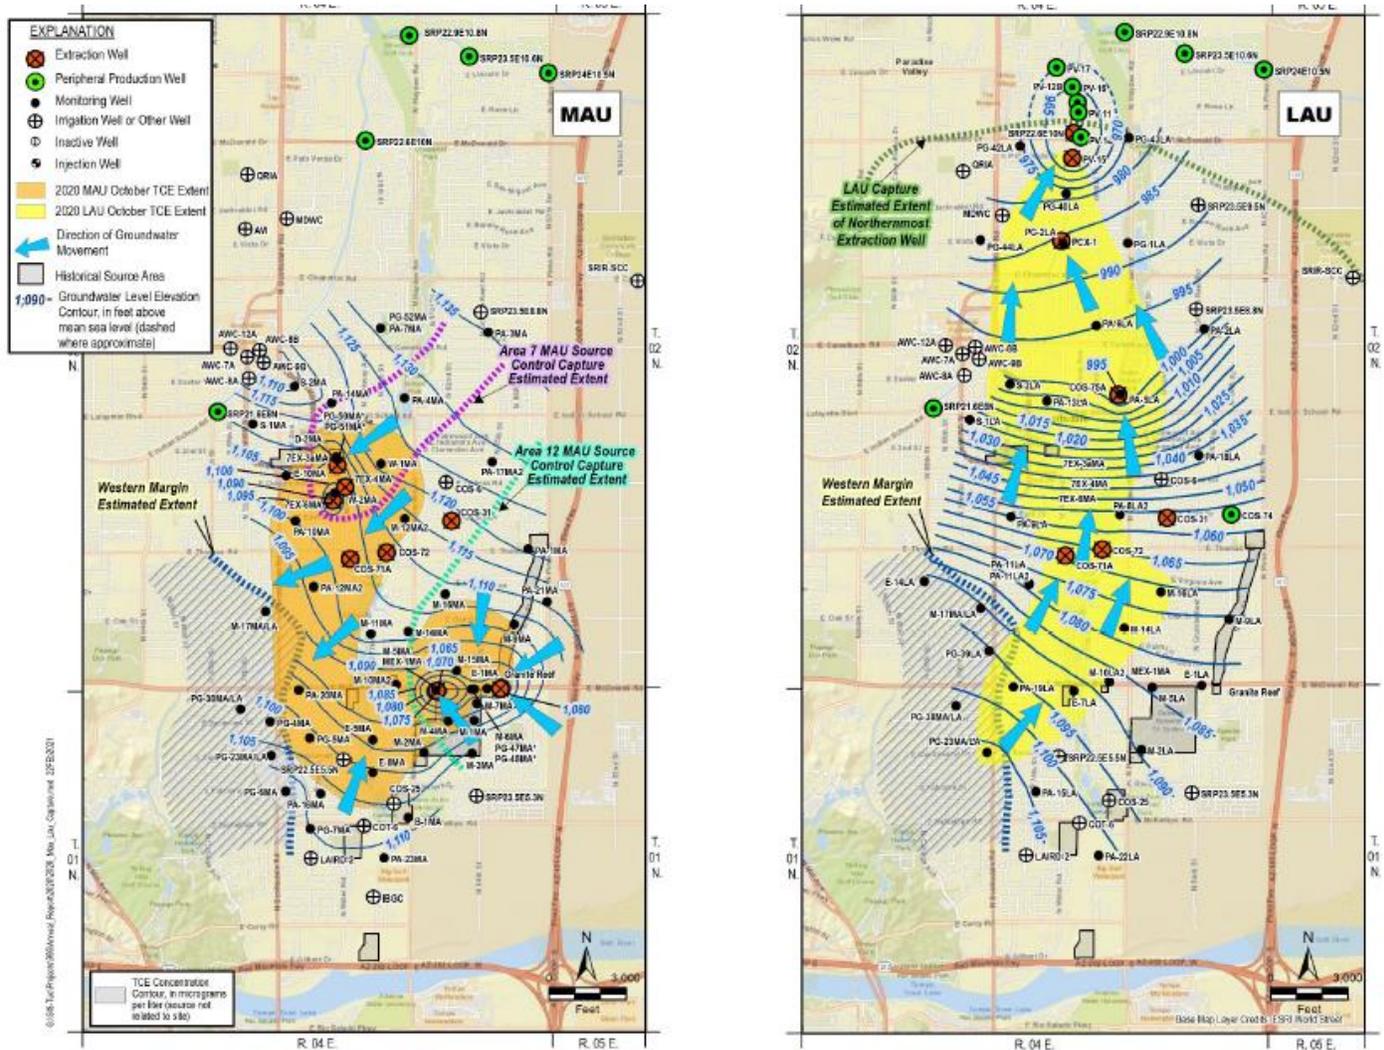
Figure 5. Groundwater Flow and Estimated Hydraulic Capture in the Middle and Lower Alluvial Units

Groundwater contamination is found within the upper, middle, and lower alluvial units within the North Indian Bend Wash area. The primary contaminants of concern are DCE, TCE, TCE, and PCE. Over the past five years DCE and TCA concentrations in monitoring wells were below Federal drinking water standards, and in many cases below detection limits; only TCE and PCE were detected at concentrations above the Federal drinking water standards. To date, about 135 billion gallons of groundwater have been extracted to remove an estimated 96,300 pounds of TCE (4.9 billion gallons of groundwater and removal of about 1,860 pounds of TCE in 2020) (Table 7). The most significant declines observed in TCE concentrations are in upper alluvial unit groundwater. In almost all upper alluvial unit wells across the North Indian Bend Wash, DCE and TCA concentrations were below Federal drinking water standards, and in many cases below detection limits, over the entire Five-Year Review period. One well in the upper aquifer (PG-31UA) near Area 7 still has TCE concentrations ranging up to 36 µg/L exceeding the Federal Maximum Contaminant Level drinking water standards (5 micrograms per liter or µg/L). Figure 5 shows the TCE groundwater plume in the upper, middle and lower alluvial units. Groundwater in the middle alluvial unit has the highest TCE concentrations, particularly within the Area 7 capture zone, where concentrations exceed 1,000 µg/L in a localized area. The highest concentrations of TCE occur at wells W-1MA and W-2 MA with maximum TCE concentrations of 520 and 2,100 µg/L respectively for this reporting period (See Appendix D for TCE results). In the Area 12 capture zone near the Granite Reef extraction well TCE concentrations were approximately 150 µg/L in 2019. Groundwater in the middle alluvial unit generally flows northeast to southwest toward the Western Margin, where it merges with the lower alluvial unit and groundwater flow reverses towards the extraction wells to the north.

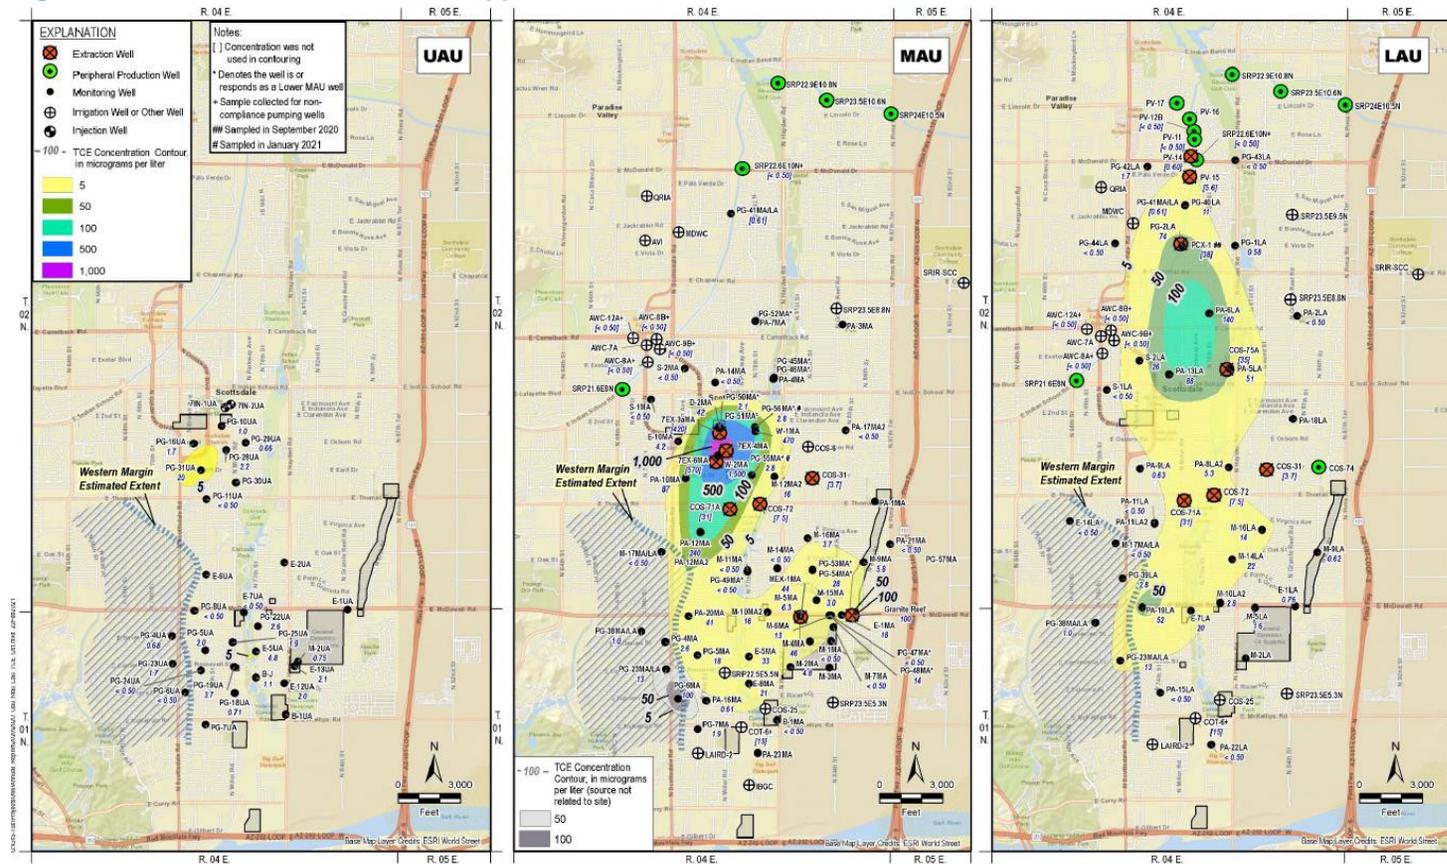
Figure 6. TCE Concentrations in the upper, middle, and lower alluvial units

The Participating Companies performed five-year TCE Mann-Kendall trend analyses that show 9 of the 84 monitoring wells had increasing concentrations of TCE across the North Indian Bend Wash area within the upper, middle, and lower alluvial units (NIBW PCs, 2021). Thirteen of the 84 monitoring wells had decreasing concentrations and 62 of the 84 monitoring wells showed no trend (NIBW PCs, 2021). As part of this Five-Year Review, US Army Corps of Engineers performed additional five-year TCE Mann-Kendall trend analyses on behalf of EPA for 32 monitoring wells in the upper, middle, and lower alluvial units with TCE concentrations greater than the TCE Federal drinking water standard of 5 µg/L. TCE data are presented in Appendix D. USACE Mann-Kendall trend analyses show TCE concentrations increasing or probably increasing at 7 monitoring wells, decreasing or probably decreasing at 6 monitoring wells, and there was either no trend or stable at 19 monitoring wells.

The areas where concentrations are increasing are either in the Western Margin region of the Site or the western edge of the lower alluvial unit. During this five-year reporting period, the US Army Corps of Engineers performed Mann-Kendall trend analyses for several select monitoring wells (See Appendix D). The trend analyses identified increasing PCE concentrations at wells PA-10MA, PG-38MA, and S-1LA, although PA-10MA and PG-38MA are still below EPA drinking water standards. All of these wells are located within the Western Margin. PG38-MA is located near PG-4-UA where there is another PCB source unrelated to the North Indian Bend Wash plume. PA-10MA is outside of the currently reduced Area 7 capture zone, where PCE from this location may migrate to the western margin. Monitoring well S-1LA has increasing PCE concentrations ranging from 21 to 48 µg/L and is also located on the western margin of the plume near groundwater production wells for the Salt River Project and Arcadia Water Company, which are being used for irrigation. Monitoring well S-2LA is to the northeast and downgradient of S-1LA and also has increasing TCE concentrations. The western edge of the lower alluvial unit does not appear to be fully contained by the currently operating extraction well network. Groundwater in this area is poorly defined due inadequate monitoring well network along the periphery of the Western Margin, as shown in Figure 7. Additional characterization is warranted given the proximity of the production wells. Groundwater iso-concentration maps have demonstrated a gradual westward shift over time, as shown on Figure 8.

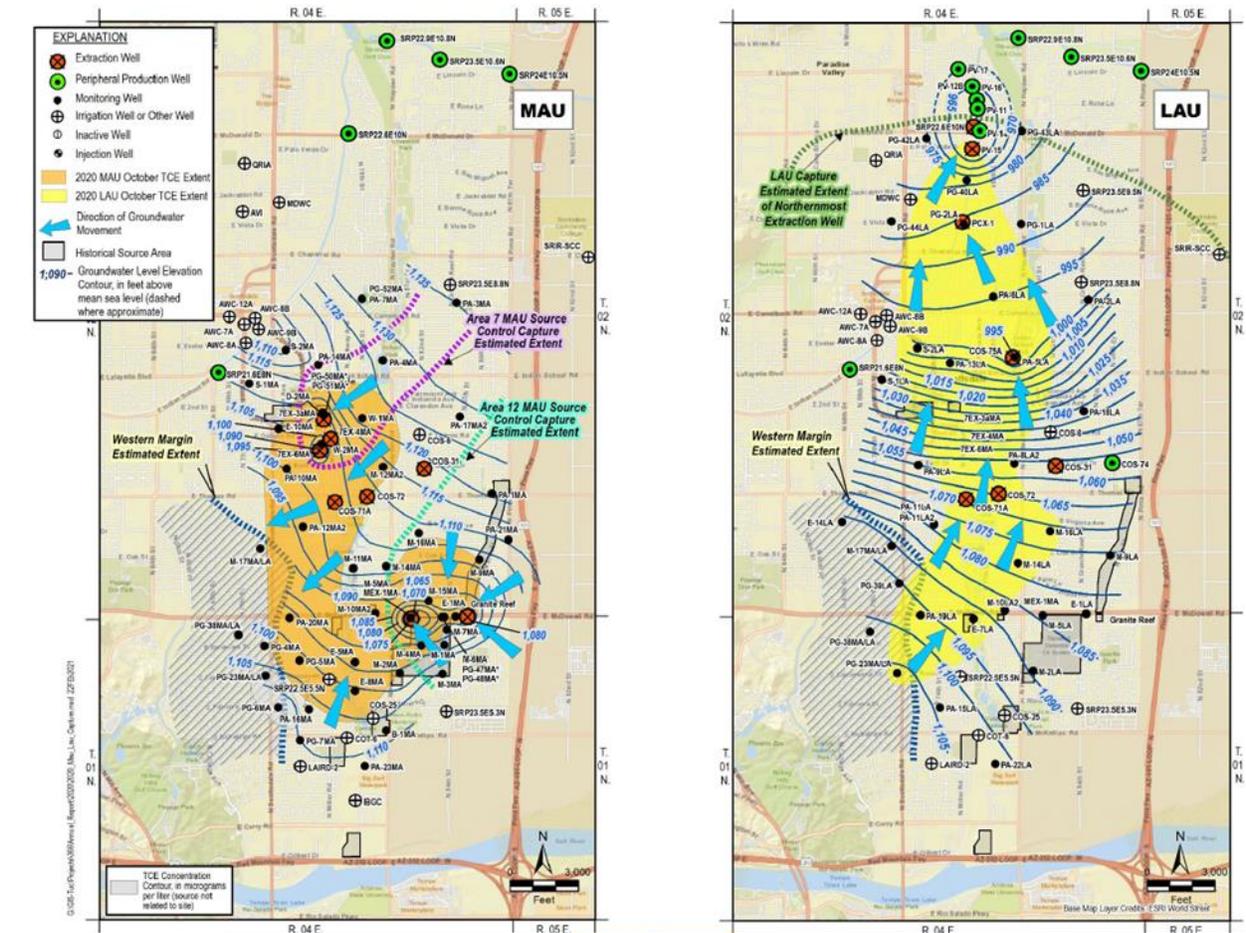
Figure D-2. Estimated Hydraulic Capture of TCE Plume by middle alluvial unit source control and Northernmost lower alluvial unit Extraction Wells October 2020.

The Participating Companies have performed five-year TCE Mann- Kendall trend analyses that show that 9 of the 84 monitoring wells had increasing concentrations TCE across the North Indian Bend Wash area within the middle and lower alluvial units. Thirteen of the 84 monitoring wells had decreasing concentrations and 62 of the 84 monitoring wells showed no trend. (NIBW Participating Companies, 2021.) Five-Year Mann- Kendall analyses were also independently performed by USACE for EPA on 32 select wells in the upper, middle and lower alluvial unit wells with concentrations exceeding the federal drinking water standard of 5 µg/L. These data are presented in Figures D-3 to D-8. These trend analyses show TCE concentrations increasing at 7 of the selected wells, decreasing or probably decreasing at 6 monitoring wells and stable or no trend at 19 monitoring wells.

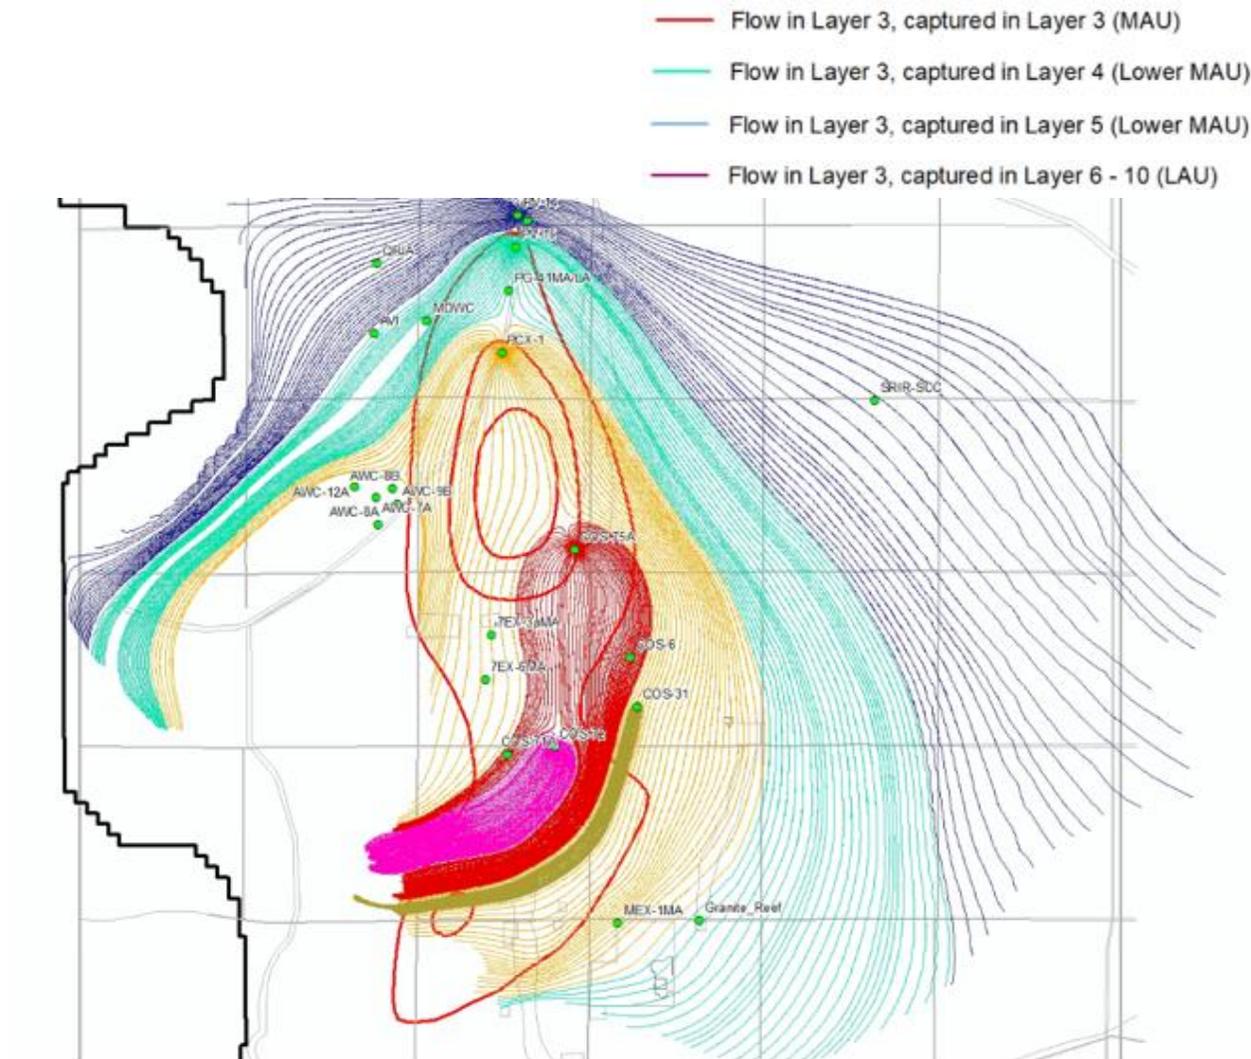
Figure D-9 Particle flow groundwater modeling gradients

The North Indian Bend Wash Participating Companies ran a particle tracking modeling of the horizontal groundwater movement towards the extraction wells. As shown below, the empty space west of MEX-1MA well shows the area of uncertainty regarding the movement of groundwater from the upper and middle alluvial units into the lower alluvial unit (Figure D-9).

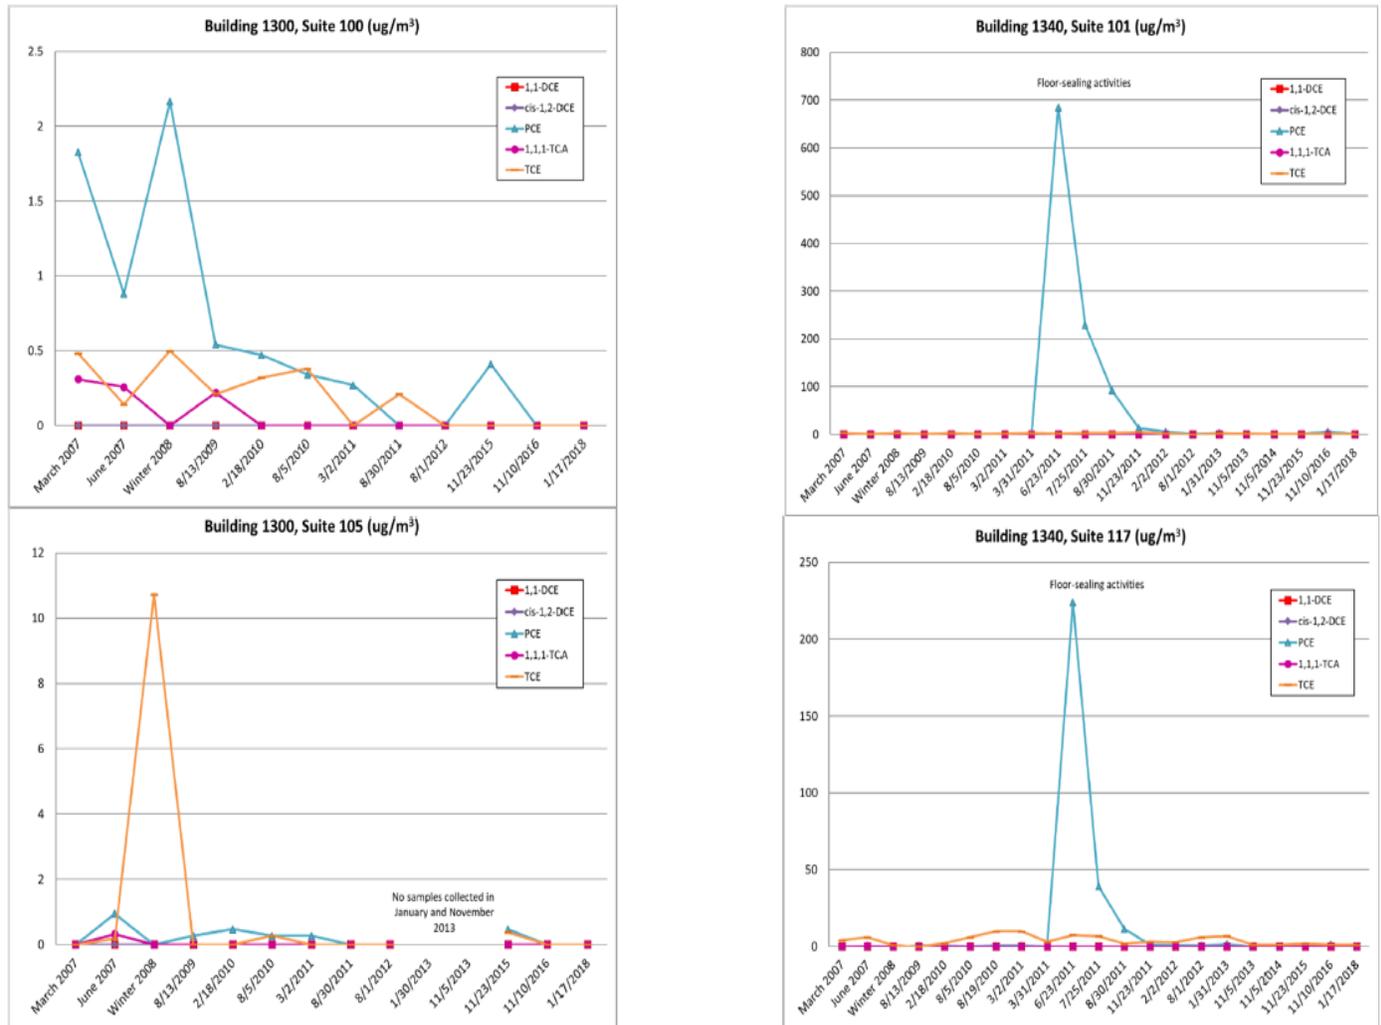
Figure D-12. Indoor Air Trends in Commercial Suites at DCE Circuits Subsite

EPA collected soil gas samples of all former source areas with respect to the vapor intrusion pathway. Based upon the soil gas sampling results, all twelve former South Indian Bend Wash source areas were determined to require no further action for vapor intrusion. A vapor intrusion assessment for the DCE Circuits Subsite was conducted in April 2019 to assess the risk to human health. Neither the accelerated response action level or urgent response action level was exceeded in any of soil gas indoor/outdoor air samples for TCE for commercial/industrial or residential use (Figure D-12).
