# ENGINEERING CONTROL PLAN

Former Universal Propulsion Company, Inc.  
Facility Phoenix, Arizona

Former Universal Propulsion Company, Inc.  
Facility, Phoenix, Arizona

# CONSTRUCTION DRAWINGS FOR SOIL EXCAVATION AND CAPPING FORMER UPKO FACILITY FOR UTC AEROSPACE SYSTEMS

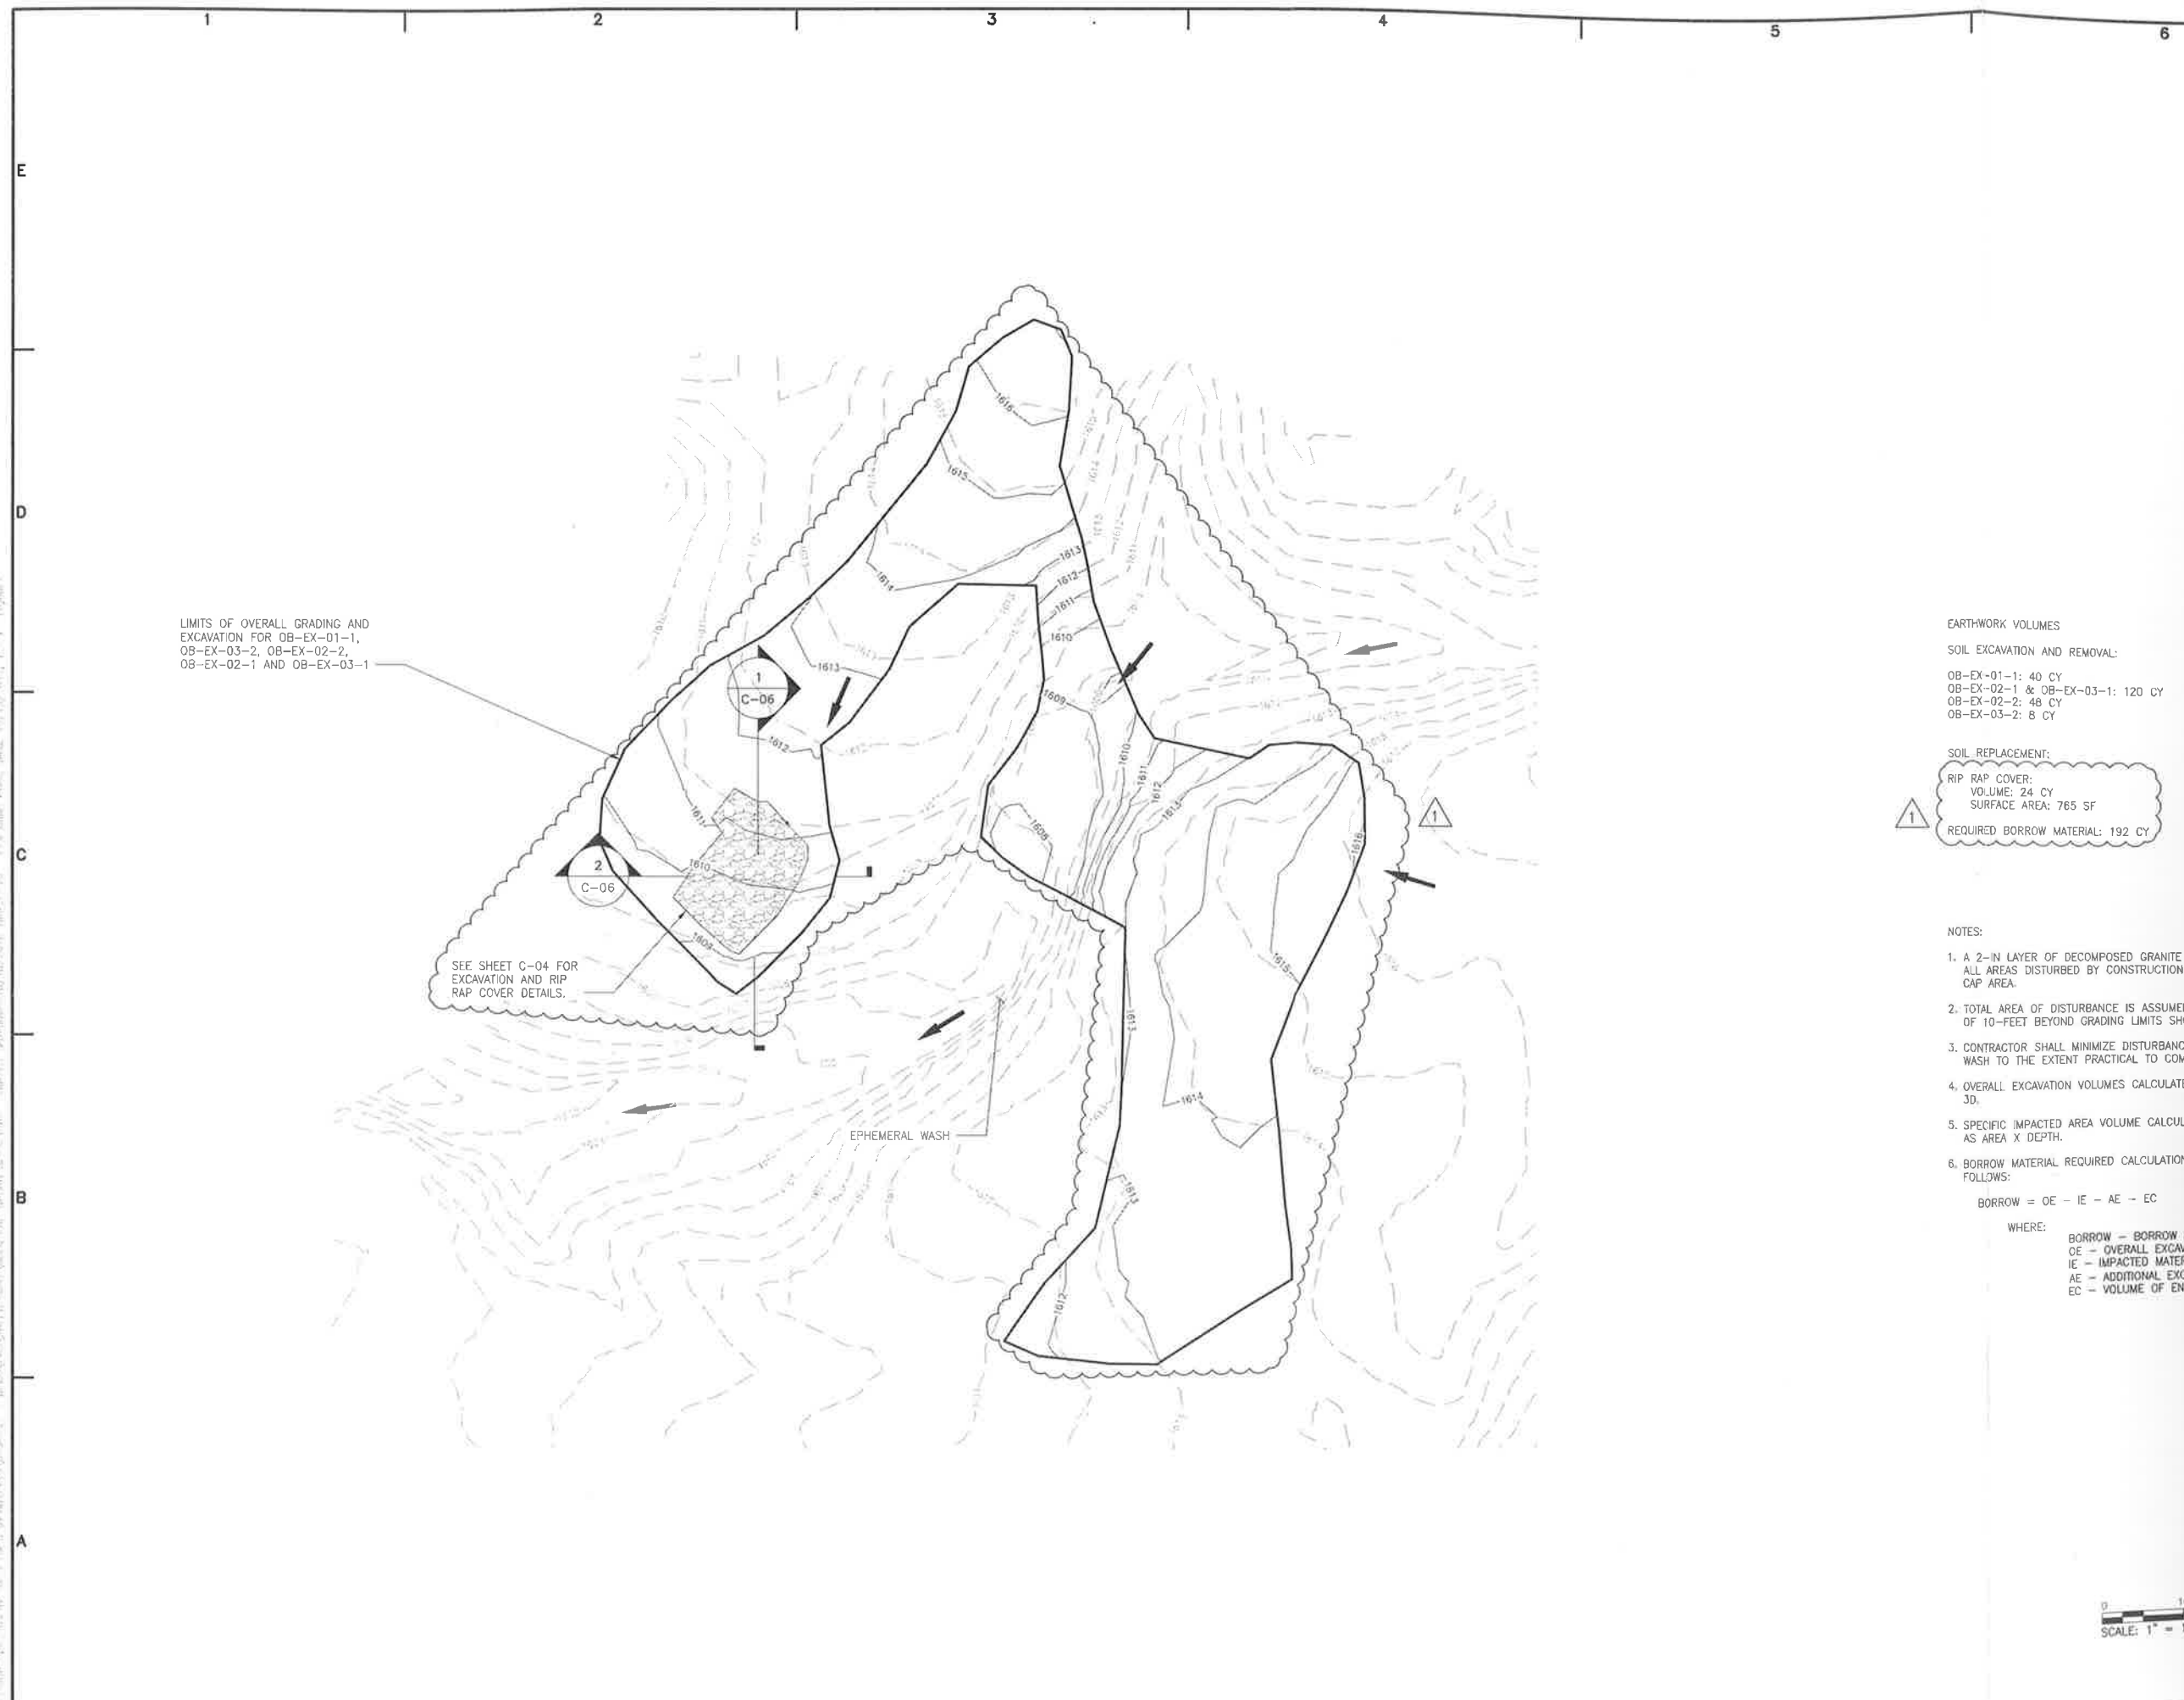
OLD BURN AREA  
EXCAVATION AND RESTORATION  
PLAN

EARTHWORK VOLUMES

The final cover system installed within the Old Burn Area consists of a rip-rap cover (**Appendix A**) that protects an area of approximately 765 sq. ft. The rip-rap cover is constructed of a 1-foot thick layer of rip-rap stone underlain by a nonwoven geotextile fabric. Prior to installation of the rip-rap cover, the area was excavated, backfilled, and compacted to within 1-foot of the ground surface. A nonwoven geotextile fabric (THRACE LINQ 130EX), 4-feet wide, was installed on top of the soil. Each joint of the geotextile was overlapped a minimum of 12-inches and brought up around the edges of the excavation. D<sub>50</sub> 8-inch size stone, with a size no smaller than 4-inches, was placed on the geotextile within the cap area in a uniform rip-rap layer. The top of the rip-rap cover is at the same grade as the ground surface of the surrounding area. The rip-rap cover was installed in accordance with ADEQ guidance and was subsequently approved by ADEQ via site inspection of the cover construction. As-builts for the rip-rap cover are provided in **Appendix A** and photos of the constructed rip-rap cover are provided in **Appendix B**.

Rip-rap underlain by a non-woven geotextile fabric, as described in Section 2.1.2, provides the run-on and run-off control for the rip-rap cover located in the Old Burn Area (**Appendix A**). The rip-rap cover protects against erosion of soils containing arsenic concentrations that exceed the site clean-up standard. Procedures for maintaining the cover are described in Section 5.2 and construction details for the rip-rap cover is provided in **Appendix A**.

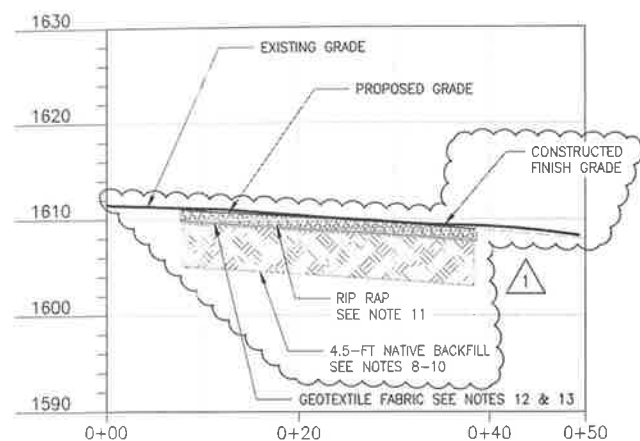
1 SECTION 1

C-05 SCALE: 1" = 10' HORIZONTAL  
SCALE: 1" = 10' VERTICAL

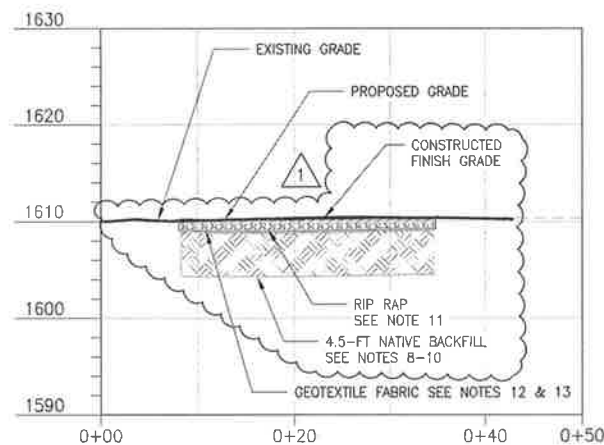
2 SECTION 2

C-05 SCALE: 1" = 10' HORIZONTAL  
SCALE: 1" = 10' VERTICAL

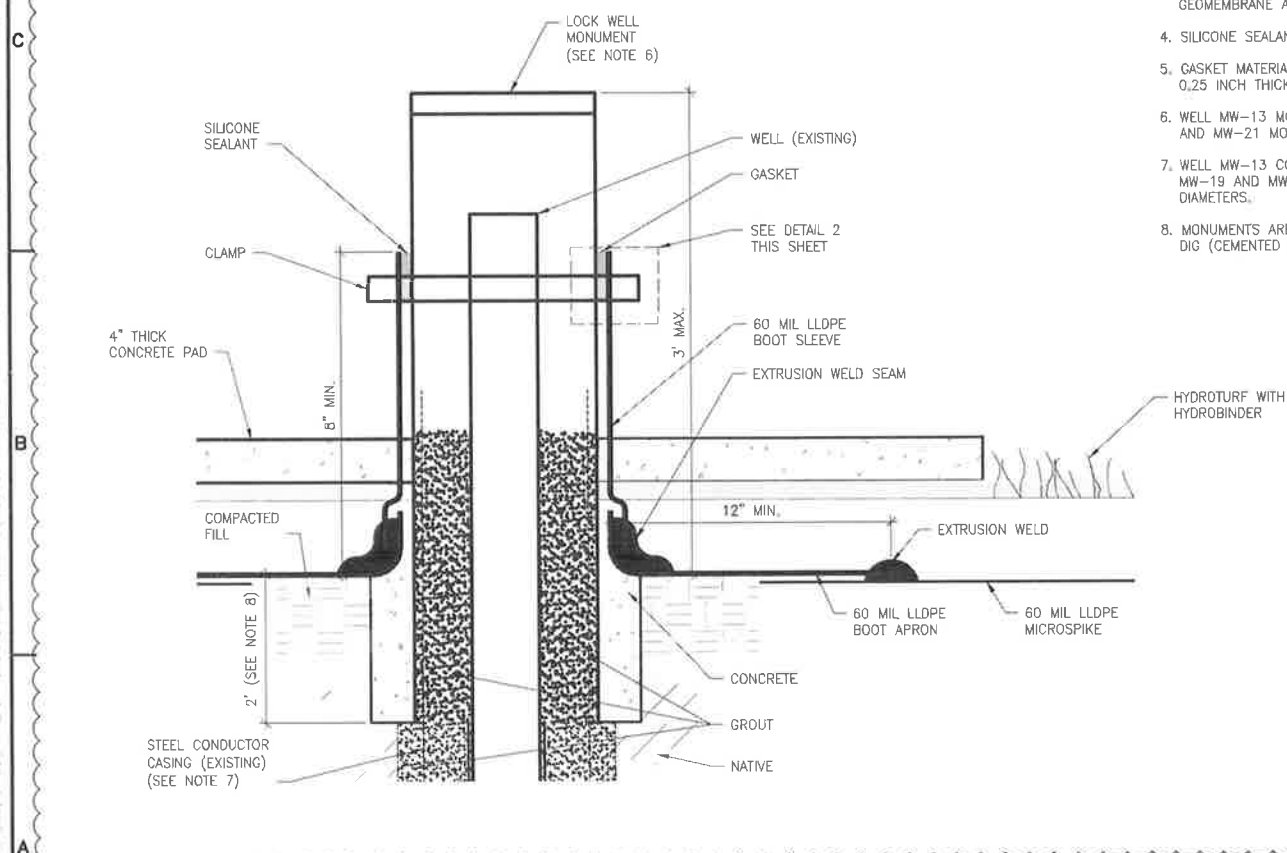
3 GROUNDWATER WELL PENETRATION SEAL

- NOTE:
- HYDROTURF GOES DOWN INTO TRENCH.
  - HYDROTURF CS INCLUDES: SYNTHETIC TURF; HYDROBINDER INFILL; PP WOVEN GEOTEXTILE; 50 MIL LLDPE DUAL TEXTURED LINER (AGRU AMERICA MICROSPIKE)
  - TWO STAINLESS STEEL "BAND-IT" OR "SCREW-TYPE" CLAMPS; CLAMPS TO BE 1/8" THICK BY 1.5" WIDE TO THE EXACT DIAMETER OF THE PIPE (ALLOWING FOR THE THICKNESS OF THE GEOMEMBRANE AND GASKET).
  - SILICONE SEALANT SHALL BE SILICONE, RTV103, OR EQUIVALENT.
  - GASKET MATERIAL SHALL BE NEOPRENE, CLOSED CELL MEDIUM, 0.25 INCH THICK, WITH ADHESIVE ON ONE SIDE.
  - WELL MW-13 MONUMENT HAS AN 18 INCH DIAMETER, WELLS MW-19 AND MW-21 MONUMENTS HAVE 13 INCH DIAMETERS.
  - WELL MW-13 CONDUCTOR CASING HAS A 13 INCH DIAMETER, WELLS MW-19 AND MW-21 CONDUCTORS CASINGS HAVE 10 INCH DIAMETERS.
  - MONUMENTS ARE EMBEDDED INTO GROUND 2' DEEP DUE TO HARD DIG (CEMENTED ALLUVIUM).

sealed around each well penetration with an LLDPE liner boot. Boot details are shown on the as-builts provided in **Appendix A**. The concrete anchor trench encompasses the entire HydroTurf® to anchor the liner and HydroTurf® into the native ground. The anchor trench is approximately 2'-6" wide and approximately 2' feet deep except where it crosses the ephemeral wash. Due to potential scouring within the wash from rain events, and to protect against surface water infiltrating laterally beneath the cap, the anchor trench upgradient of the cap is a minimum of 4' deep, 8' wide at the surface, and 4' wide at the bottom. The anchor trench downgradient of the cap is a minimum of 4' deep and 2'-6" wide and tied into the downgradient rip-rap apron. Photos of the constructed engineered cap are provided in **Appendix B**.

- Walk the perimeter of the anchor trench and inspect for substantial erosion or subsidence and note signs of areas where pooling of water may occur.
- Inspect the boot around each the five wells that penetrate the cap HydroTurf®. Check to ensure that the two stainless steel bands are tight and in good condition on each of the five boots. Check the condition of the sealant at the top of the boot and confirm that the entire circumference between the boot and well casing is sealed and that there is no excessive cracking or deterioration that could lead to a leak. Check condition of LLDPE boot around each well monument and verify no signs of cracks or punctures through the boot.

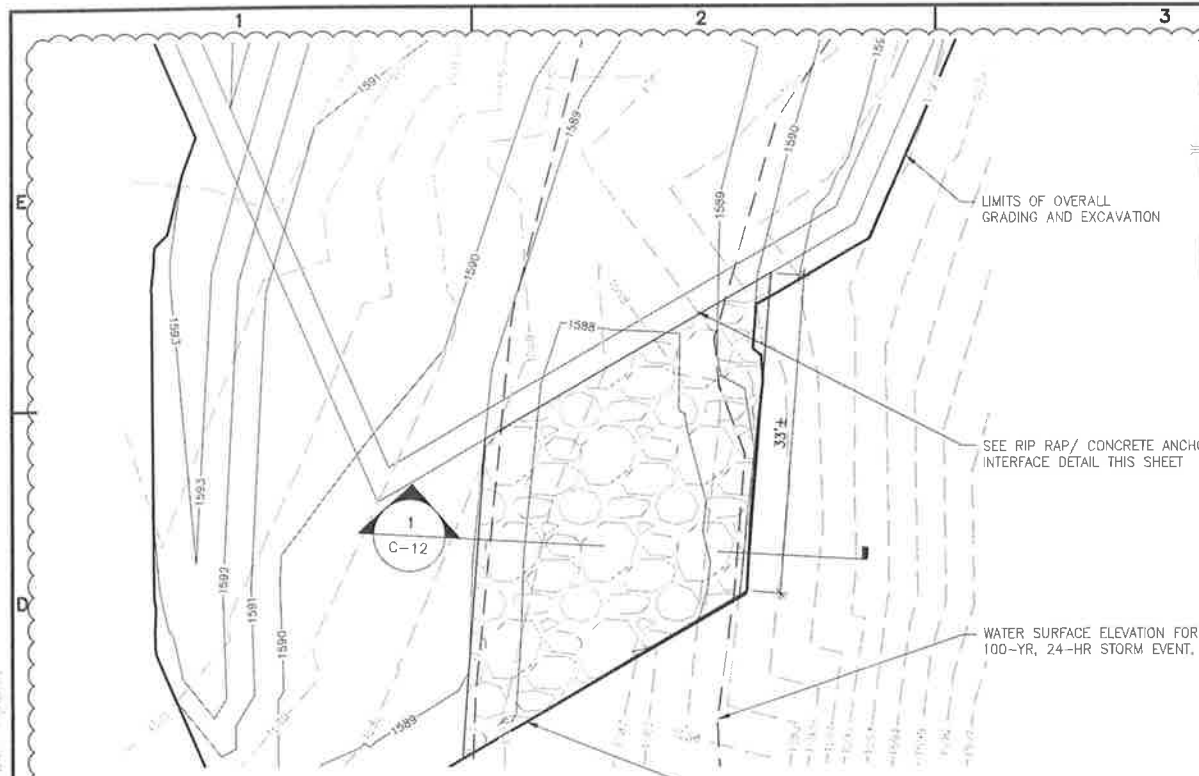
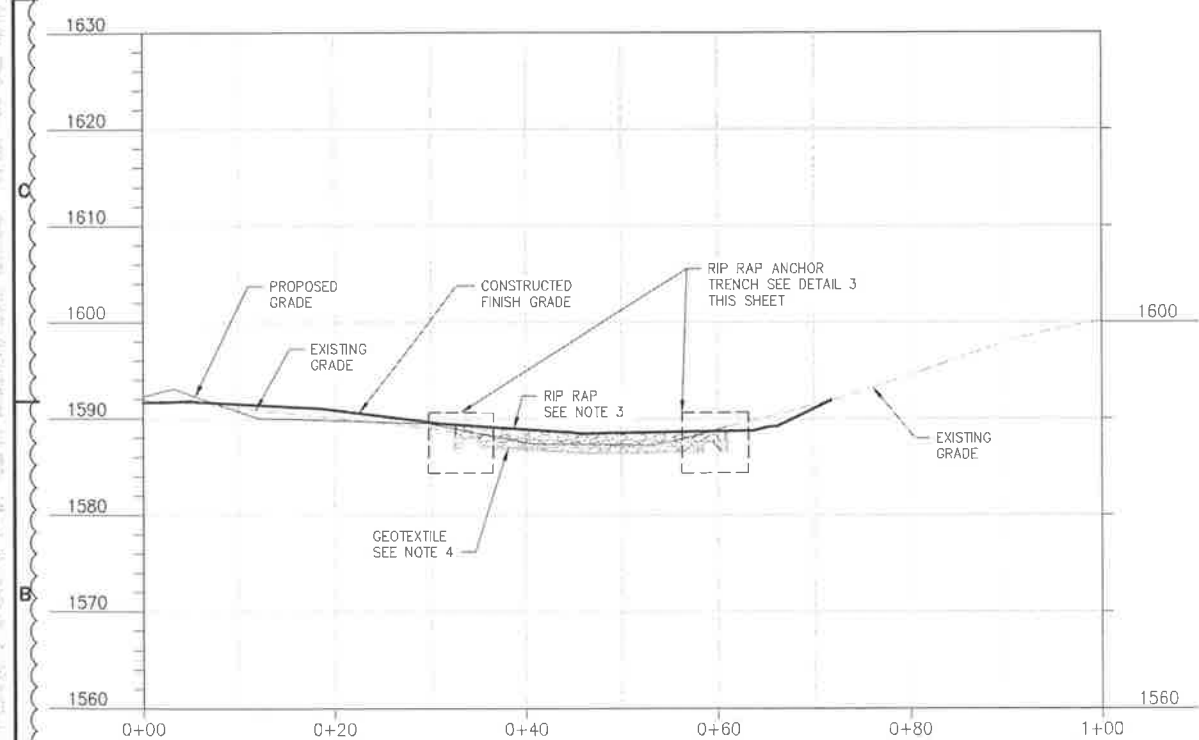
**1 SECTION 1**  
C-12 SCALE: 1"=10'

- NOTES:
- RIP RAP SHALL CONFORM TO MAG STANDARD SPECIFICATION 703.
  - RIP RAP SHALL BE PLACED PER MAG STANDARD SPECIFICATION 220.
  - RIP RAP SHALL HAVE A MINIMUM D50 OF 12-INCHES WITH A SIZE NO SMALLER THAN 8-INCHES IN DIAMETER AND SHALL BE PLACED IN A LAYER A MINIMUM OF 24-INCHES THICK.

- RIP RAP SHALL HAVE A MINIMUM D50 OF 8-INCHES WITH A SIZE NO SMALLER THAN 4-INCHES IN DIAMETER AND SHALL BE PLACED IN A LAYER A MINIMUM OF 24-INCHES THICK.

- GEOTEXTILE SHALL CONFORM TO CLASS A PER MAG STANDARD SPECIFICATION 796. NONWOVEN GEOTEXTILE FABRIC (THRACE LINO 130EX), 4- FEET WIDE, SHALL BE INSTALLED ON TOP OF THE SOIL. EACH JOINT OF THE GEOTEXTILE SHALL BE OVERLAPPED A MINIMUM OF 12-INCHES AND BROUGHT UP AROUND THE EDGES OF THE EXCAVATION.

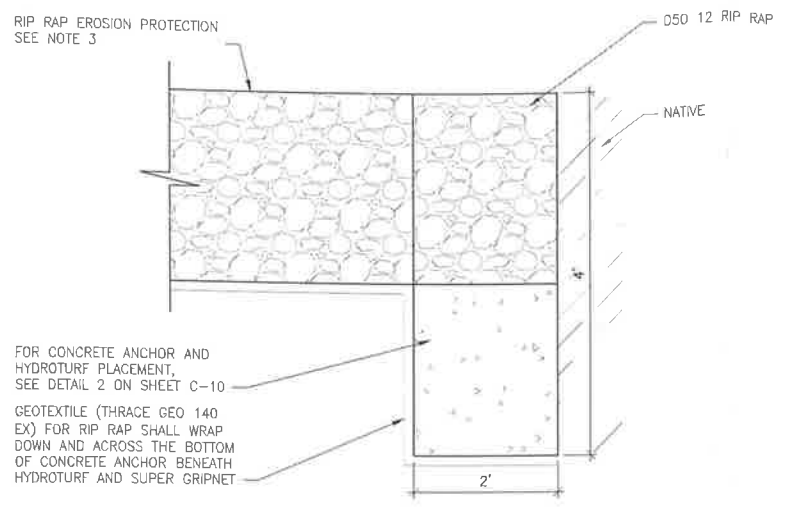
**2 RIP RAP CONCRETE ANCHOR INTERFACE DETAIL (DOWNSTREAM)**  
C-12 SCALE: 1"=1'-0"

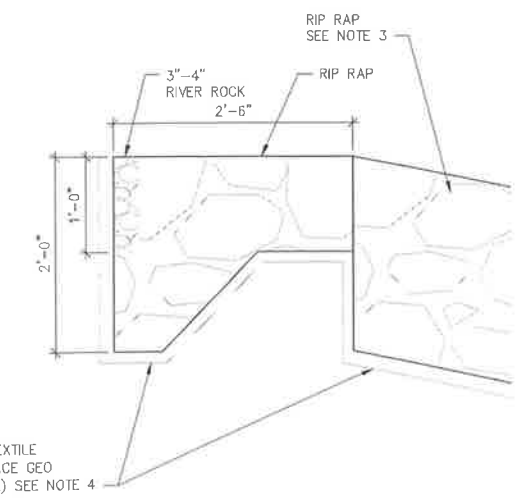
**3 RIP RAP ANCHOR TRENCH (SIDES)**  
C-12 SCALE: 1"=1'-0"

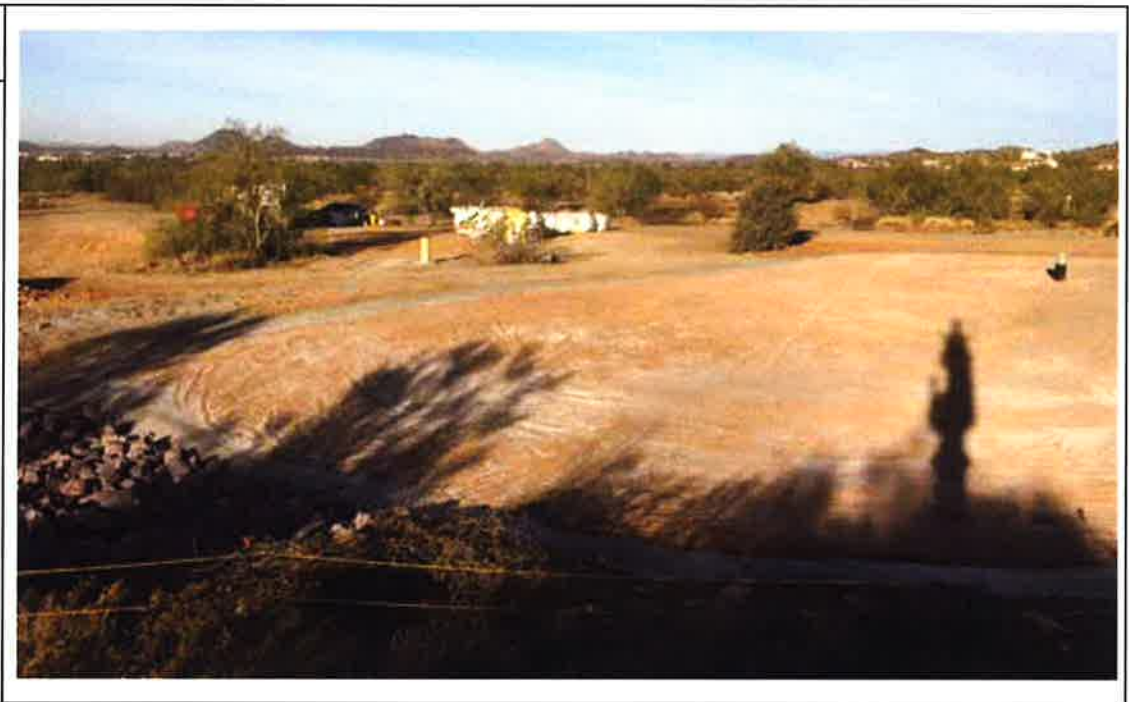
<b>Photo No.</b> <b>1</b>

<b>Location/Description:</b> Waterbore Area Cap  <b>Additional Details:</b> South Side		
<b>Photo No.</b> <b>2</b>

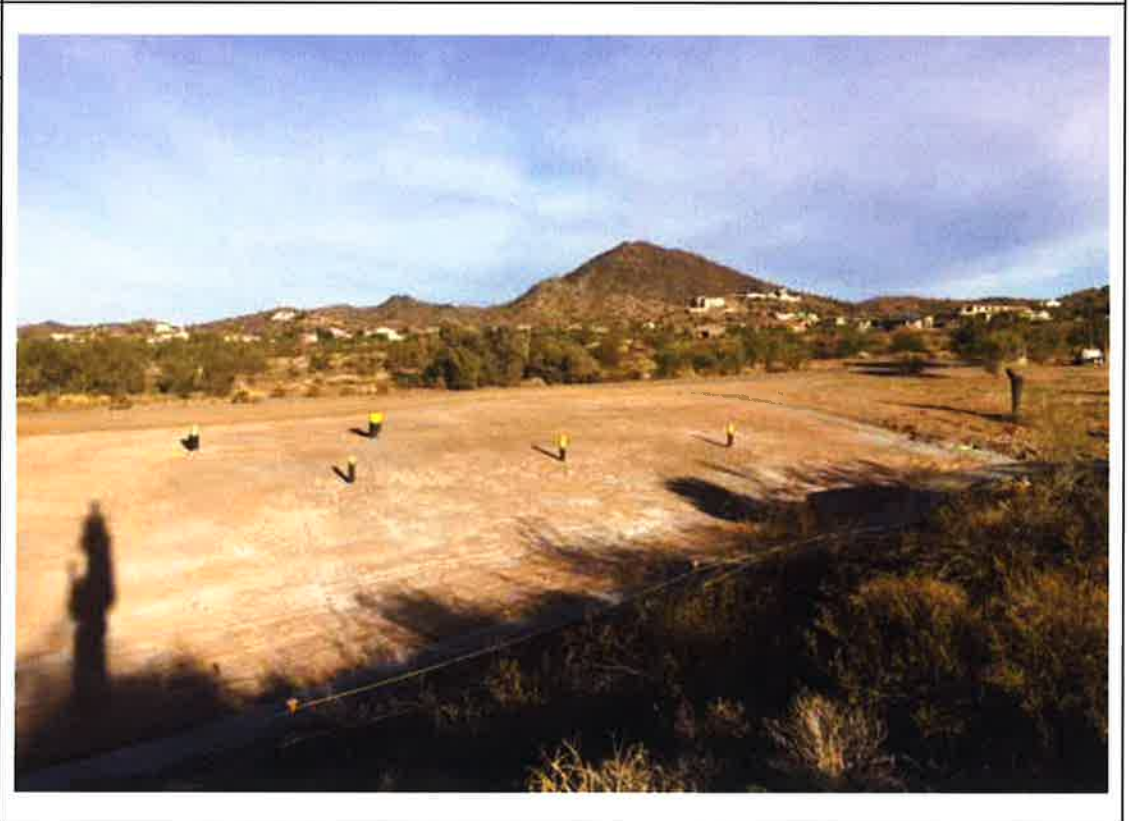
<b>Location/Description:</b> Waterbore Area Cap  <b>Additional Details:</b> North Side

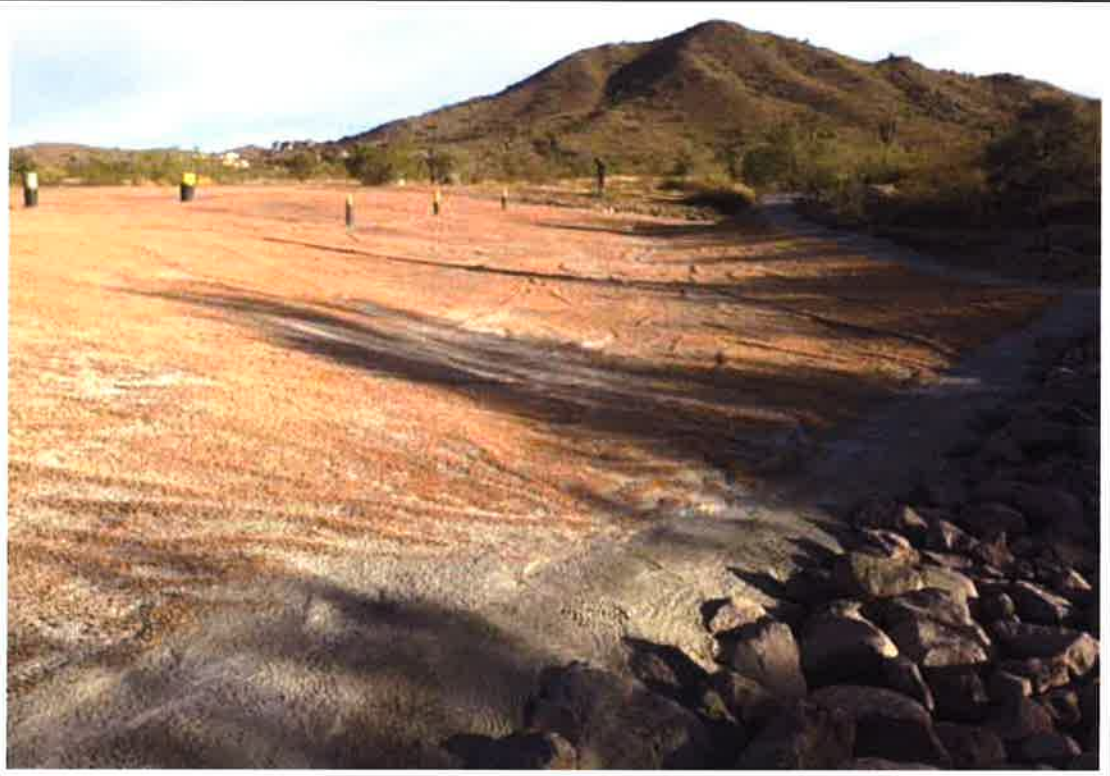
<p><b>Photo No.</b> <b>7</b></p>

<p><b>Location/Description:</b> Waterbore Area Cap</p> <p><b>Additional Details:</b> Looking Upgradient, from rip rap, of Cap through the wash to Cap</p>	
<p><b>Photo No.</b> <b>8</b></p>

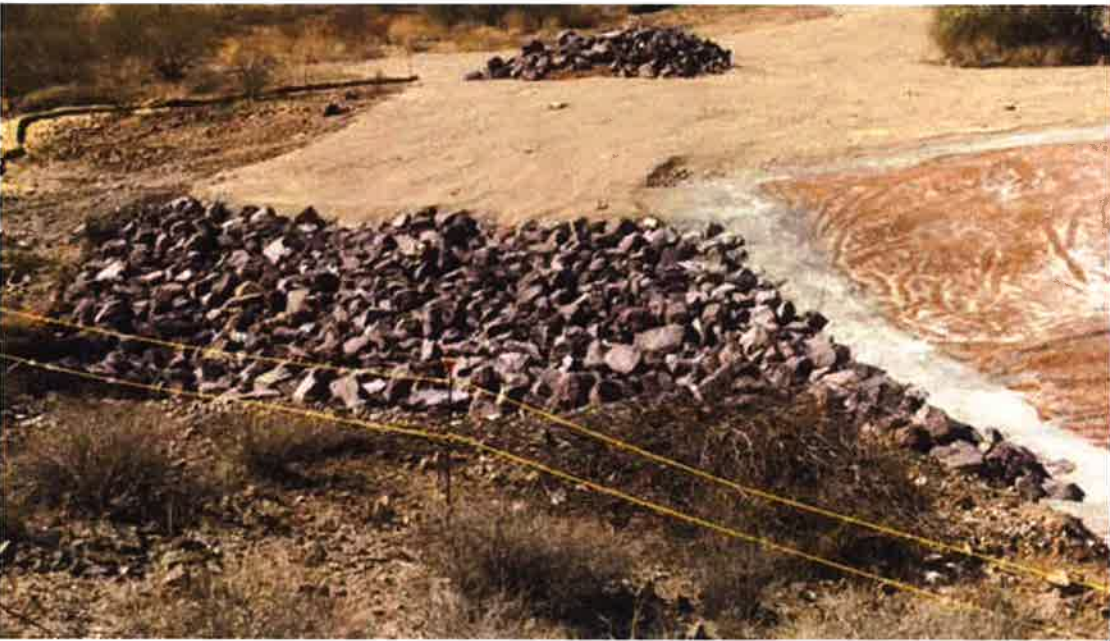
<p><b>Location/Description:</b> Waterbore Area Cap</p> <p><b>Additional Details:</b> Anchor Trench Across Wash; at Upgradient to Cap</p>

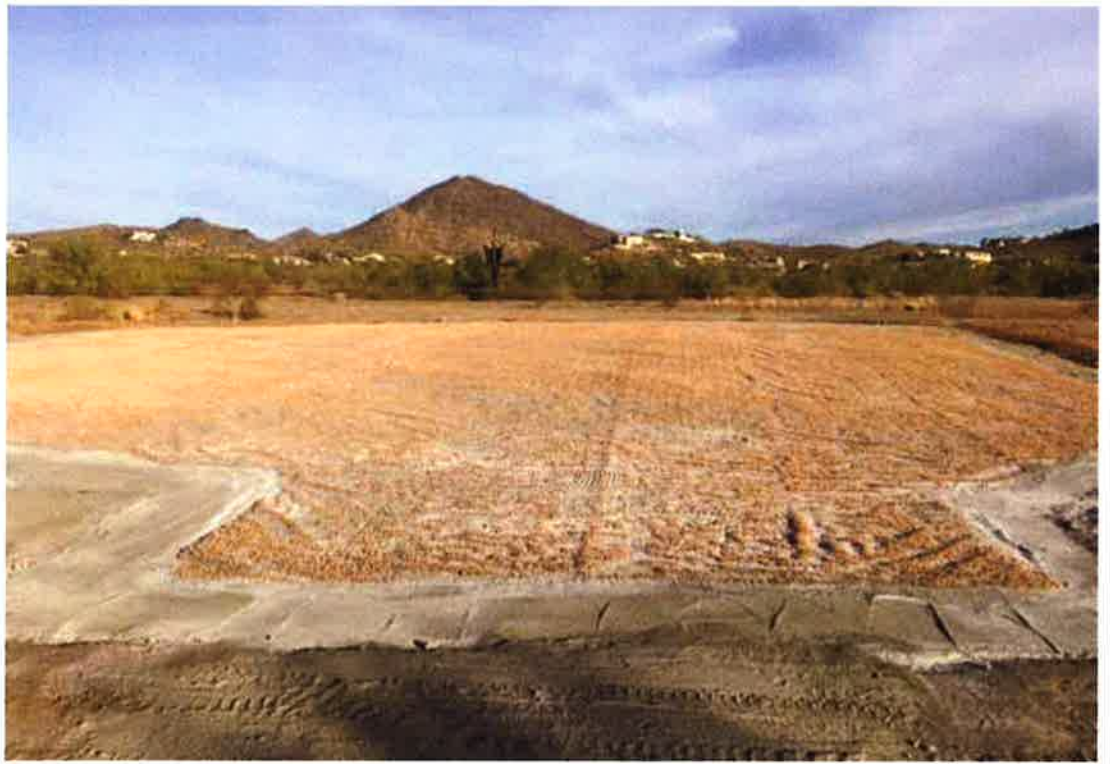
<b>Photo No.</b> <b>9</b>
<b>Location/Description:</b> C-Complex Area Cap
<b>Additional Details:</b> Looking North

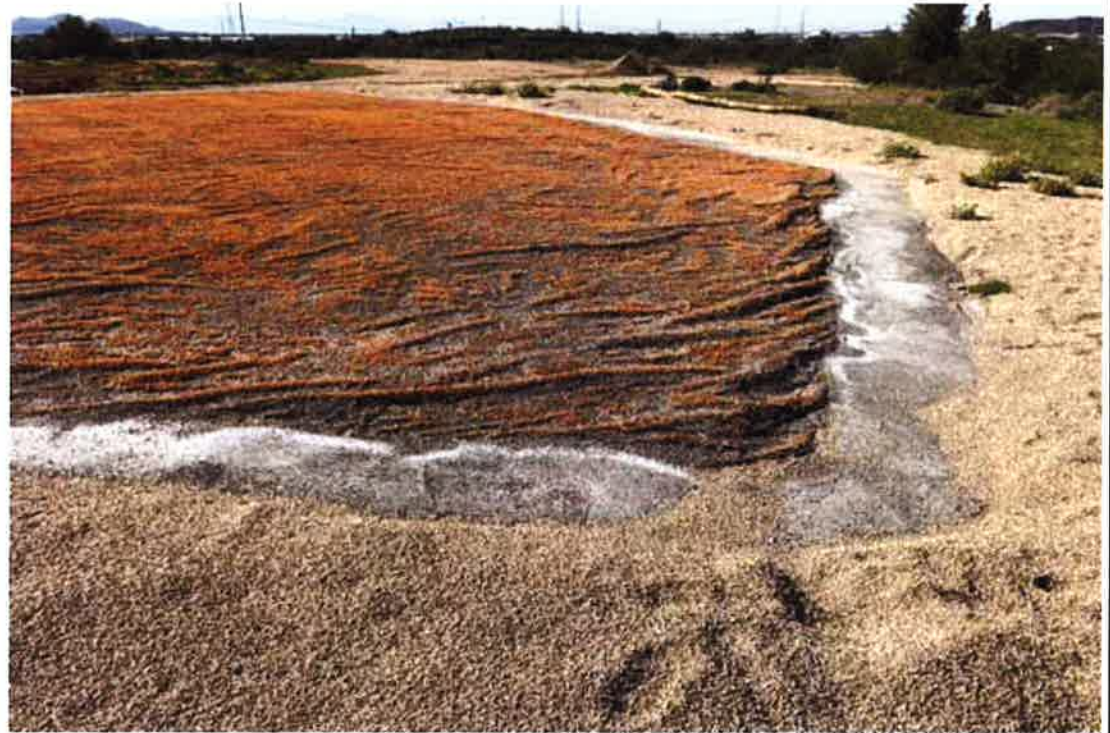
<b>Photo No.</b> <b>10</b>
<b>Location/Description:</b> C-Complex Area Cap
<b>Additional Details:</b> Looking South

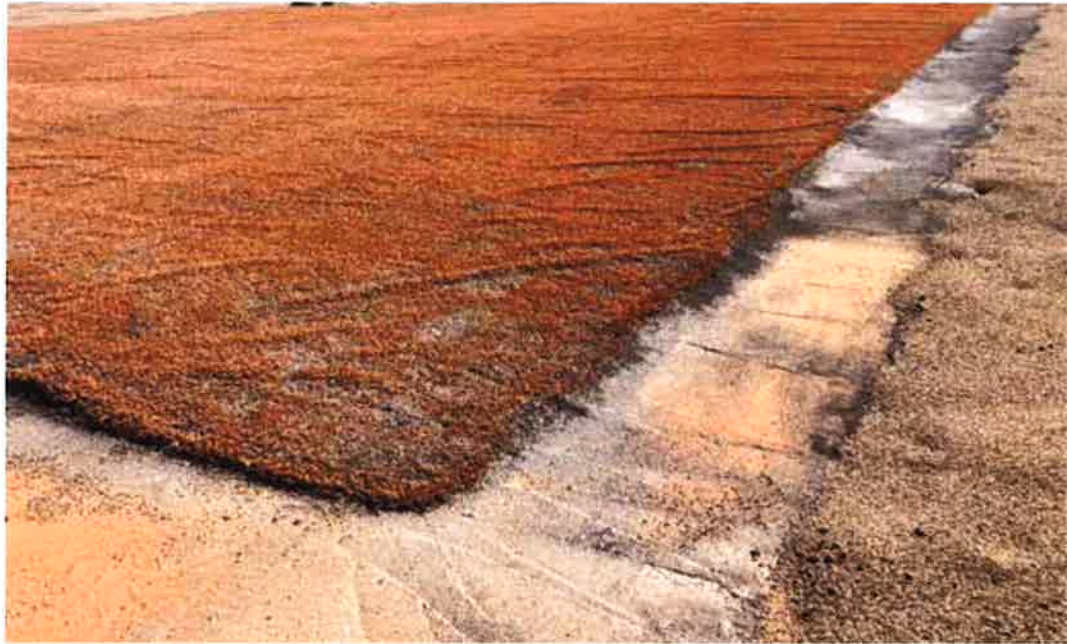
<b>Photo No.</b> <b>11</b>

<b>Location/Description:</b> New Burn Area Cap (Large)  <b>Additional Details:</b> Looking South		
<b>Photo No.</b> <b>12</b>

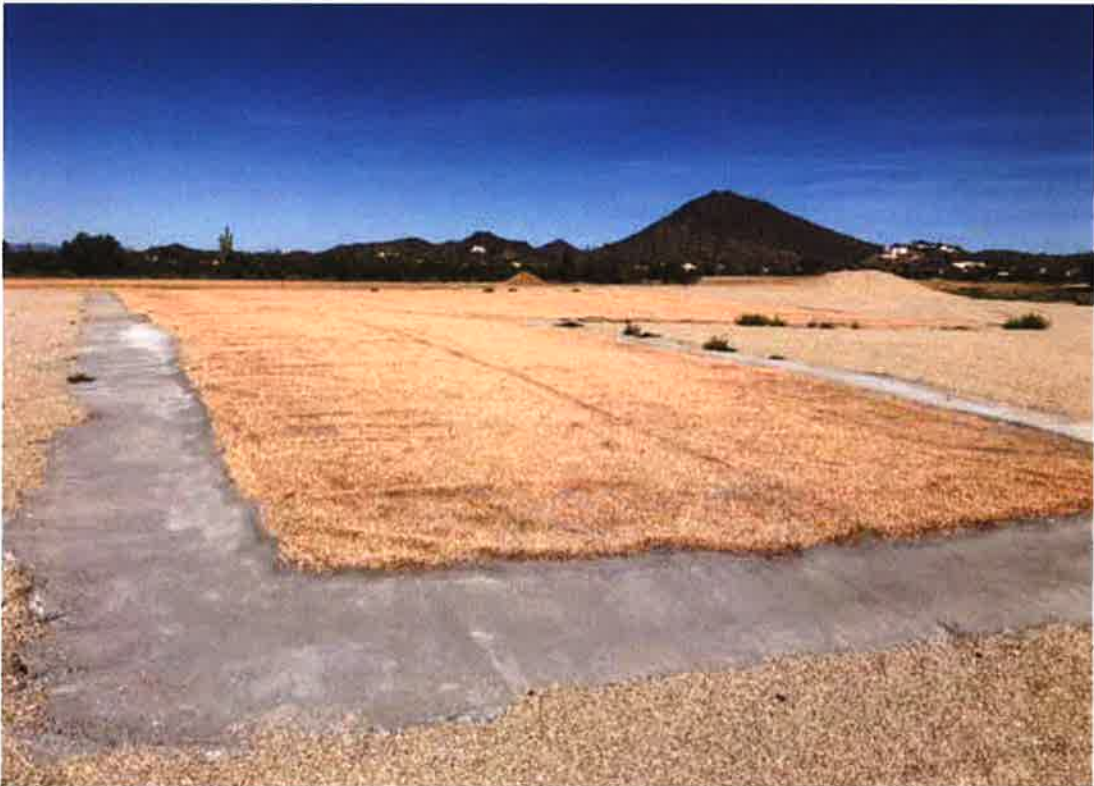
<b>Location/Description:</b> New Burn Area Cap (Large)  <b>Additional Details:</b> Looking North

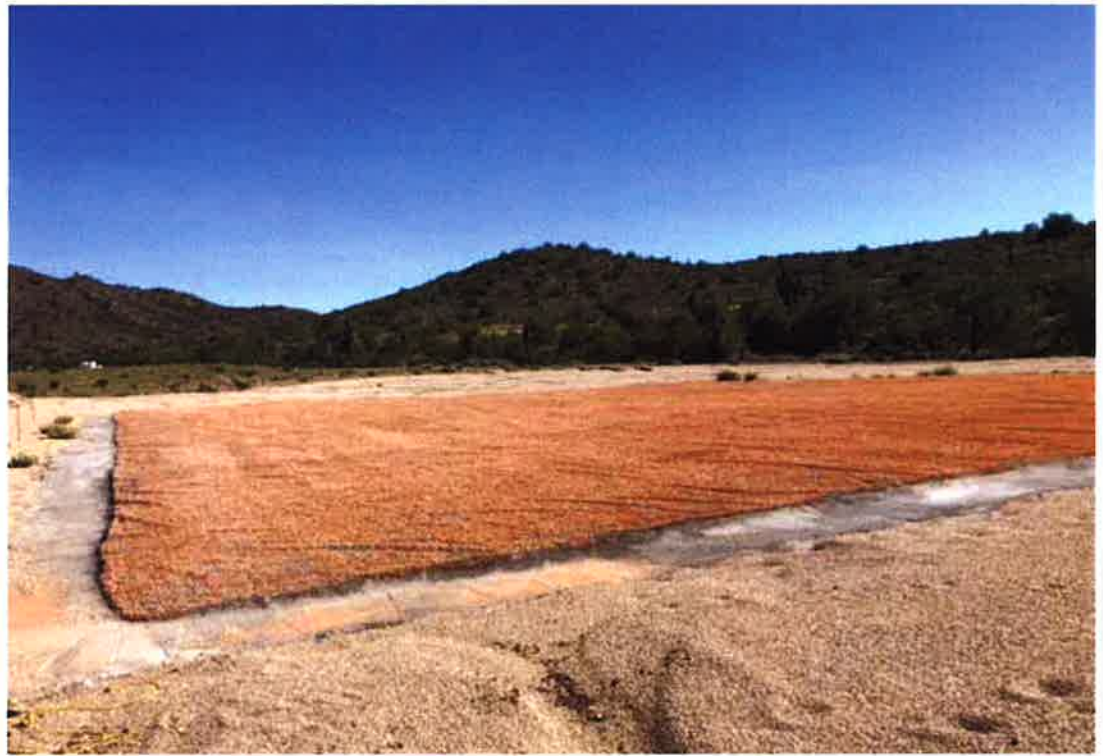
<b>Photo No.</b> <b>13</b>	
<b>Location/Description:</b>  New Burn Area Cap (Large)	
<b>Additional Details:</b> Looking North

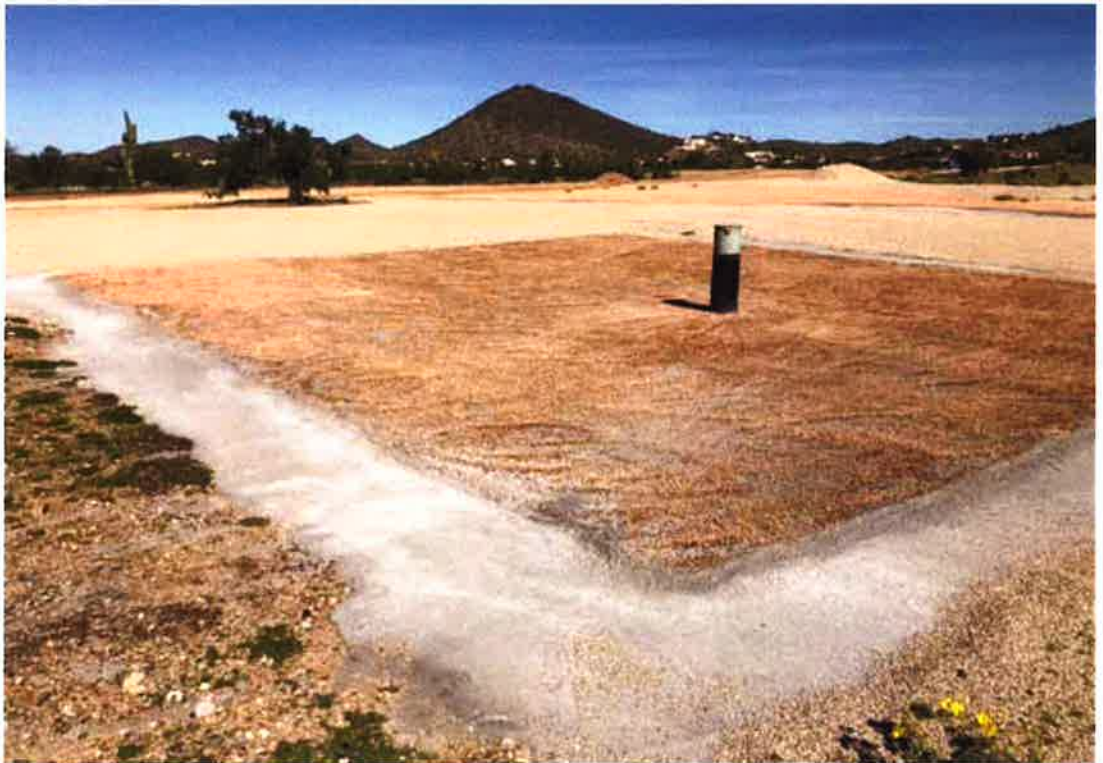
<b>Photo No.</b> <b>14</b>	
<b>Location/Description:</b>  New Burn Area Cap (Small)	
<b>Additional Details:</b> Looking North
