FEASIBILITY STUDY REPORT

HARRISON ROAD AND MILLMAR ROAD DROSS WQARF SITE TUCSON, ARIZONA

March 14, 2018

HYDRO GEO CHEM, INC.
51 W. Wetmore Rd, Suite 101
Tucson, Arizona 85705
(520) 293-1500

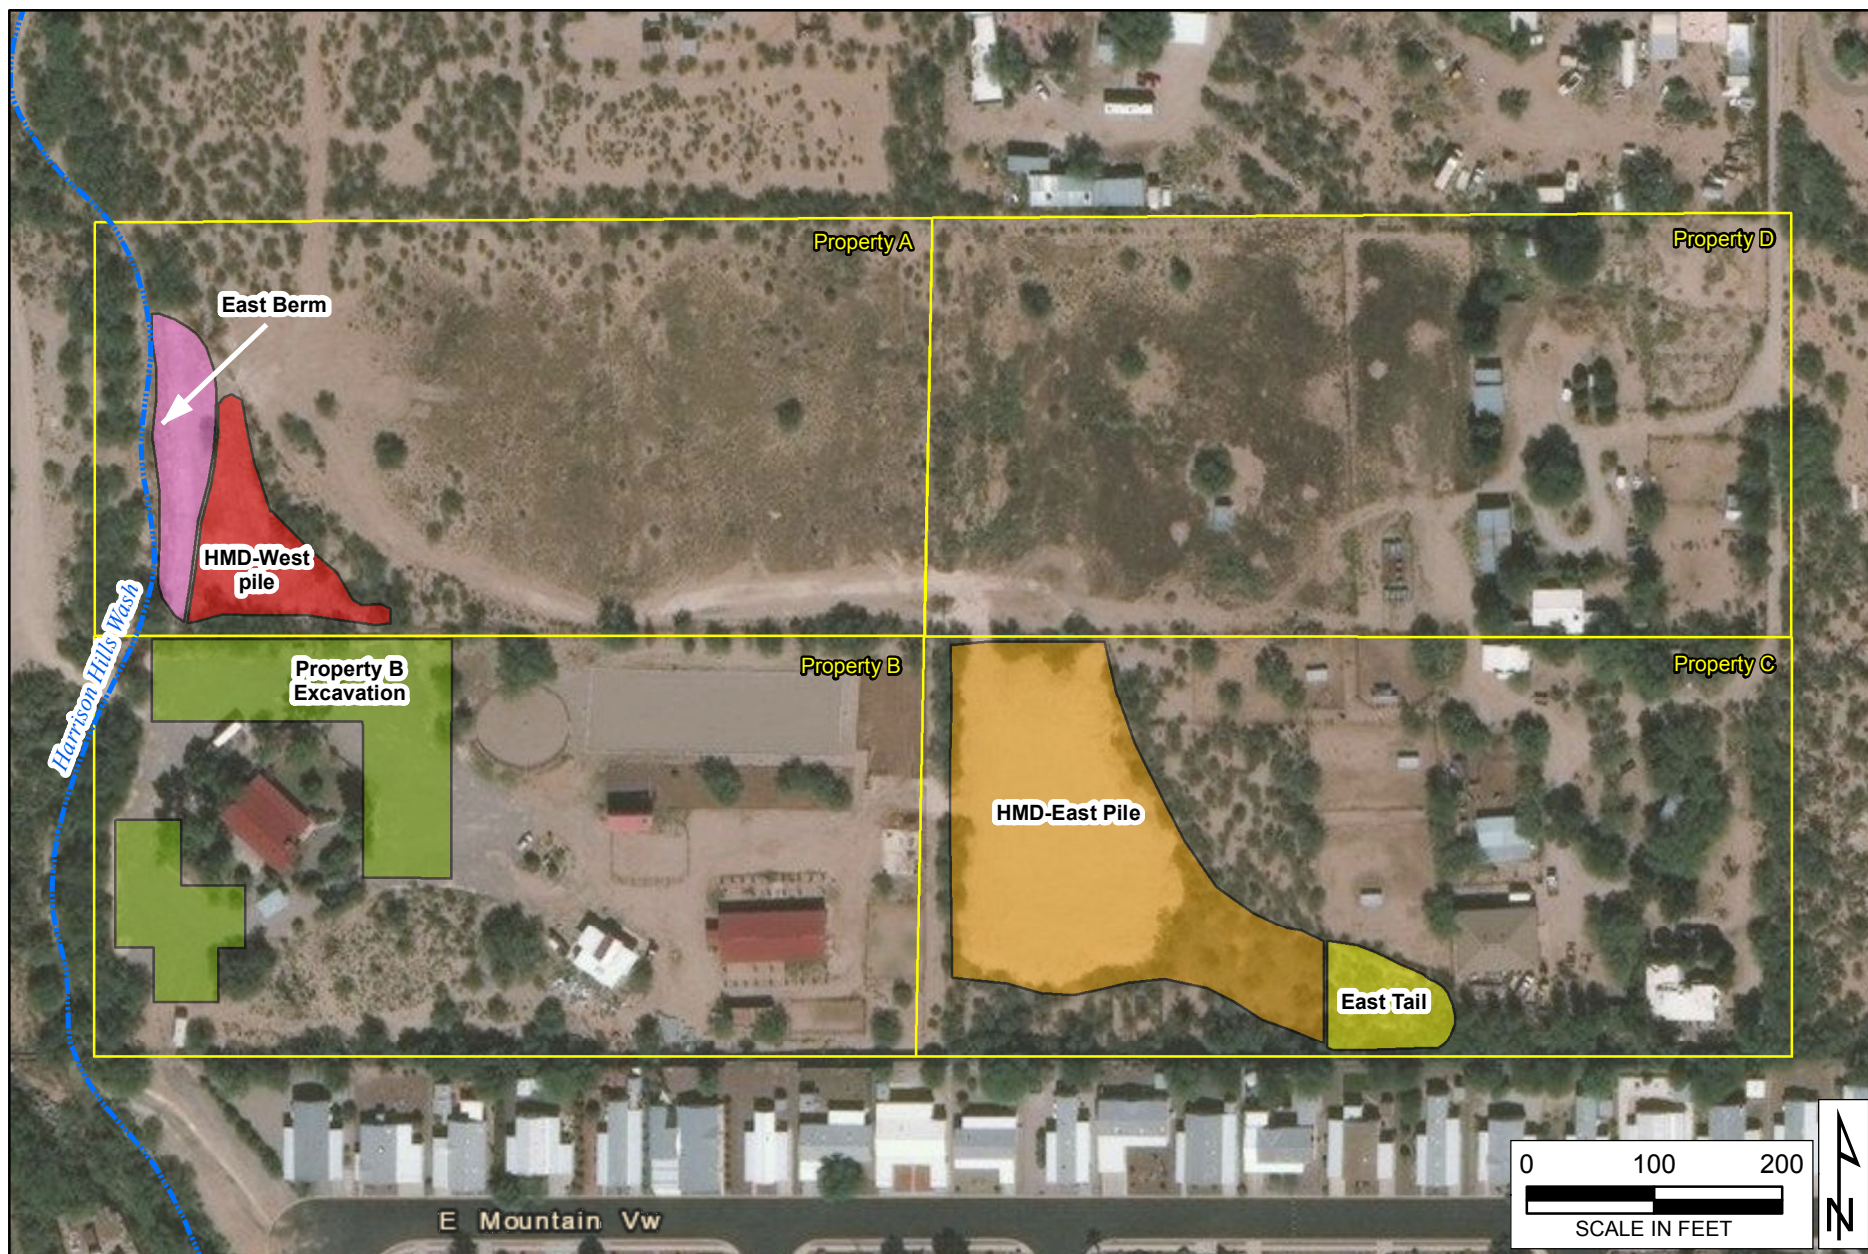
Approved	Date	Author	Date	File Name	Figure
AJB	9/13/17	GEM	9/13/17	2015053112G	3

**EXTENT OF EXCAVATION AND COVER AREAS
HARRISON ROAD & MILLMAR ROAD DROSS SITE**
