Feasibility Study Report Klondyke Tailings WQARF Site Klondyke, Graham County, Arizona

Amec Foster Wheeler Environment & Infrastructure, Inc. Phoenix, Arizona

May 5, 2017

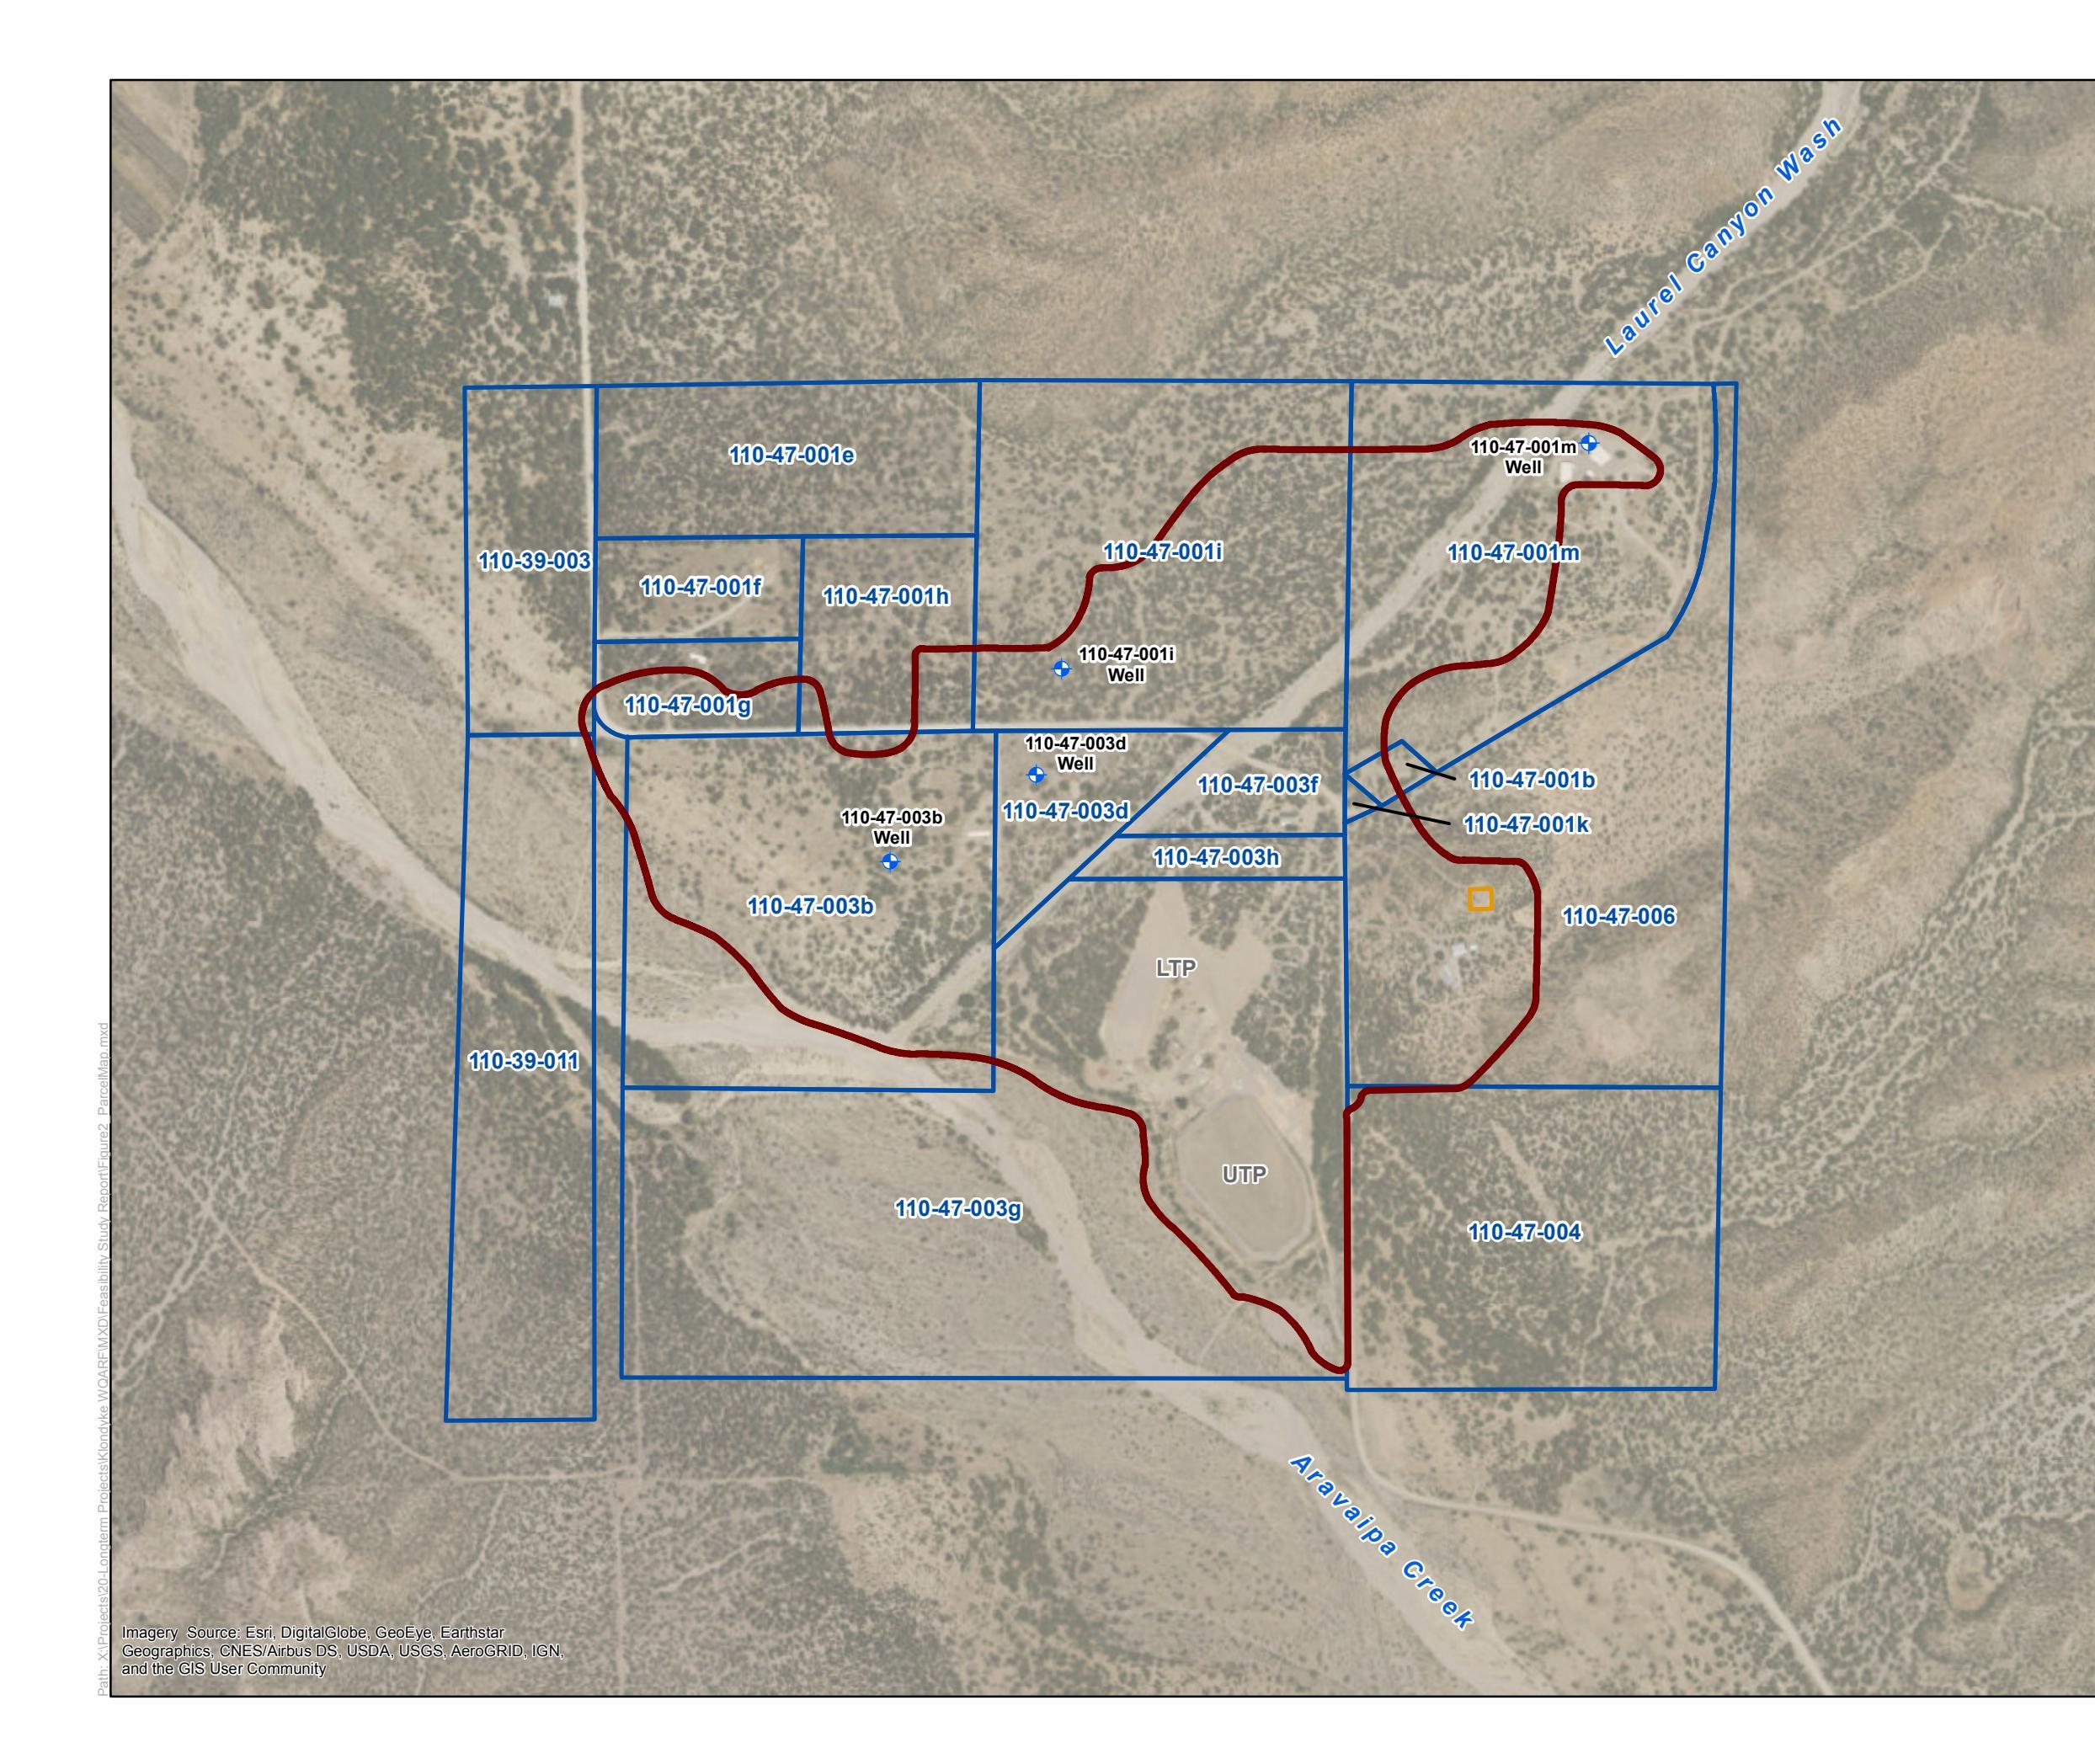
Parcel 110-47-006 Tailings Deposit

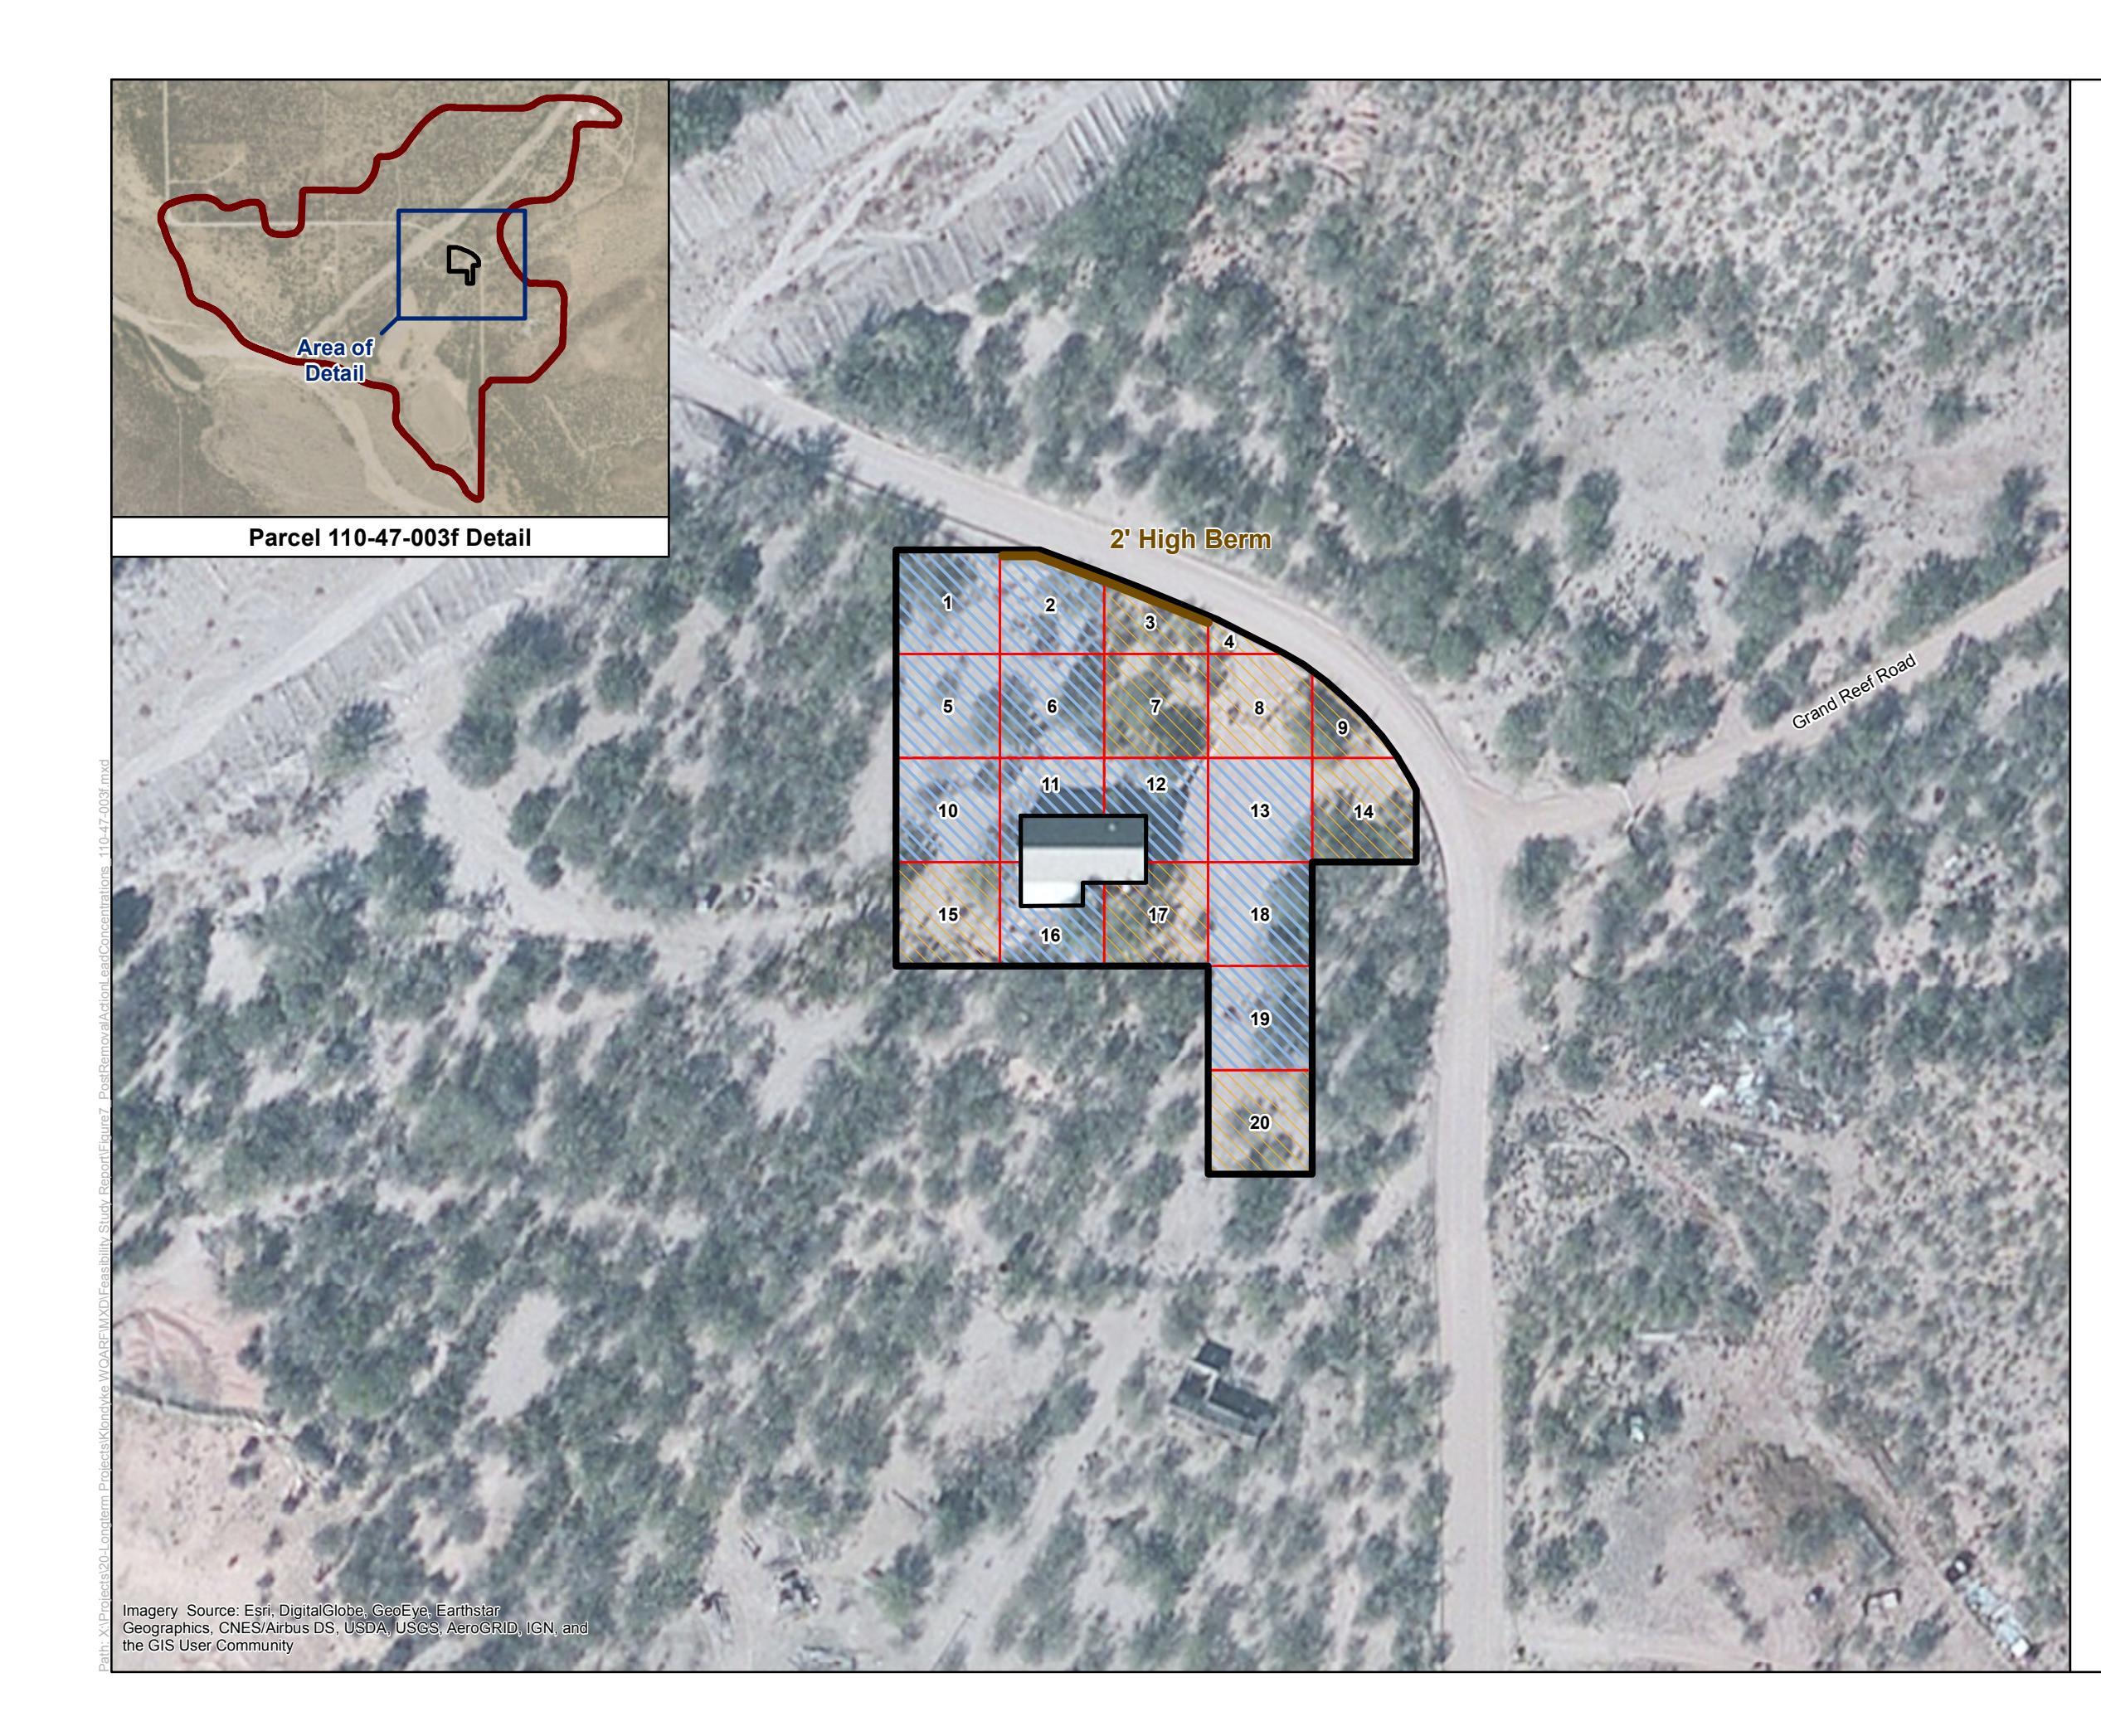
Decision Unit (50' x 50') Structure Footprint *2,266ft*<sup>2</sup> Excavation Area *42,683ft*<sup>2</sup>

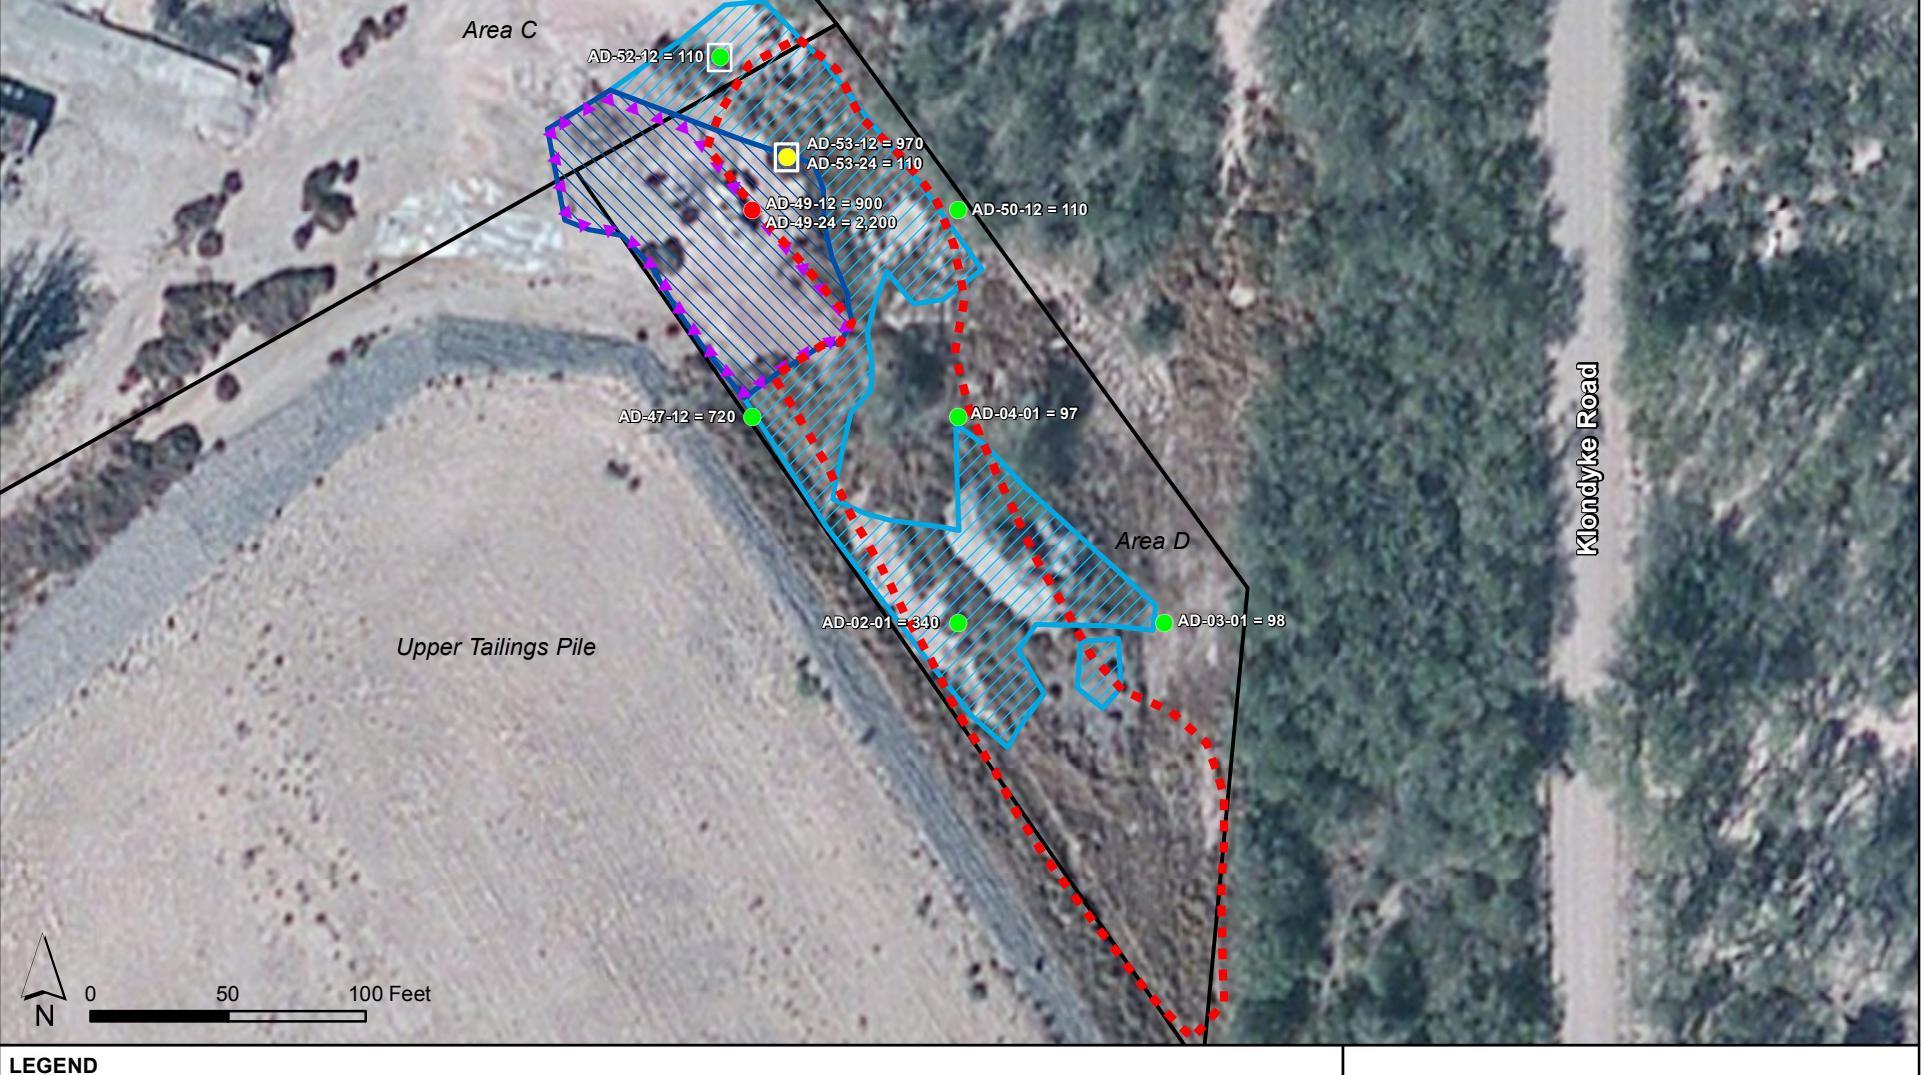
Figure 13 Area D Removal Klondyke Tailings Removal Graham County, Arizona 85643

•	1,601 - 2,200		K
		Approximate Borrow Area for 'Area D Clay' cap material. After contaminated surface soils were removed to the LTP, this area was excavated at depths up to 15 ft bgs for high clay con		
	<b>*</b> 1	Vertical extent of contamination was not reached during excavation.	NOTES	
		2 ft bgs excavation area. Material removed to LTP.	Samples with IDs ending in:	
	$\mathbb{Z}\mathbb{Z}$	1 ft bgs excavation area. Material removed to LTP.	-01 or -12 = Taken 12 in bgs -24 = Taken 24 in bos	1
		Area Boundaries		1
		(Outline) Discrete sample location added in the field to extend grid across all unvegetated areas	XRF = X-ray fluorescence bgs = Below ground surface	
			All areas excavated below grade were backfilled with unscreened material from the Aravaipa borrow area to restore previous surface drainage patterns.

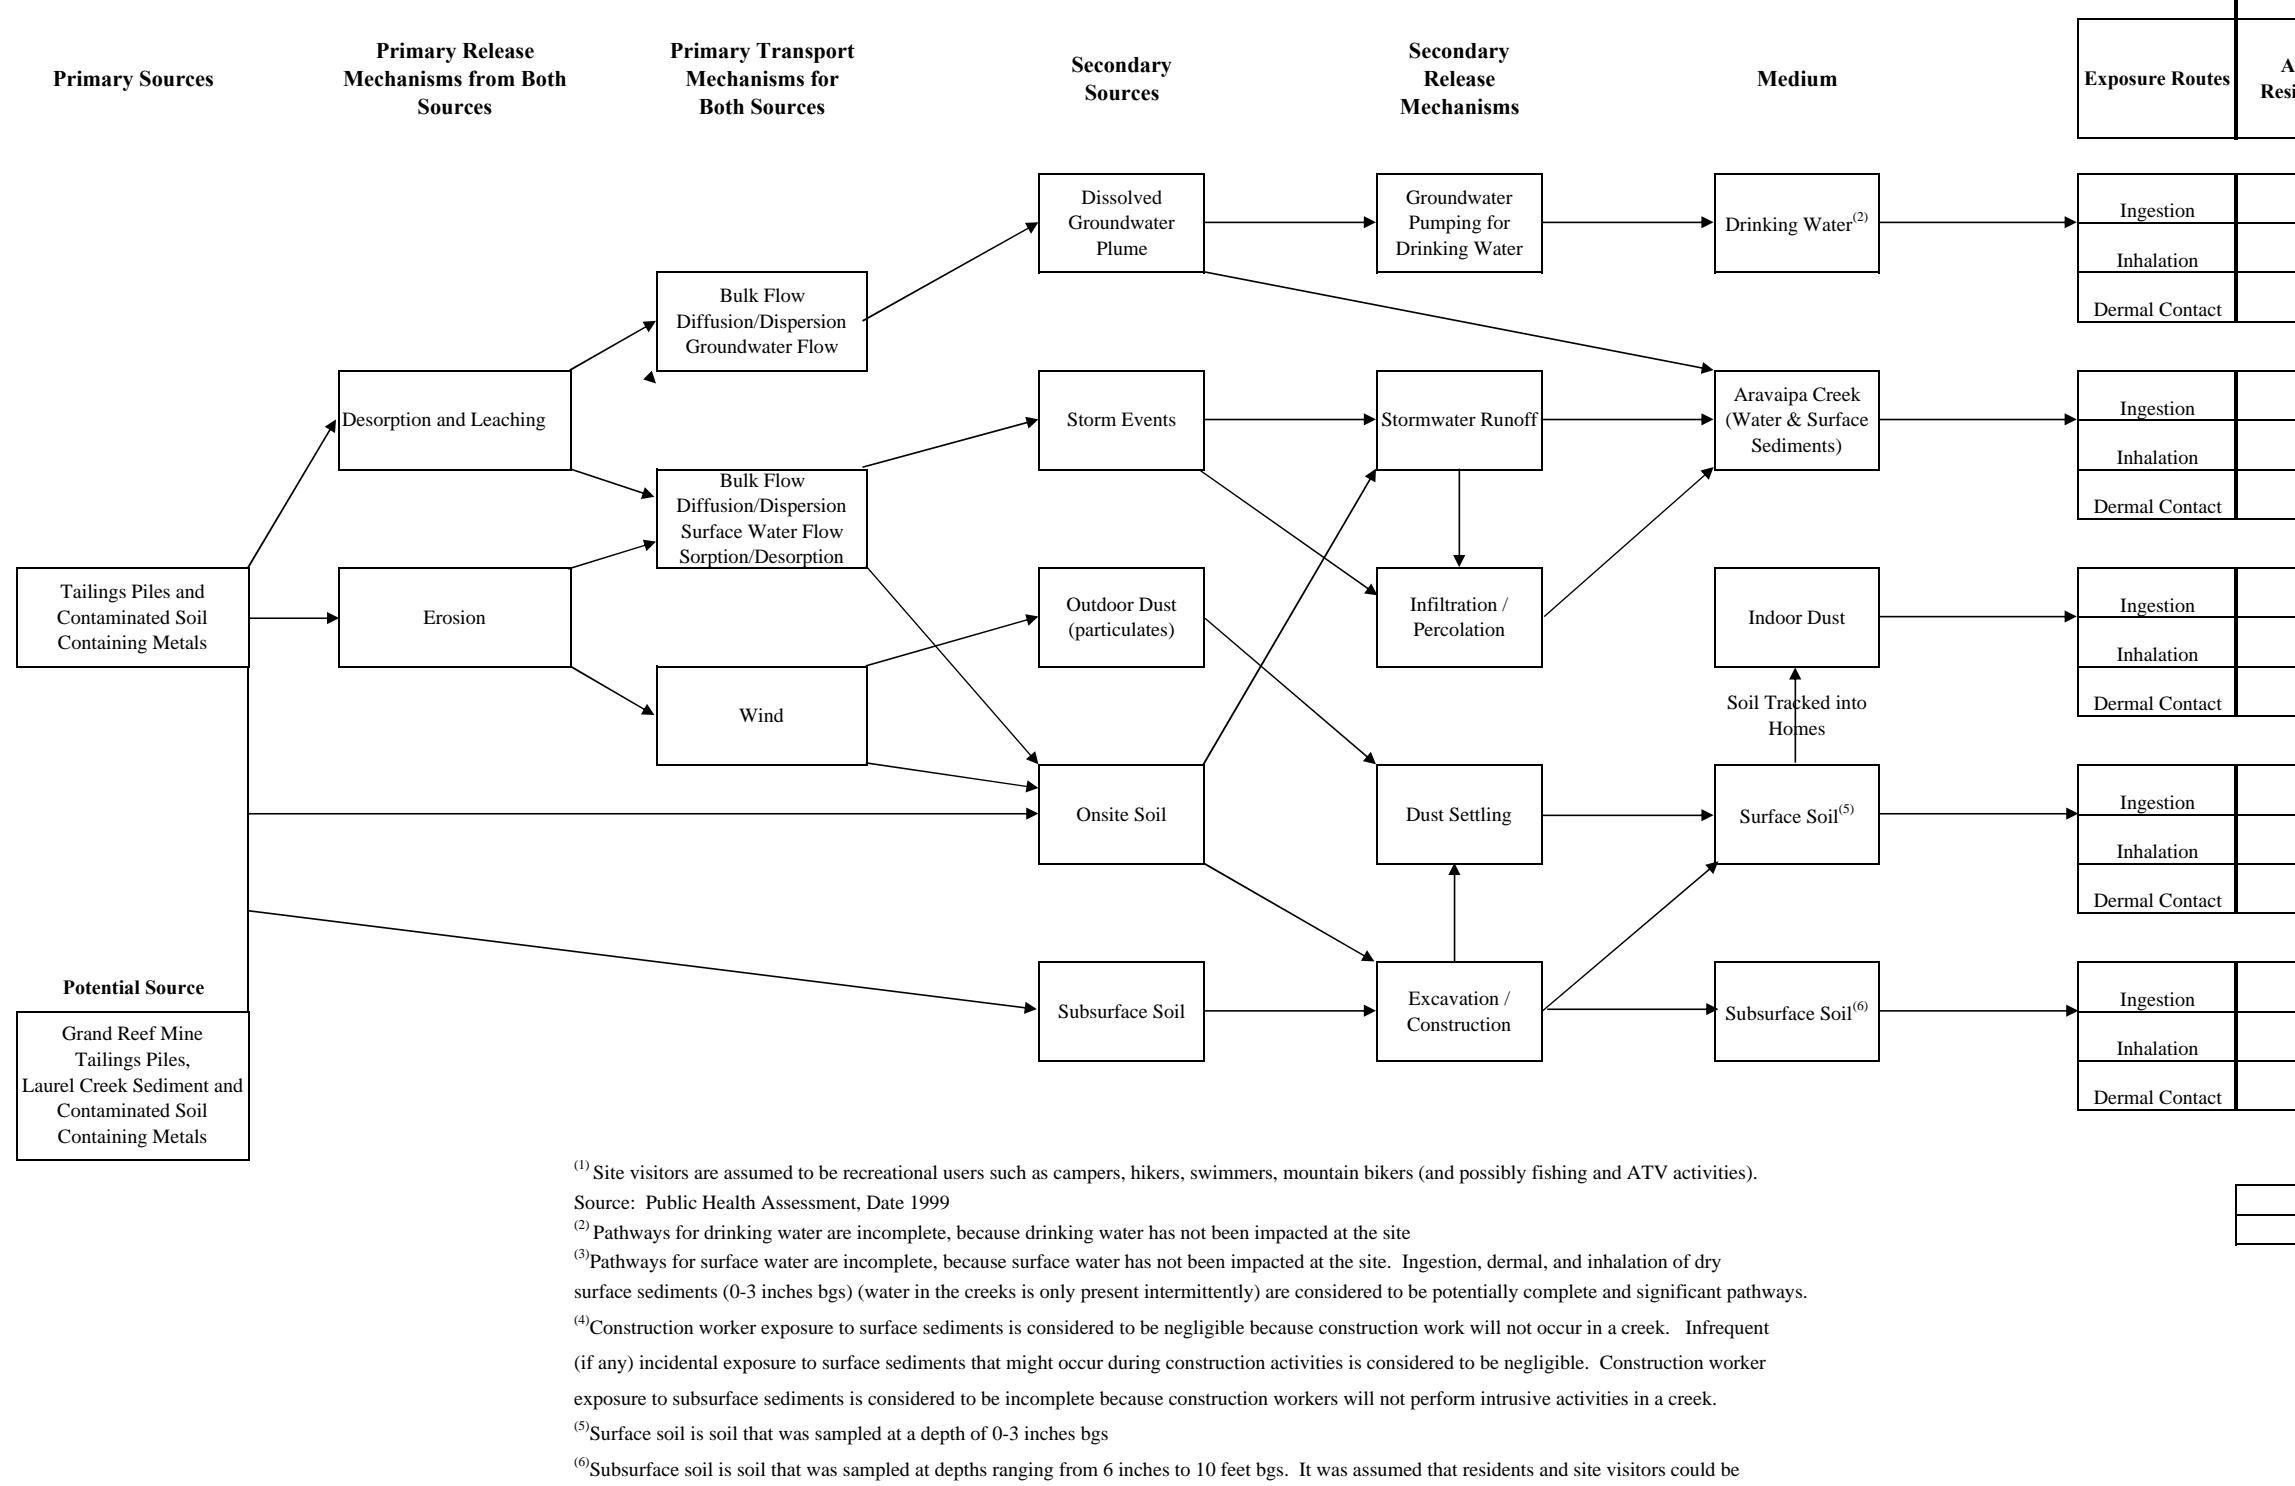
#### Figure 22 Conceptual Site Model Klondyke Tailings WQARF Site

exposed to subsurface soil brought to the surface during excavation activities

The conceptual site model provided in the RI Report is included as Appendix C. Arcadis has performed a Human Health Risk Assessment (HHRA) to support the ERAs and the remedy selection process in this FS Report (Arcadis 2016a and 2017). The COCs identified by the HHRA are lead, arsenic, and vanadium. Therefore, the HHRA provides an evaluation of risks and hazards to human health from principally lead, arsenic, and vanadium in surface soil of residential properties following soil removal actions based on current land use. However, since the arsenic and vanadium are co-distributed with the lead, if lead soil remediation levels (SRLs) are achieved in surface soils, then the other COCs are expected to be below their respective SRLs. There is also potential for exposure to subsurface soils by residents and construction workers should excavation occur. However, lead concentrations generally attenuate below 400 mg/kg below 12 inches bgs. Additionally, according to the USEPA, excavations of 12 inches depth are protective of human health in most cases (USEPA, 2003). Therefore, remediating the upper 12 inches of the soil is considered capable of achieving the ROs for the Site.

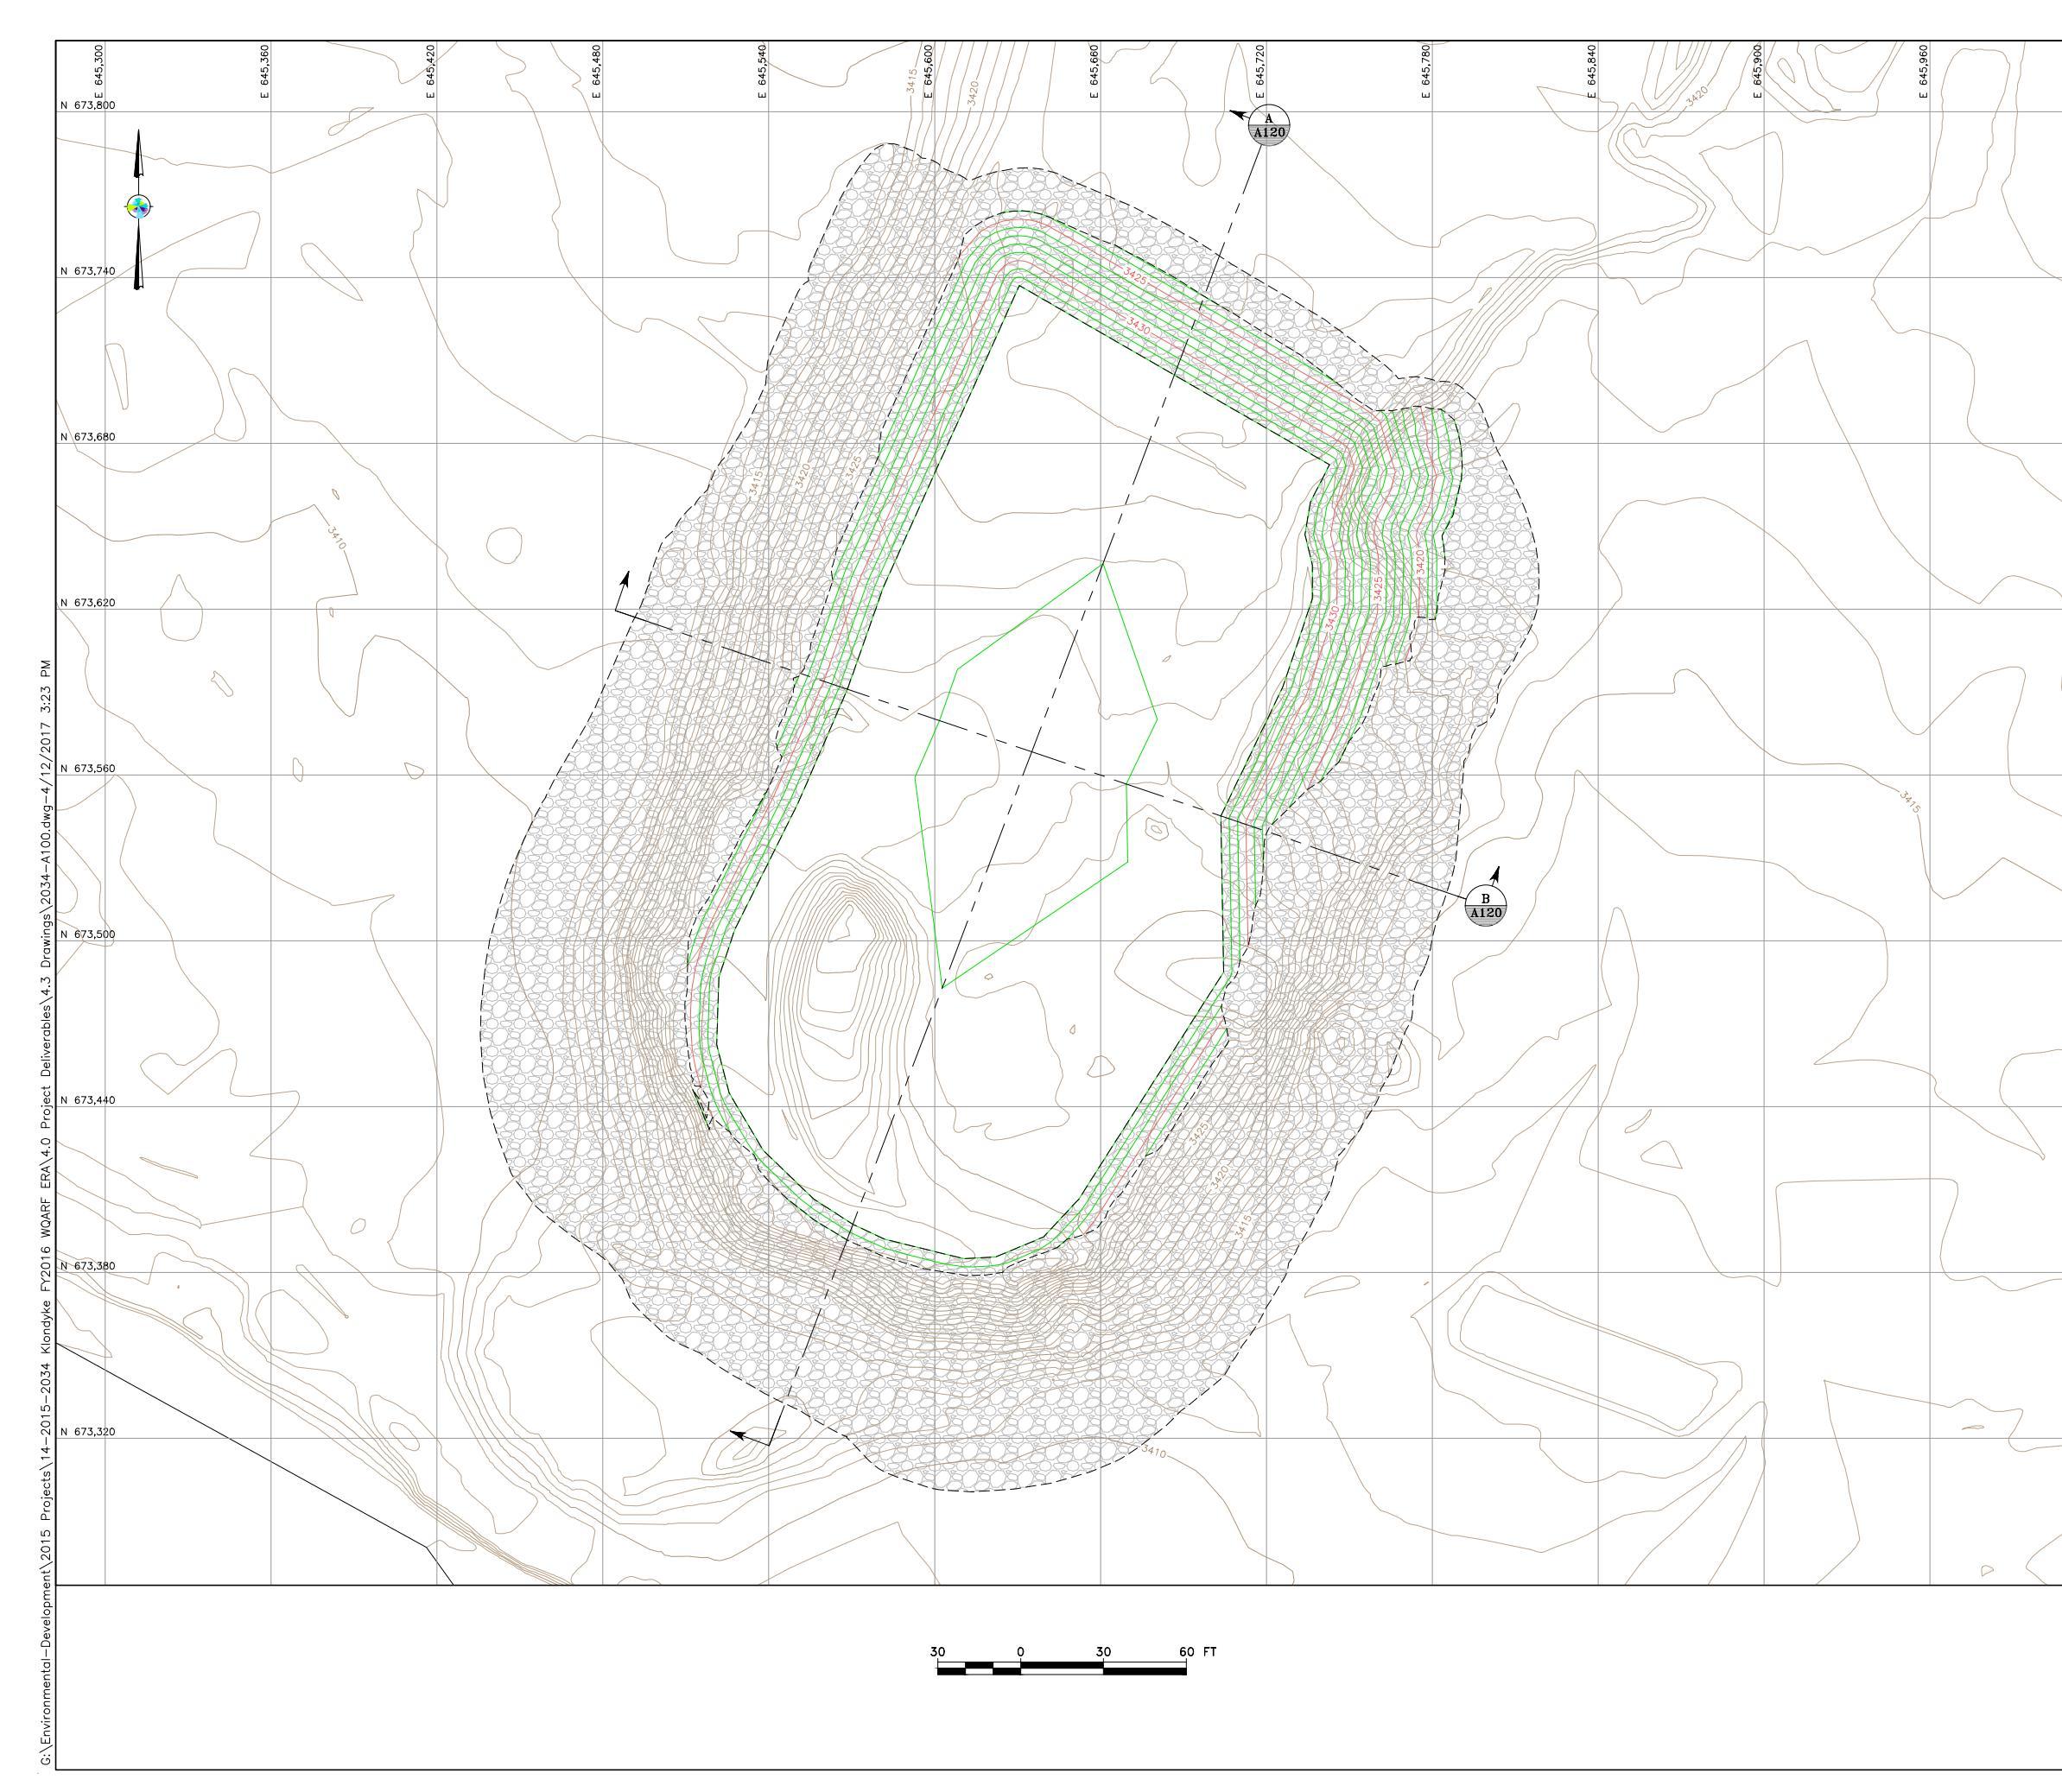
CONCEPTUAL LTP CONSOLIDATION AND CAP DESIGN

LEGEND:
100 EXISTING GROUND SURFACE CONTOUR EL, FEET
100 PROPOSED GROUND SURFACE CONTOUR EL, FEET
PROPOSED SOIL CAP LIMITS

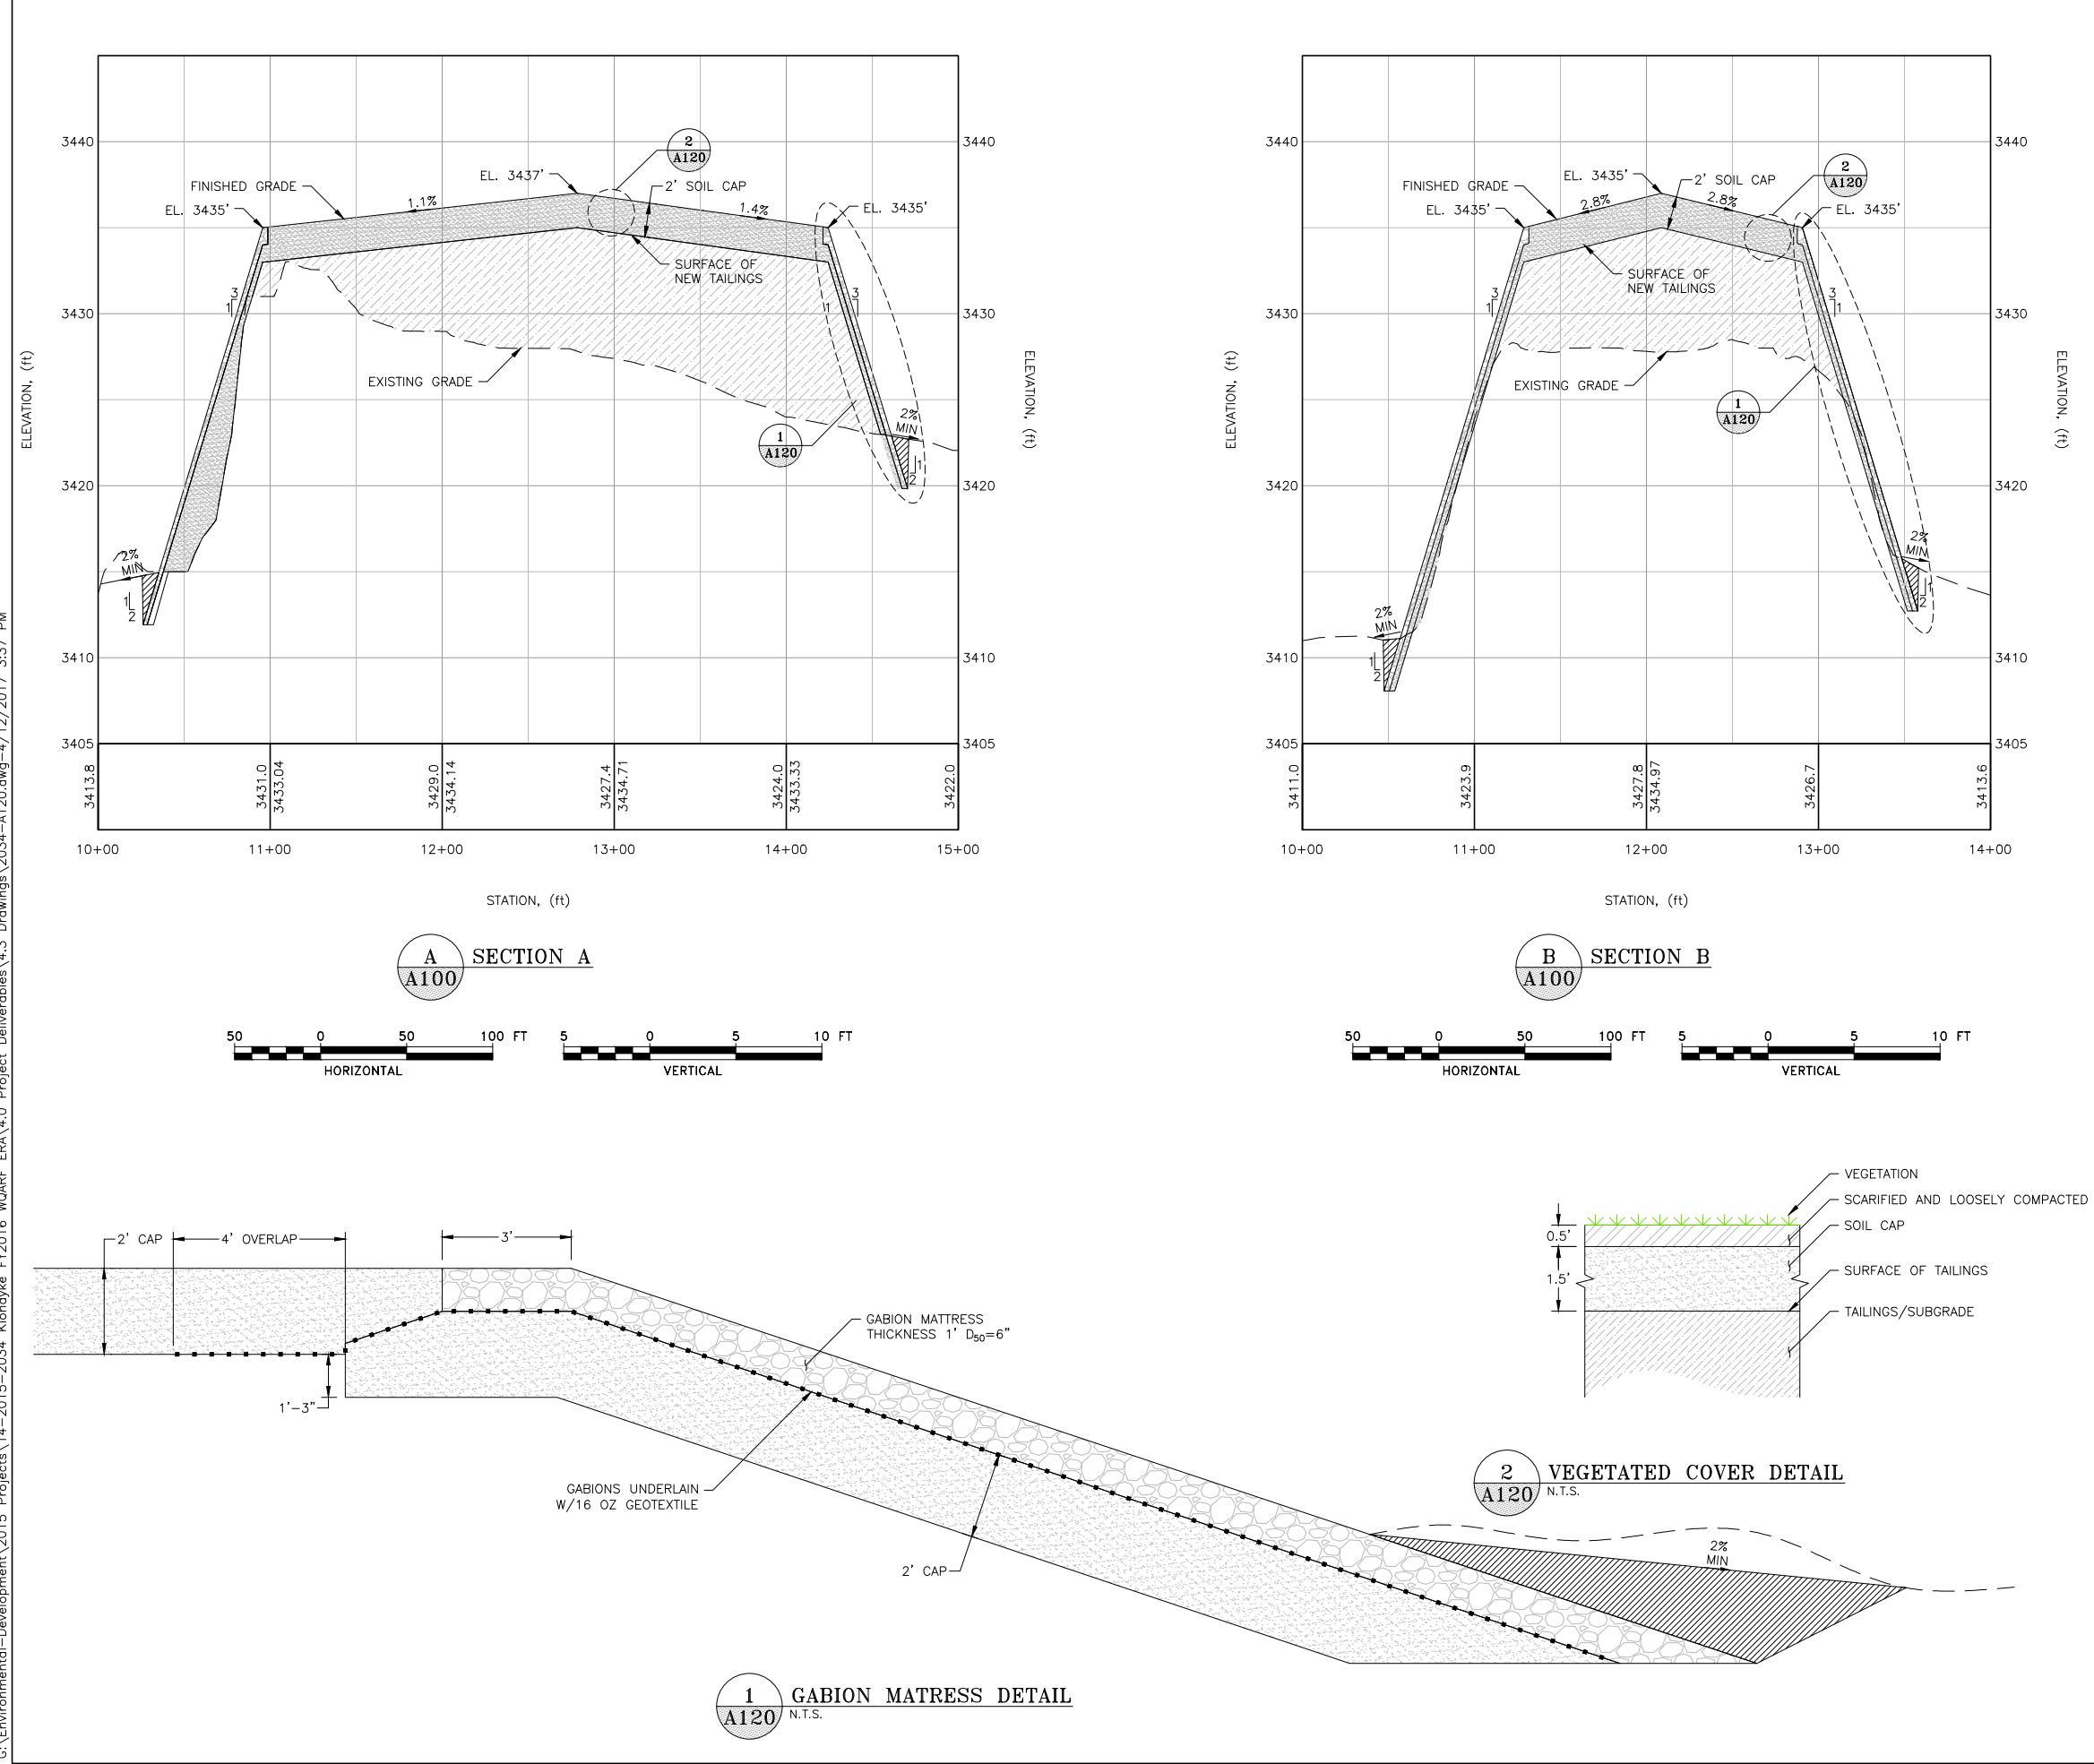
PROPOSED GEOTEXTILE
NEW TAILINGS MATERIAL
PROPOSED SOIL CAP
PROPOSED GABION MATTRESS
PROPOSED STRUCTURAL FILL

- The gabion mattresses will be constructed of plastic coated, heavy, zinc plated, 2.70 millimeter diameter wire mesh baskets filled with 4 to 8 inch rock in the existing on-site stockpile obtained from the Aravaipa borrow area. Sufficient 4 to 8 inch rock is not available; therefore, 2-4 inch gravel from the existing on-site stockpile will be used as make up. There are sufficient on-site materials to construct the erosion protection system. The gabion mattresses will be secured with a wire mesh lid that is attached to the top of the baskets with stainless steel clips.
