Ambient Groundwater Quality of the Lower Gila Basin: A 2013-2017 Baseline Study – May 2017

The Arizona Department of Environmental Quality (ADEQ) Ambient Groundwater Monitoring Program conducted a baseline study to characterize the groundwater quality of the Lower Gila Basin from 2013 to 2017. ADEQ carried out this task under Arizona Revised Statutes §49-225 that mandates monitoring of waters of the state including its aquifers. The fact sheet is a synopsis of the ADEQ Open-File Report 17-01.¹

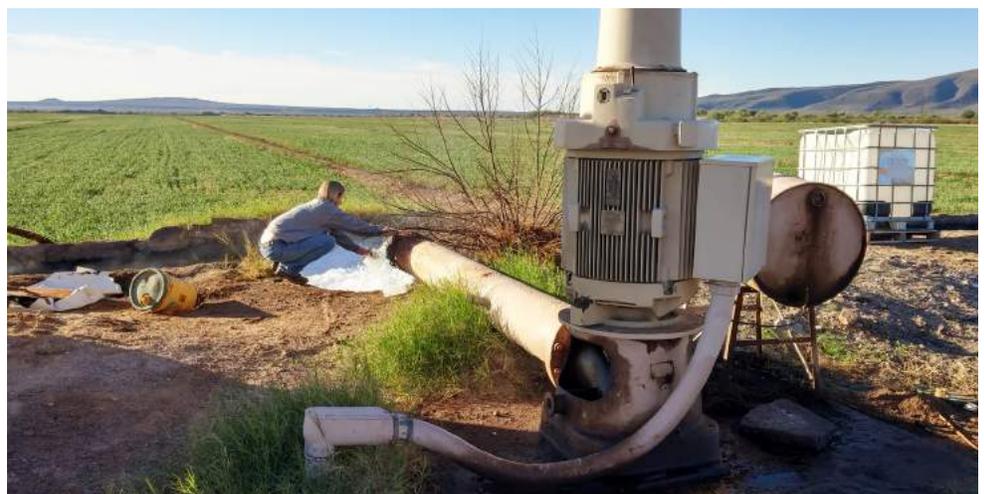
Figure 2 - ADEQ's Elizabeth Boettcher samples an irrigation well in the Dendora Valley sub-basin.

The basin is divided into eastern and western sections near Dateland, and into three hydrologic sub-basins: Childs Valley, Dendora Valley (Figure 2), and Wellton-Mohawk.

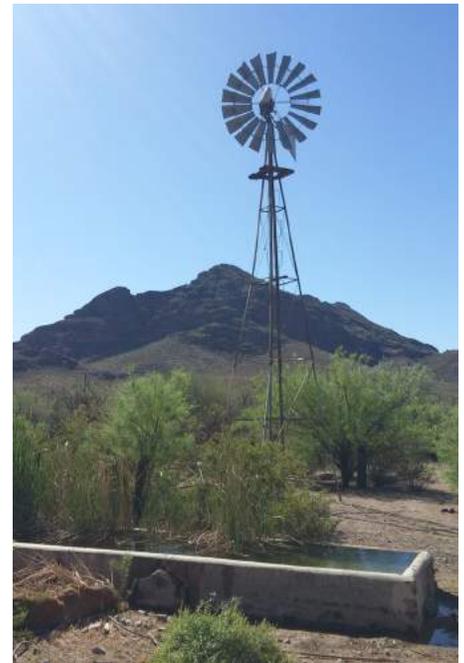
Figure 4 - Darby Well located south of Ajo produces water for endangered Sonoran pronghorns.

ADEQ personnel collected samples from 108 wells (Figure 4) to characterize regional groundwater quality, divided into the following three sub-basins: Childs Valley (9), Dendora Valley (9) and Wellton-Mohawk (90). Inorganic constituents and stable isotopes of oxygen, deuterium, and nitrogen were collected at all wells. Other samples collected include radon at 51 wells and radionuclides at 39 wells.

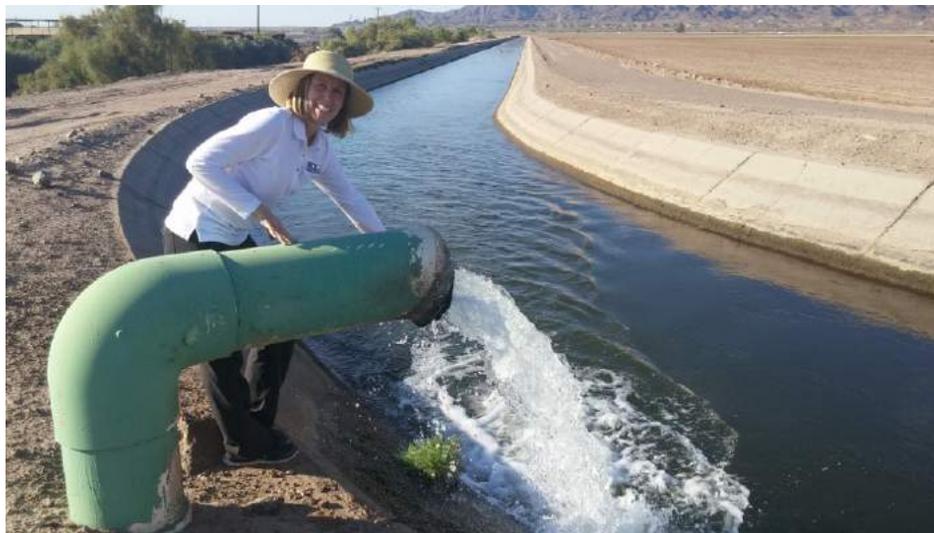
Figure 3 - ADEQ's Elizabeth Boettcher samples one of the 90 Wellton-Mohawk Irrigation and Drainage District drainage wells that empty into the Wellton-Mohawk Conveyance Channel.

Groundwater levels, which rose into the plant's root zone, hindered crop production. Drainage wells averaging 100 feet in depth were drilled for dewatering purposes starting in 1961. The wells discharge saline irrigation recharge into the concrete-lined Wellton-Mohawk Main Conveyance Channel (Figure 3),

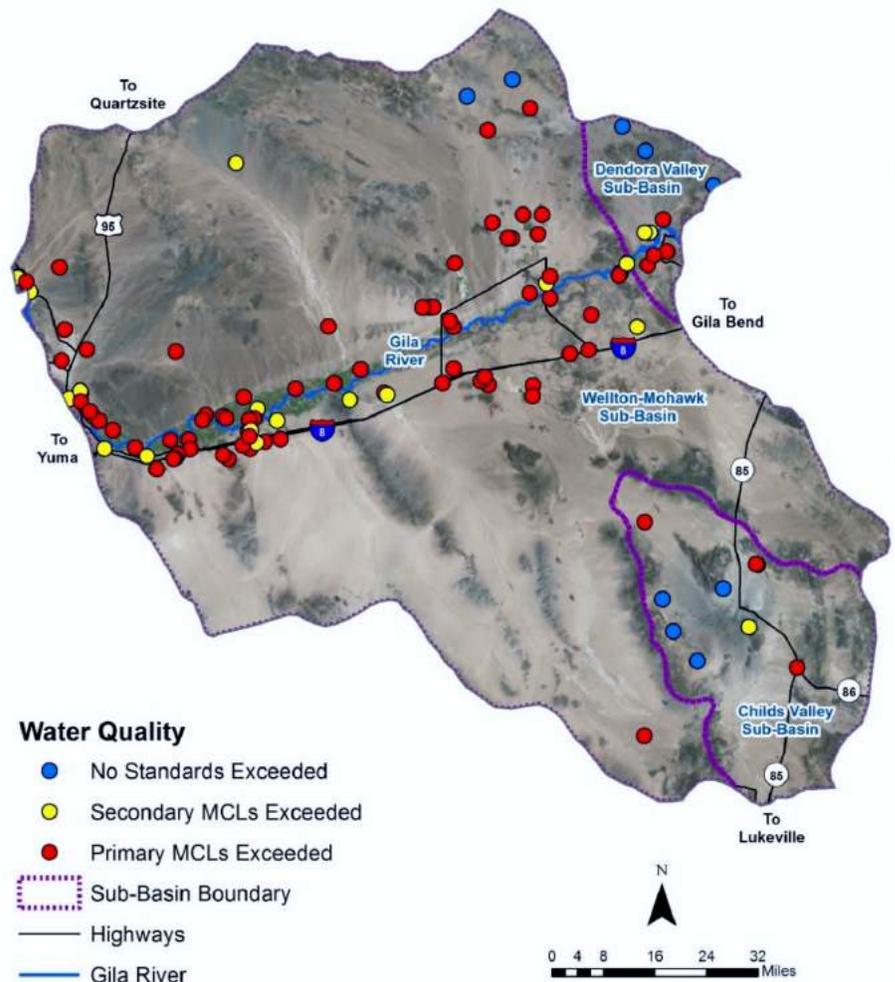
Figure 5 - Water quality status of sampled sites in the Lower Gila basin.

Of the 108 wells sampled, 9 (8 percent) met all drinking water quality standards. Health-based, Primary MCLs were exceeded at 78 sites (76 percent). Aesthetics-based Secondary MCL water quality guidelines were exceeded at 97 sites (90 percent) (Figure 5).

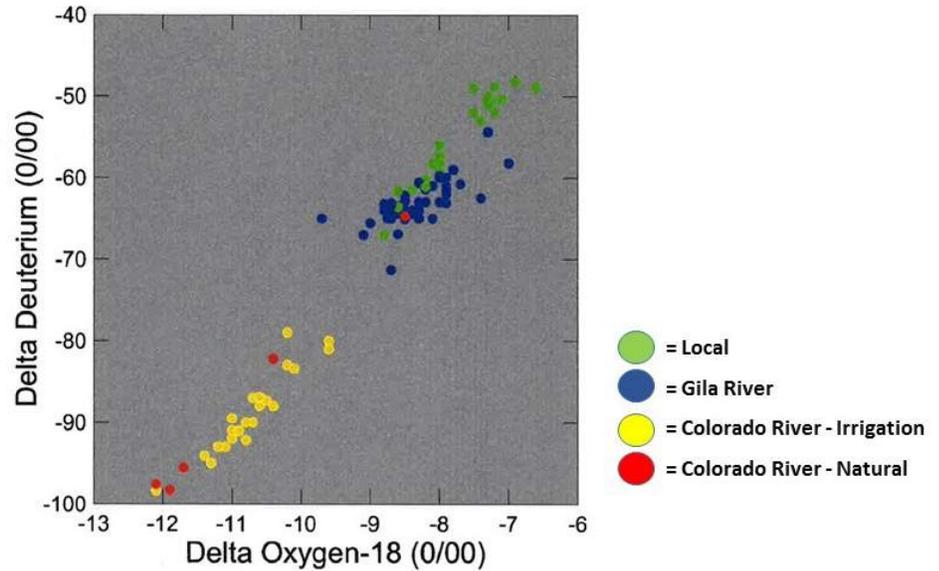
Figure 6 - Stable isotopes of oxygen and hydrogen illustrate the four groundwater recharge sources.

sources: local precipitation, Gila River, Colorado River-natural and Colorado River-artificial (Figure 6). Some mixing, however, is evident between the groups. Usually, local rainfall recharge samples are the most evaporated, Gila River recharge occurring at higher elevations in Arizona is less evaporated, and Colorado River recharge that occurs at higher elevations in Wyoming and Colorado is the least evaporated.

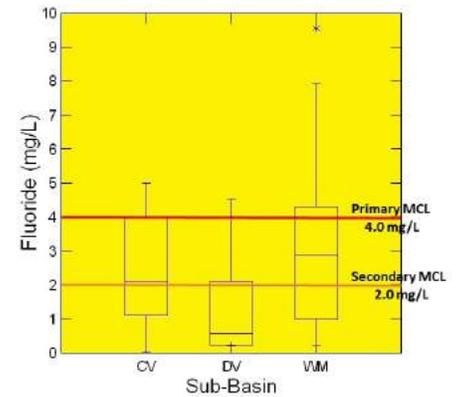
Figure 7 - Fluoride concentrations are significantly higher in the Wellton-Mohawk sub-basin than in the Dendora Valley sub-basin.

A few constituents had significantly different concentrations by sub-basin, such as fluoride (Figure 7), along with the stable isotopes of oxygen-18 and deuterium (Kruskal-Wallis with Tukey test, $p \leq 0.05$).

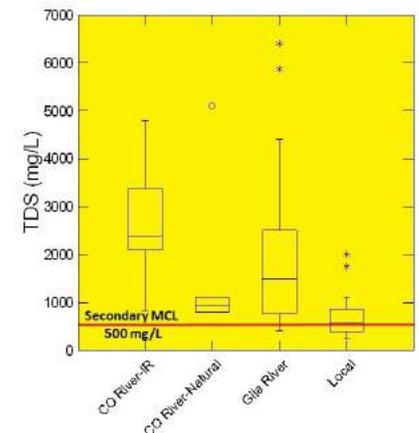
Figure 8 - TDS concentrations are highest in groundwater recharged from Colorado River or Gila River are significantly higher than from local recharge.

Many constituent concentrations were significantly different when compared by recharge source. Colorado River water recharged from irrigation applications typically had higher constituent concentrations than Gila River recharge, which was significantly higher than local precipitation (Kruskal-Wallis with Tukey test, $p \leq 0.05$). Constituents following this general pattern include TDS (Figure 8), major ions, boron and strontium.

This ADEQ study revealed that Total Dissolved Solids (TDS) and major ion concentrations in groundwater recharged by the Colorado River is significantly higher than in recharge from Gila River or local precipitation. Recharge from the Gila River was typically also significantly higher for these constituents than in recharge from local precipitation (Kruskal-Wallis and Tukey tests, $p \leq 0.05$).

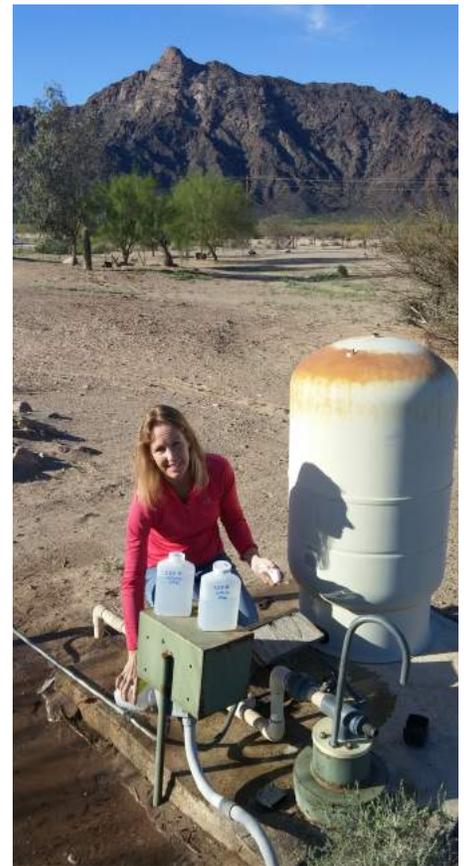
Figure 9 - ADEQ's Elizabeth Boettcher samples a domestic well near the Mohawk Mountains.

The Lower Gila basin comprises most of southwestern Arizona. Groundwater in most areas of the basin is not suitable for drinking water use without treatment (Figure 9). The basin contains some of the most challenging groundwater in Arizona, as judged by water quality standard exceedances and salinity levels.
