Project Name: Miracle Mile Remedial Investigation Report

**Time-Series Graphs**

**Selected Wells**

**Miracle Mile Remedial Investigation Report  
Tucson, Arizona**

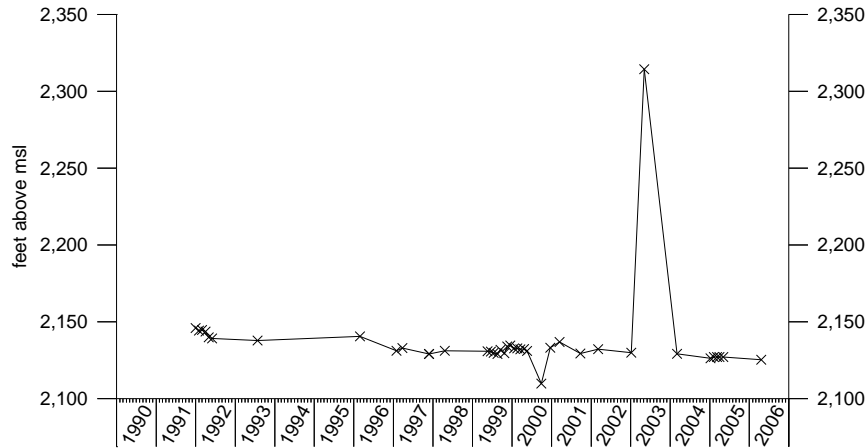
**GW Elevation  
Crescent Manor**

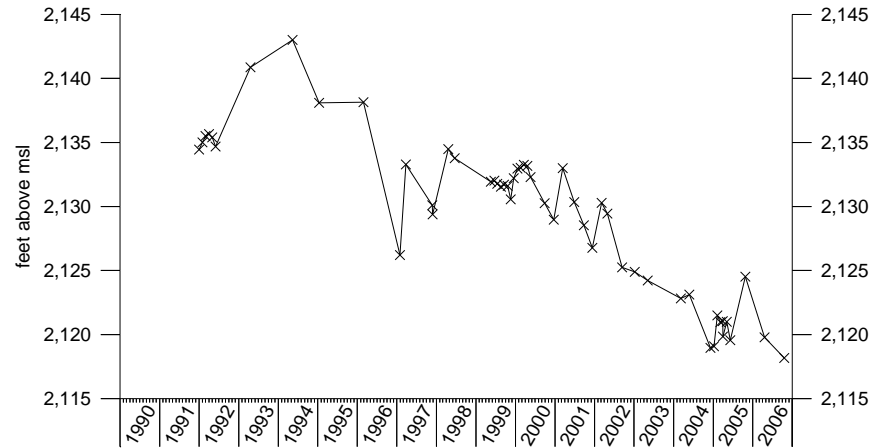
**GW Elevation  
Douglas**

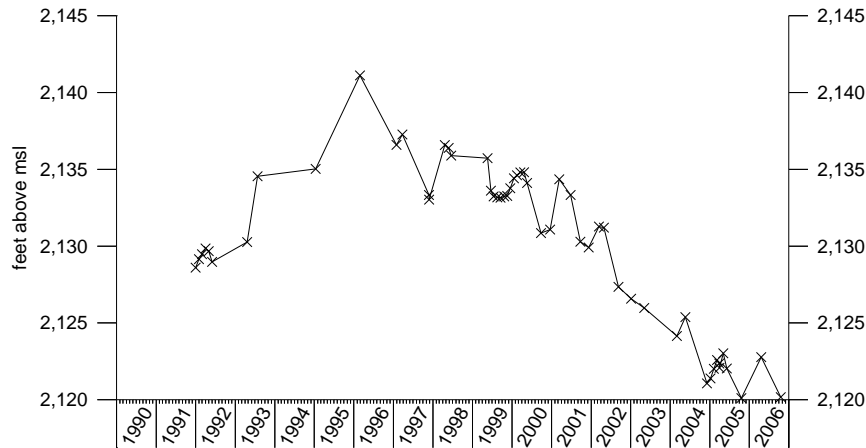
**GW Elevation  
IRA-1**

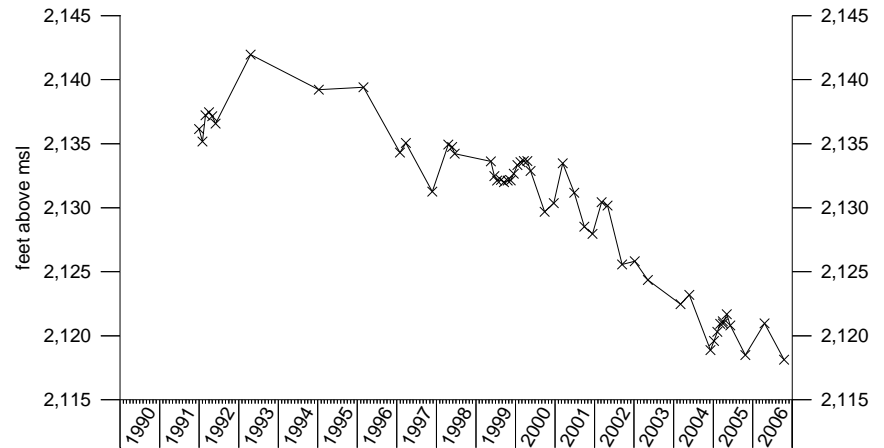
**GW Elevation  
IRA-2**

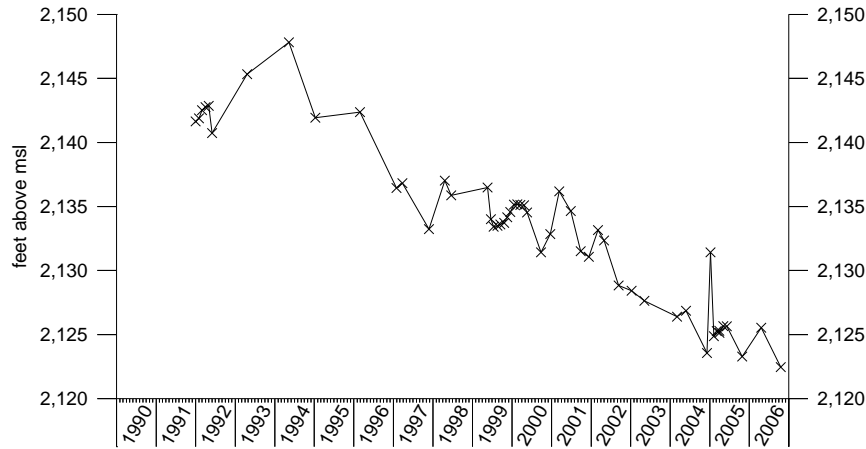
**GW Elevation  
IRA-3**

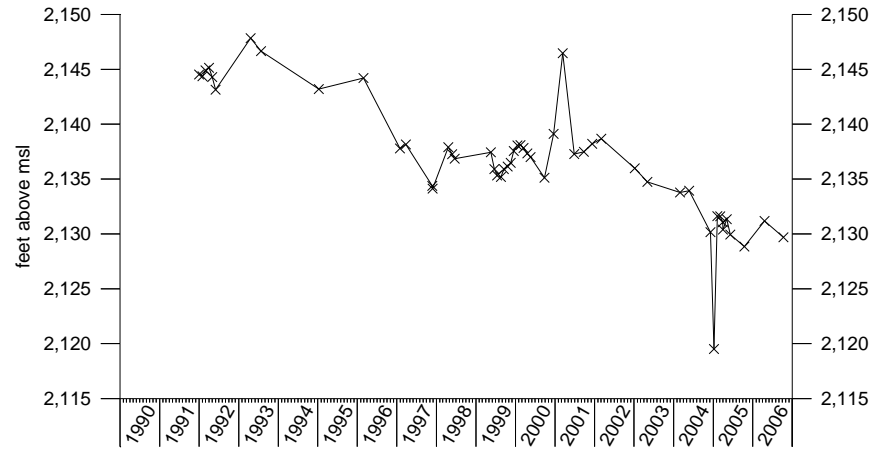
**GW Elevation  
IRA-4**

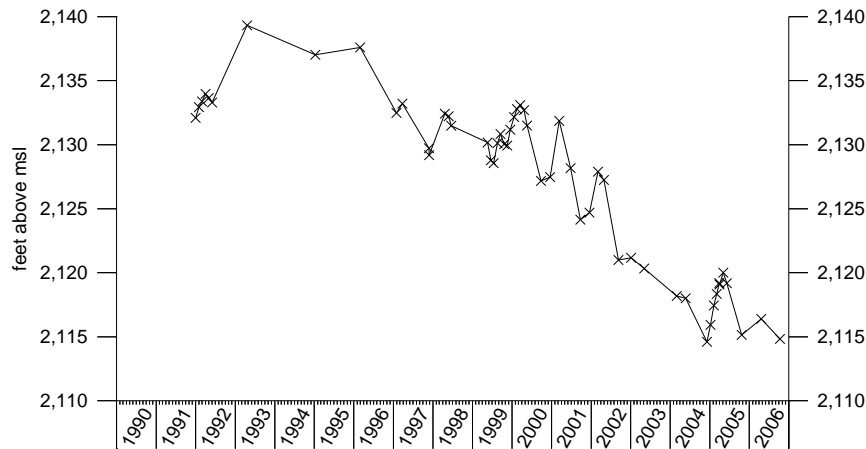
**GW Elevation  
IRA-5**

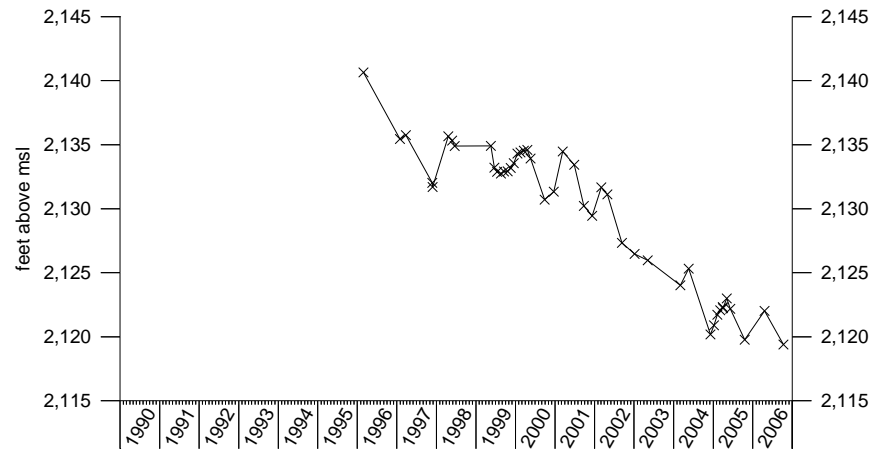
**GW Elevation  
IRA-6**

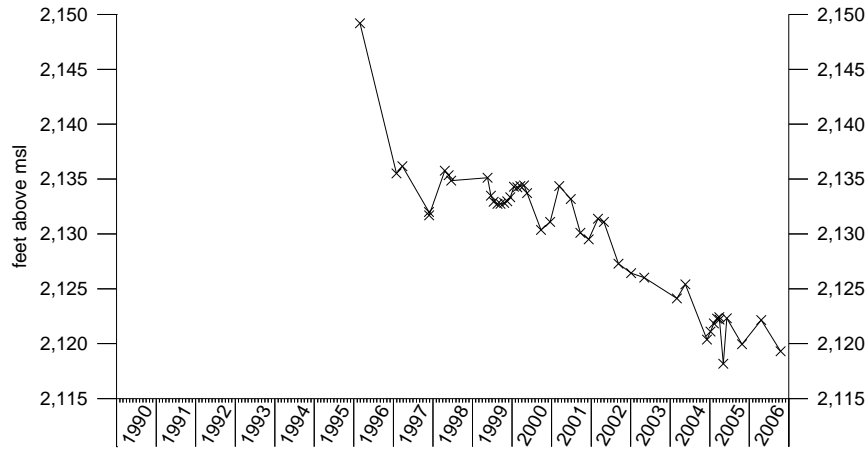
**GW Elevation  
IRA-7**

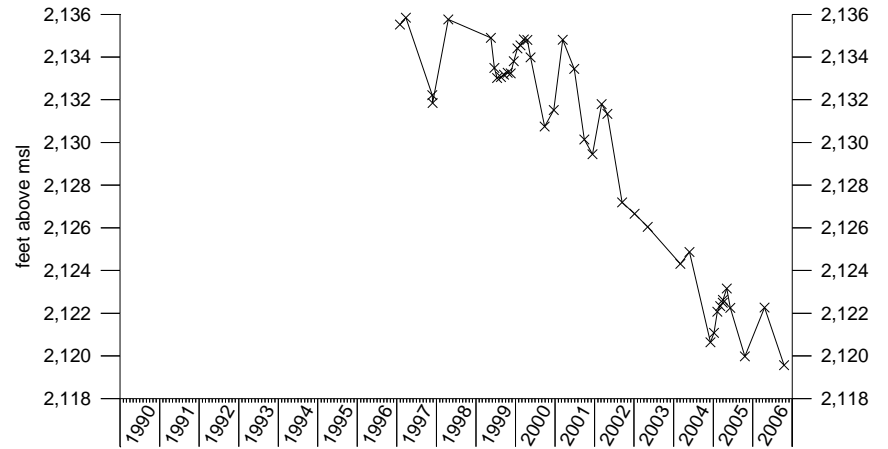
**GW Elevation  
IRA-8**

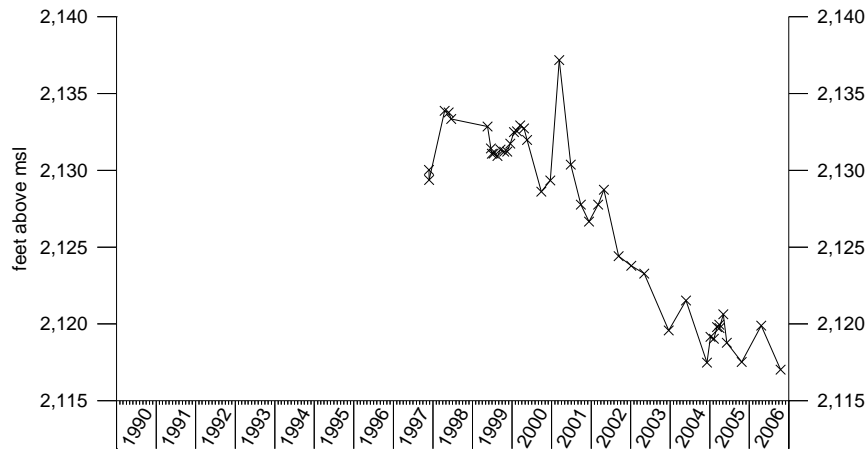
**GW Elevation  
IRA-9**

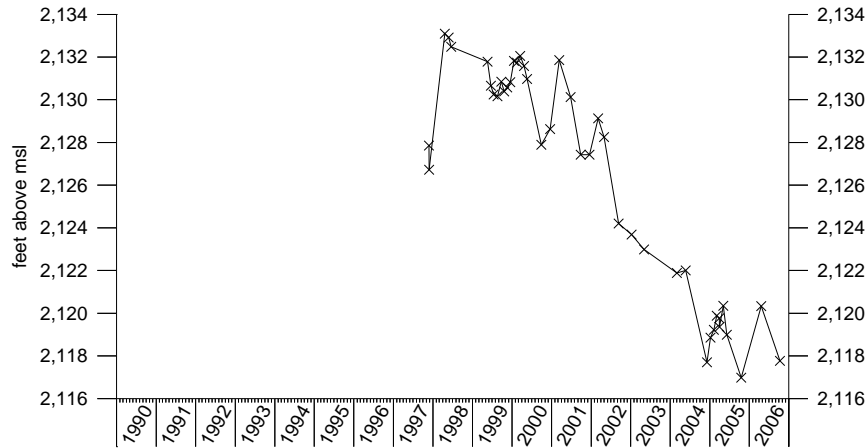
**GW Elevation  
IRA-10-230**

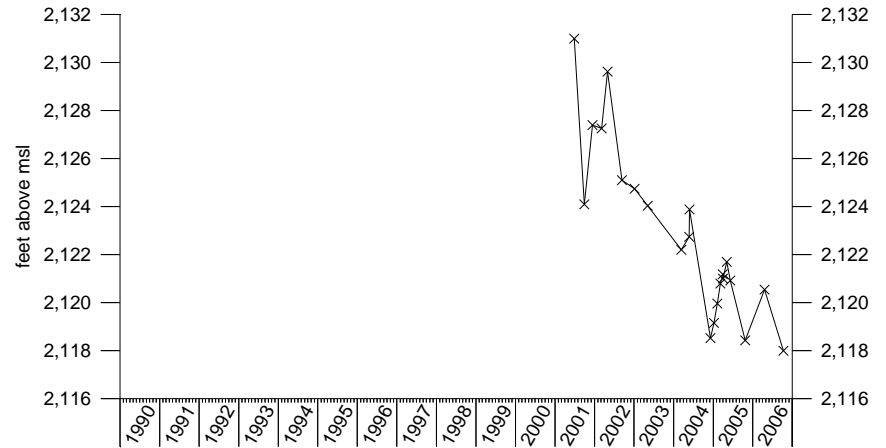
**GW Elevation  
IRA-11-210**

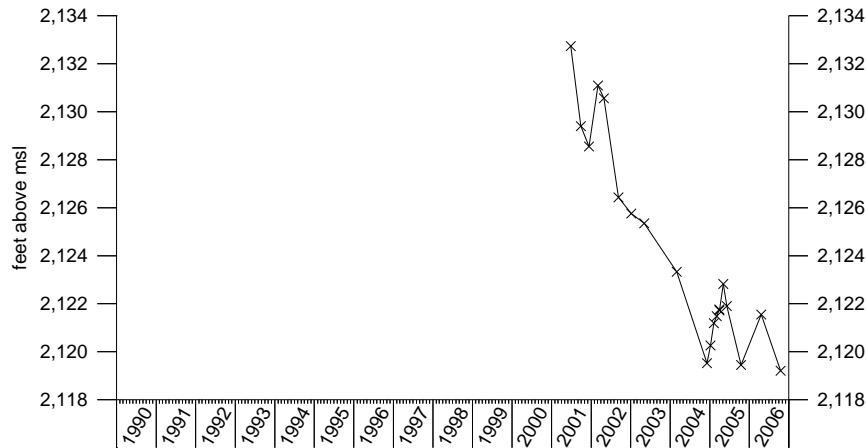
**GW Elevation  
IRA-12-210**

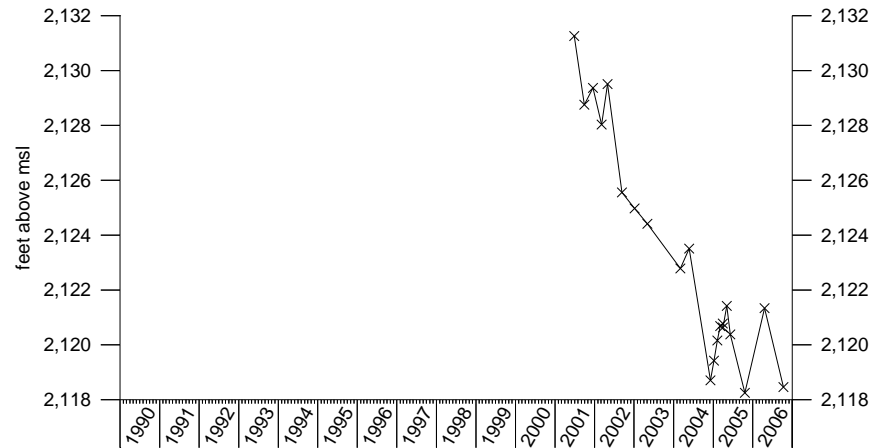
**GW Elevation  
IRA-13-210**

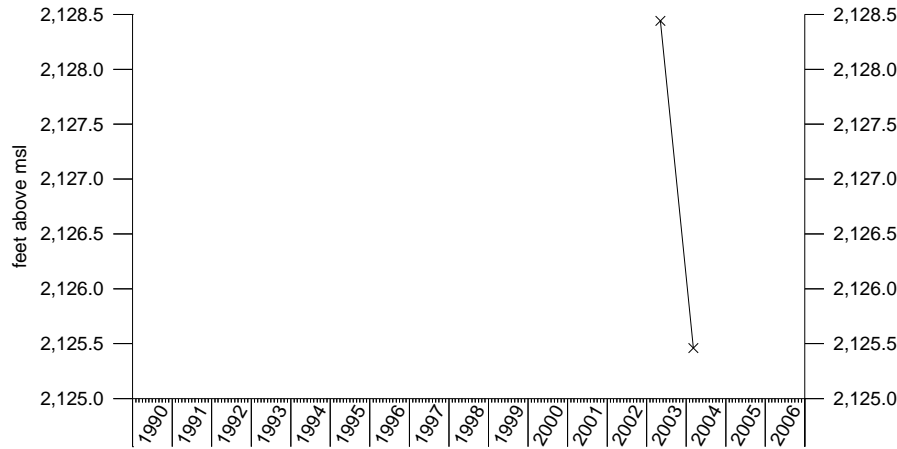
**GW Elevation  
IRA-14-1**

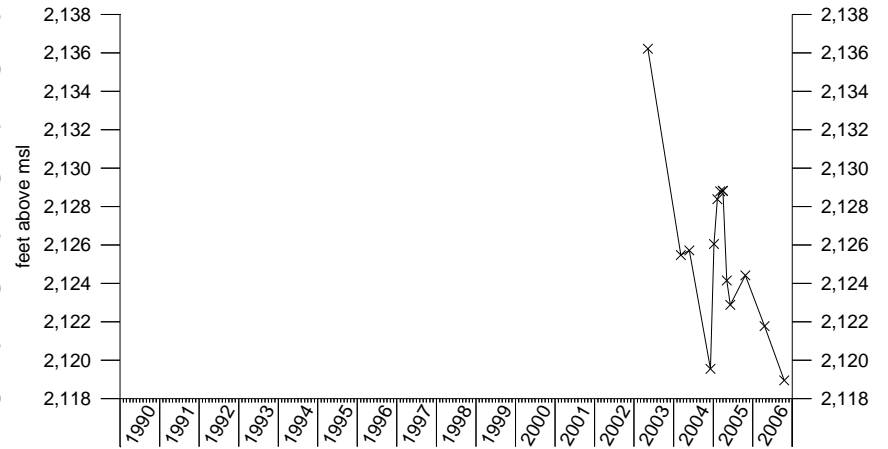
**GW Elevation  
IRA-14-2**

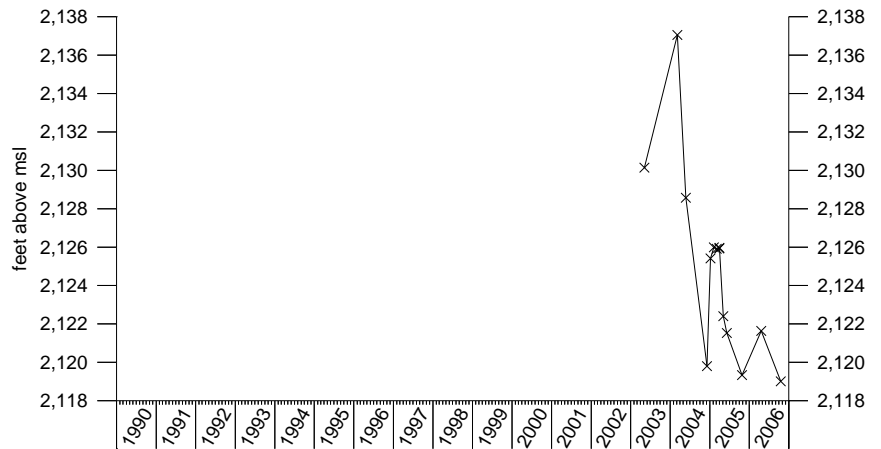
**GW Elevation  
IRA-14-3**

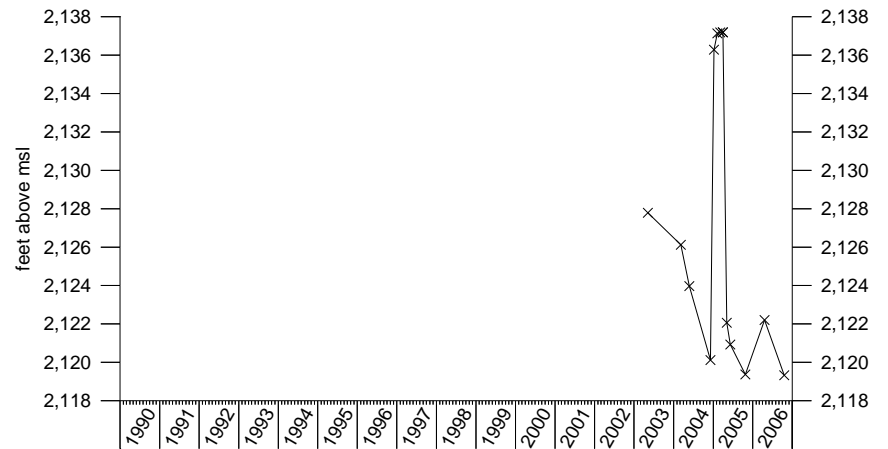
**GW Elevation  
IRA-14-4**

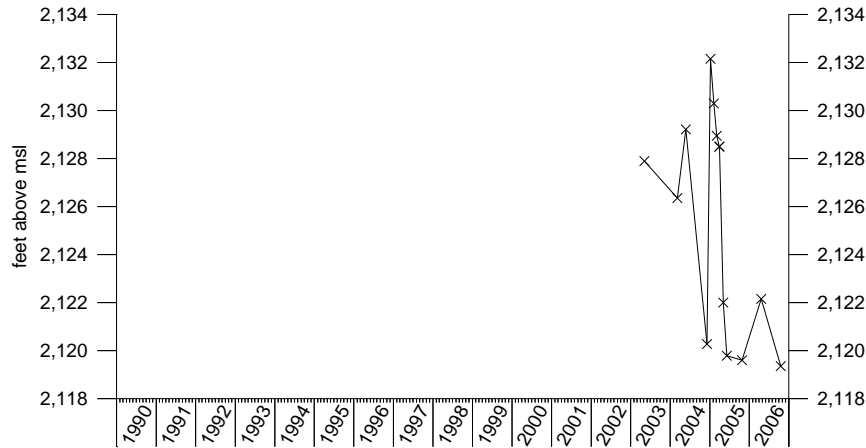
**GW Elevation  
IRA-14-5**

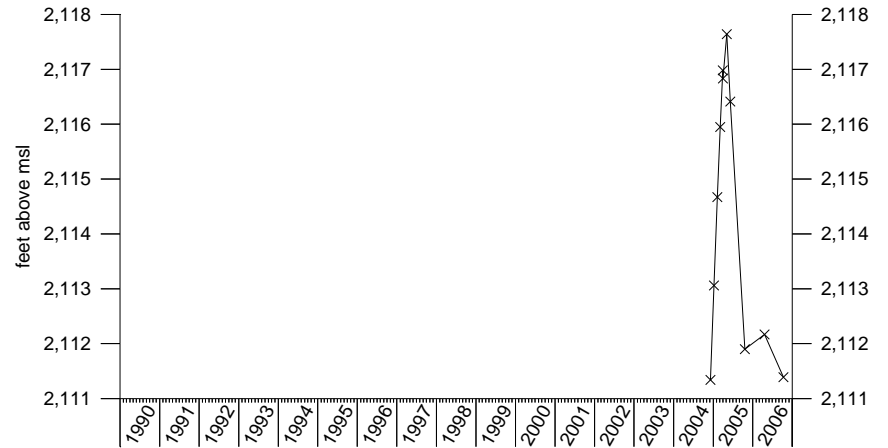
**GW Elevation  
IRA-24**

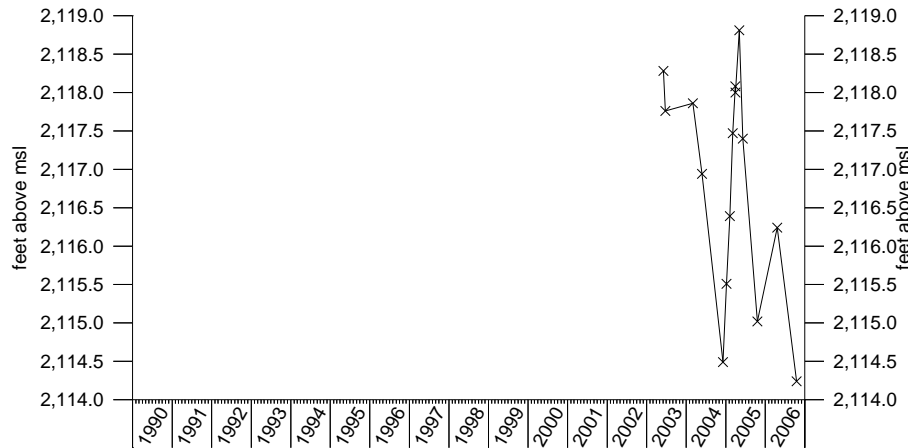
**GW Elevation  
IRA-25**

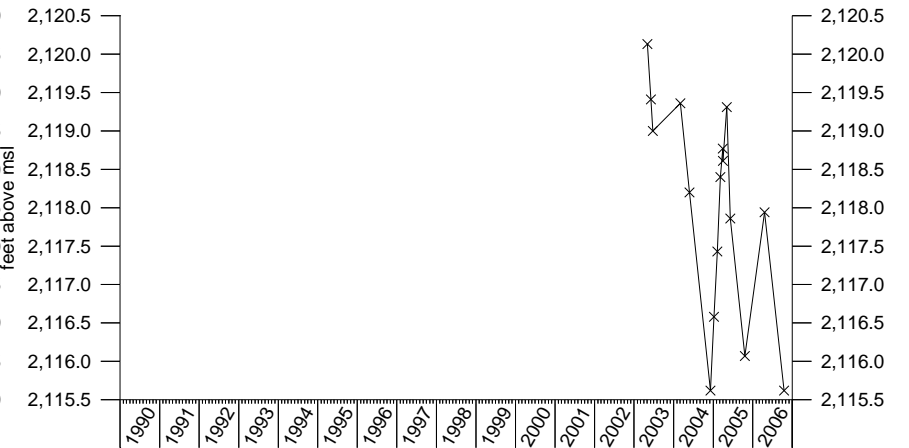
**GW Elevation  
IRA-26**

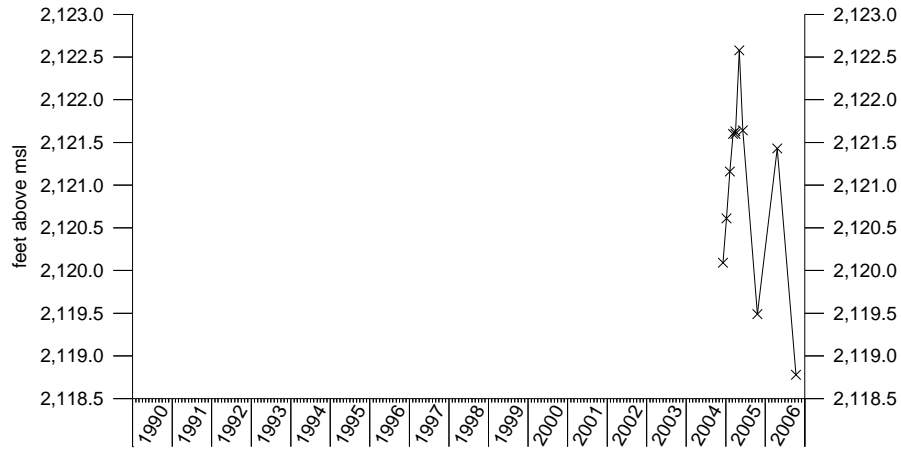
**GW Elevation  
IRA-31**

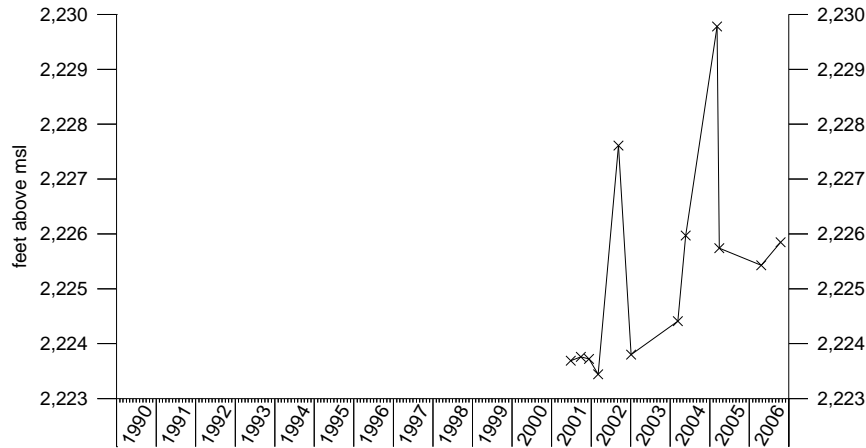
**GW Elevation  
IRA-11-70**

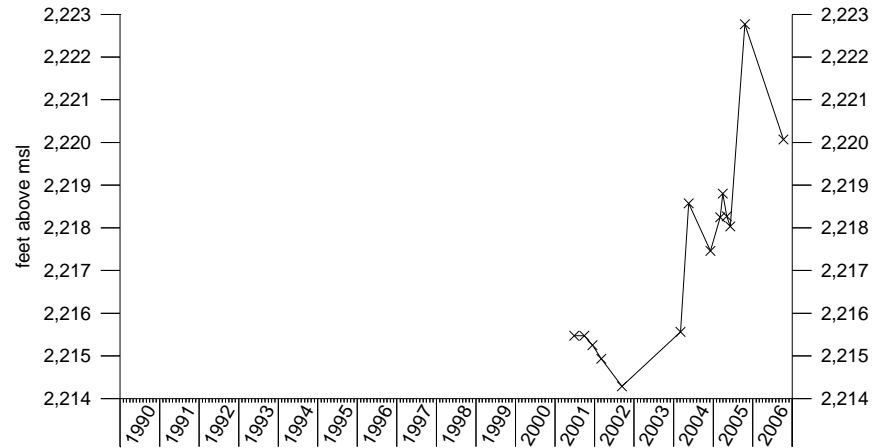
**GW Elevation  
IRA-12-70**

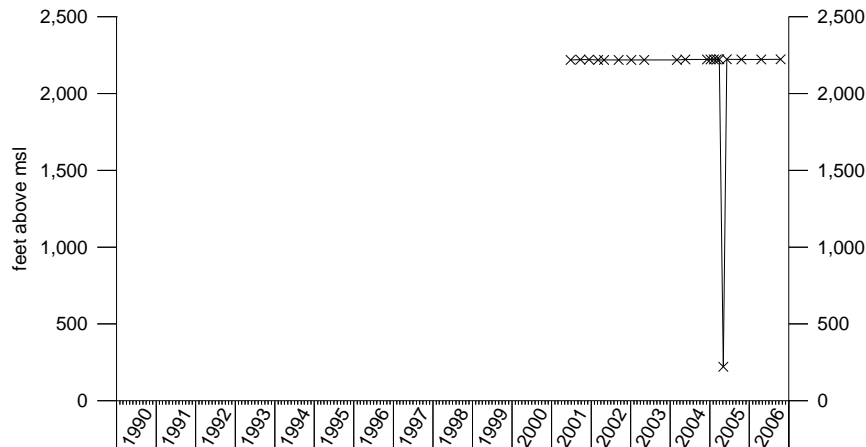
**GW Elevation  
IRA-16**

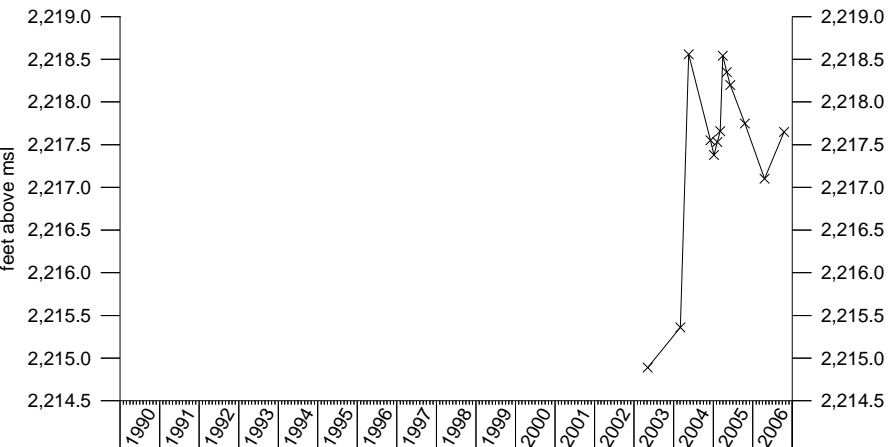
**GW Elevation  
IRA-17**

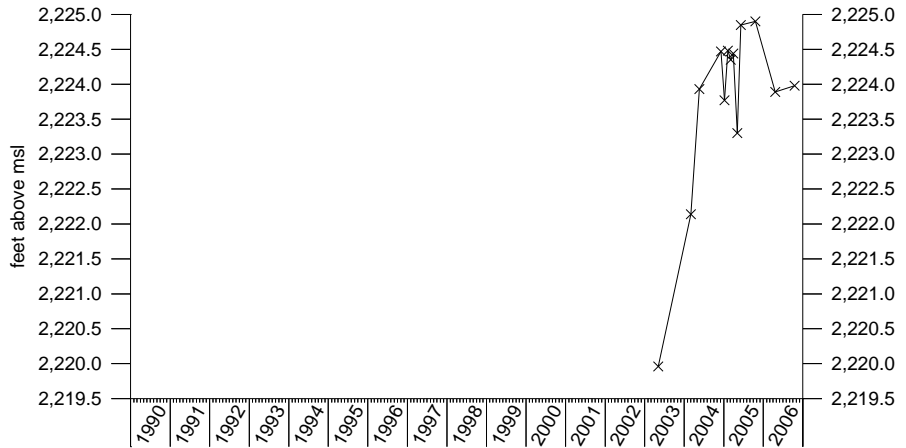
**GW Elevation  
IRA-19**

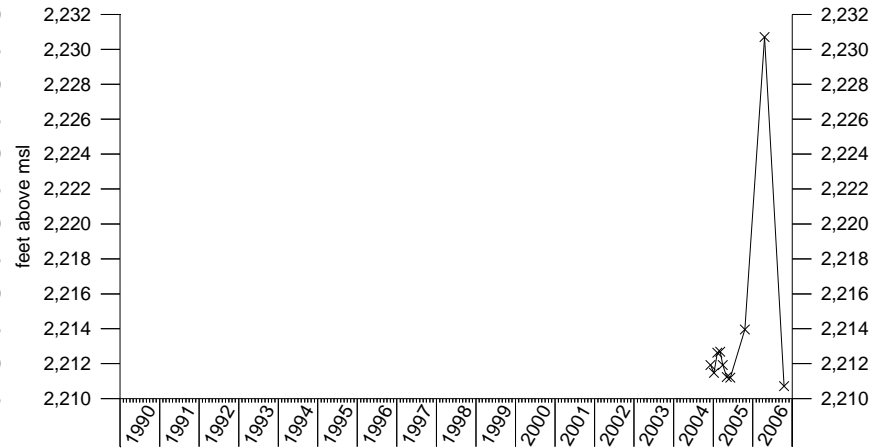
**GW Elevation  
IRA-20**

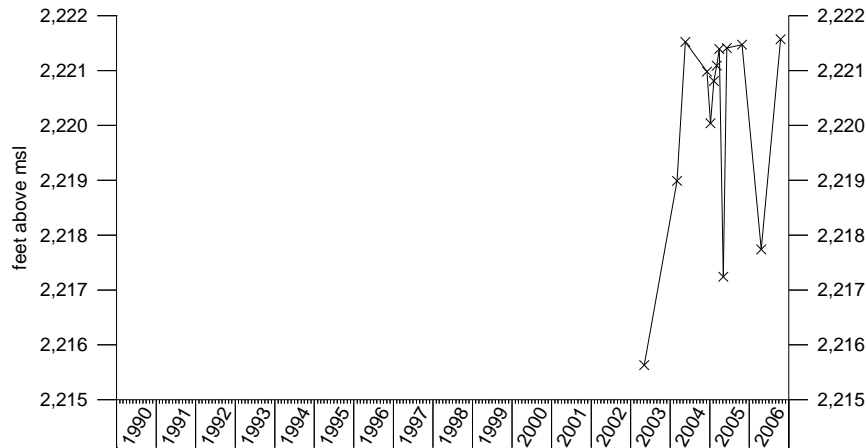
**GW Elevation  
IRA-21**

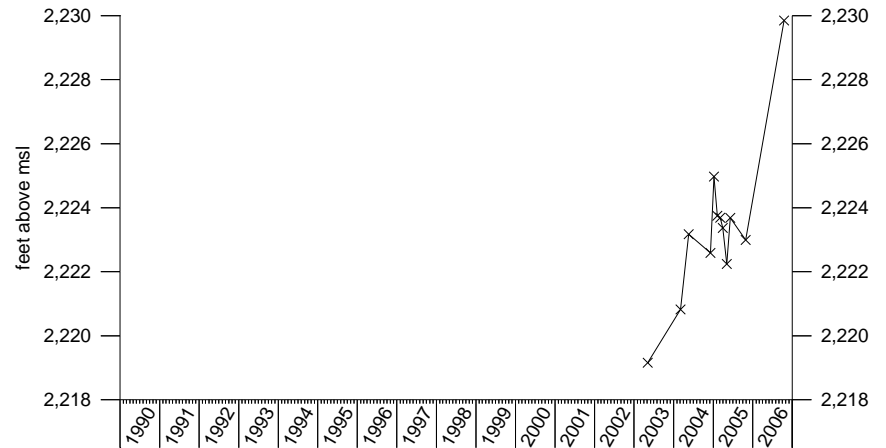
**GW Elevation  
IRA-22**

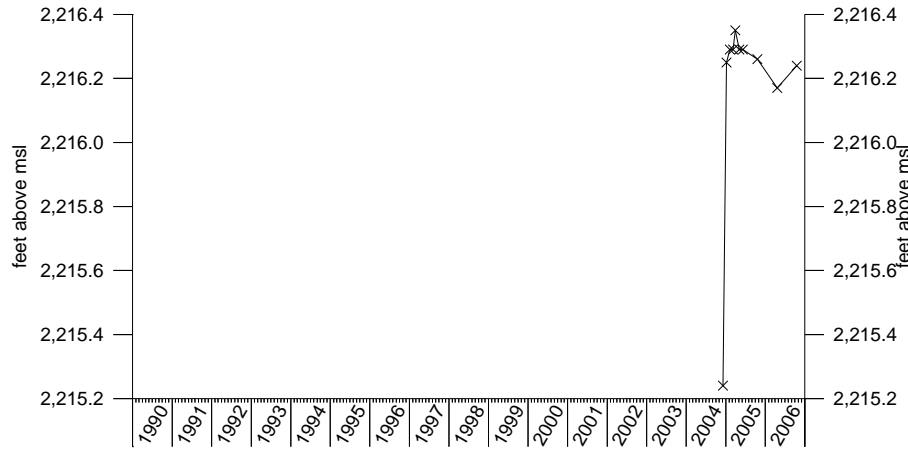
**GW Elevation  
IRA-27**

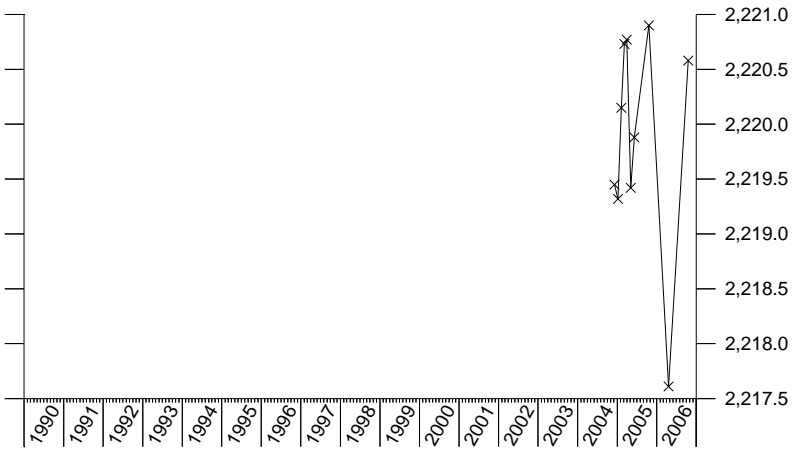
**GW Elevation  
IRA-29**

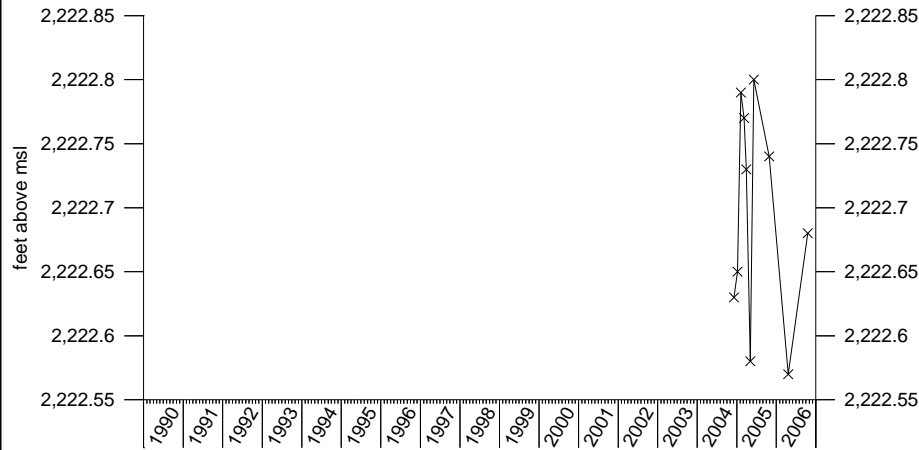
**GW Elevation  
IRA-30**
